Jimma University
School of Graduate Studies
Jimma Institute of Technology
School of Civil and Environmental Engineering
Department of Civil Engineering
Construction Engineering and Management Stream

**Assessment of Pavement Distress and Remedial Measures from Addis Ababa
to Gibe River Trunk Road**

By: - Michael Agonafir

October, 2016
Jimma, Ethiopia

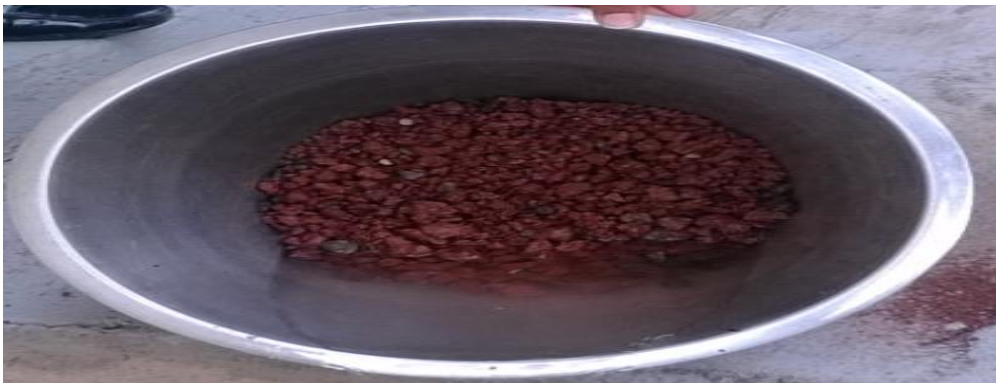
Figure 4.1: Red Cinder (Red Ash)

The laboratory test result of permeability on Table 4.1 indicate that the permeability of sub base is **K20 (Average) = 2.303×10^{-2} cm/sec**. According to Karl, T. (1967) the soil type is categorized under clean gravel, sand or gravel mixture and this type soil have good drainage property that means the soil have high permeability property (see Appendix-A on Table A5).

And also after washing the soil in laboratory the result shows that the soil was practically red cinder (red ash) as presented in Figure below 4.1.

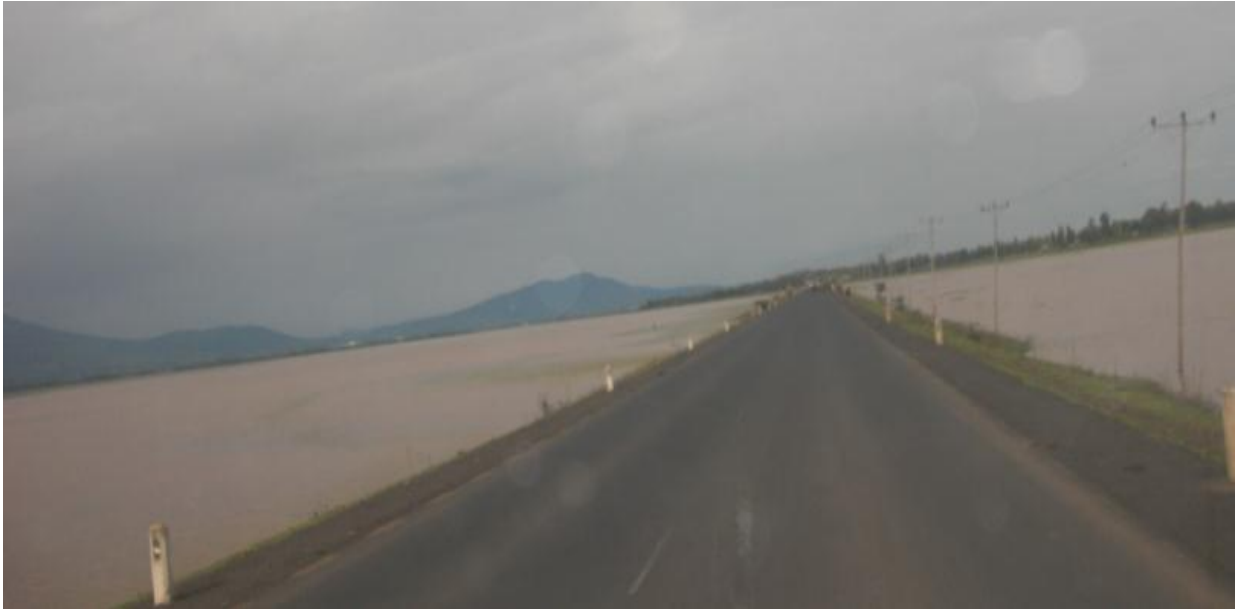
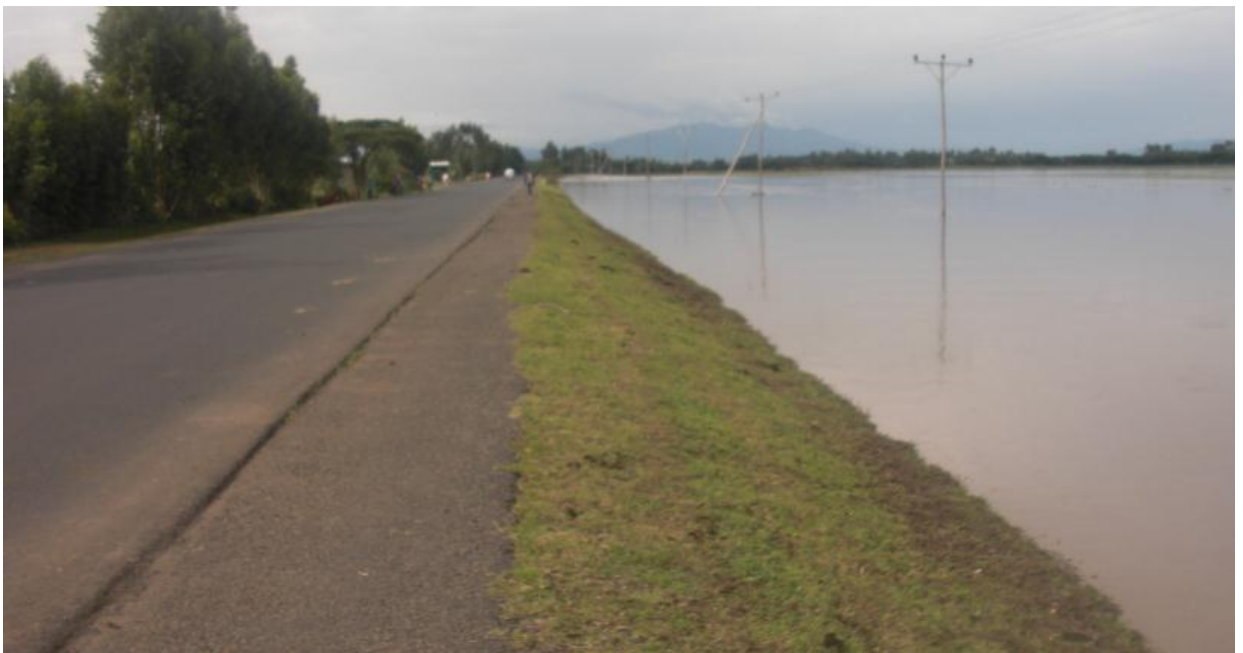
Figure 4.2: High Ponding of Water

Due to flat terrain type of the region there is high ponding of water of from Tefki to Tulu Bolo. And crack was the dominant problem in the region because of the permeability of sub base and fill material.

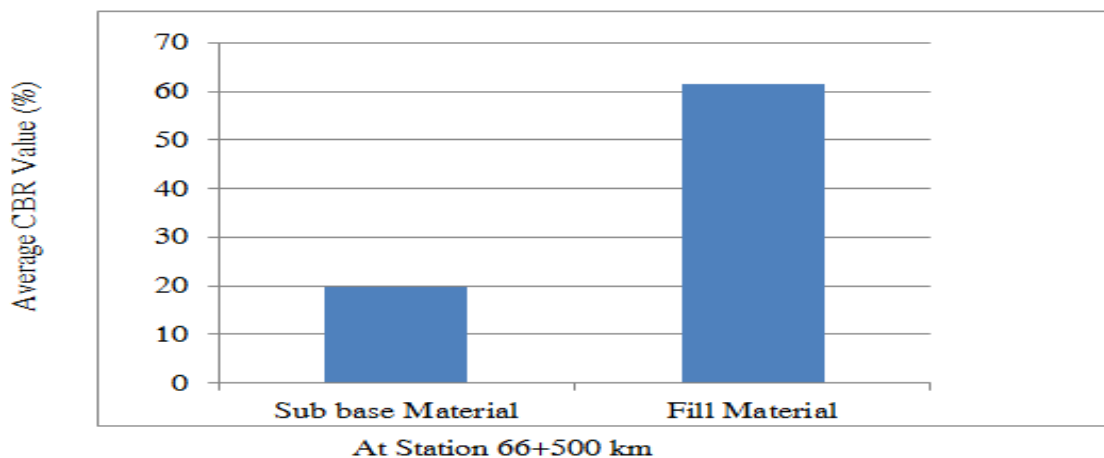
Figure 4.3: Average CBR Value of Sub base and Fill Material at Alligator Crack

Due to poor compaction of the sub base and highly permeable material at Station 66+500 it was dominantly affected by different types of pavement cracks. The embankment materials have good compaction but due to the soil type which is red cinder, the embankment allows moisture infiltration as a result of this shrinkage of pavement layer occurs, which finally propagates to the upper surface.

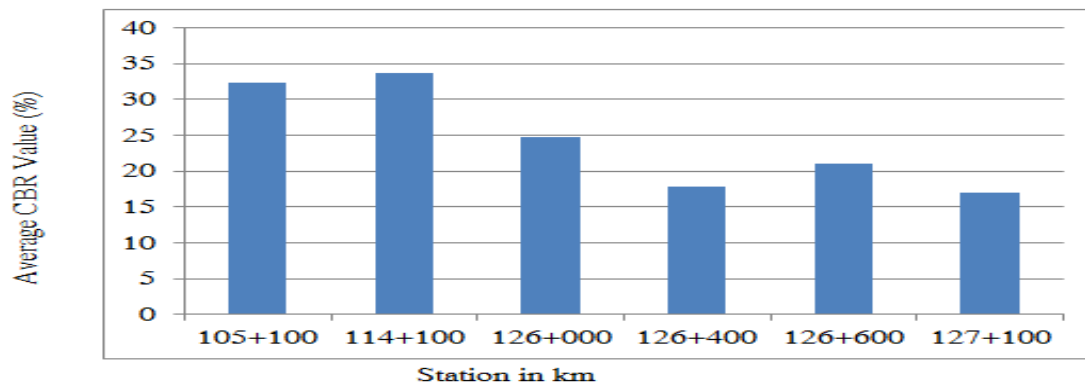
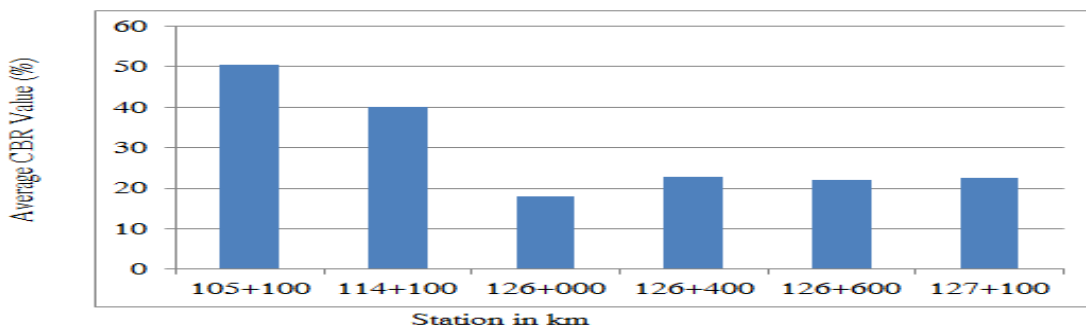
Figure 4.4: Average CBR Value of Sub base Material at Settlement or Depression area

Figure 4.5: Average CBR Value of Fill Material at Settlement or Depression area

Therefore, the CBR value indicates that settlement or depression of the pavement on the above station was occur due to poor compaction of sub base material.

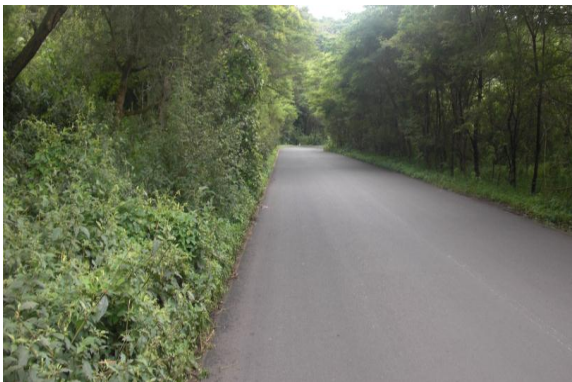
A. Vegetation on shoulder

- The area to receive bush clearing shall normally extend at least to the outer edge of the side drains [11].
- Vegetation shall be removed by cutting. The finished cut height shall be between 50 – 75 mm above ground surface. Plants shall not be uprooted as the root structure contributes to erosion resistance [11].

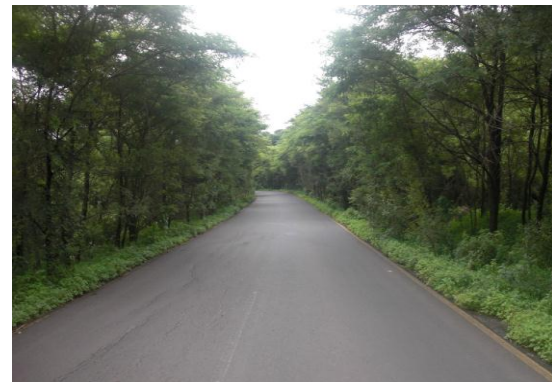
B. Vegetation on shoulder

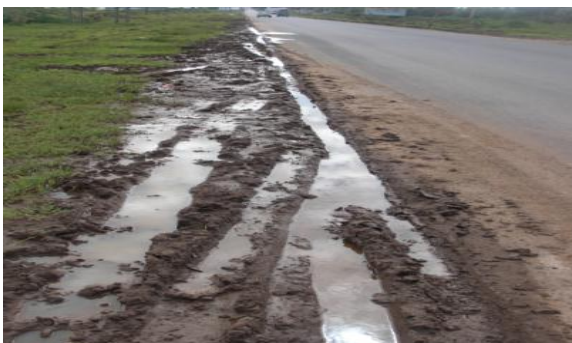
C. Silt- up on shoulder

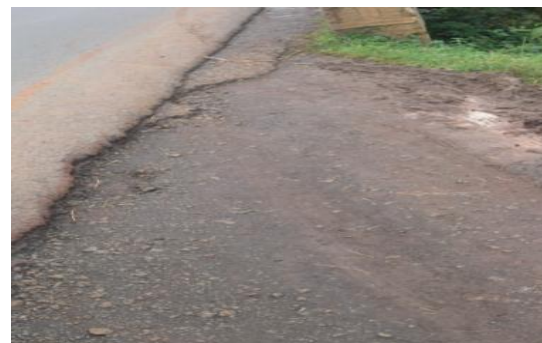
D. Scour on shoulder

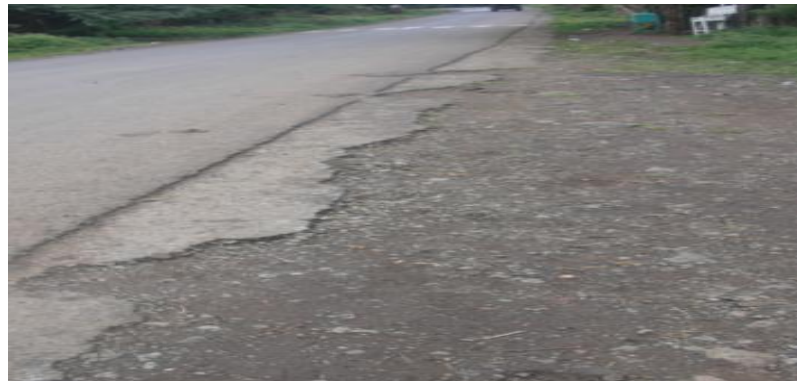
E. Shoulder deformation

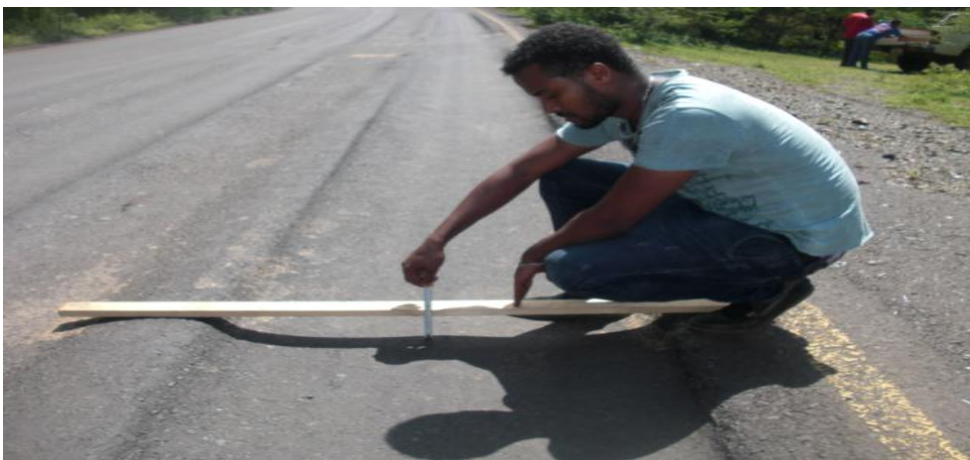
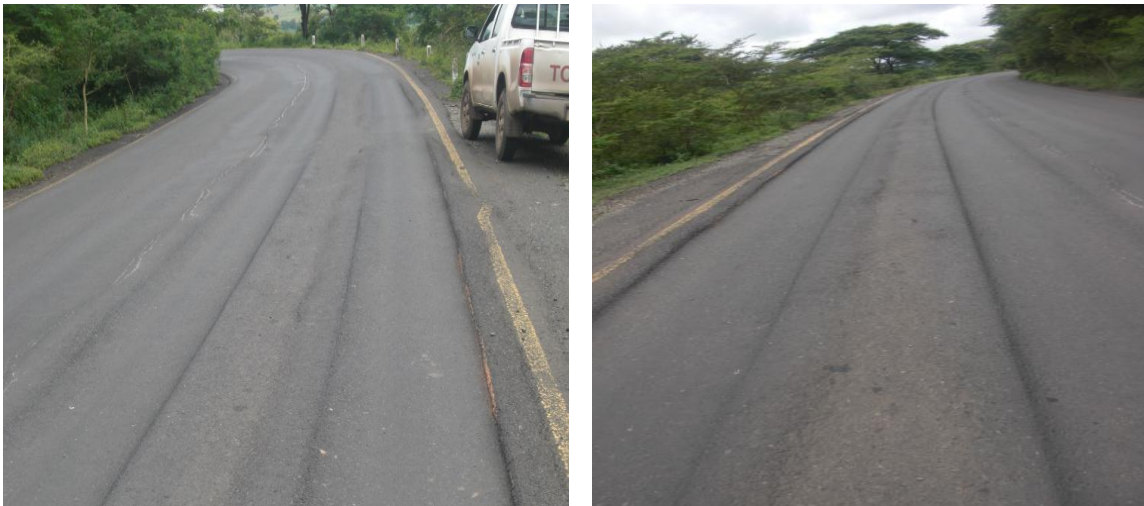
Figure 4.24: Rutting depth 10 cm (High Severity)

A heavily rutted pavement should be investigated to determine the root cause of failure (e.g. insufficient compaction, subgrade rutting, poor mix design or studded tire wear). Slight ruts (< 1/3 inch deep) can generally be left untreated. Pavement with deeper ruts should be leveled and overlaid [17].

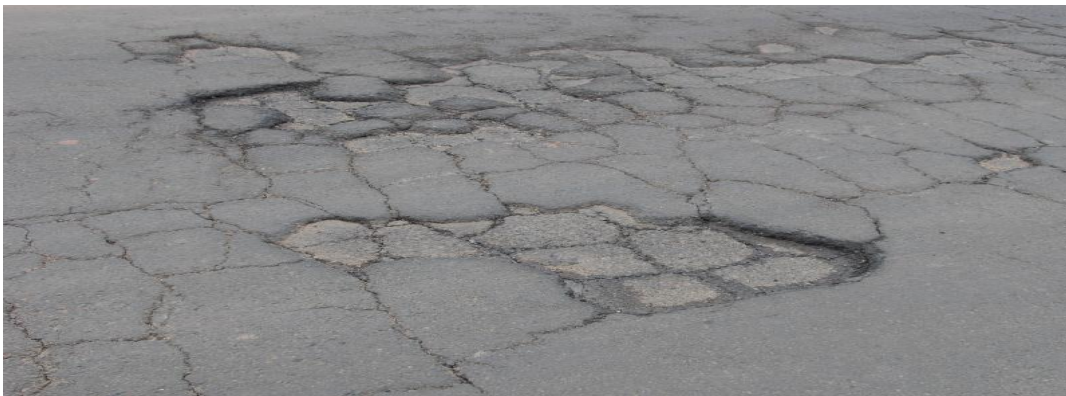
A. Patching on existing crack

- First remove highly defected area or properly clear dusts from the surface before spraying bitumen.
- Material gradation should be similar to the surrounding material.
- Apply proper compaction using roller [11].
- Care should be taken during joint construction.
- Production of asphalt mix should be at maintenance site or very nearby.
- Don't patch over the defect.
- Keep the Mix Temperature as per the specification for hot- mix asphalt.
- Use dry aggregate for mix [11].
- The maintenance should be level with the surrounding pavement.

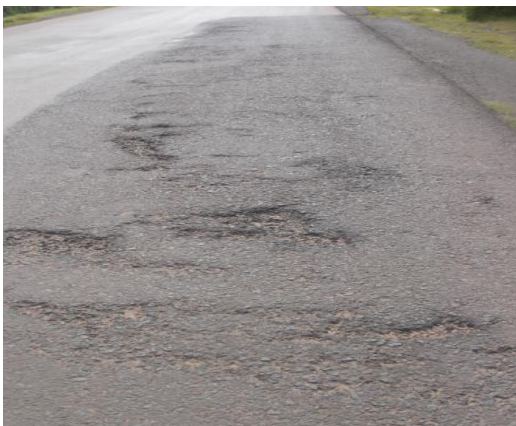
B. Raveling Due To Patching Problem

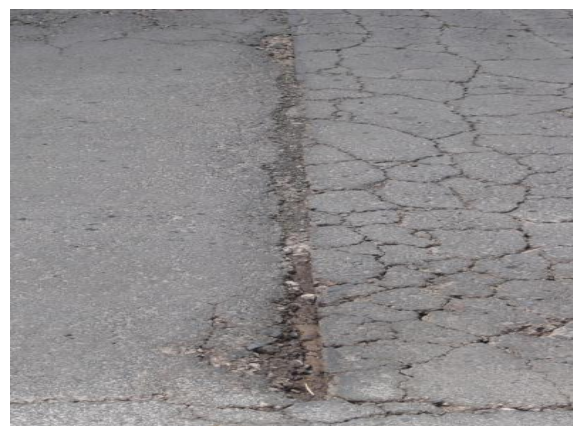
C. Poor Jointing Of Patching

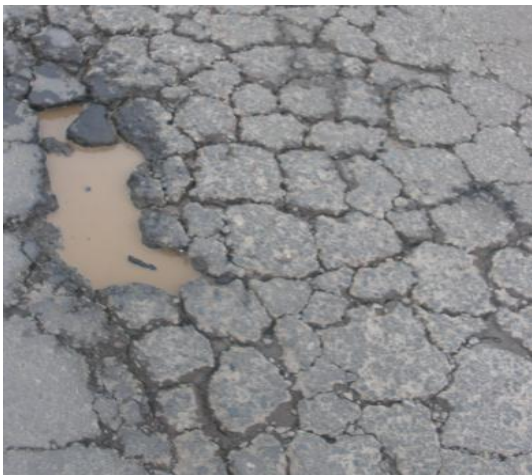
A. Pothole of low severity

- Remove water and dusts inside the pot hole using air compressor.
- Mark the area to be patched, extending outside the distressed area. The Outline should be rectangular with two sides at right angles to the direction of traffic. Cut the outline of the patch with a saw. Excavate as much pavement as necessary, including granular base and subgrade, to reach firm support. The faces of the excavation should be straight, vertical, and solid. Trim and compact the granular base or subgrade to establish a firm foundation. Apply tack to the vertical edges of the excavation, and a prime or tack coat to the base of the excavation [2].

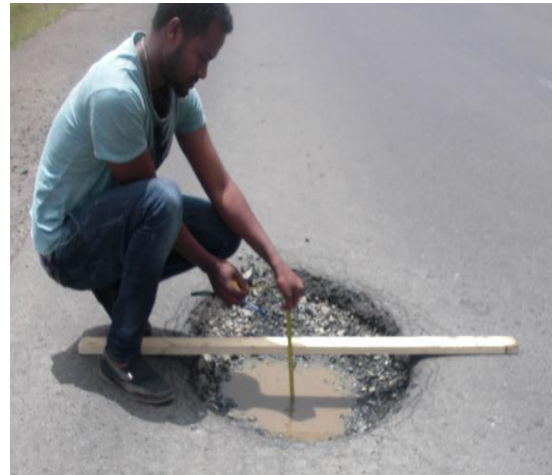
B. Pothole of high severity

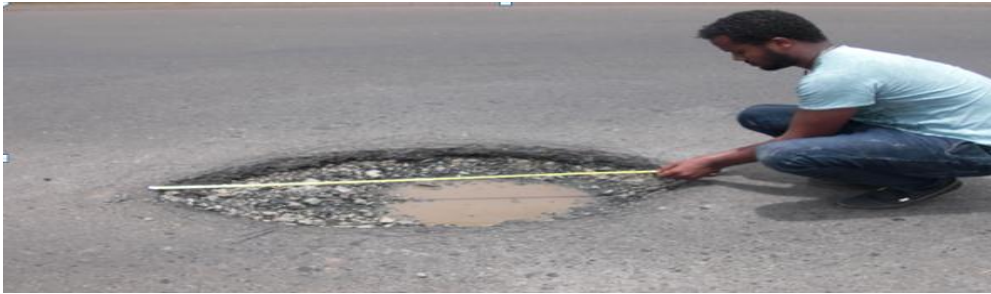
C. Pothole high severity
