**CAUSE OF FAILURE OF MICRO EMBANKMENT DAM AND REMEDIAL
MEASURES; A CASE OF GOMIT MICRO EMBANKMENT DAM, AMHARA
REGION, ETHIOPIA**

BY: GETASEW AYNALEM GEBEYEHU

**A THESIS SUBMITTED TO SCHOOL OF GRADUATE STUDIES OF JIMMA
UNIVERSITY IN PARTIAL FULFILLMENT OF THE REQUIREMENTS FOR
DEGREE OF MASTERS OF SCIENCE IN HYDRAULIC ENGINEERING**

November, 2016
Jimma, Ethiopia

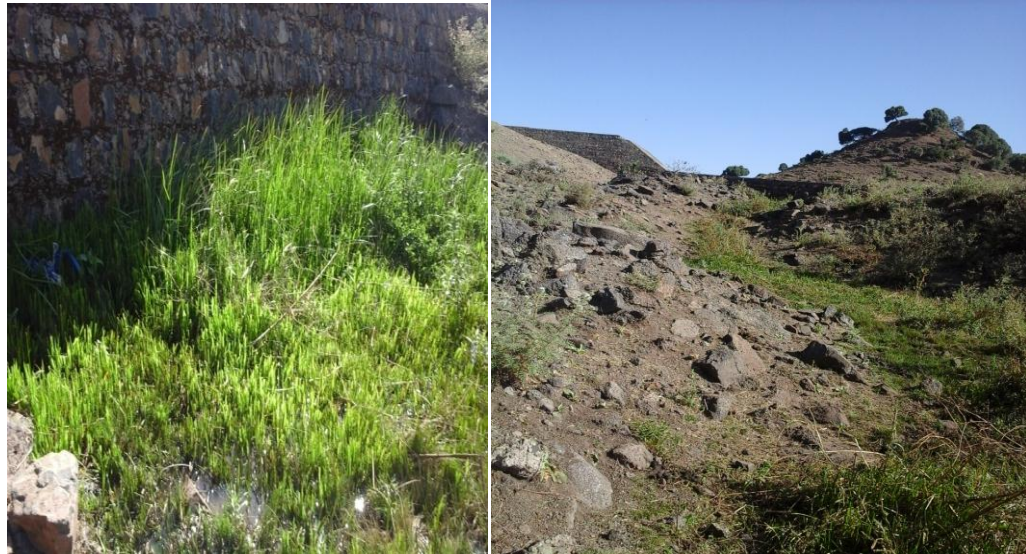
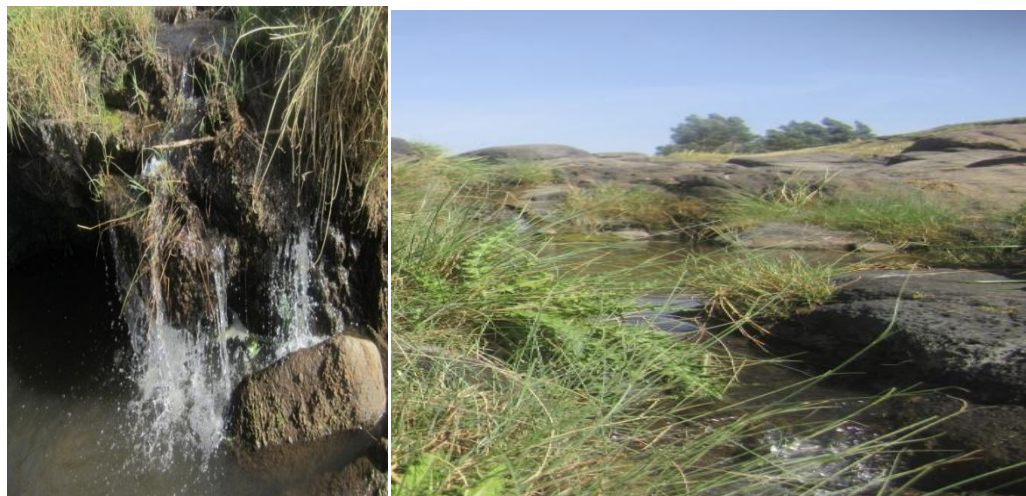
Significant amount of water that seeps from the left dawn stream part of the dam and leakage at the right part of the spillway was clearly observed. In addition to these sloughing of downstream toe, wet spots or muddy areas, growth of greener grass on dawn stream toe and right side of the spill way and surrounding areas, was clearly observed on the study area, it may indicate the presence of concentrated seepage failure.

Figure 12 a and b, Location of seepage at right side of the spillway and downstream toe of the dam

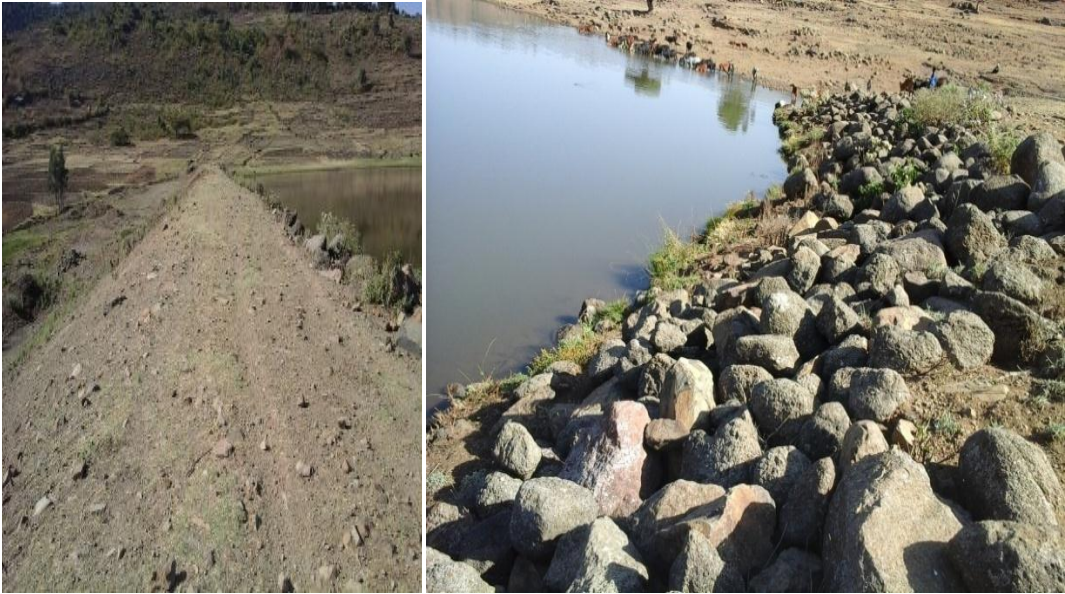
Figure 13 GMED crest and upstream riprap

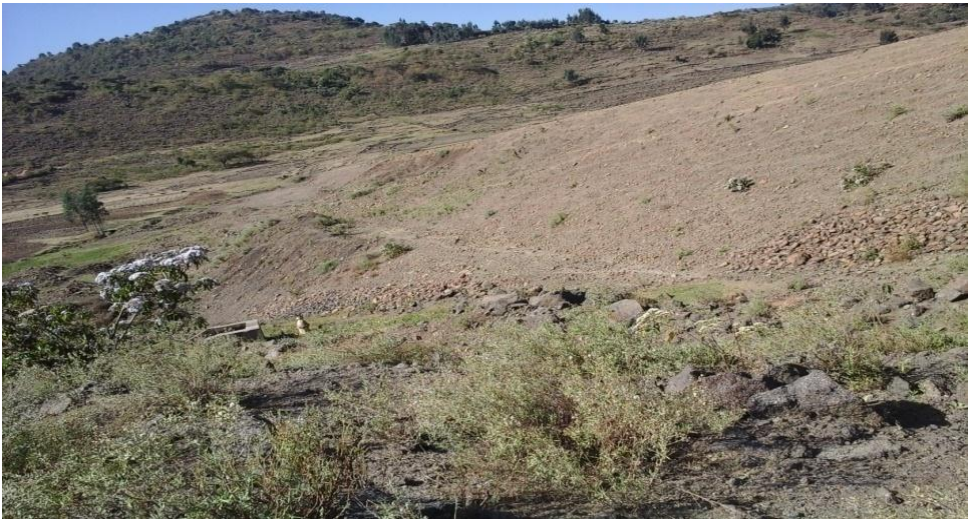
The other problem observed during inspection was embankment sliding, the dawn stream slope settlement is clearly observed at the right part of the dam. Which is indicated the presence of structural failure on the dam.

Figure 14 Downstream face of GMED

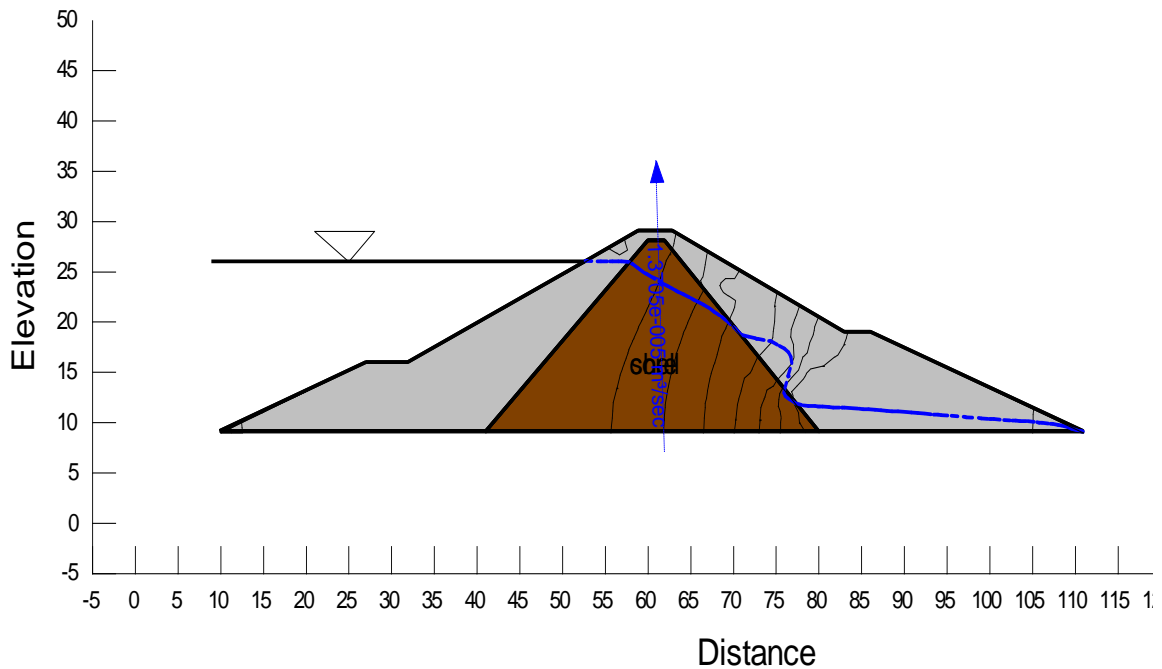
Figure 16 Seepage analyzed for zoned dam without horizontal filter

The estimated quantity of seepage by SEE/W software model for zoned dam without horizontal drainage filter is $1.3705 \times 10^{-5} \text{m}^3/\text{s}/\text{m}$ which is located at the center of the dam. See figure 16.

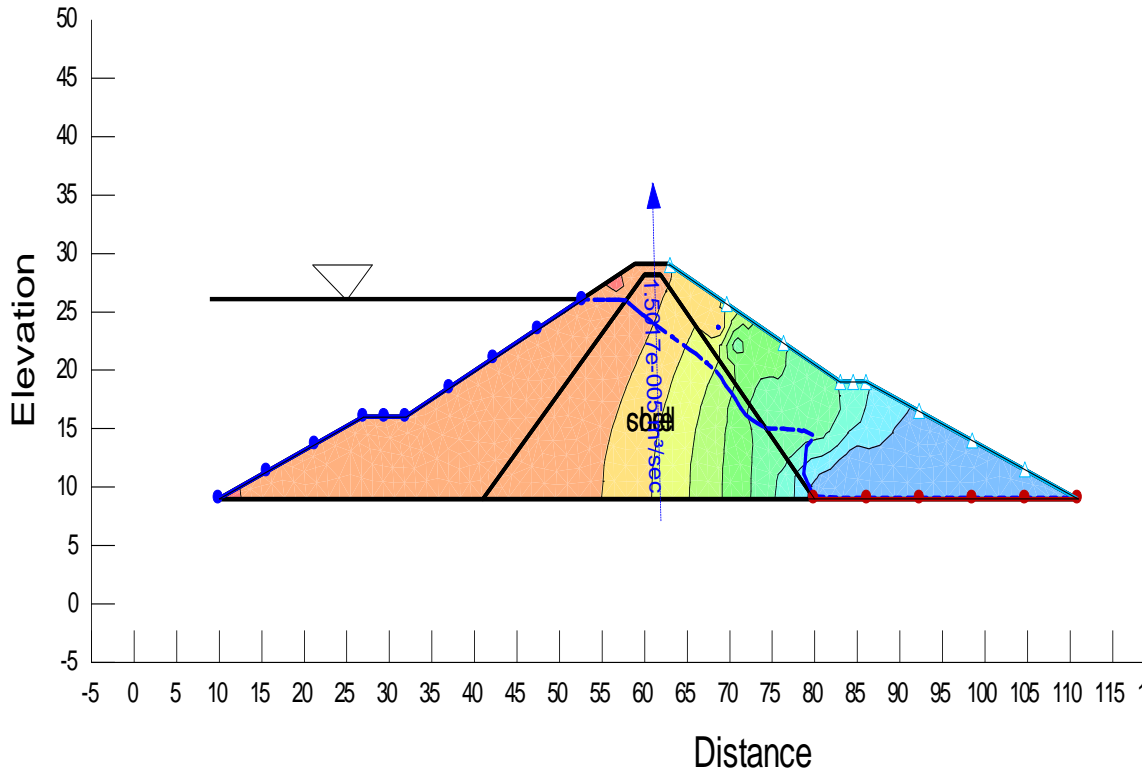
Figure 17 Seepage analyzed for zoned dam with filter

The estimated quantity of seepage for zoned dam with consideration of horizontal drainage filter is $1.5017 \times 10^{-5} \text{ m}^3/\text{s}/\text{m}$ which is located at the center of the dam. See figure 17.

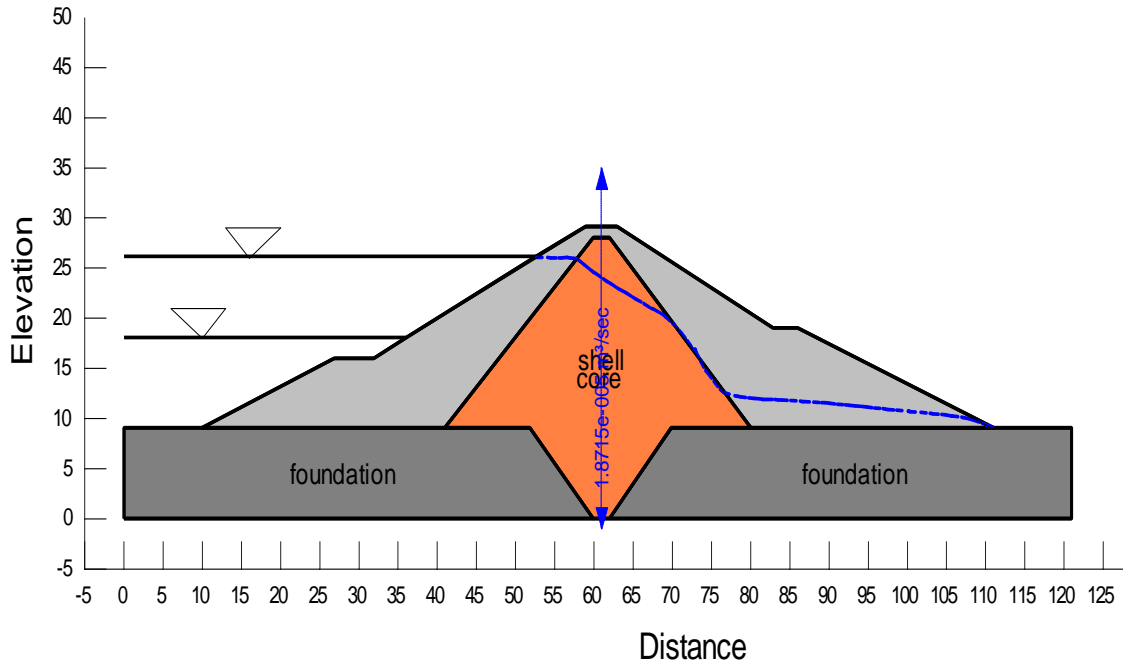
Figure 18 Seepage analyzed for zoned dam with foundation and without filter

At the normal pool level the estimated quantity of seepage analyzed by the model is $1.87 \times 10^{-5} \text{ m}^3/\text{s}/\text{m}$ at the center of the dam without consideration of filter. See figure 18.

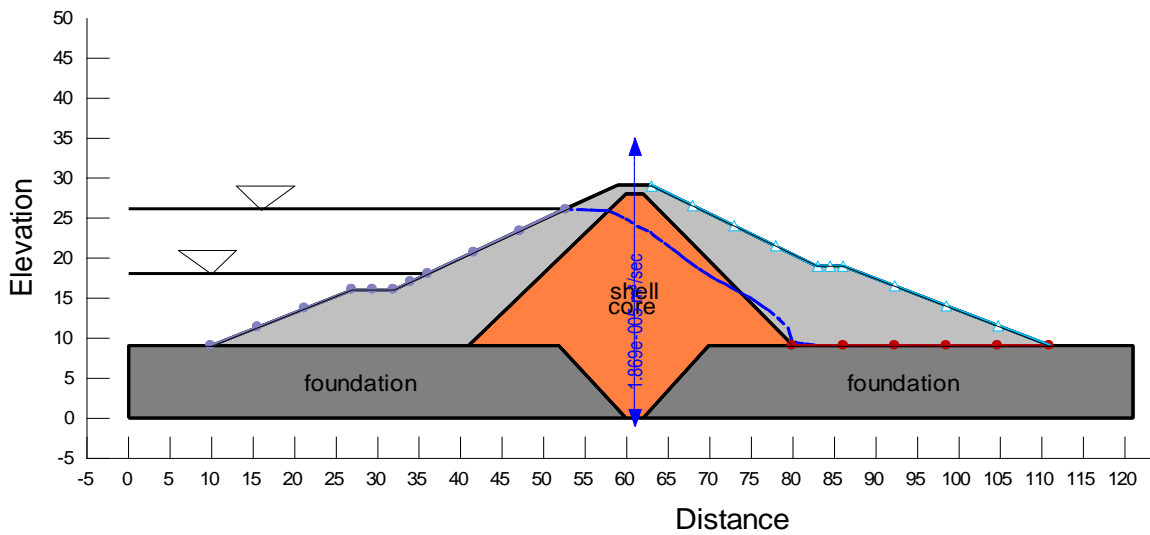
Figure 19 Seepage analyzed for zoned dam with foundation and filter

Similarly as shown from figure 19 quantity of seepage estimated with filter is $1.869 \times 10^{-5} \text{ m}^3/\text{s}/\text{m}$ which is located at the center of the dam.

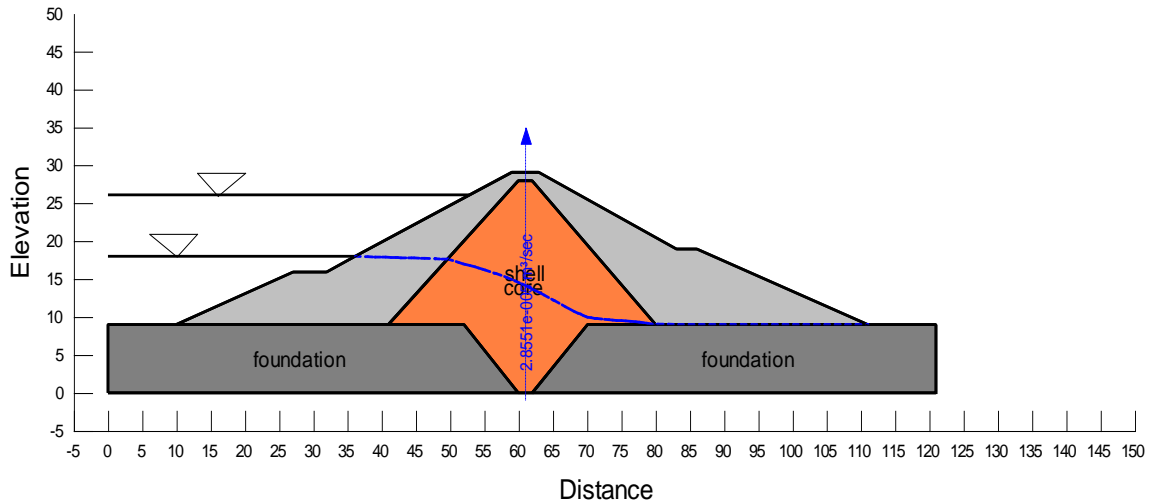
Figure 20 Seepage analyzed for zoned dam with foundation and filter at current water level

At the current water level = 9m which has gating from the report that has done by wereda super visor, the estimated quantity of seepage analyzed by the model is, $2.8551 \times 10^{-5} \text{ m}^3/\text{s}/\text{m}$ at the center of the dam with the consideration of d/s filter.
