INVESTIGATION OF THE CAUSES OF PREMATURE PAVEMENT FAILURES AND ITS ALTERNATIVE TREATMENTS

One of these roads failed before serving the design period is the Bedele - Metu road upgrading project, Lot - II (50.659 km) trunk road with 20 years design life. However, premature pavement failures have been manifested since the year 2017. The objective of this study is to assess the Causes of the premature pavement failures and also propose its alternative treatments. Hence, a desk study, field visual inspection and in-depth field and laboratory investigations have been undertaken.

The road condition survey indicates the existence of different types of distresses such as: potholes/patch failure, cracking, rutting, depression/failure, raveling/fretting and others. Field and laboratory investigation have been carried out and it shown that low air voids with void in mix result in a wearing course material <3%, such as 1%, that indicates the possible factor for occurrence premature pavement deformation. Also, insufficient surfacing layer thickness, such as 11.34 mm thickness difference would be the possible causes for the formation of surface deformation and workmanship problem of the asphalt

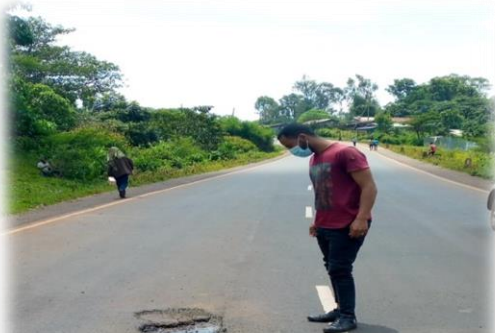
- Station: 62+200
- Longitude: 35.92506
- Latitude: 8.37063
- Defect Type: Potholes/Patch failure
- Pictured by: Eng. Asrat Getaye

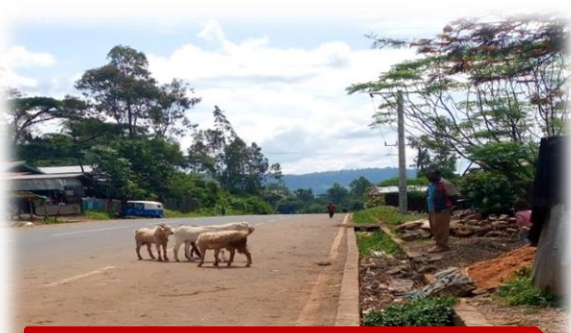
- Station: 61+900
- Longitude: 35.91925
- Latitude: 8.36877
- Defect Type: Siltation of Side Drainage
- Pictured by: Eng. Asrat Getaye

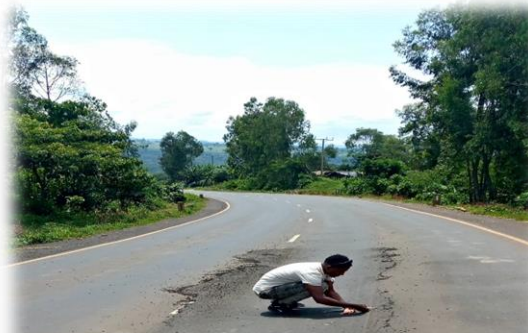
- Station: 63+400
- Longitude: 35.9063
- Latitude: 8.36569
- Defect Type: Rutting
- Pictured by: Eng. Remzu Mohammed

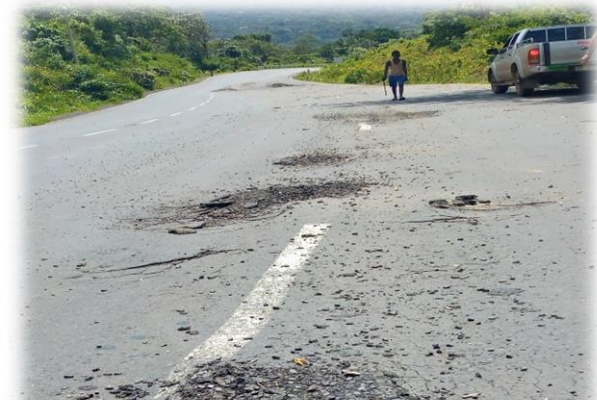
- Station: 63+900
- Longitude: 35.90181
- Latitude: 8.36538
- Defect Type: Stripping
- Pictured by: Eng. Asrat Getaye

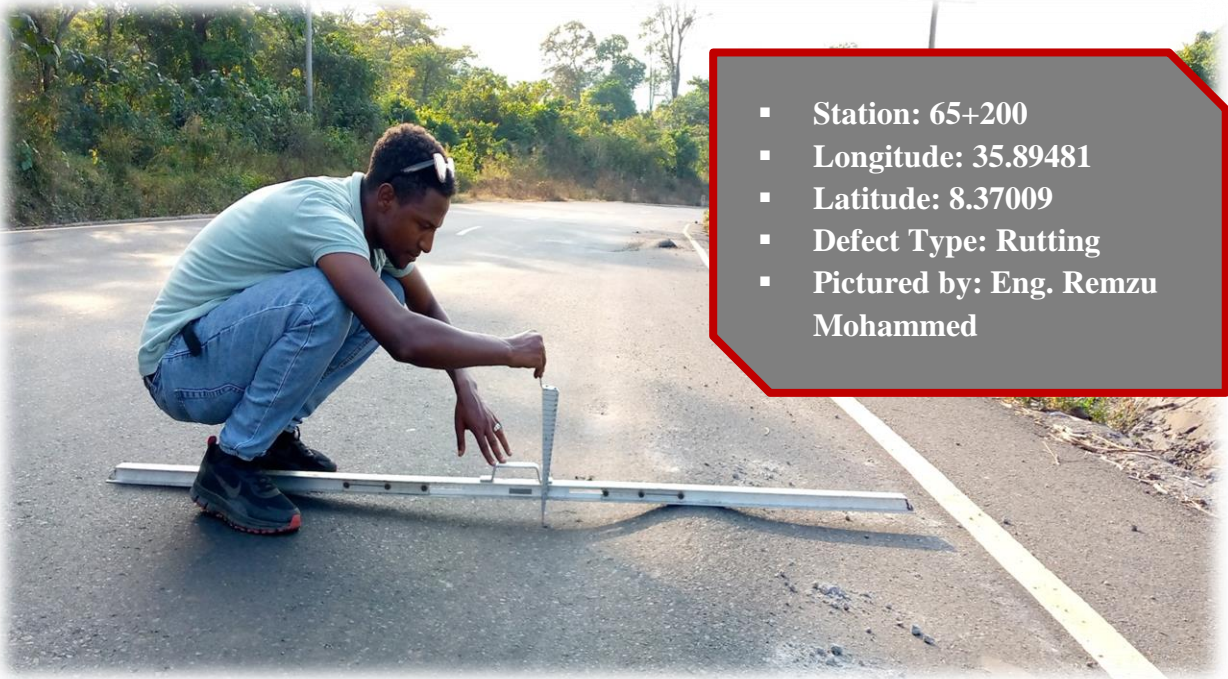
- Station: 65+200
- Longitude: 35.89481
- Latitude: 8.37009
- Defect Type: Rutting
- Pictured by: Eng. Remzu Mohammed

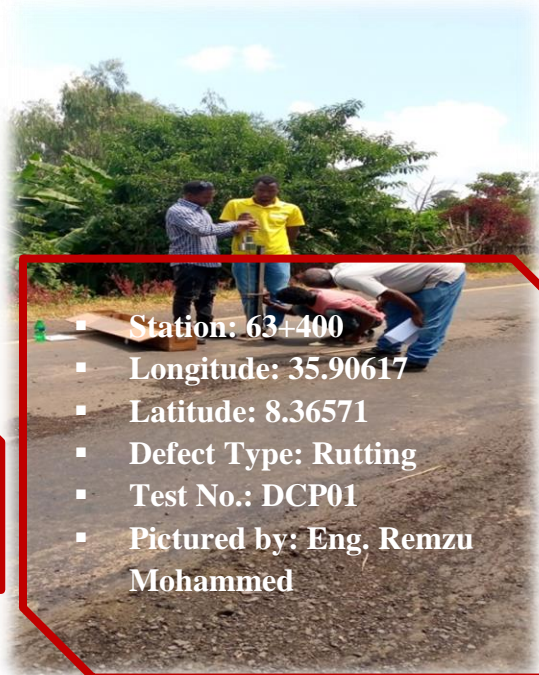
- Station: 63+400
- Longitude: 35.90617
- Latitude: 8.36571
- Defect Type: Rutting
- Test No.: DCP01
- Pictured by: Eng. Remzu Mohammed

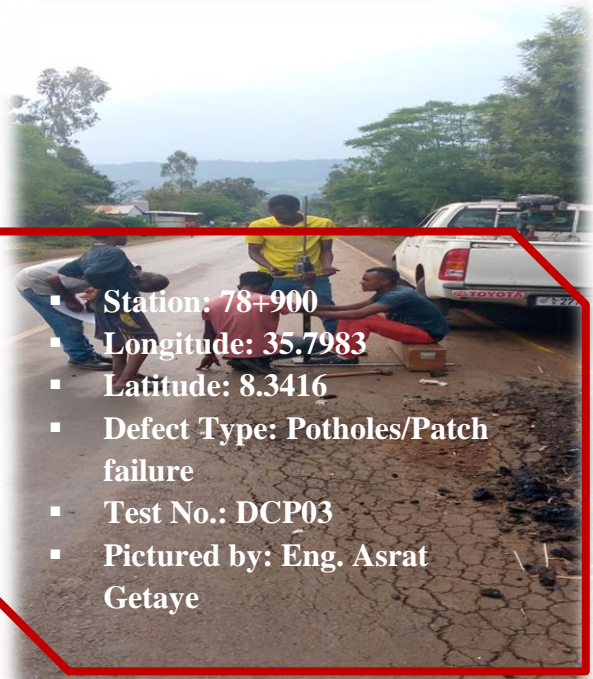
- Station: 78+900
- Longitude: 35.7983
- Latitude: 8.3416
- Defect Type: Potholes/Patch failure
- Test No.: DCP03
- Pictured by: Eng. Asrat Getaye

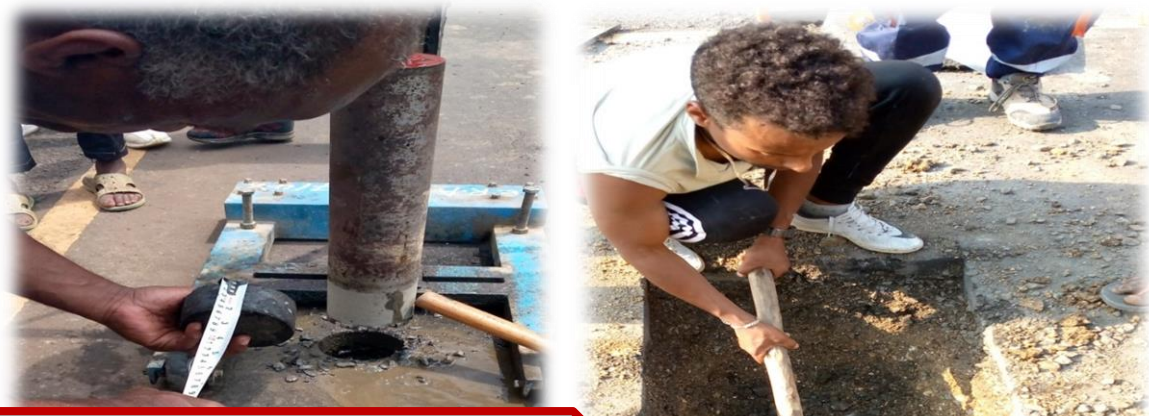
- Station: 63+400
- Longitude: 8.3657
- Latitude: 35.90617
- Defect Type: Rutting
- Test No.: DCP01
- Pictured by: Eng. Asrat Getaye
