Corrosion Characterization at Surface and Subsurface of Iron-Based Buried Water Pipelines

Citation: Yeshanew, D.A.; Jiru, M.G.; Ahmed, G.M.S.; Badruddin, I.A.; Soudagar, M.E.M.; Kamangar, S.; Tolcha, M.A. Corrosion Characterization at Surface and Subsurface of Iron-Based Buried Water Pipelines. *Materials* **2021**, *14*, 5877. <https://doi.org/10.3390/ma14195877>

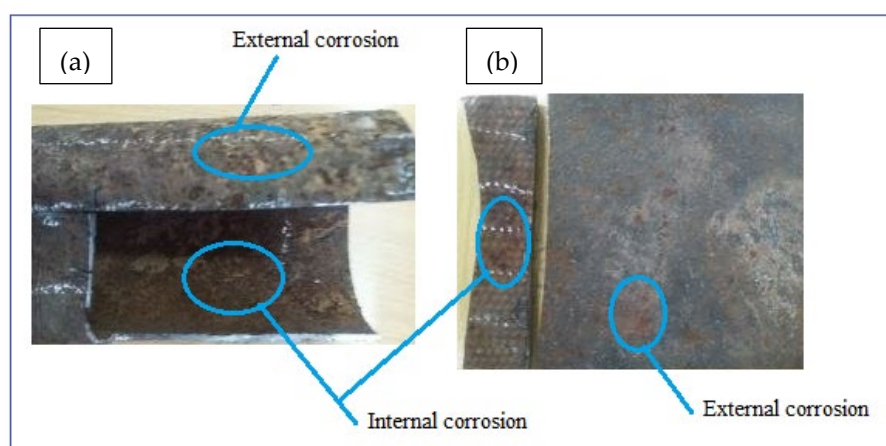
Figure 2. Photographs of typical corrosion damaged surfaces: (a) GS pipe and (b) DIP pipe.

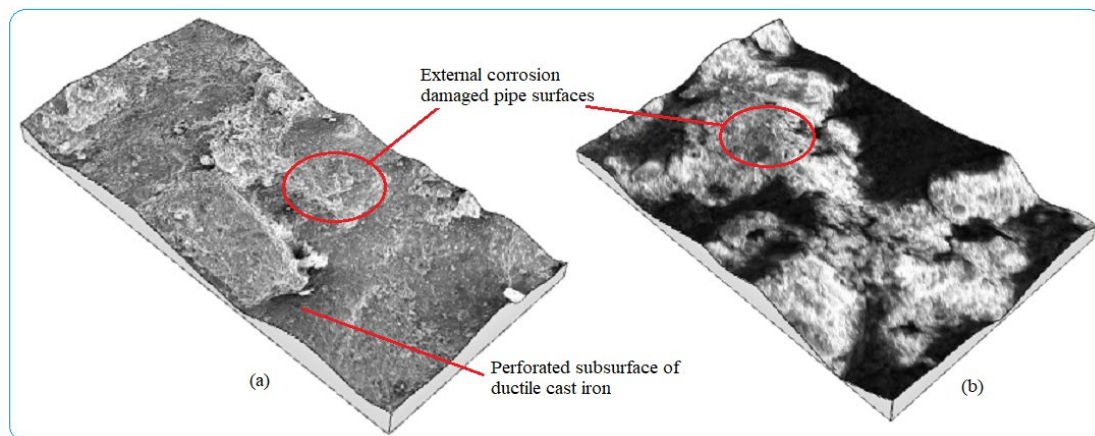
Figure 4. 3D images of external corrosion damaged pipe surface: (a) Ductile iron pipe and (b) Galvanized steel.

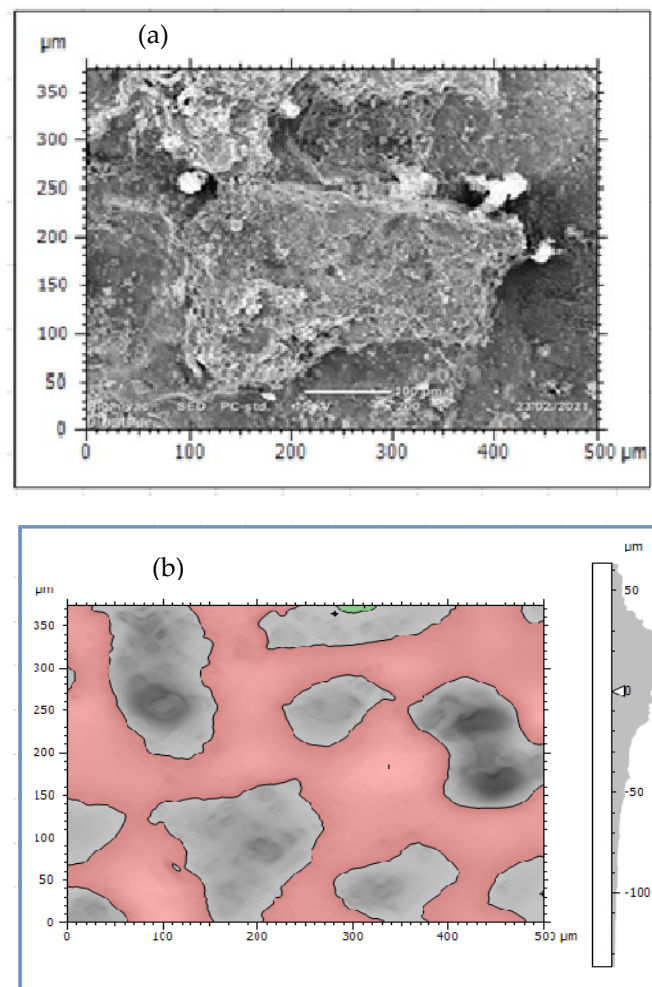
The rate of pipe surface deterioration accelerates with the presence of chlorine ion which dissolves iron particles at the anodic site. Others such as galvanic, uniform, and pitting corrosions are the failure mechanisms of water pipes. The formation pitting passes three stages; namely, pitting initiation, pitting growth, and pitting termination or leakage. At the initiation phase, the external surface including coating has direct contact with moisture and oxygen which can form films. The films then easily break due to electrochemical reaction and create initial pitting which damages the coating and then the external surface. The pits growth occurs at the second stage and damages the external pipe surface then it proceeds to the subsurface of the pipes due to the formation of depth. At this stage, stress corrosion cracking contributes the rate of pit corrosion to be faster and the size of pits grows easily. Depending on the variations in pit depth and width, a local colony of pits meets each other and the surface of the pipes deteriorates layer-by-layer as shown in Figure 5a. Further dissolution occurred at the anodic site and consequently, the growth of pits form pipe breakage and leakage. The cycle continued to damage the external and subsurface are easily attacked by electrochemical reactions. When the pit depth increased, it can hold more amount of moisture and oxygen which accelerated the rate of corrosion till leakage formation. This indicates the combined effect of pitting and uniform corrosions lead to surface deterioration with time function. Figure 5b presents the result of topography features of image processing obtained from corrosion morphology of DIP deteriorated surface which identified peaks and dale of the surface textures. The topography of the damaged surface was filled with watershed detection to process it for further analysis at particle level categorizing by grain boundaries. From the image analysis, it is concluded that the Mountains 8.2 surface analysis software identified the topography of corrosion failed pipe surface that the structure is deteriorated layer-by-layer creating the peaks and dale of corrosion damaged surface which indicates the process of corrosion rates.

Figure 5. External corrosion damaged surface of DIP: (a) True color of SEM image and (b) Corrosion scale morphologies.

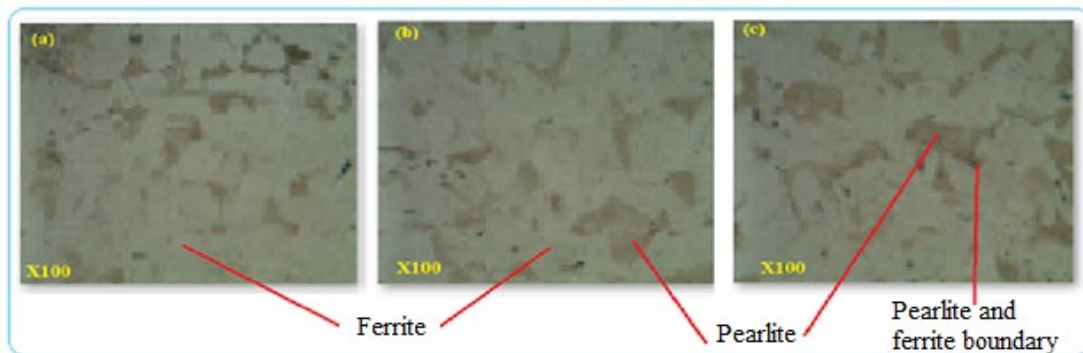
The composition of alloying elements and manufacturing process were able to create defects that contribute to corrosion formation especially when there are voids and micropores in the structure. Cross-sections of metallographic structures of 4" galvanized steel water pipe were shown in Figure 6. The samples give full structural information of grain size and boundaries that were observed as uniform distribution of alloying elements. The microstructures were analyzed at a magnification of $100\times$ under optical metallurgical microscopy and the structures were observed as pearlite with dark color and ferrite marked by white color Figure 6. The cross-sectional surface micromorphology shows that the possibility of particle deterioration formed on the surface where at the interface between ferrite and pearlite due to the two dissimilar structures acting as galvanic corrosion. The uneven distributions of alloying elements lead to microcracks at the boundaries and develop low corrosion resistance to the products which forms intergranular corrosion along the contact lines. Directional grains can create intergranular corrosion that causes the formation of microcracks in the structure. Non-uniform alloying elements and grain structures developed uneven morphologies in the internal microstructures which were formed as intergranular corrosion. The microstructure analysis was conducted from the sample of the new galvanized steel pipe cross-section, not from the top or bottom surface. The reason was to evaluate the internal details easily from the cross-sectioned part and to control the effect of zinc coating on the micrographs. Figure 7a–c are the images of optical microscope from the sections of three GS pipe samples. The images have similar internal

microstructures consisting of ferrite and pearlite structures which are separated by the grain boundaries.

Figure 6. (a–c) Microstructures of GS pipe.

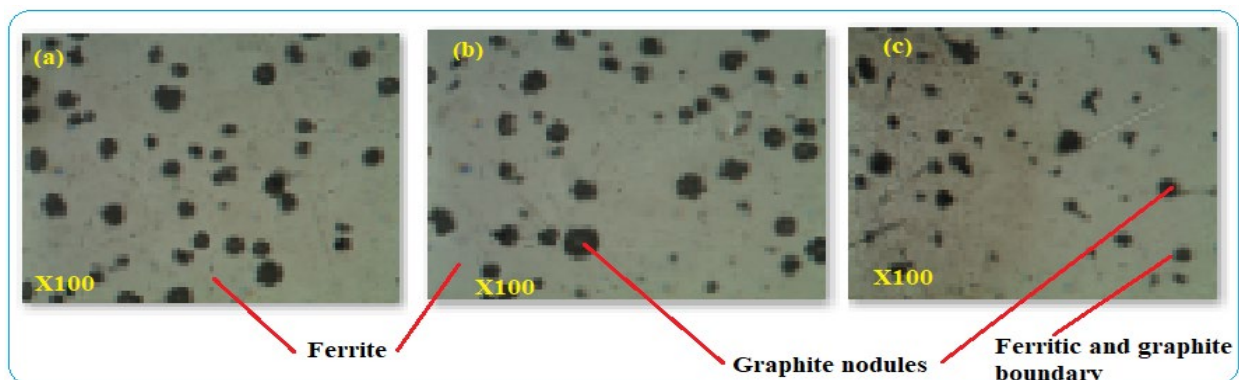
The typical ductile iron pipe was used for the characterization and is shown in Figure 7. The distribution and amount of alloying elements have their effect on the microstructures and defect formation. The microstructures indicated spheroidal graphite shape distributed in the DIP structure and surrounded by α -ferrite. Graphite makes the pipe have better tensile properties than other types of cast-iron pipes. The size and shape of graphite depend on the manufacturing process of the pipe. At the boundaries of graphite and pearlite or ferrite, corrosion initiation can be developed due to dissimilar structures. After 40 years, DIP pipe was deteriorating relatively at a faster rate and its safe service condition was 50% pipe thickness loss. Beyond this thickness, the rate of corrosion was faster which caused water quality reduction and consequences to pipe leakage and breakage. Figure 7a–c are the optical microscope images of the three DIP samples which were cut from the same pipe. The images comprises ferrite and graphite nodules in the microstructures of the samples. All the specimens have similar metallurgical structures and have corrosion tendency between the contacts of unlike microstructures.

Figure 7. (a–c) Microstructures of DIP pipe.

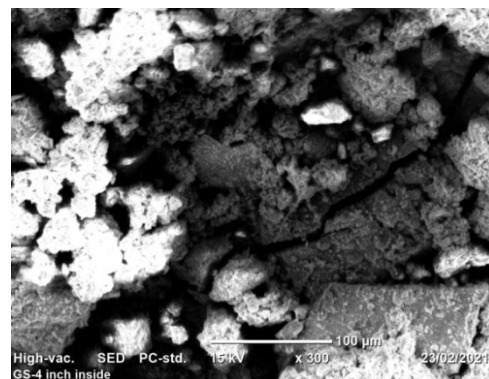
Maximum pit depth was evaluated by adding minimum depth (Z-min) and height (Z-max) in-situ condition after uniform corrosion attacked the thickness of the pipe during service time. The morphology showed that pitting corrosion shared a large contribution to the failure of pipe structures during long exposure of service time. Mountains surface analysis software was effective to detect the morphology of corroded surfaces at the micro-level and was able to measure pit depth, diameter, area, roundness, and volume in a small micrometer precision from the source of SEM image. The characteristics and features of corrosion-damaged surface indicated the morphology of pit depth, cracks, cavity, and peaks as shown in Figure 8. The major oxides present on the surfaces of the pipe are Fe_3O_4 and Fe_2O_3 . The depth of the pit is increasing due to the release of metallic ions at the anode during electrochemical reaction which creates pipe surface damage. Other pit characterization topographies including maximum and minimum diameters, pitting density, the shape of pitting such as roundness were extracted from 2D pseudo color images shown in Figure 9. The image was analyzed using watershed segmentation based on the ISO 25178-2 standard. The image was fully segmented as shown in Figure 9 and filled with watershed to detect pit depth, area, volume, roundness, and diameters from a 3D image which was generated from 2D. As the image processing indicates, the value of roundness is less than one (<1) which depicts the opening shape of the pit as hemispherical as shown in Figure 10e. During the study of corrosion characterization at the surface and subsurface of iron pipes, micro-cracks were identified. This scenario happens as the depth of the pit increases. Water pressure and stresses were responsible for the occurrence of cracks. Micro-cracks begin at the subsurface of the pipe due to narrow pits penetrating the pipe surface and leads to crack formation, propagation, and growth.

Figure 8. Corrosion morphology: True color of SEM image.

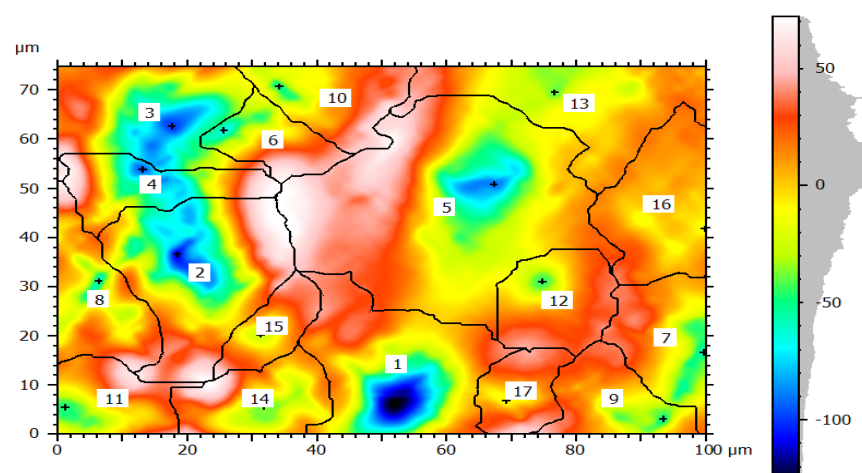
Figure 9. Corrosion morphology of watershed segmentation per particle.

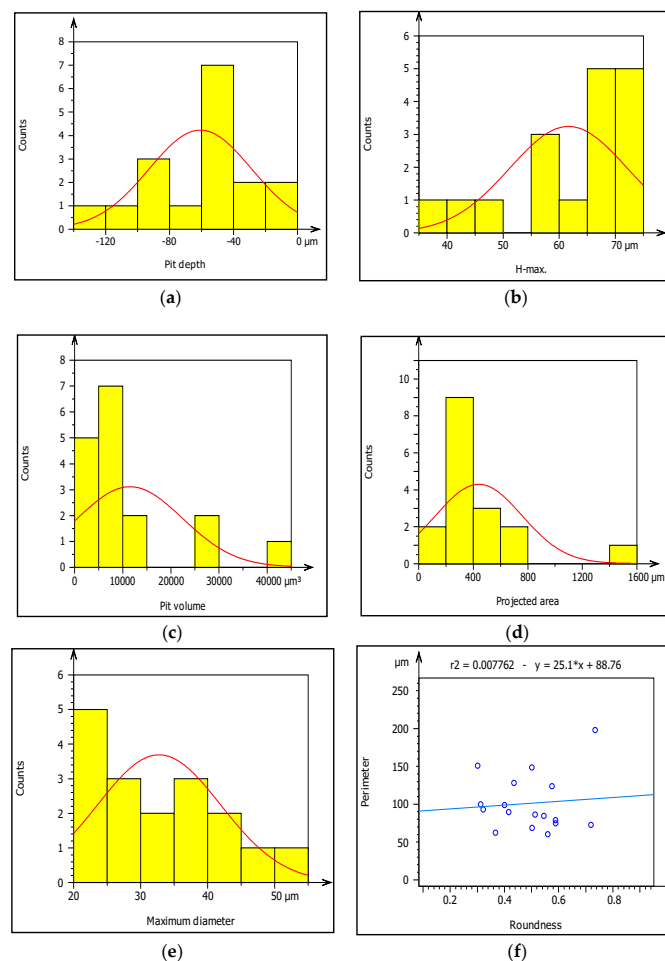
Figure 10. (a–f) Characterization of pitting corrosion results obtained from galvanized steel pipe.

Figure 10a–f presents summary result of corrosion characterization of image processing analysis including pit depth, maximum height from the neutral line, pit volume, pit area, maximum pit diameter and pit shape. The figures show the outputs of watershed segmentation of the entire SEM image to analyze particles, grain boundaries, and other features including pit area, depth, shape, cavity, and diameters from the 2D image. The results of image processing are represented graphically in Figure 10a–f. Figure 10a shows the threshold values of pit depth which are ranged from (40–120) μm even though both values are very small which can be considered as uniform corrosion. Figure 10b presents the result of maximum height (Z-max) which is above the mean line of surface features.

The graph shows the roughness or irregularity of corrosion-damaged surface values ranging from 40 to 70 μm . Figure 10c also presents minimum and maximum of pit area ranged from 400 to 1600 μm^2 . Additionally, Figure 10d is indicating that the volume of the pit varied from 10,000 to 40,000 μm^3 among the particles. Similarly, Figure 10e presents the evaluation of pit shapes (roundness) per particle. As it is shown on the graph, the roundness values are less than 1 μm which means the shape of the pit was elliptical. According to image processing, corrosion characterization of pitting features such as diameter is a very important parameter to describe the pitting situation with the relation of pipe surface damage. From the ISO 25178-2 watershed segmentation method; the study detected morphology of corrosion damaged surface to characterize corrosion behaviors in-situ condition. Based on the study, the maximum pit diameter was 50 μm . Based on characterization, the values of pit depth, area, and volume are 390 μm , 4000 μm^2 , and 1600 μm^3 , respectively, obtained from 20 years old corrosion-damaged GS pipe. Similarly, from the image processing; the pit depth of DIP was 380 μm , whereas maximum pitting area and volume are 4000 μm^2 and 200,000 μm^3 , respectively, as shown in Table 4.

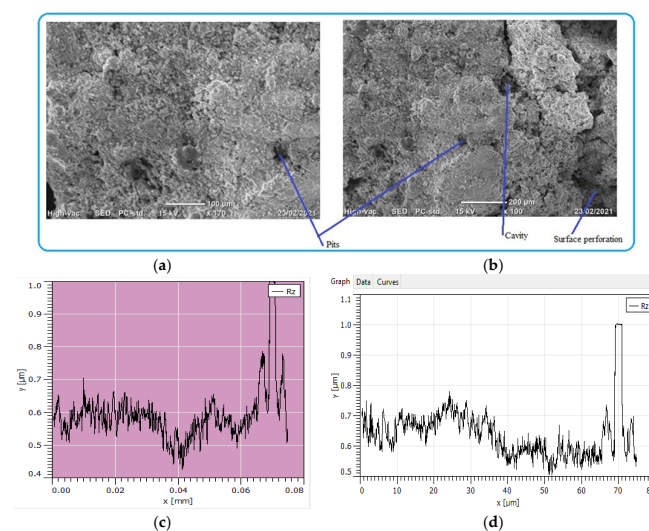
The process of pipe surface damage was reducing pipe thickness layer-by-layer during the electrochemical process. This is due to the formation of shallow pitting corrosion at random locations and the neighboring pitting colonies joined together to form uniform corrosion. In this case, a smaller pit depth was created on the remaining surface of the pipe. For example, the pit depth up to 400 μm can be categorized as uniform corrosion. On the other hand, localized pitting corrosion created a cavity and perforation of pipe surface while the pits grow with the function of time and environmental factors Figure 11. As the pit depth increases, the pit can hold deposits and chloride. With the presence of chloride ions, the rate of corrosion is more accelerated than the accumulation created a leakage. The magnification of images was ranged from 100 \times (Figure 11a) to 170 \times (Figure 11b) for the internal pipe wall of GS pipe.

Figure 11. SEM images of localized and uniform corrosion morphologies of GS pipe: (a,b), and (c,d) are showing cross-sectional details of (a,b).

Figure 11c presents the cross-sectional details of the corrosion-damaged pipe surface. Maximum pit depth was found at the center of the surface; similarly, a more damaged surface with pit and crack was found at the left age of the sample (Figure 11d). As compared to the two figures of cross-sections, Figure 11d has more pit depth and crack propagates than Figure 11c.

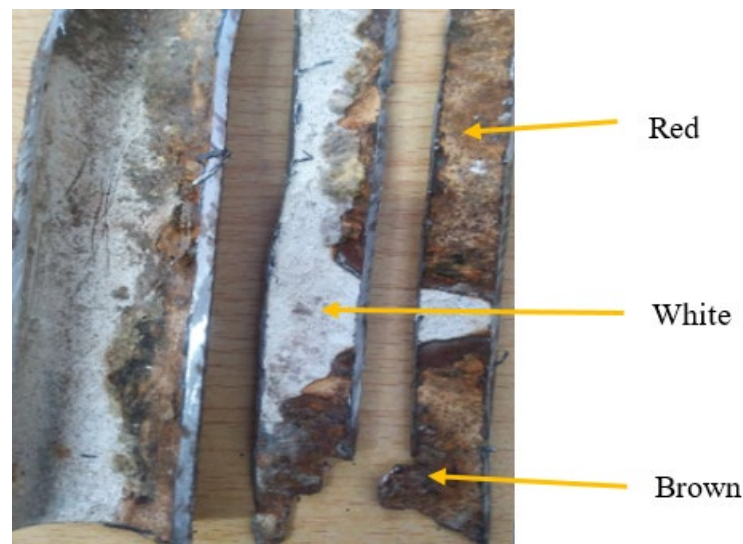
A corrosion pit was caused by scratch, localized surface defect, environmental corrosion, and variations of alloy compositions. Corrosion products have different colors such as white, red, and brown Figure 12. Corrosion product that had white color was ZnO and the red color represented as Fe_3O_4 while brown color was identified as Fe_2O_3 . The white color ZnO was observed at some random points on the surface of the pipes and the geometry of corrosion had different sizes, shapes, and depths of localized corrosion.

Figure 12. Photographs of the typical corroded pipe surface.

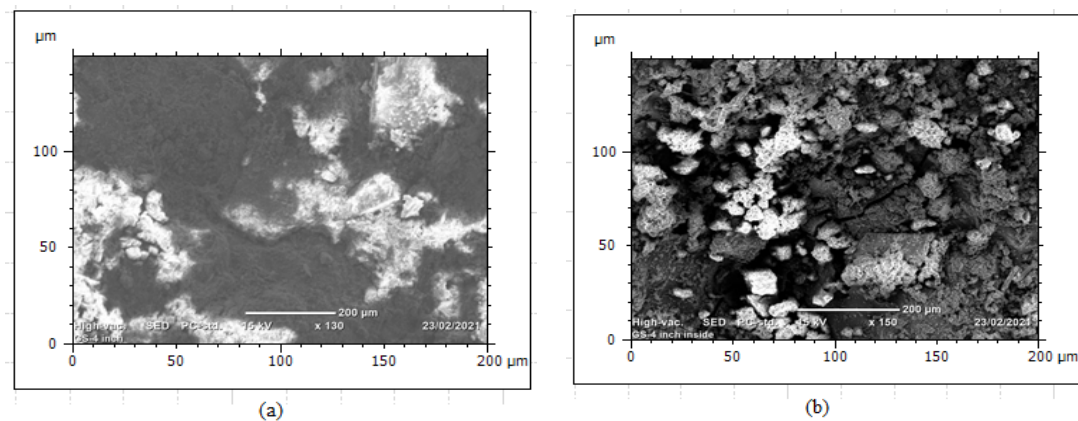
The surface irregularities observed on both internal and external surfaces were a result of soil and water effect during long-run service years. After the protecting of zinc coating has oxidized, the steel surface begins to form corrosion scales around the pipe and localized corrosion damage continued to the subsurface of the pipes even further attacked the whole pipe thickness. The internal pipe corrosion was a result of hydraulic operating conditions that influence the formation of erosion–corrosion and cracks due to water pressure and the effect of stagnant water during a steady time. Figure 13 shows that the morphology of internal corrosion was different from external corrosion due to inherent variations of environmental corrosion mechanisms. The study of corrosion-damaged pipe surface characterization helps to investigate water quality from the rate of corrosion. This is because the water is directly in contact with the pipe surface. Thus, it requires regular inspection and testing of water. In this case, when internal pipe surface damages due to corrosion and operating conditions, the release of pipe material affects the water quality. The water distribution owners need to test the water after treatment to evaluate the corrosion rate. It was also very important to the industries to evaluate corrosion behavior on the iron material at any stage to control the risks of corrosion.

Figure 13. SEM image of corrosion damaged GS pipe: (a) external corrosion and (b) internal corrosion.
