**INVESTIGATION ON THE CAUSES OF FAILURE IN UNPAVED ROADS AND
RECOMMENDED REMEDIAL MEASURES (THE CASE OF JIMMA –METESO
ROAD SECTION)**

A FINAL THESIS SUBMITTED TO JIMMA UNIVERSITY, SCHOOL OF GRADUATE
STUDIES IN PARTIAL FULFILLMENT OF THE REQUIREMENTS FOR DEGREE OF
MASTERS OF SCIENCE IN CIVIL ENGINEERING (GEOTECHNICAL ENGINEERING)

BY: RUHAMA BEYENE

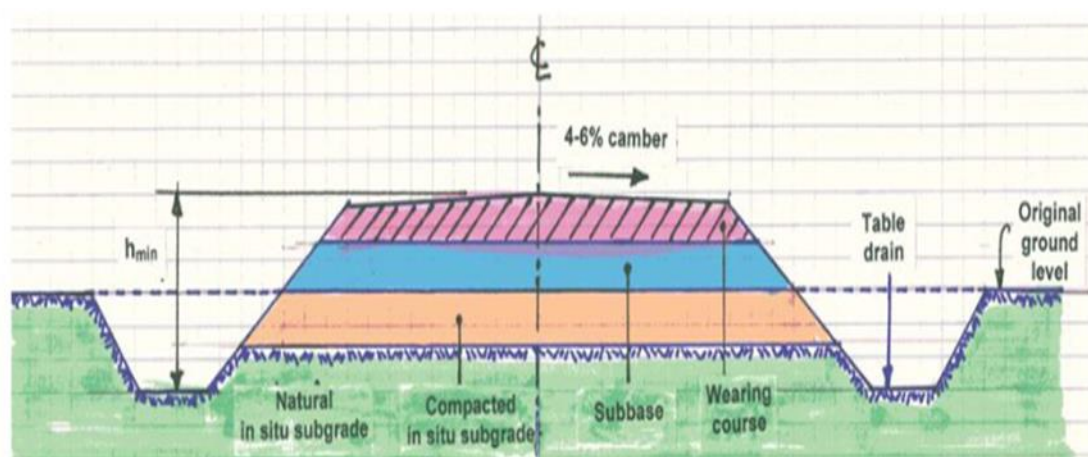
Figure 2-1 typical section of gravel roads

A gravel road is mostly constructed of three layers the subgrade, the subbase placed on top of the sub grade and the surface (wearing course) [10] but in practice many gravel roads have only a subgrade and surface layer.

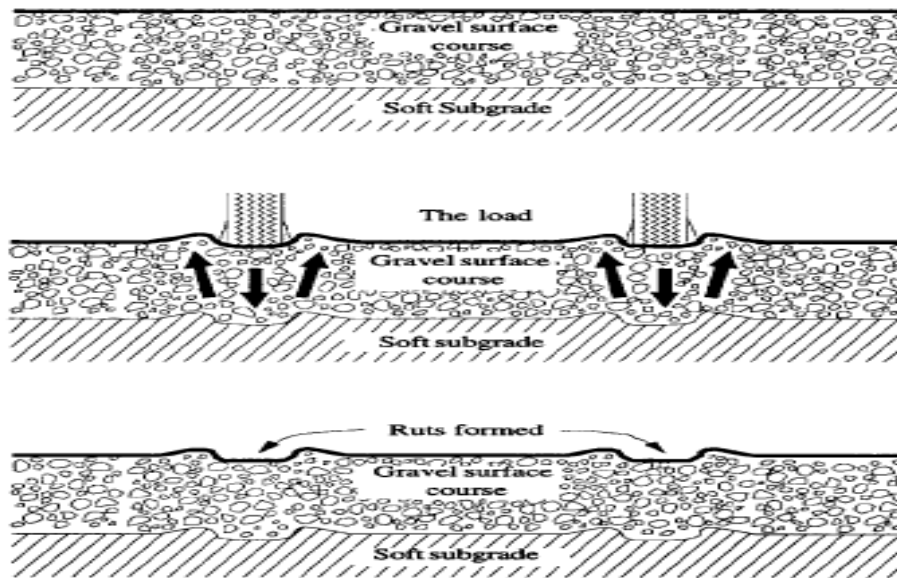
Figure 2-2 development of ruts (source [13])

Longitudinal depressions parallel to the road track which are caused by permanent deformation of the subgrade or road surface are called rutting. [23]. Ruts are caused by the compaction of the subgrade, compaction and loss of gravel from the wearing course. Ruts are classified as slight or severe ruts based on the rut depth. If the rut depth is less than 25mm the ruts are slight ruts [2]

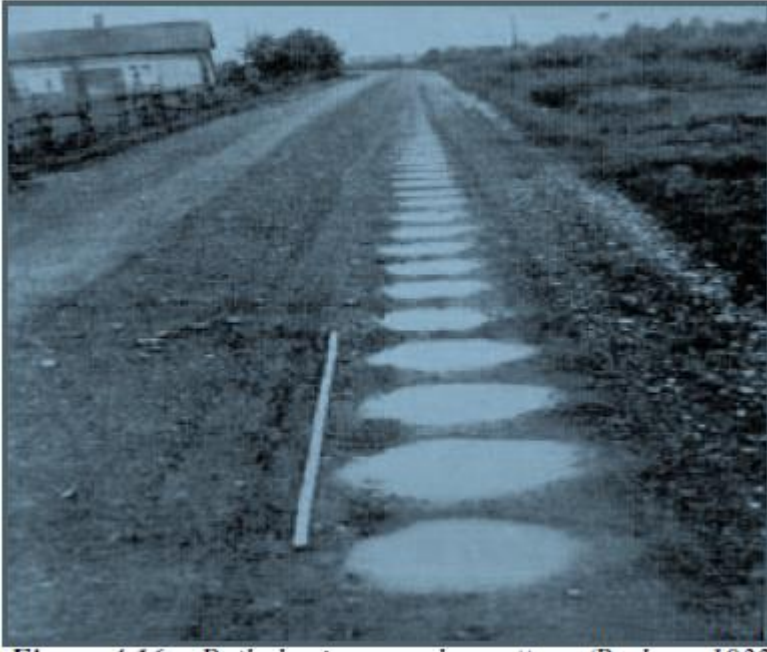
Figure 2-3 regular potholes on gravel roads (source [23])

Potholes are bowl-shaped, round or elongated depressions in gravel road surface. Potholes predominantly form in areas where the *subgrade* is wet, and the action of passing vehicles causes a failure in the *subgrade* producing a series of deformations in the road surface [11]. Jones and Paige green [27] [18] states the main causes of potholes as

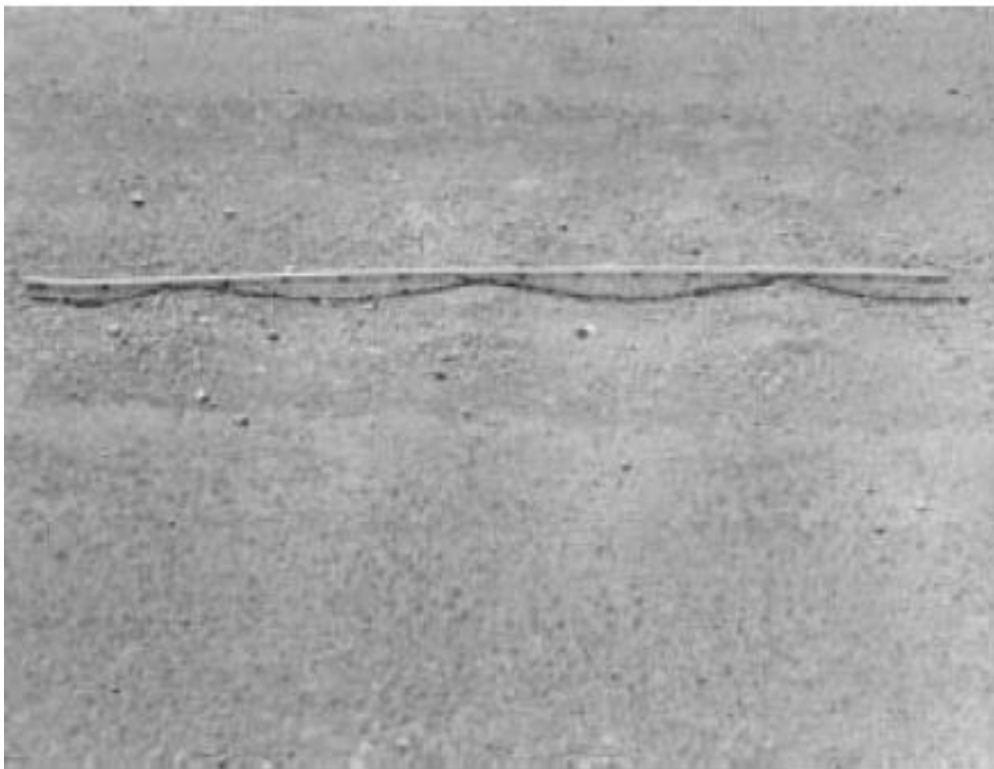
Figure 2-4 corrugation on gravel roads (source [19])

dead stop, decelerating suddenly to zero, or turning sharply at high speed, all heightens the effects even more. The parts of the road to which the road surface mostly corrugated are intersections, drive ways, curves grade of the roads [11].corrugation is caused by lack of fines in the aggregate and air suspensions it can be caused due to dusted and washed away or lack of fines initially during construction [2]can be corrected by increasing the content of fines up to 10-15% and adding more plastic fines in the aggregate. [27] Corrugation can be corrected by taking the following measures

- constructing the gravel roads on firm subgrades that are stable materials and drain well
- the road must be constructed of well graded aggregate that has sufficient amount of fines

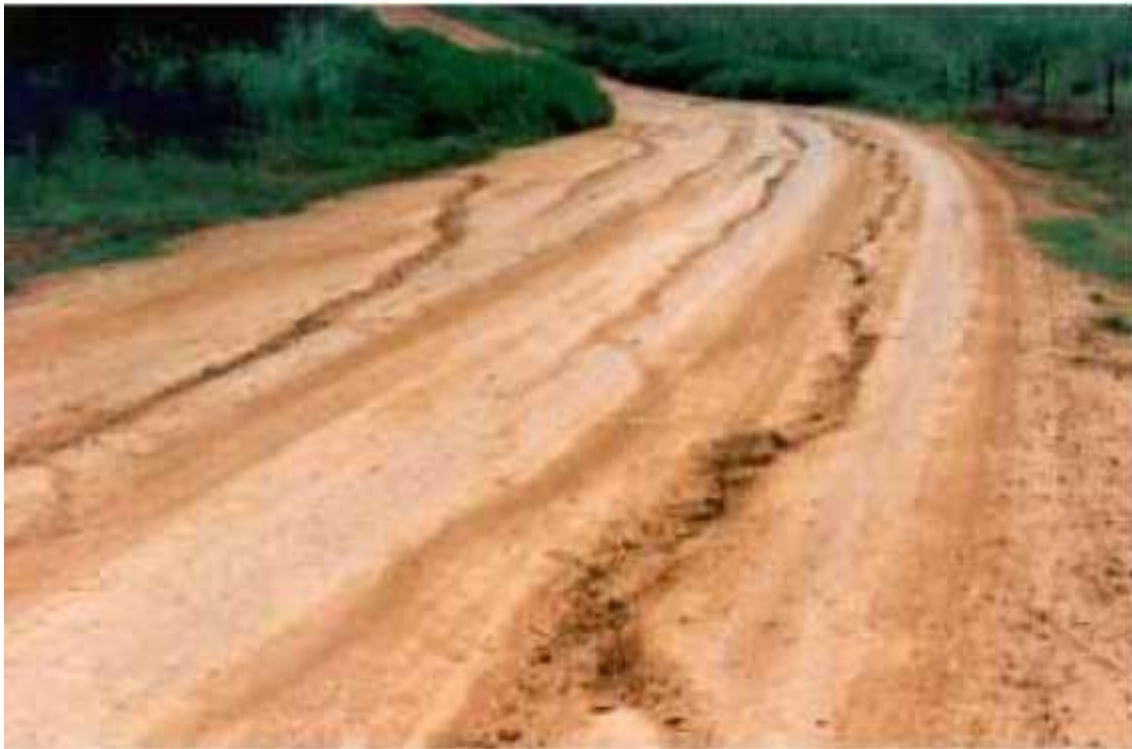
Figure 2-5 transverse erosion on gravel roads (Source [28])

Erosion is defined as the natural process by which wind, moving water, ice, and gravitational Forces displace the solid and particulate materials of the land .and in gravel roads, erosion of surfacing material is caused by the flow of water over the road and by the action of traffic and

wind. The ability of a material to resist erosion depends on the shear strength (equal to the cohesion, as the normal stress is zero) under the conditions at which the water flow occurs. Erosion will occur if the shear strength of the material is less than the tractive forces induced by the water flowing over the materials, grains will become detached [19]. materials that are prone to erosion are typically fine grained and have some plasticity. But these materials generally perform well when used in roads on flat terrain or in areas of very low rainfall. In other areas they will quickly erode during rainfall, leaving channels in the road that are dangerous and unpleasant to drive over and expensive to maintain [18]

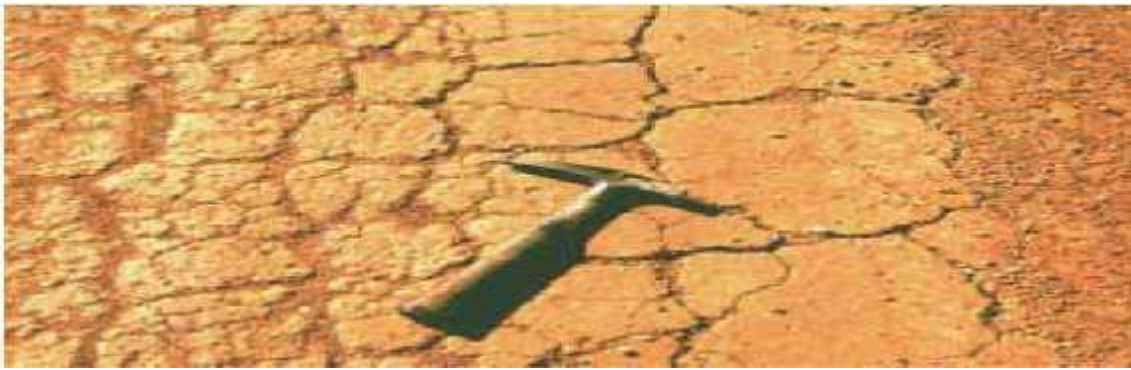
Figure 2-6 cracks on unpaved roads (source [23])

Cracking is not a usual deterioration type on gravel roads but in some circumstances it is observed on the surface of the roads. These defects are due to highly plastic surface material and the percentage of fines material become higher than the allowable range. Cracks can be the cause of pothole formation in dry season.

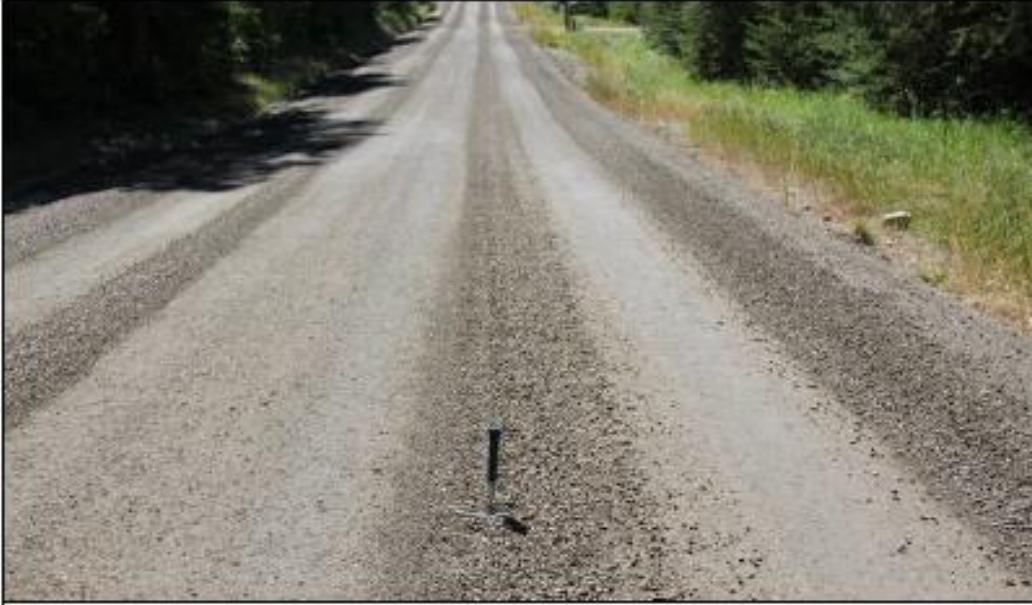
Figure 2-7 raveling on unpaved roads (source: [18])

The generation of loose gravel under traffic is termed raveling and is mainly caused by a deficiency of fine material (and hence cohesion), a poor particle size distribution (e.g. skip grading) in the wearing course gravel and inadequate compaction [19]. Raveling is generally worse in the dry season than in the wet season when capillary suction results in some “cohesion”. Although Materials that ravel have some plasticity, but are gap-graded the presence of clay does not prevent raveling. [18] Fine material can often be blended with the gravel to increase cohesion. A good degree of moist compaction can also be used to cut down raveling

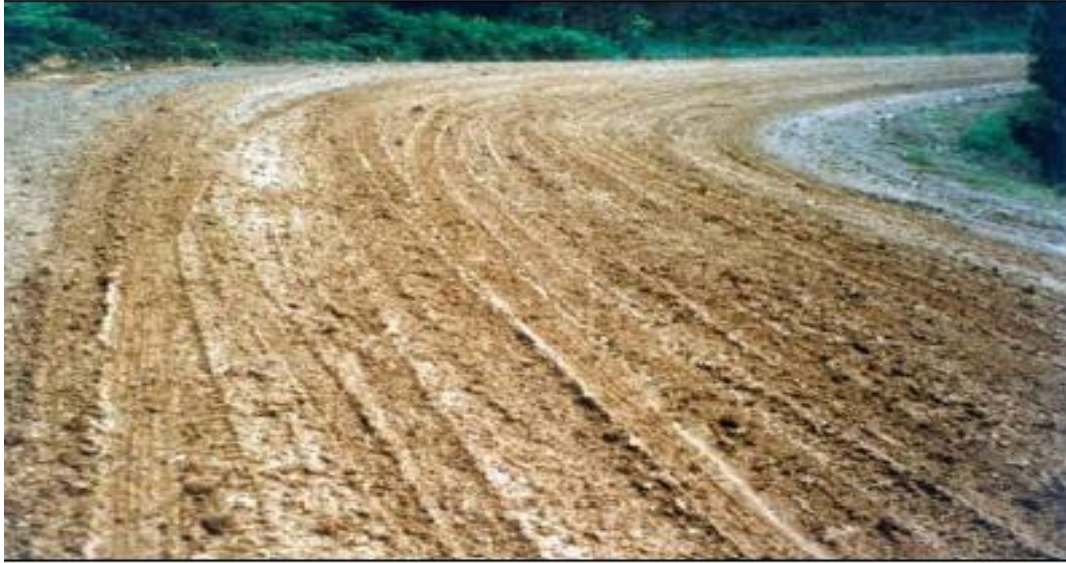
Figure 2-8 slippery gravel road (source [19])

In dry weather, unpaved roads may become slippery if an excess of loose, fine gravel (between 2 and 7 mm in diameter) accumulates on the road surface through raveling under traffic or poor blading practices. This layer behaves like a layer of ball bearings and the skid resistance is reduced practically to zero. In wet weather, slipperiness is caused by excessively fine or plastic material in the wearing course. Even materials with adequate coarse aggregate may become slippery if the fine silt and clay fraction becomes concentrated near the surface [19]

Materials that are slippery when wet and very dusty when dry typically have high fines and clay contents. Increasing clay content also results in decreasing CBR, leading to poor passability in addition to the slipperiness [16].

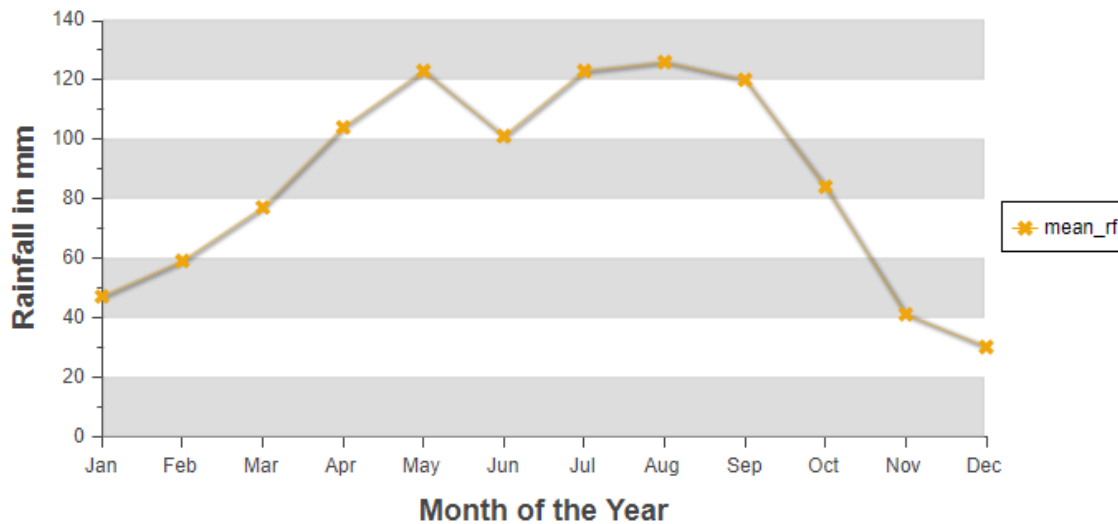
Figure 3-2 Average monthly rainfall data of Jimma area

The Project Climate has a rainy season from April to October and Dry Season until into February continuing into March. The duration of the rainy season is longer in the vicinity of the project of a road project and the mean annual rainfall is in the order of 2000mm. The mean maximum temperature ranges 20°C - 25°C and the mean minimum temperature is 10°C

-15^o C. The climatic data that we get from the national meteorological agency is that of Jimma town the climatic data for rainfall and temperature of Jimma town is given in the Figure 3.2 and Figure 3.3 below.

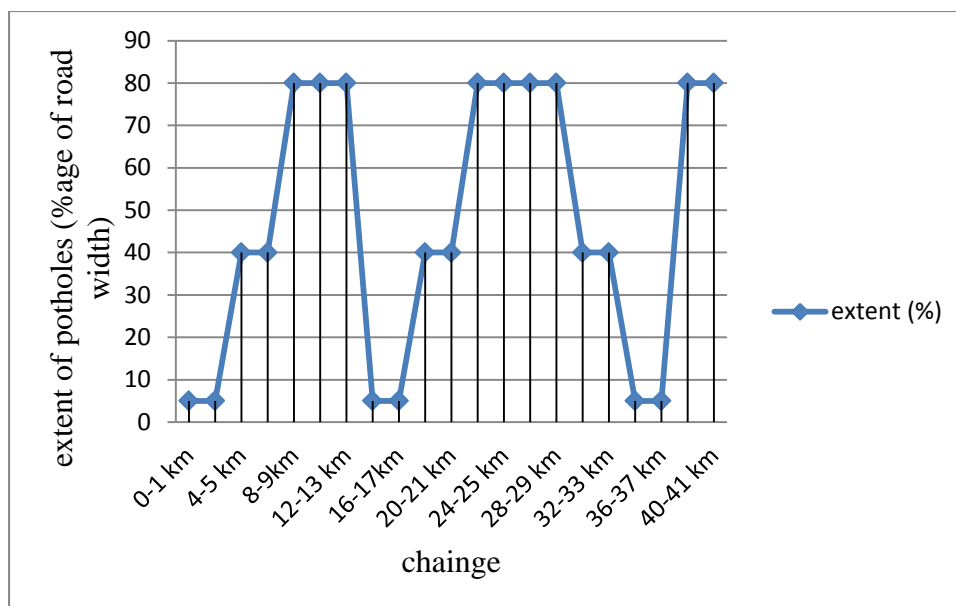
Figure 4-1 Extent of Potholes

The extent of potholes was sever (5) on the stations located between 8 -13km and 22-29 km the rest of the stations are intermediate and slight failures observed. The rating of the severity was also in accordance with the degree. Extent of potholes on the road varies on the road as given on figure 4.1

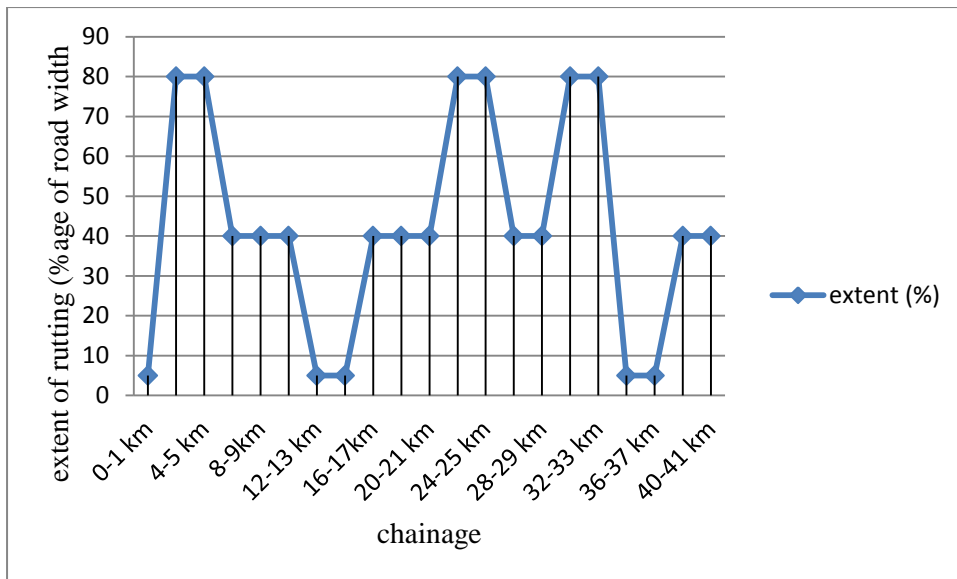
Figure 4-2 Extent of Rutting

The extent of rutting on the road was done on accordance with estimation of the depth of the rutting to determine the severity. Over the width of the road rutting was dominantly observed between stations 2-5 km, 22-25 km and 30-33 km on the rest it was only slight and intermediate. The extent of rutting on the road is given in figure 4.2 below

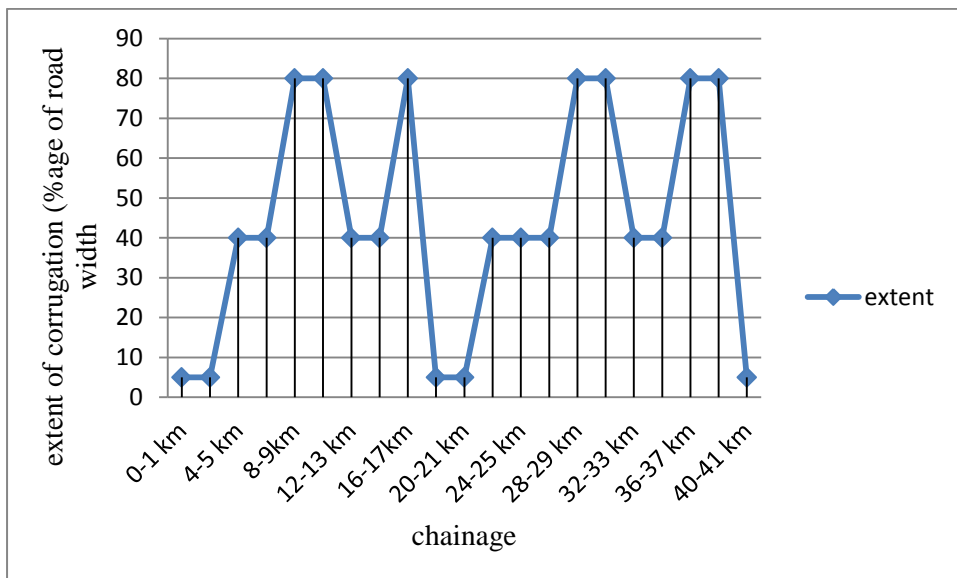
Figure 4-3 Extent of Corrugation

Corrugation can be assessed visually by using rating mechanisms the degree of corrugation varies from not heard or felt in light vehicles (degree 1) to degree 3 which is heard and felt and requires speed reduction and degree 5 where drivers have to select a different path and derive very slowly and is a safety is affected. In the Jimma Meteso road section the corrugation observed are in these ranges. And the extent with respect to the coverage of the width of the road is presented in the figure 3.3 below

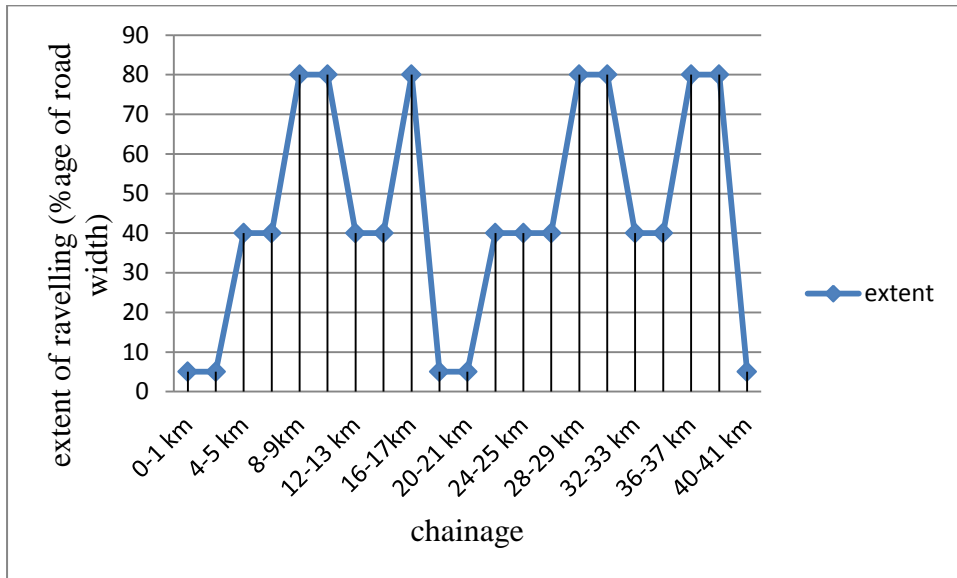
Figure 4-4 Extent of Raveling

Raveling was observed in the road it could be associated with the generation of loose aggregate or stoniness. The extent of raveling in most of the road section was extent 3

between 20-60% but in station from station 37 to 40 km the extent was 5 between 80-100 percent the variation of the extent of raveling over the road section is given in figure 4.4 below

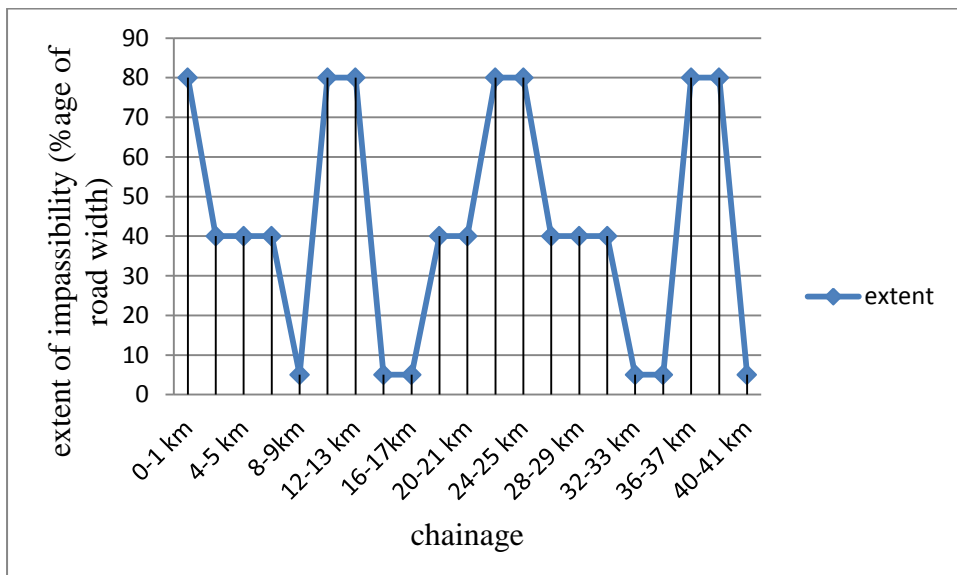
Figure 4-5 Extent of Impassibility

Impassibility on the road section is observed in extent 5 from 0-1 km, 10-13km and 36-39 km on the rest of the stations the extent is slight and intermediate. The extent of impassibility on the road

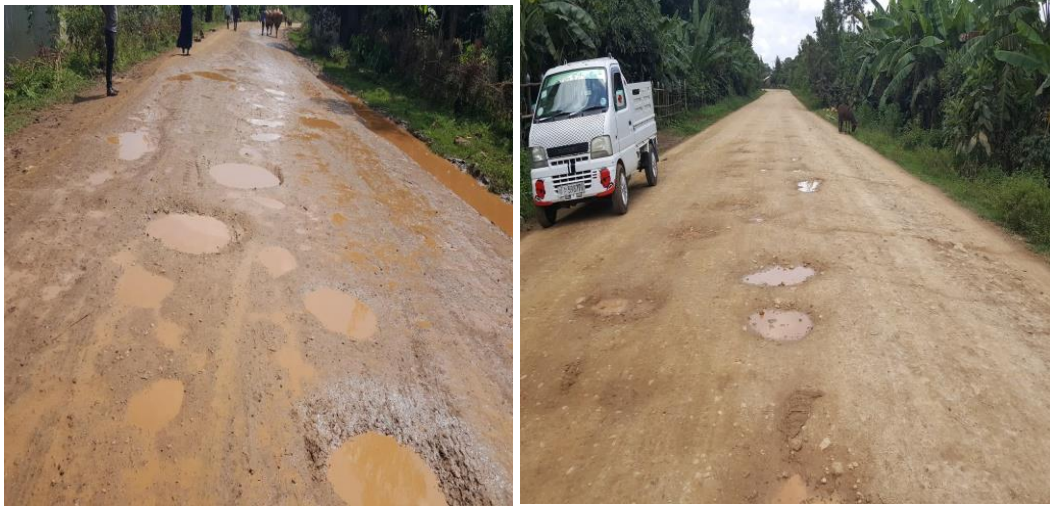
Figure 4-6 Failures observed on the road: pothole

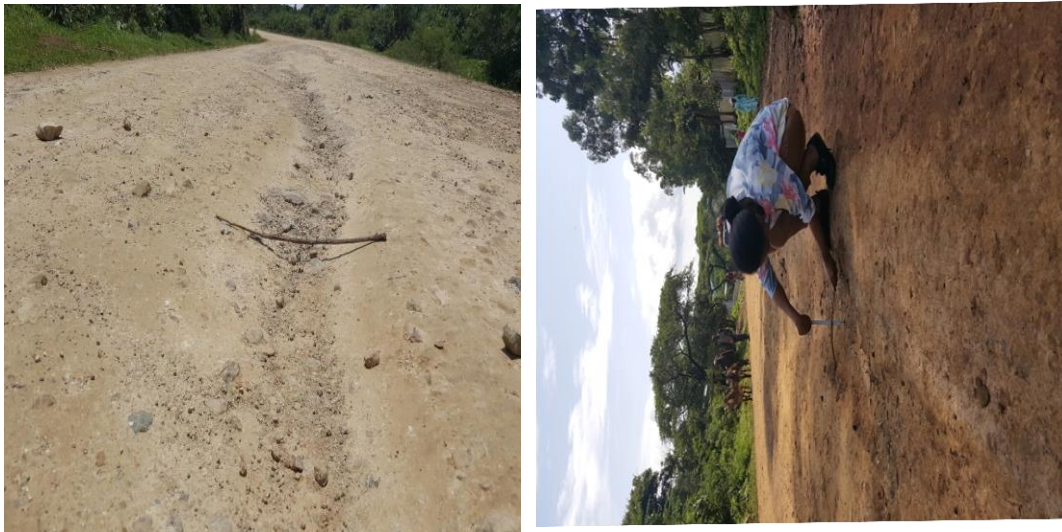
Figure 4-7 Failure observed on the road: rut.

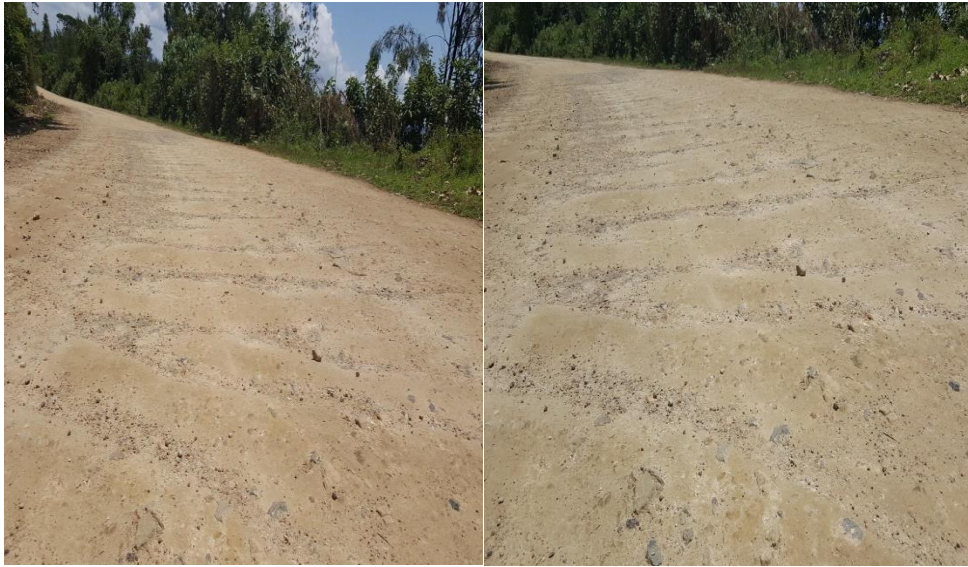
Figure 4-8 Failure observed on road corrugation

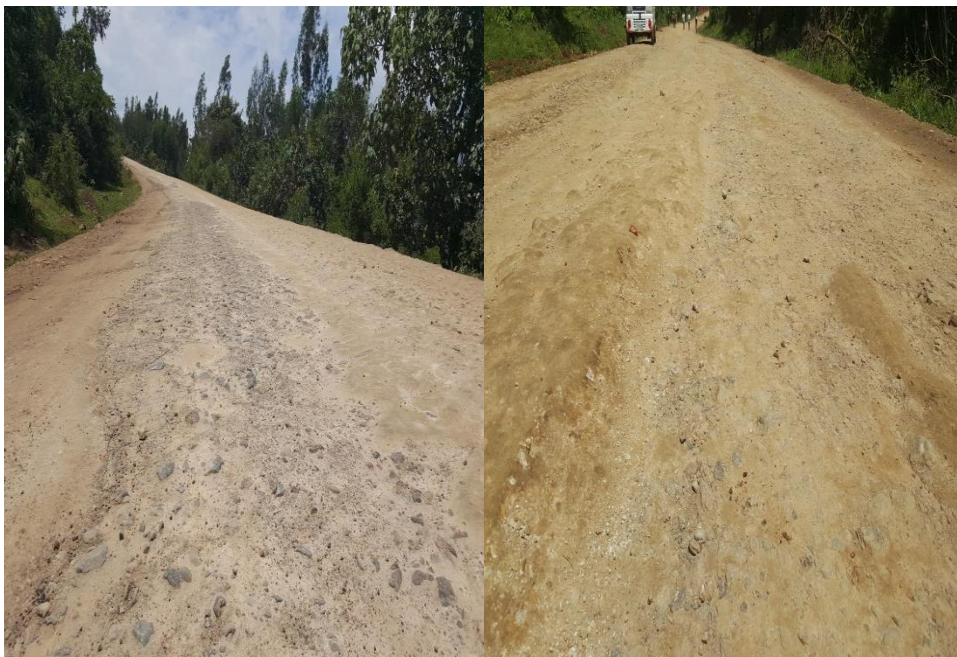
Figure 4-9 Failure observed on road raveling

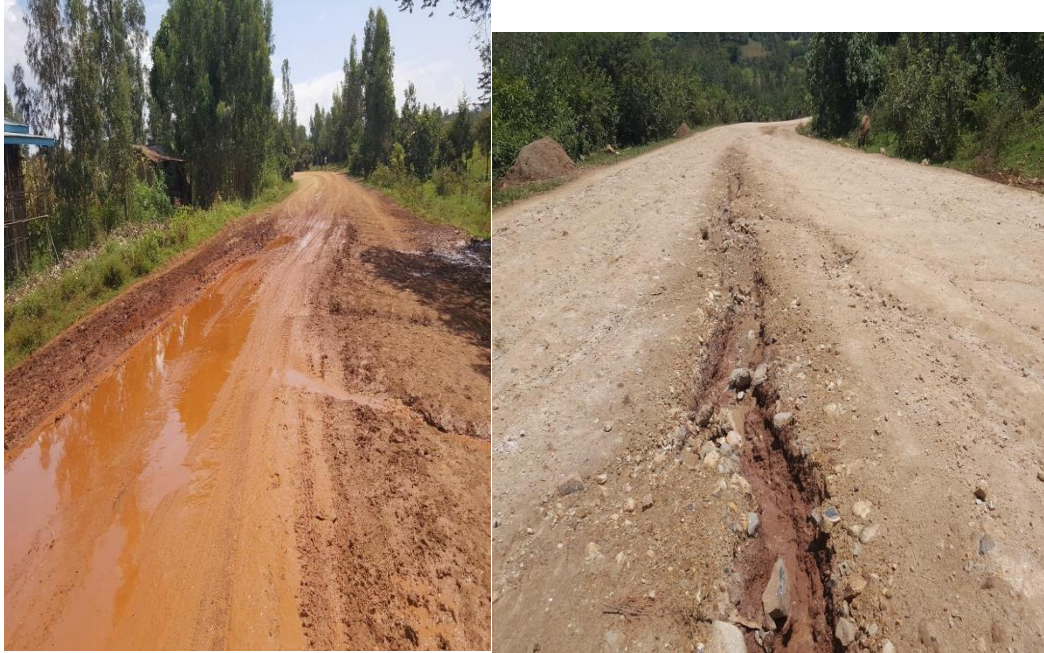
Figure 4-10 Failure observed on the road: slipperiness and impassibility

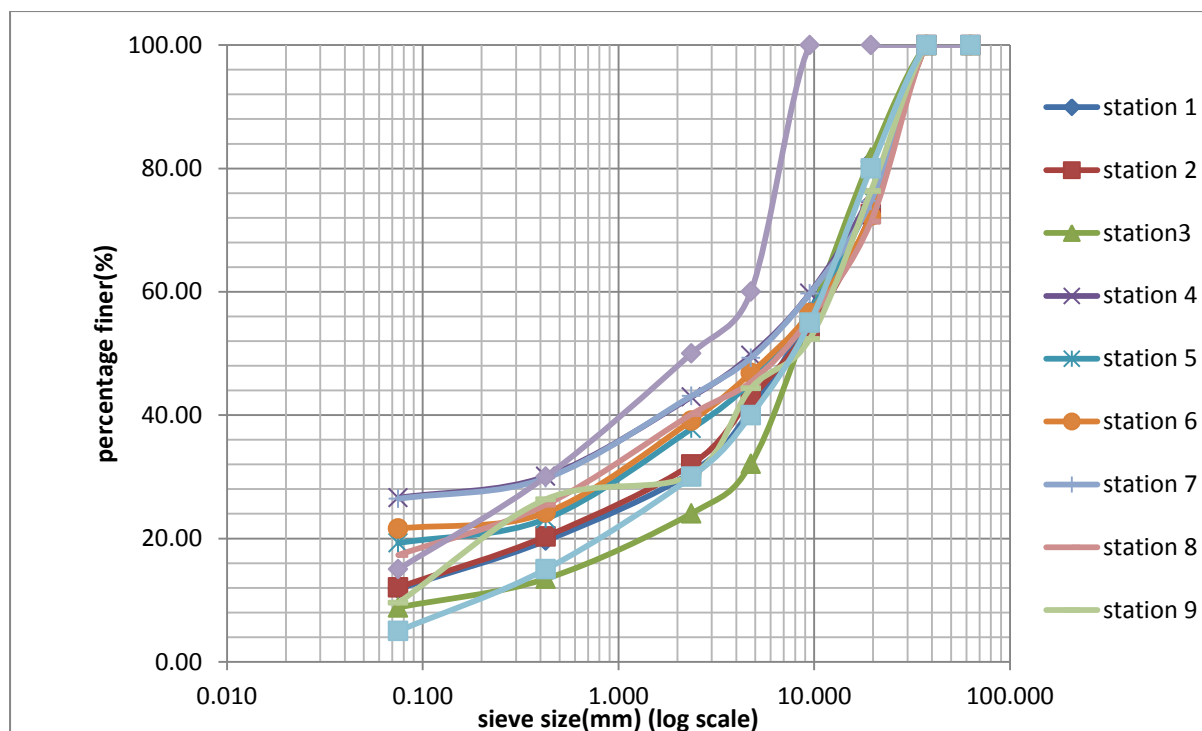
Figure 4-6 Particle Size Distribution Curves of the Gravel Wearing Course

Based on ERA gravel road design manual gravel roads are categorized under two categories, major and minor gravel roads. Since the AADT of the road is greater than 200 it falls under major gravel roads. The grading envelop used for major gravel roads is grading envelop 1 given in Table 3.3. When considering the gradation test results for the wearing course material the percentage passing for most sieve sizes is within specifications based on ERA grading requirement envelop 1. But for some sieve sizes, sieve size 0.425mm and 0.075mm we can see that the soil is finer than requirement this indicates more amount of fine materials than required in the specification. The amount of fine grained soils (silt and clay) passing sieve number 200 is in the range of 8.86-26.59%, but the specification is set to be between 5-15 percent. This value does not satisfy the specifications set and the gravel wearing course has more amount of fine materials have been used on the site.

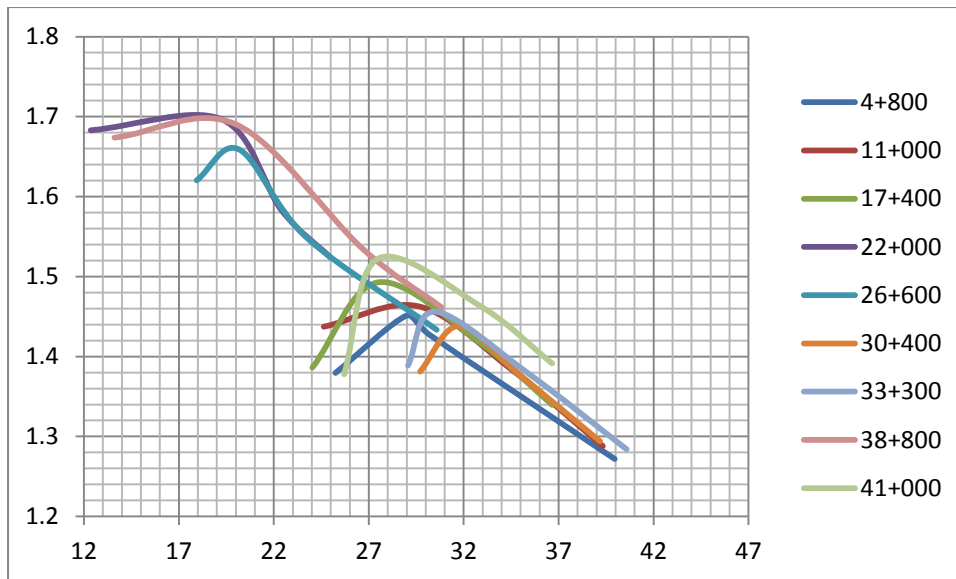
Figure 4-11 Compaction Curves for The Subgrade

The averages MDD for the subgrade material are 1.5275 gm/cc and the range for the field densities is between 1.0185g/cc-1.3515 g/cc the percentage of compaction range is between 70%-84.95% which is lower than what is required by the specification (95%).

The compaction curves for the subgrade are given in the Figure 4.11 below

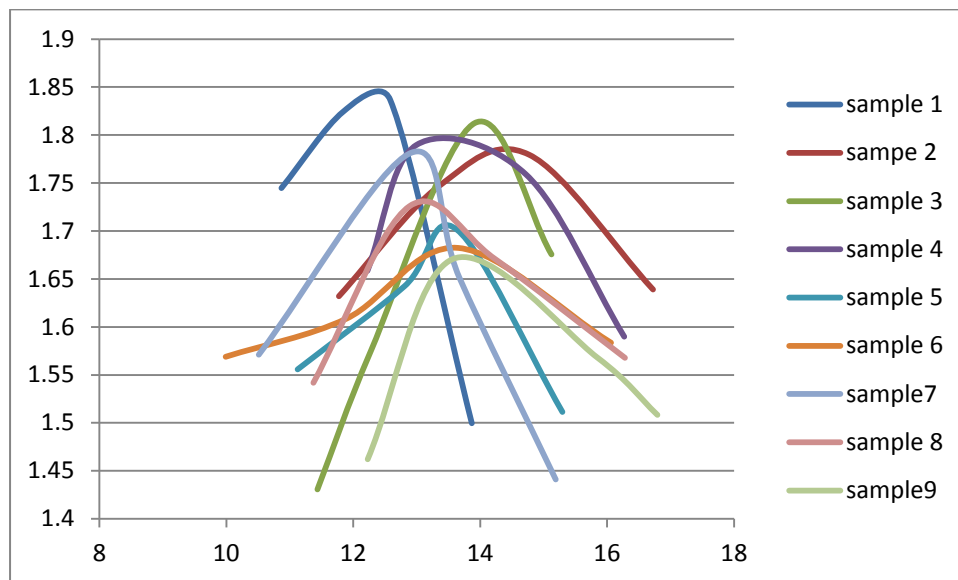
Figure 4-12 Compaction Curves of the Gravel Wearing Course

The comparison between the NMC for the gravel wearing course given in table 4.2 and the OMC obtained in the above table shows that for all of the test stations the value of NMC is greater than that of the OMC the variation ranges between 8.7 and 0.8 percent.

The wearing course used for the extremely damaged road section has the average OMC value of 14.5 % and MDD of 1.705 gm/cc and on the other hand the field test results for moisture content are ranging from 14.6%-21.3% when compared with the OMC obtained from the laboratory test result there is an increase in the value of NMC. The increase in the value of NMC could be associated with infiltration of water and poor drainage conditions on the road.
