**GEOTECHNICAL INVESTIGATION OF LAND SLIDE AND GEOPHYSICAL
TECHNIQUES: A CASE OF TULLU GOLA, WEST ARSI ZONE, OROMIYA,
ETHIOPIA**

A Thesis Submitted to the School of Graduate Studies of Jimma University, Jimma Institute of Technology, Faculty of Civil and Environmental Engineering in Partial Fulfillment of the Requirements for the Degree of Masters of Science in Geotechnical Engineering.

BY: TADESSE GEMECHU TELILA

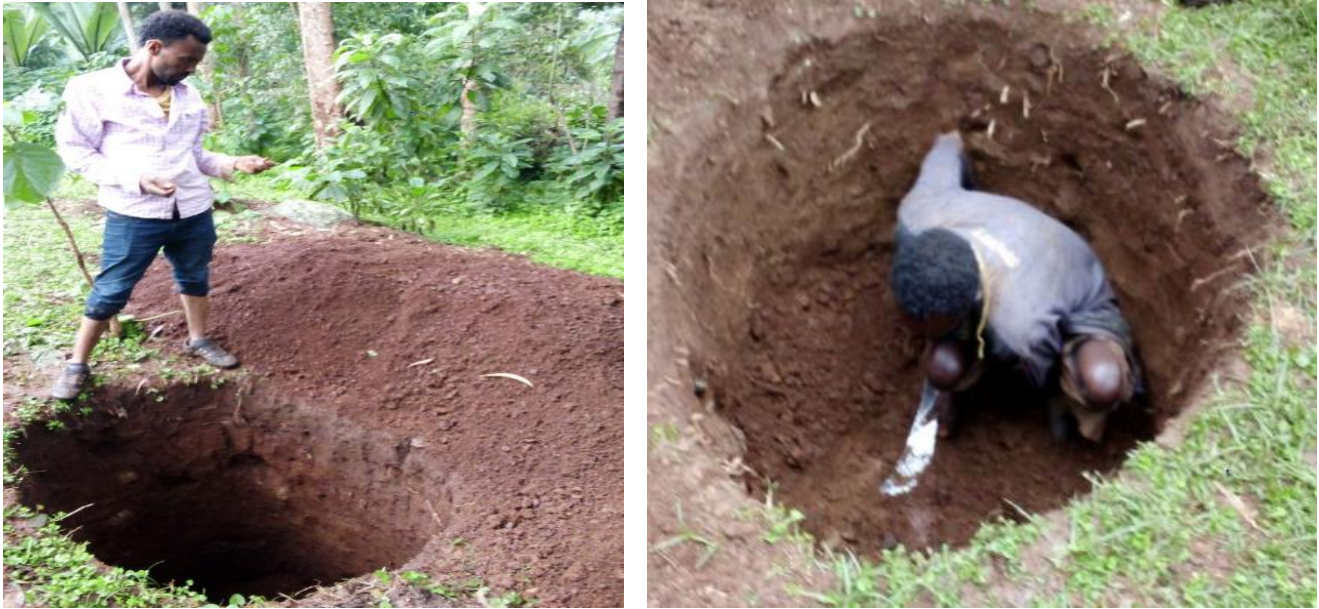
Figure 3-3: Open pit for taking sample soil test (15/10/2013)

Soil samples were collected to ascertain the geotechnical properties of the soil in the research region. Using the protocols outlined in the ASTM Standard, simple samplings were conducted. Undisturbed and disturbed samples were received for each pit of samples. The sampling axes are provided in Table 3.1. In general, four samples from four trenches up to 3 m, both disturbed and undisturbed, were collected. Landslide-prone locations were chosen at random for the sampling pits (sites). The samples were taken from the slide side area's top, bottom, left, and right. Unaltered samples were collected using a shell tube, tied with plastic, and stored in bags to preserve their in-situ moisture content. To preserve the natural moisture content, the disrupted samples were placed in plastic bags and secured with ribbons. The samples were typically taken at their original moisture content using plastic bags. To stop moisture loss, the plastic bags were knotted. As soon as the samples were brought to the JU laboratory, the in-situ moisture levels were assessed using oven-dry equipment at 105 °C for each test sample. Each sample was dried in an oven to achieve a constant weight when weighing continuously. Every sample was dried for 24 hours in an oven set at 105 °C. Four test pits' worth of soil were sampled at different depths, and the samples were then analyzed to determine the soil's cohesion, angle of friction, unit weight, water content, liquid limit, plastic limit, plasticity index, Young's modulus, specific gravity, and grain size analysis (sieve and hydrometer) in the study area. The results of these tests were used to classify the soil and analyze the stability of the slope where the landslide occurred in the study region.

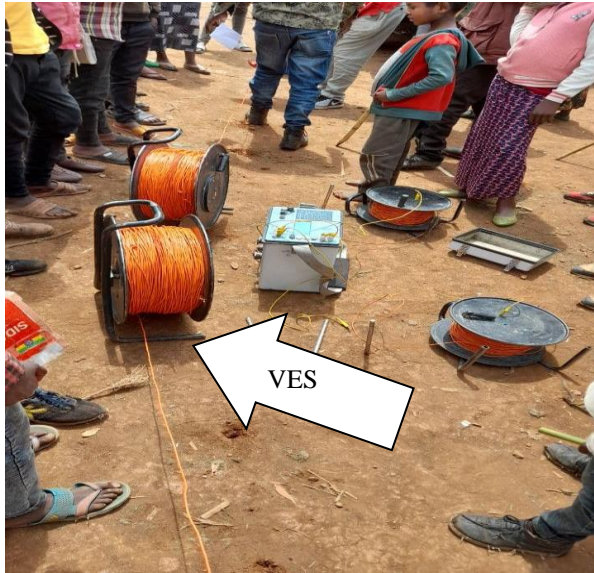
Figure 3-4: VES and Imaging Geophysical Resistivity survey

In order to ascertain the thickness, nature, and lateral variations of the geological formations, which were used to obtain a complete geological picture of the study area, both Electrical Profiling (EP) and Vertical Electrical Sounding (VES) were conducted along a single line of profile in the study area close to the side of a landslide. Profile lines were arranged from northeast to southeast.

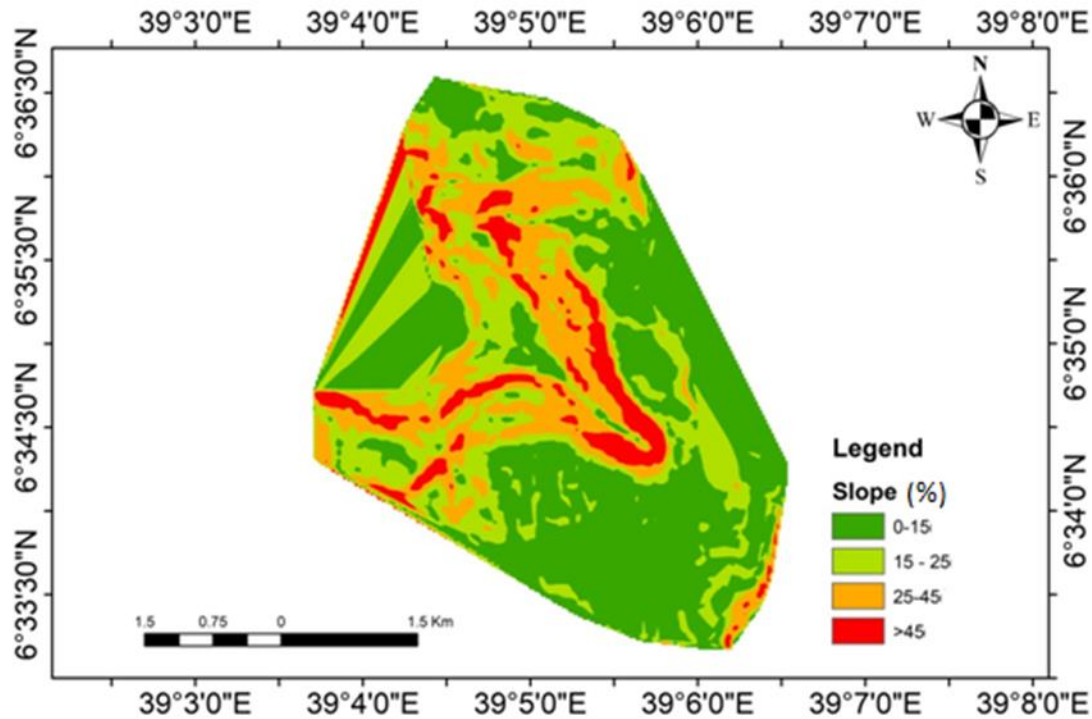
Figure 4-3: Slope map of the study area

This demonstrates that one of the causes of the study area's landslides is the gradient of the slope.

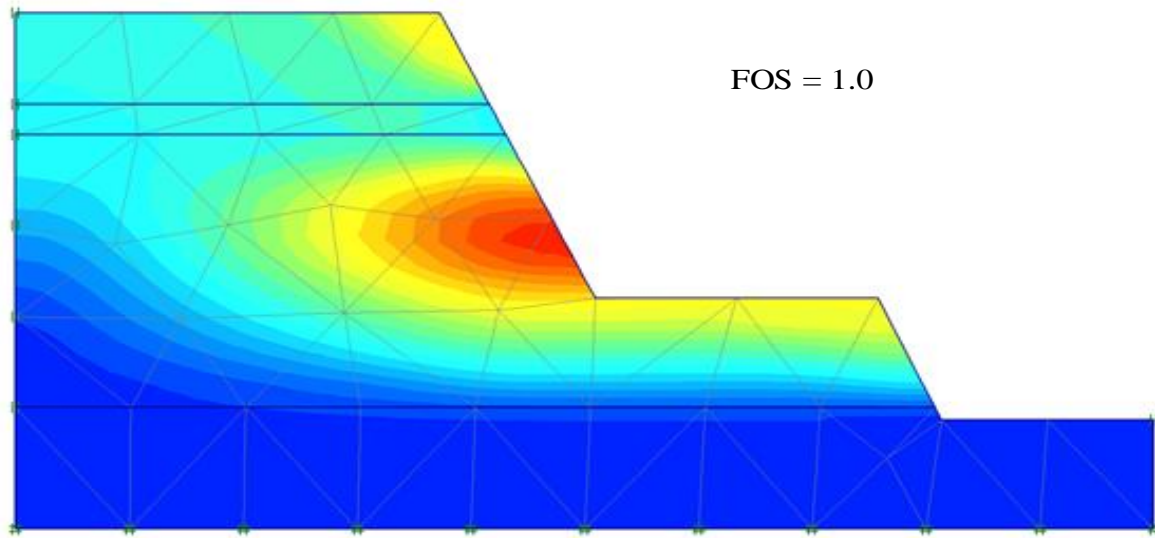
Figure 4-12: Factor of Safety output from software analysis

The material that was transported down the right side slope's face is side slope soil that comes from higher up. This slope has an unstable factor of safety of 1.00, according to the software analysis. Numerous academic works refer to $FS = 1$ as a steady slope. Accepting $FS = 1$ as the table slope is not a wise choice, nevertheless, because some uncontrollable mistakes occurred during laboratory tests and software analysis. As a result, this study's right-side slope's stability condition is an unstable slope. Additionally, this outcome is in excellent agreement with the slope's real state as seen during field observation. Figure 4.13 shown below reveals that the soil is displaced at the middle of the third layer in the right direction along the surface of the slope. This is basically due to the fact that the soil that was found along this direction was originally the collapsed soil that was displaced from the upper part of the slope a long time ago.

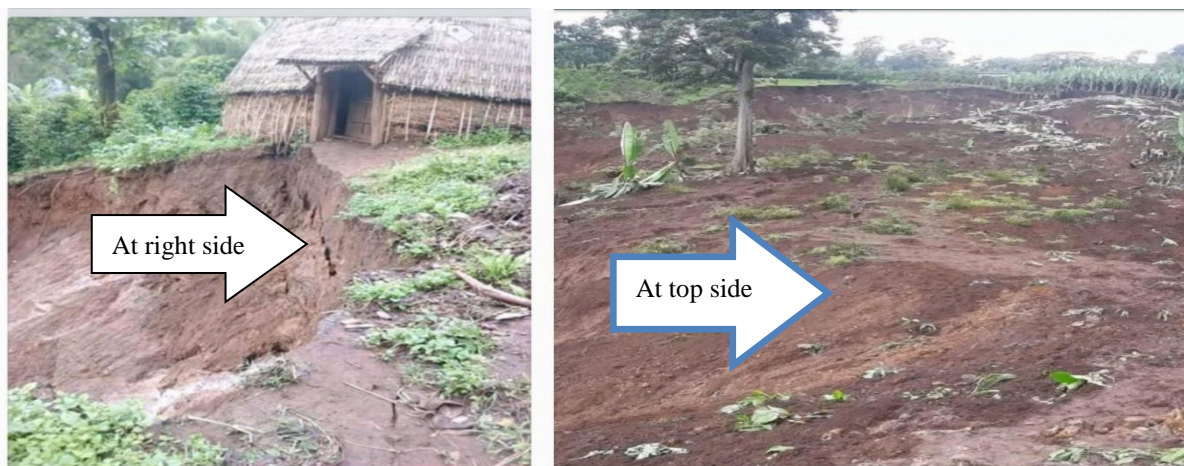
Figure 4-13: Surface damage due to landslide of Tulu Gola landslide

Tullu Gola's environmental features were destroyed when a landslide occurred. Due to unfavorable conditions for obtaining food, some trees fell and mixed with sludge soil that was fragmented; nevertheless, other trees were released from their original growing region and sloughed by standing before drying. The region's land mass began to lose its original traits and collapse. The stream was diverted away from its native bank and dispersed unevenly, with some of it being stored off to the side and the remainder flowing outside.

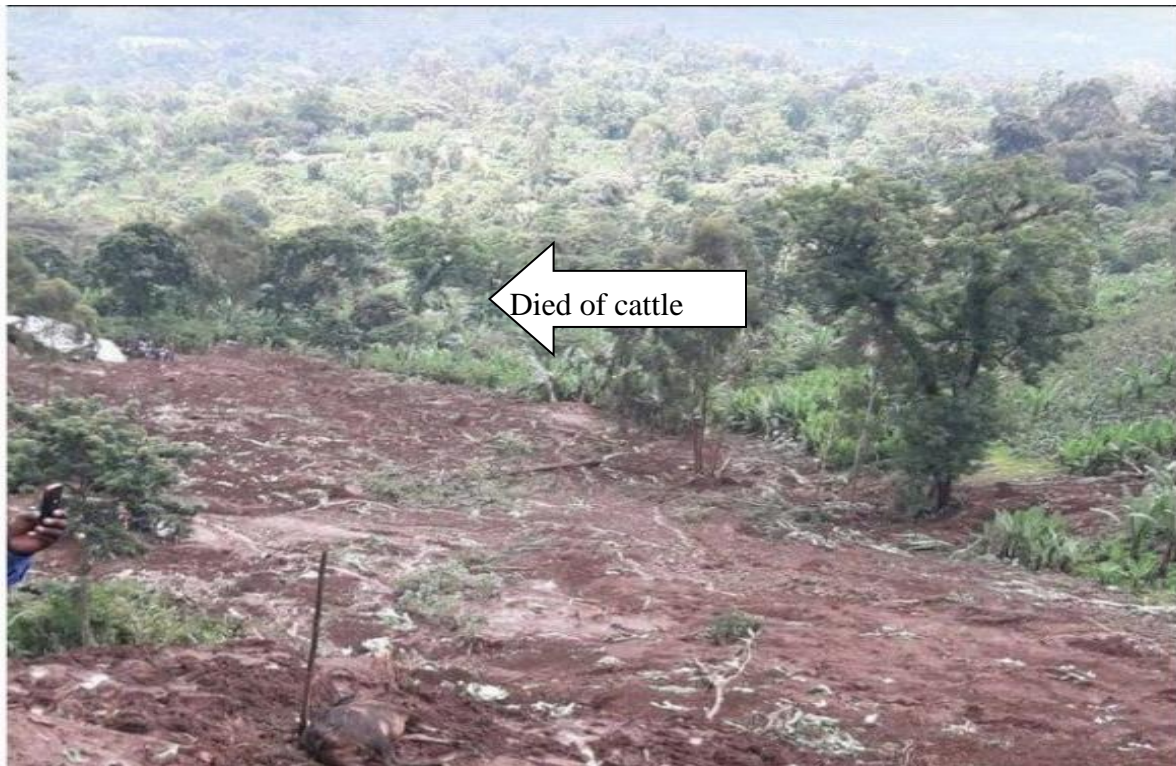
Figure 4-14: Died of cattle due to landslide of Tulu Gola Landslide

Due to earth subsidence in the study region, coffee plants and various fruits were killed. After a landslide devastated the area, the area where animals were utilized for grazing was destroyed because it was believed that the cattle might fall into the hole that had been created. Ponds that were kept at the edge of the slide area were flowing toward and distorting people's homes.
