**Assessment on Cause of Poor Drainage Condition and Its Effect on
Pavement Performance, Jimma City Bocho Bore Kebele**

A final thesis Submitted to School of Graduate Studies of Jimma University,
in partial fulfillment of the requirements for Degree of Master of Science in
Highway Engineering

November, 2017
Jimma, Ethiopia

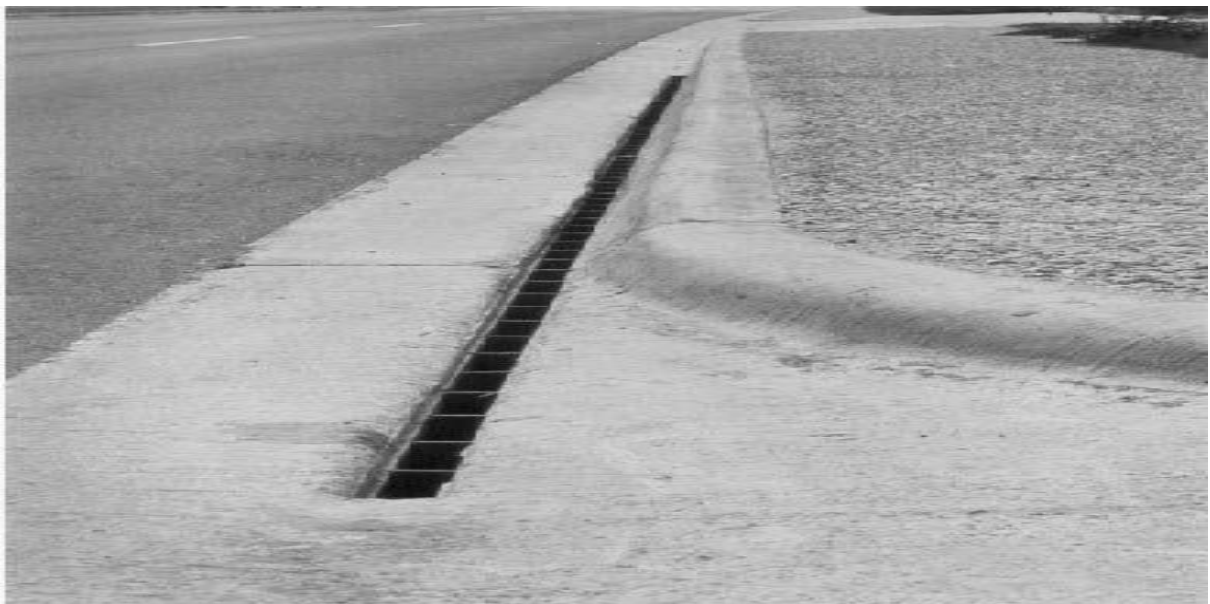
Figure 2.4 Slotted drain inlet at an intersection

Drainage inlets composed of a continuous slot built into the top of a pipe which serves to intercept, collect, and transport the flow. Slotted drain inlets consist of a slotted opening with bars perpendicular to the opening. Slotted inlets function as weirs with flow entering from the side. They can be used to intercept sheet flow, collect gutter flow with or without curbs, modify existing systems to accommodate roadway widening or increased runoff, and reduce ponding depth and spread at grate inlets. They can also be used to intercept flow in areas of limited space such as a retrofit in a problem area. The designer should ensure that maintenance access is provided with the design for this type of inlet. The two types of slotted inlets in general use are the vertical riser type and the vane type. VDOT does not have a standard for this type of inlet.

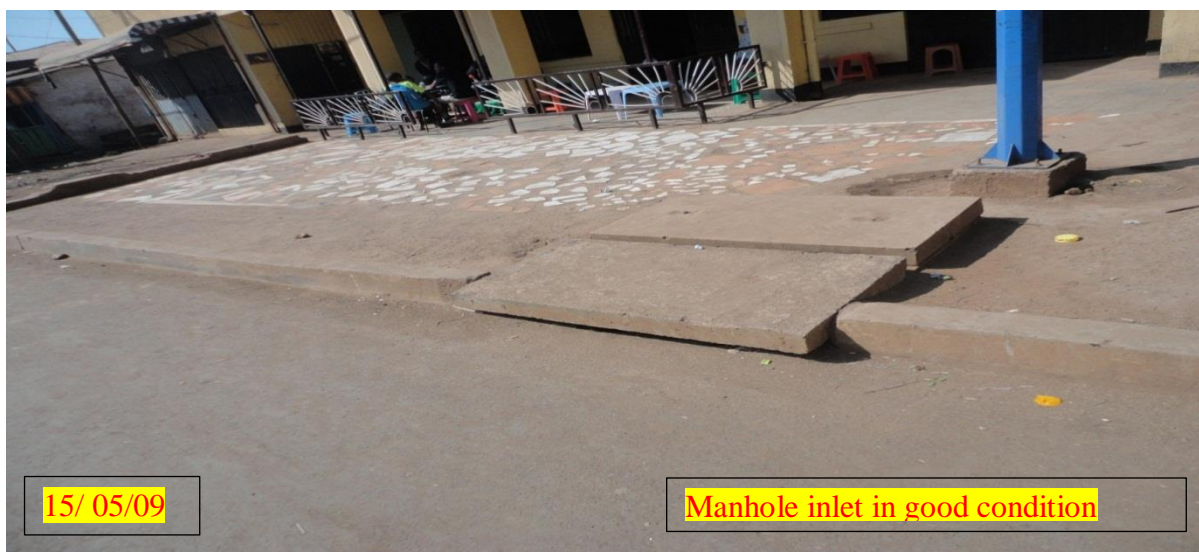
From observation, the state of the drainage system in the kebele road is poor. The main problems of the existing drainage condition are: people awareness, absent of routine maintenance of drainage, construction problem and poor management system. All this problem make drainage systems are lead to decrease the efficiency of drainage inlets and have low capacity to convey flood. The drainage capacity decrease and low efficiency of inlets lead to overflow water back to pavement structure and road are deteriorated before design life. The existing drainage facilities the surface water back to pavement, then it create pothole due to over flows and have greater problem on road and residents. If drainage structure does not have the capacity to carry surface water, overflowing, ponds other spaces are not properly allocated to accommodate discharge. Most ditches do not have proper slope to pass water. Dumping of solid wastes in to drainage Containing, debris, house refuses, plastic materials and others has been serious problem of drainage in the study area. Other problems are construction quality, absent of routine maintenance and proper follow up does give attention by government management system are major problems. However, some parts of the road have no problem with drainage.

figure 4.4 manhole inlet in good condtion

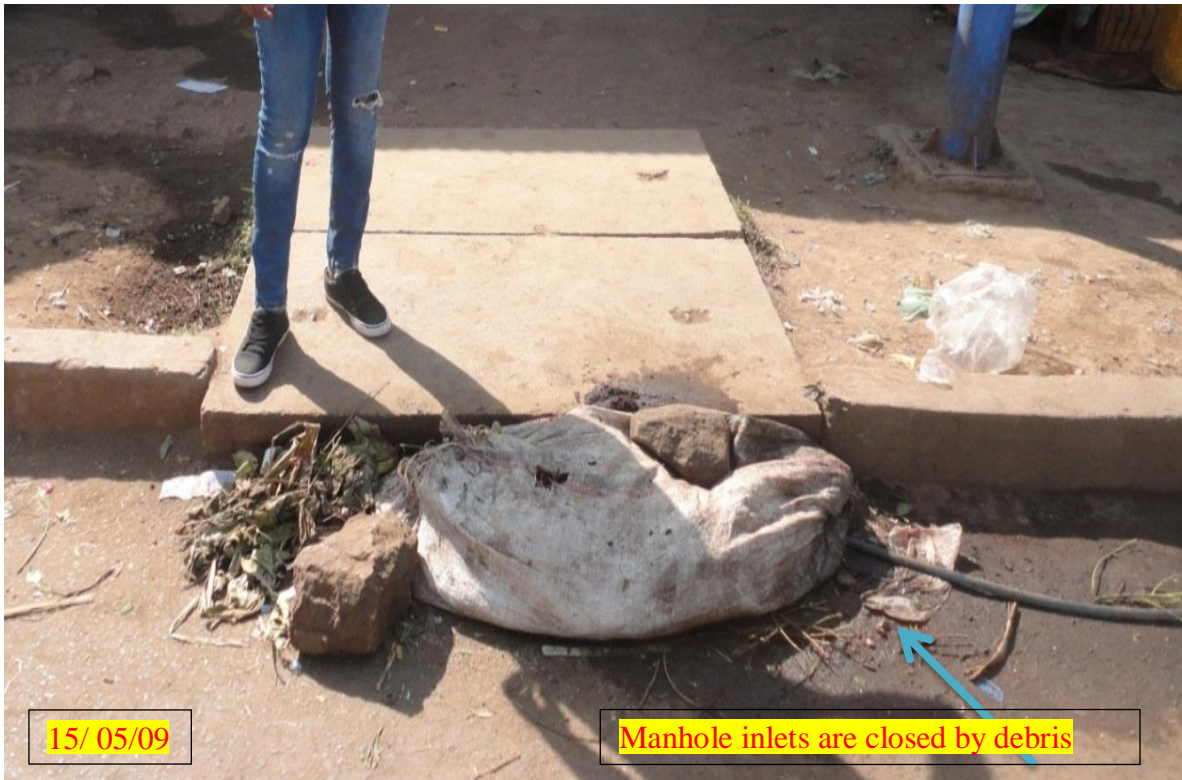
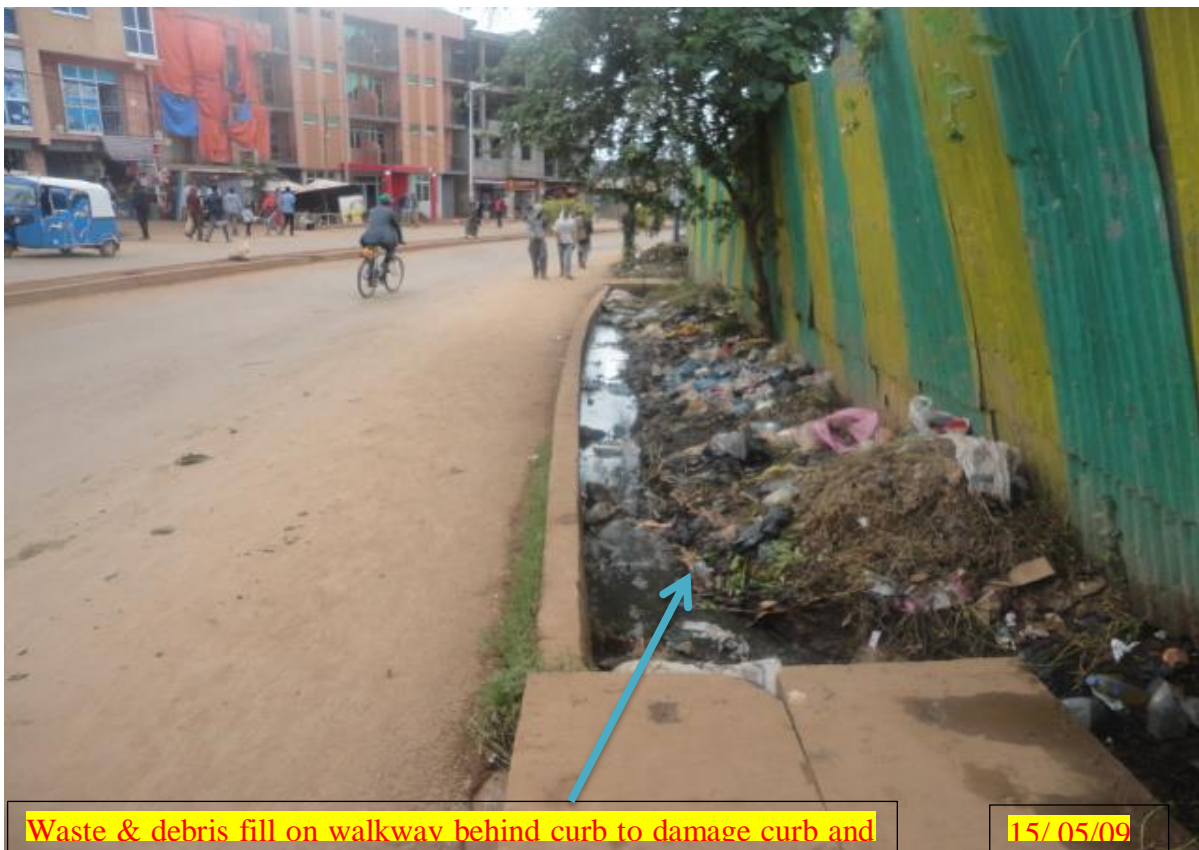
Figure 4.5 waste disposal on the drainage structure

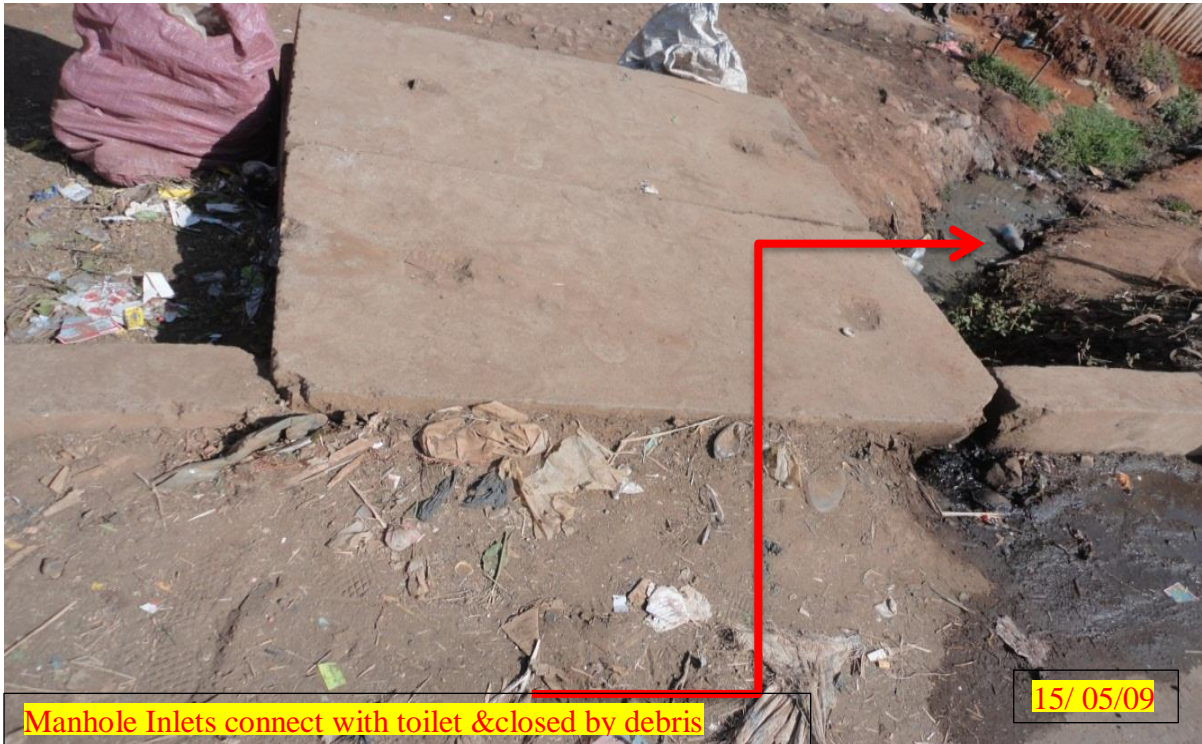
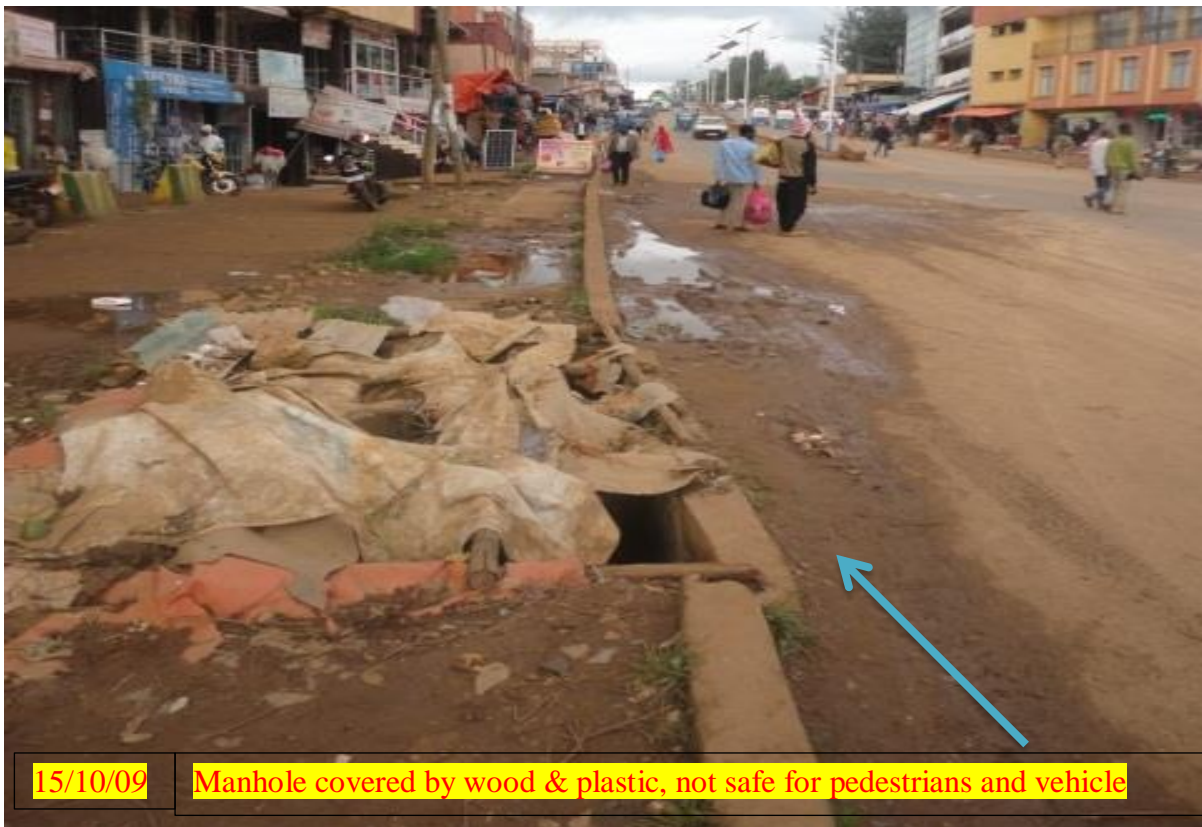
Figure 4.6 shows inlets closed by debris and connected with toilets, around genu hotel

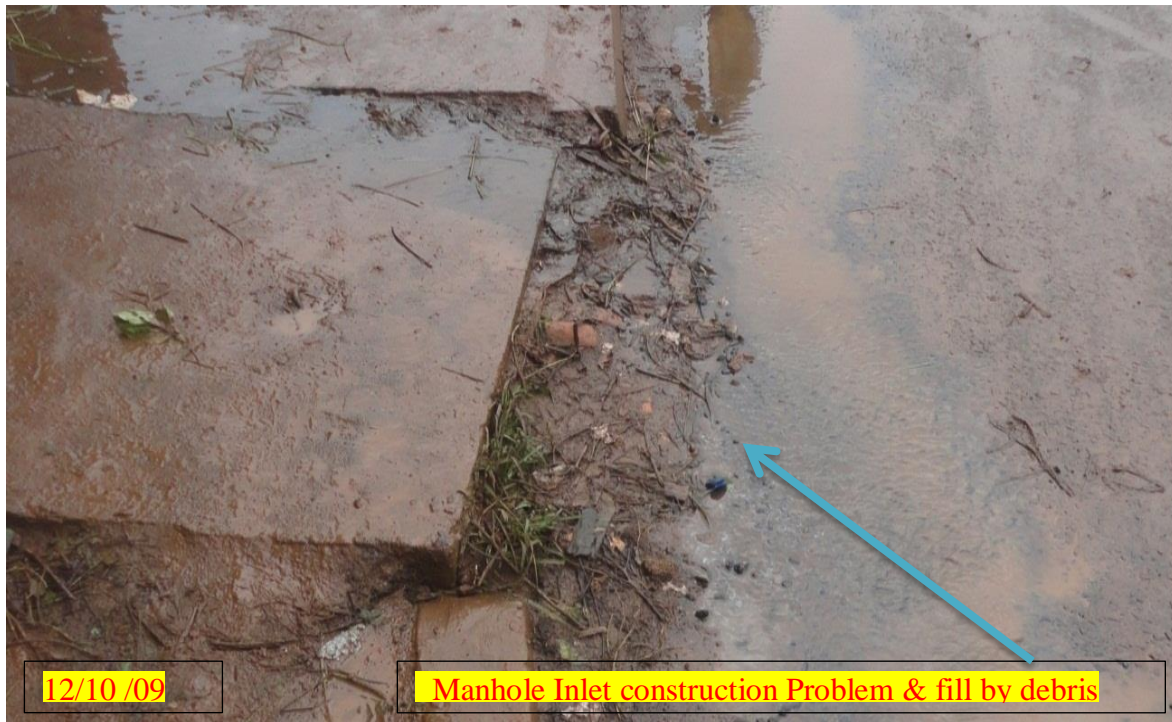
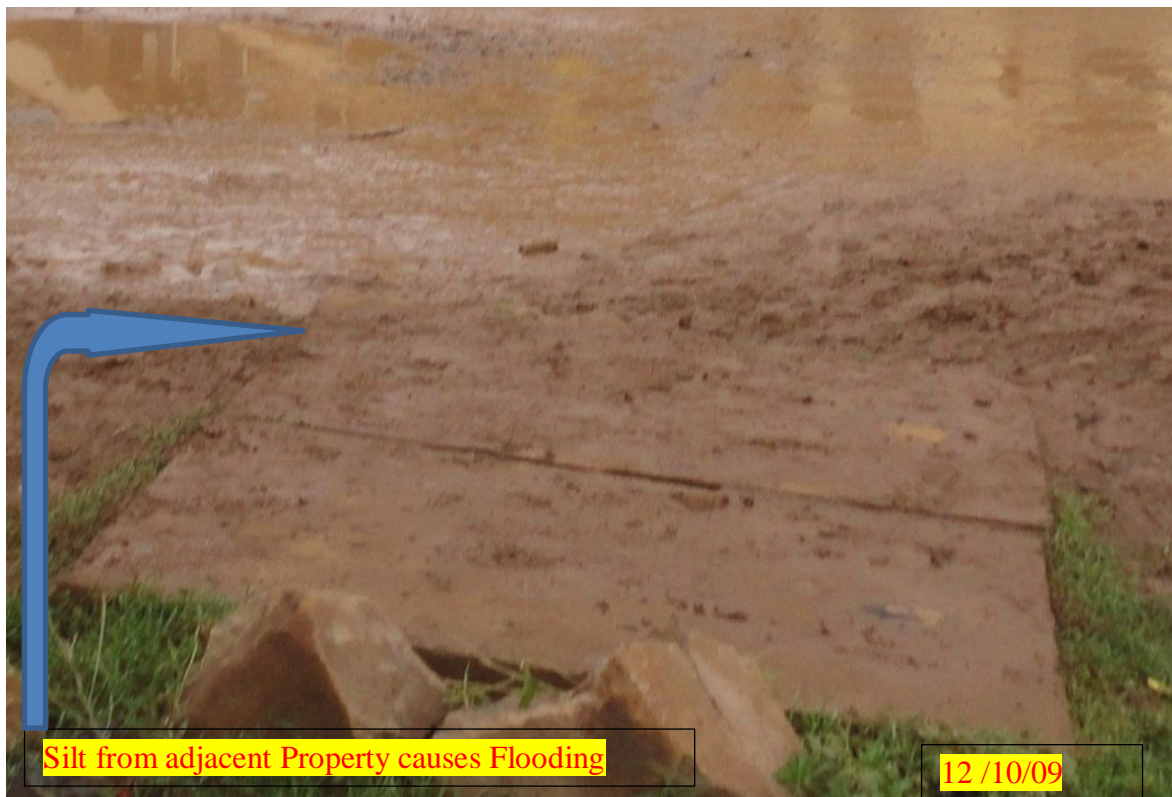
Inlet cover overlapped with pavement and no opening at all

- Silt from adjacent property causes flooding.

Figure 4.7 inlets closed by silt and mud in front of central source: field survey).café

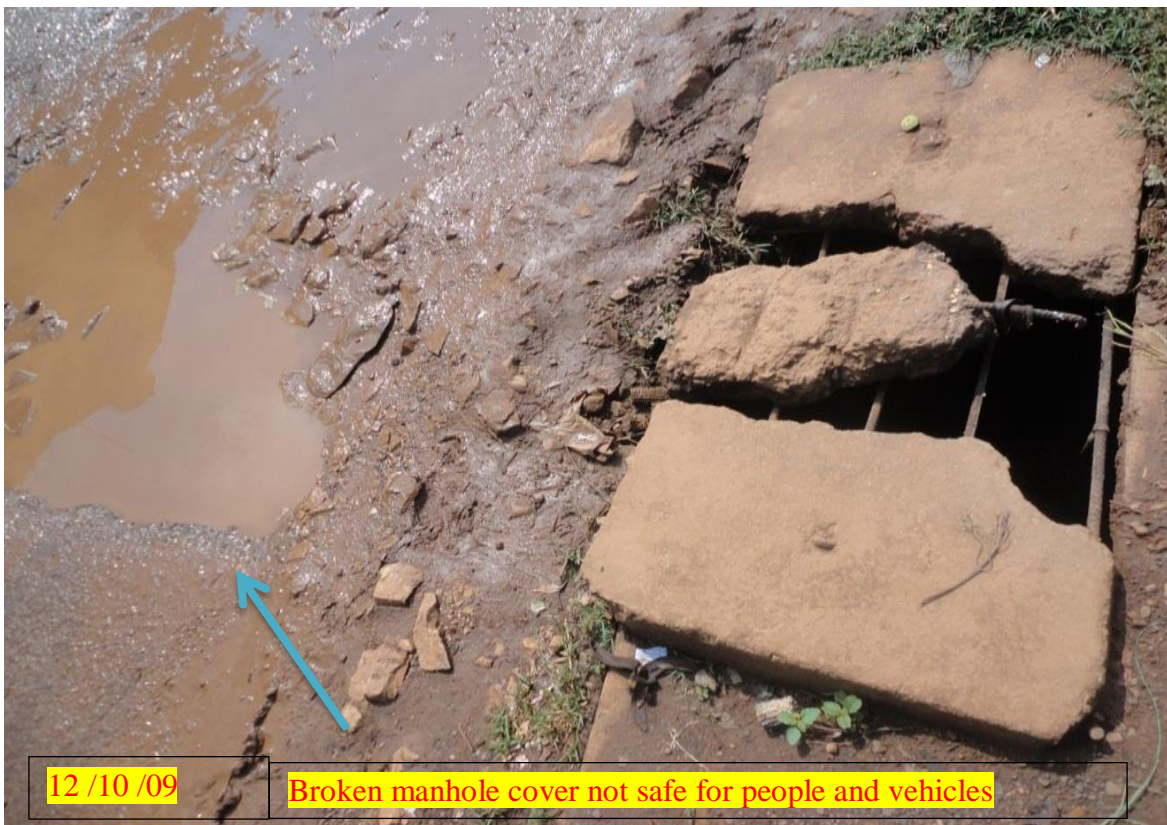
Figure 4.8 shows that manual cover damage and removed in front of total (source: field survey).

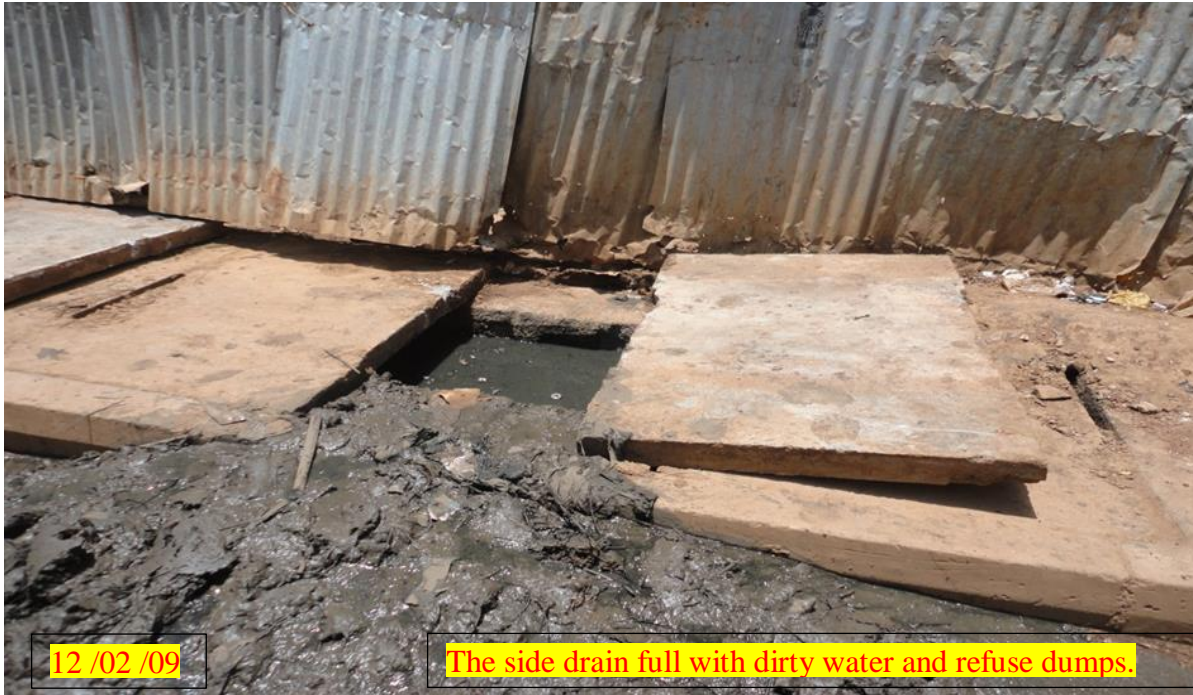
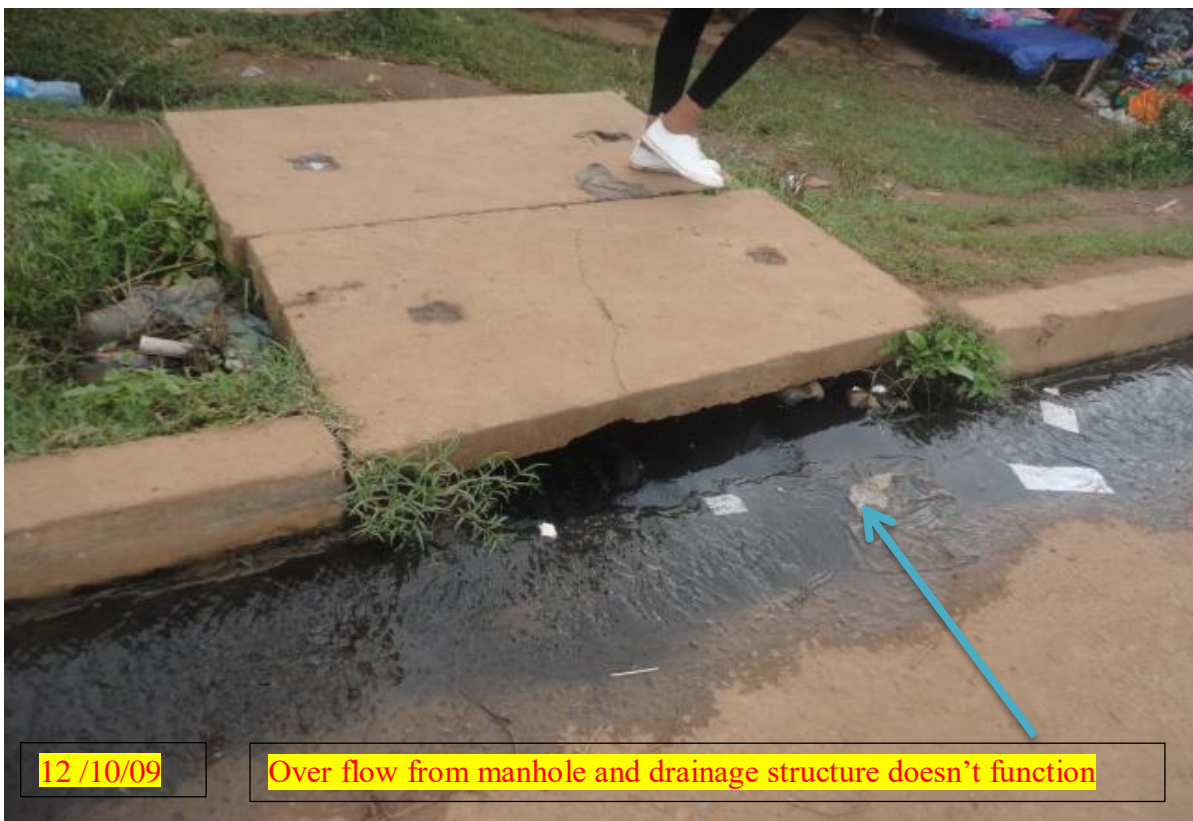
- Ditch cleaning needed and routine cleaning improves drainage capacity.
- Drainage structure doesn't function because of fill debris and silt up.

Figure 4.9 that drainage fills by debris (taken around bus station & feid roundabout)

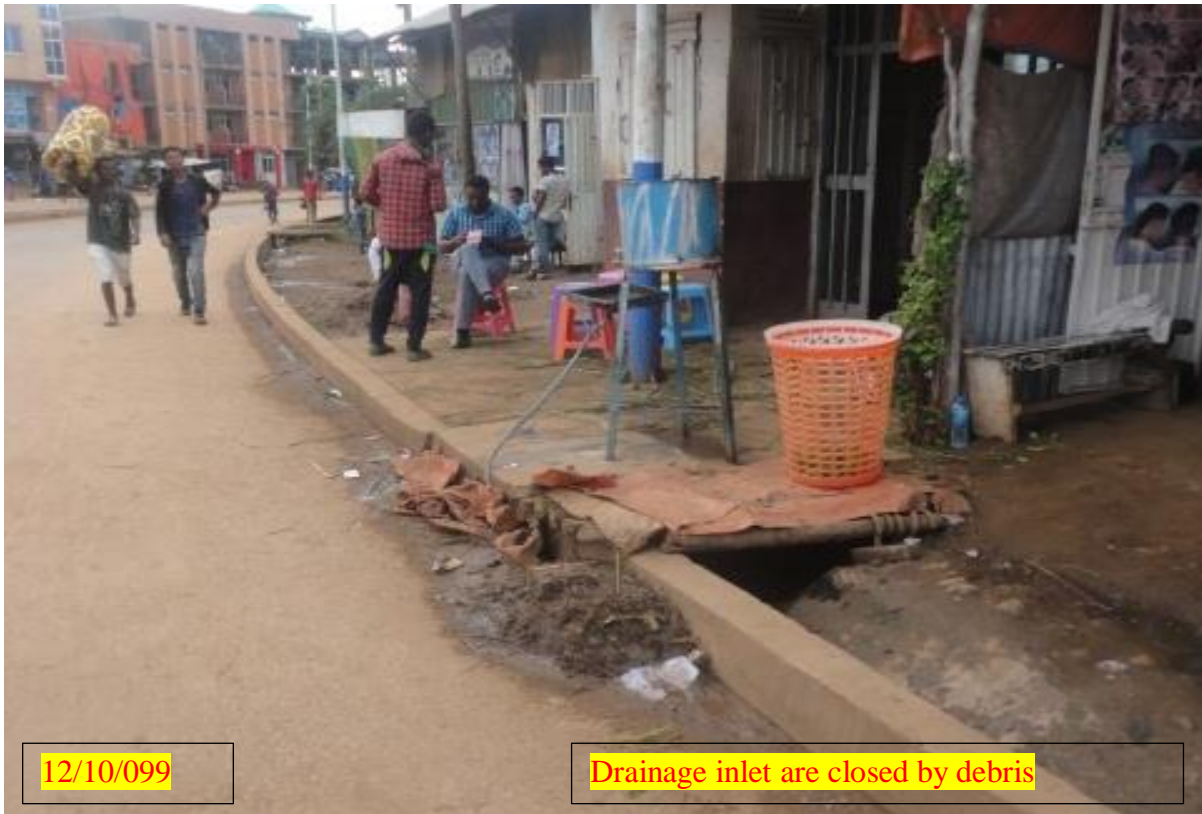
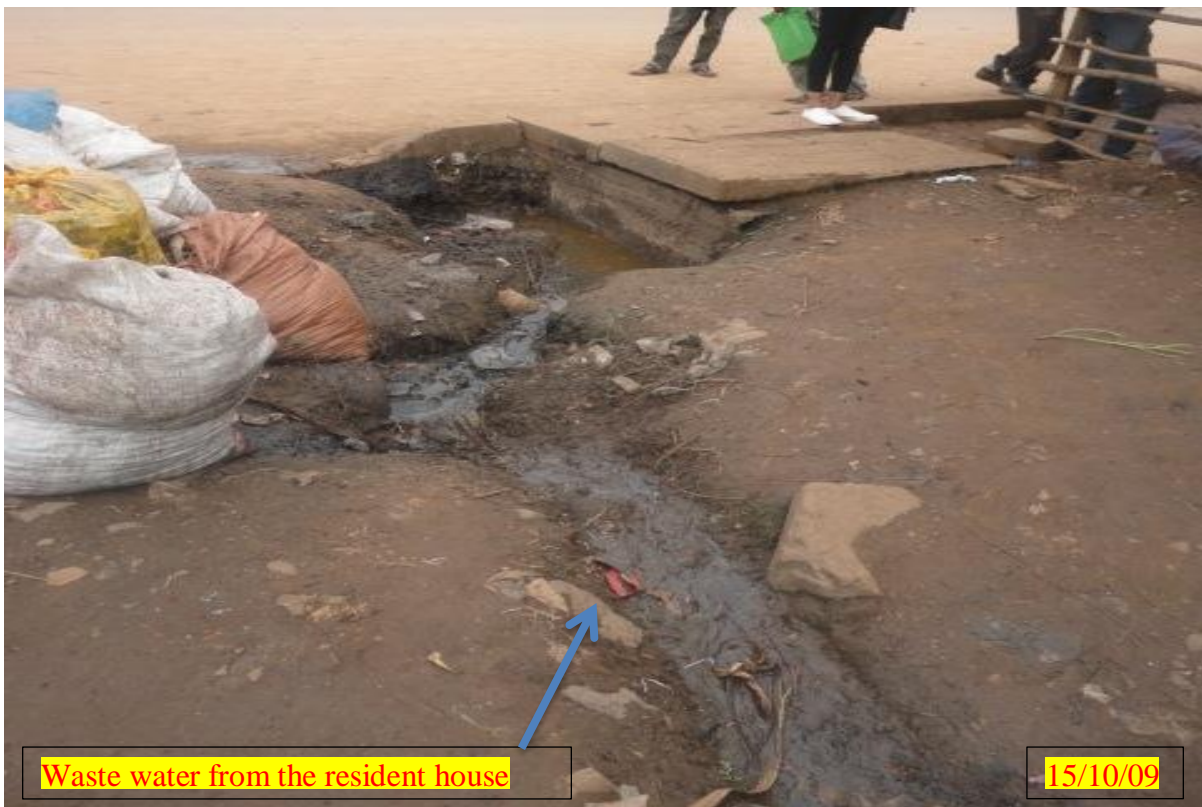
Figure 4.10 waste water and trash from resident home to outside the ditch.

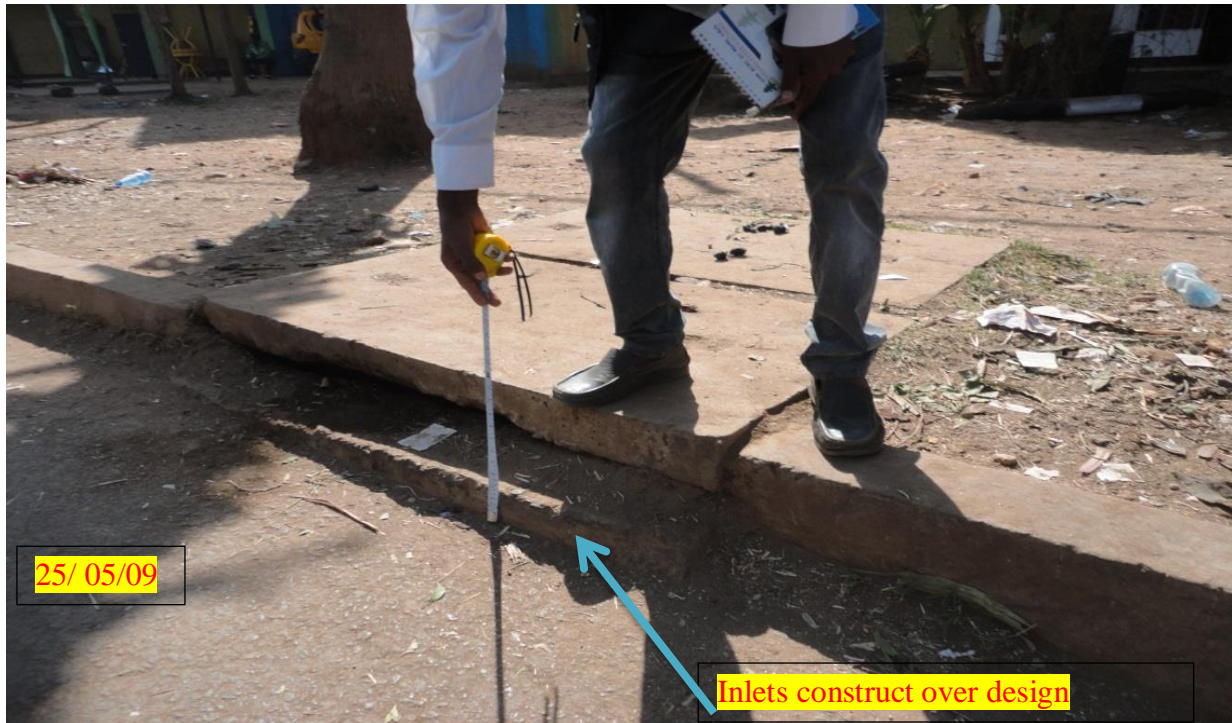
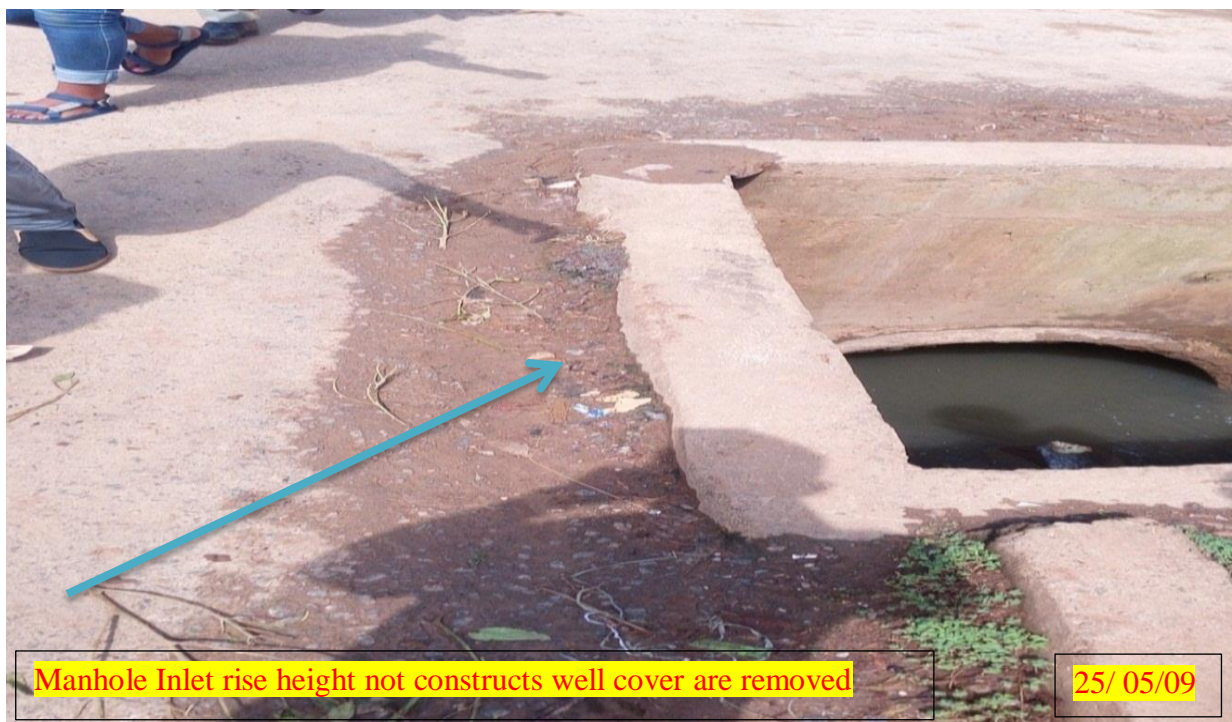
- ❖ Drainage structure Construction problem
 - Over design inlet height and small inlet opening
 - Surface water back to pavement due to poor construction.

Figure 4.11 inlets contract over design and manhole cover (around feidi roundabout)

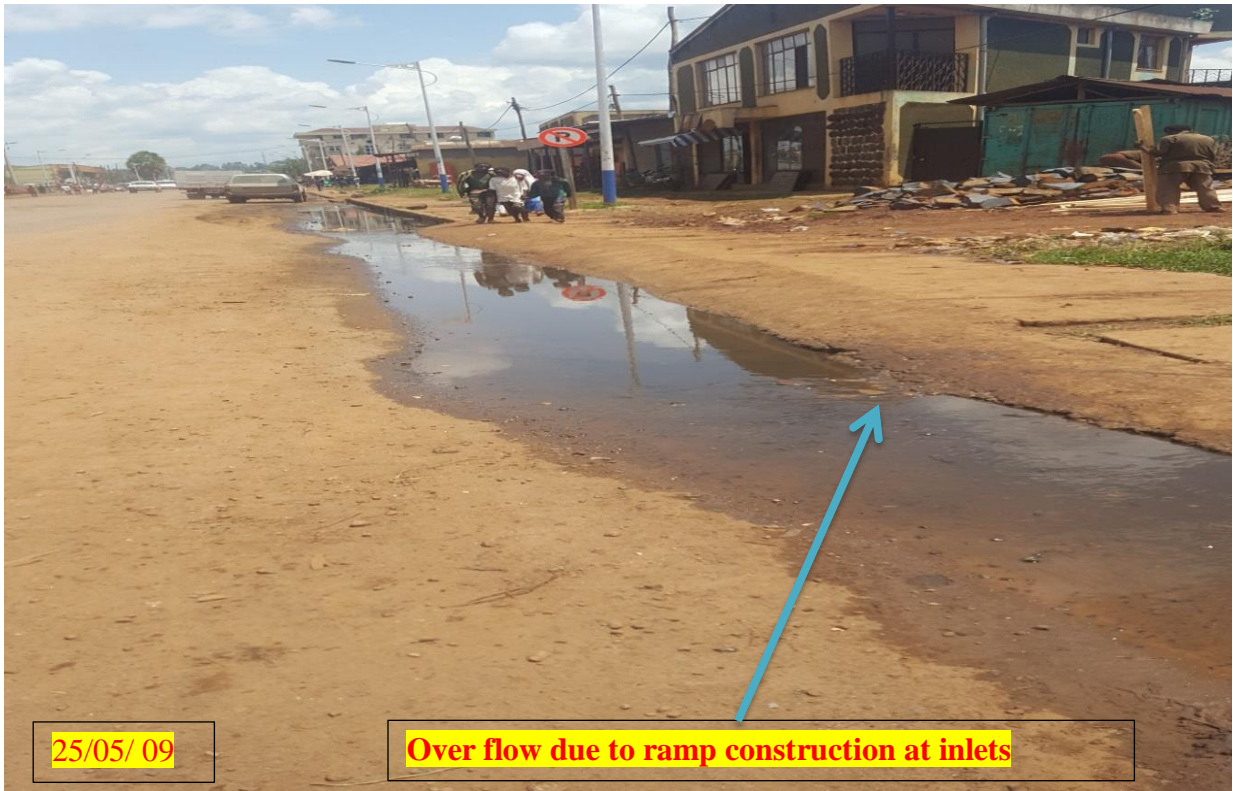
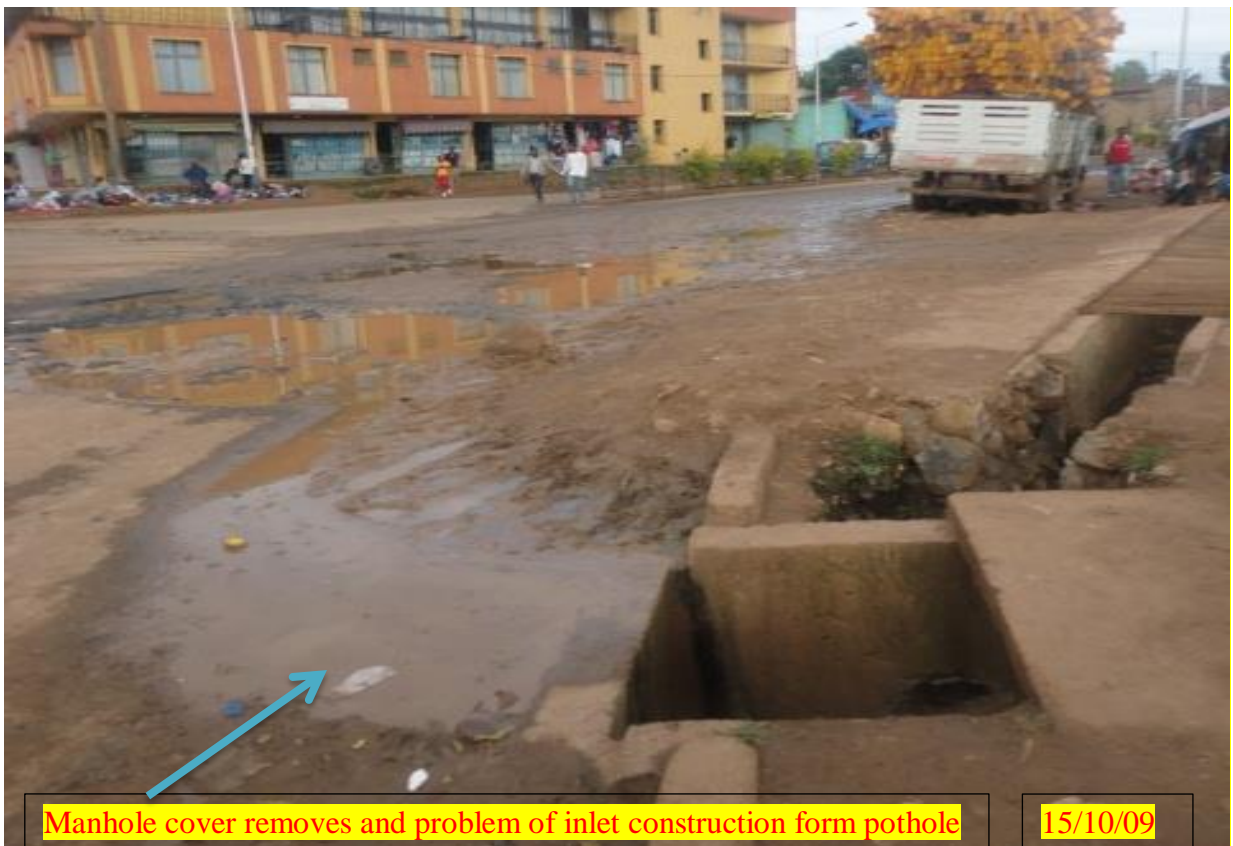
figure 4.12 assessment of drainage construction

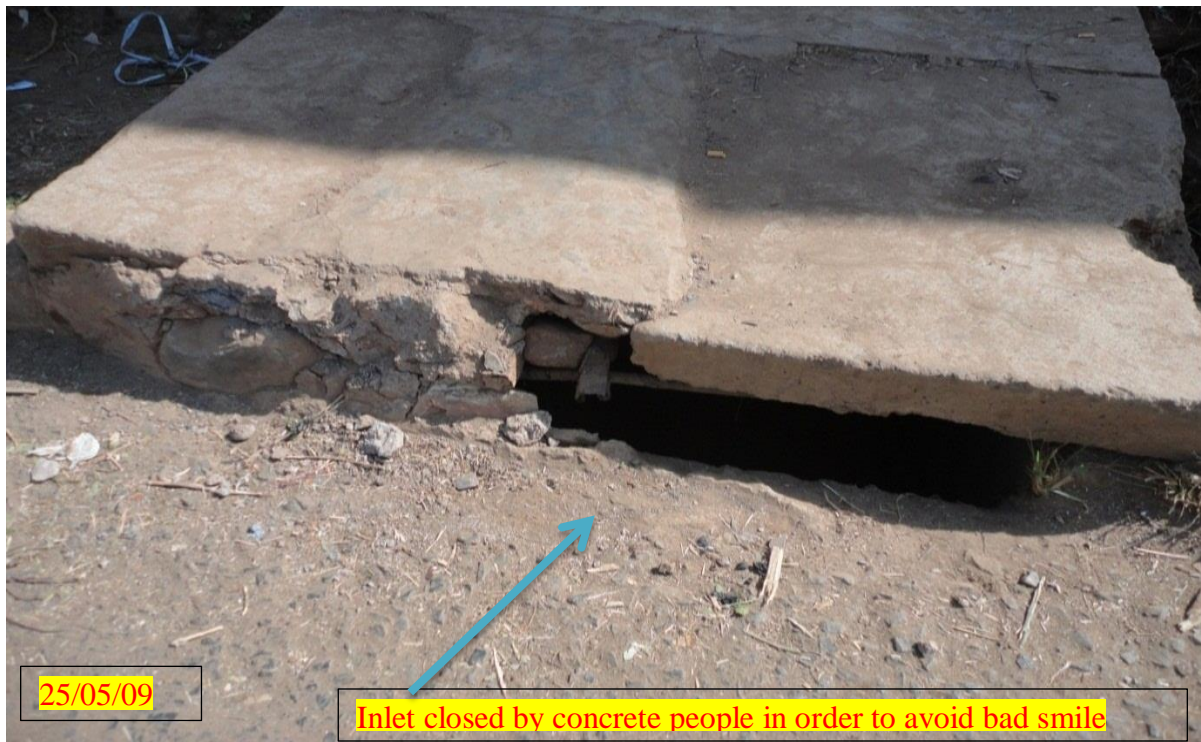
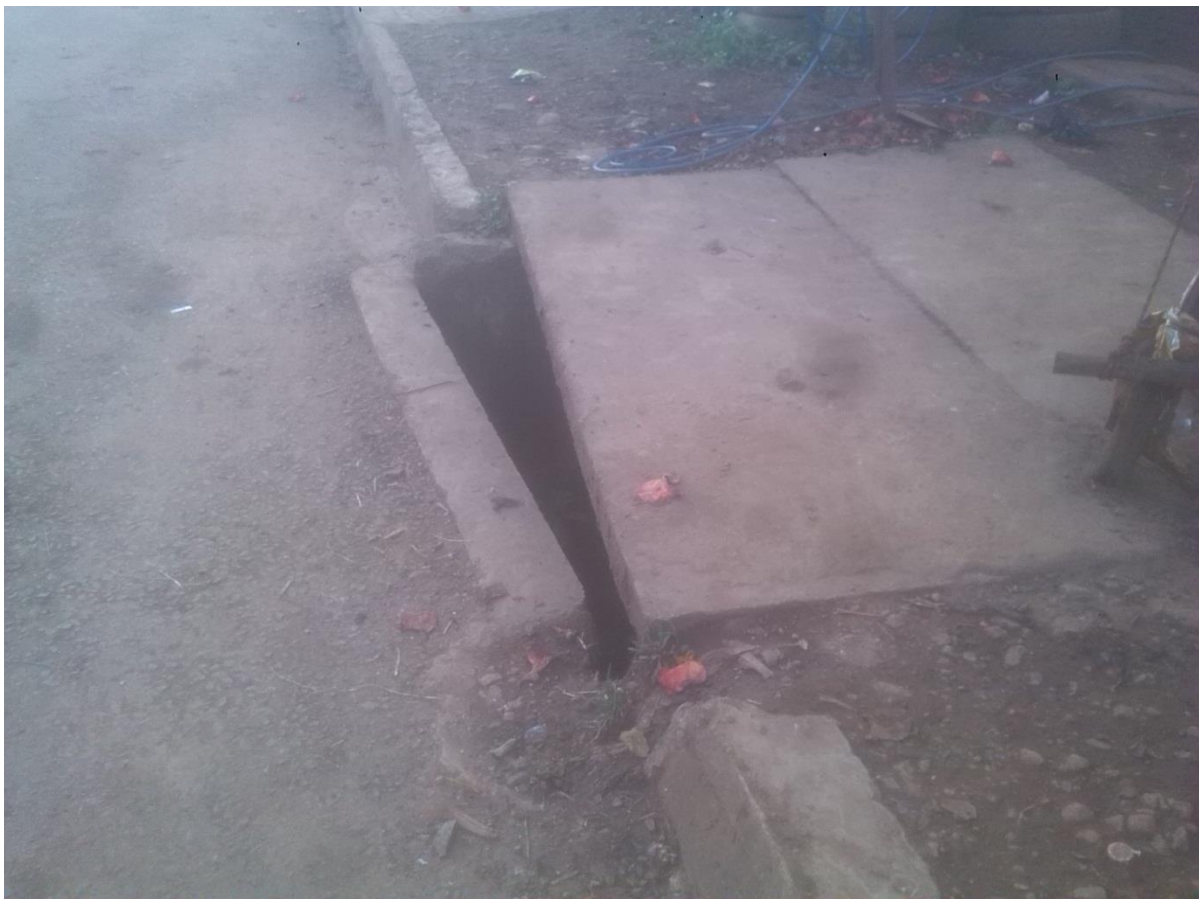
Figure 13 Drainage inlet structure construction problems and manhole cover not fit

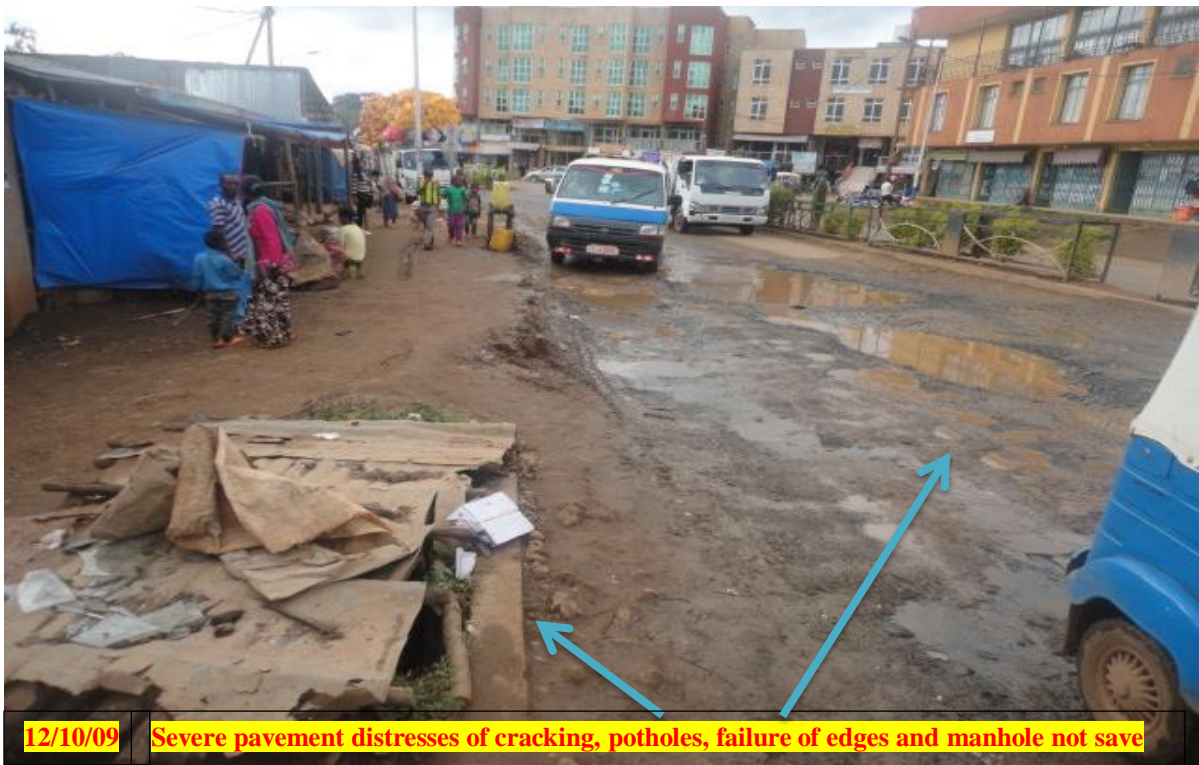
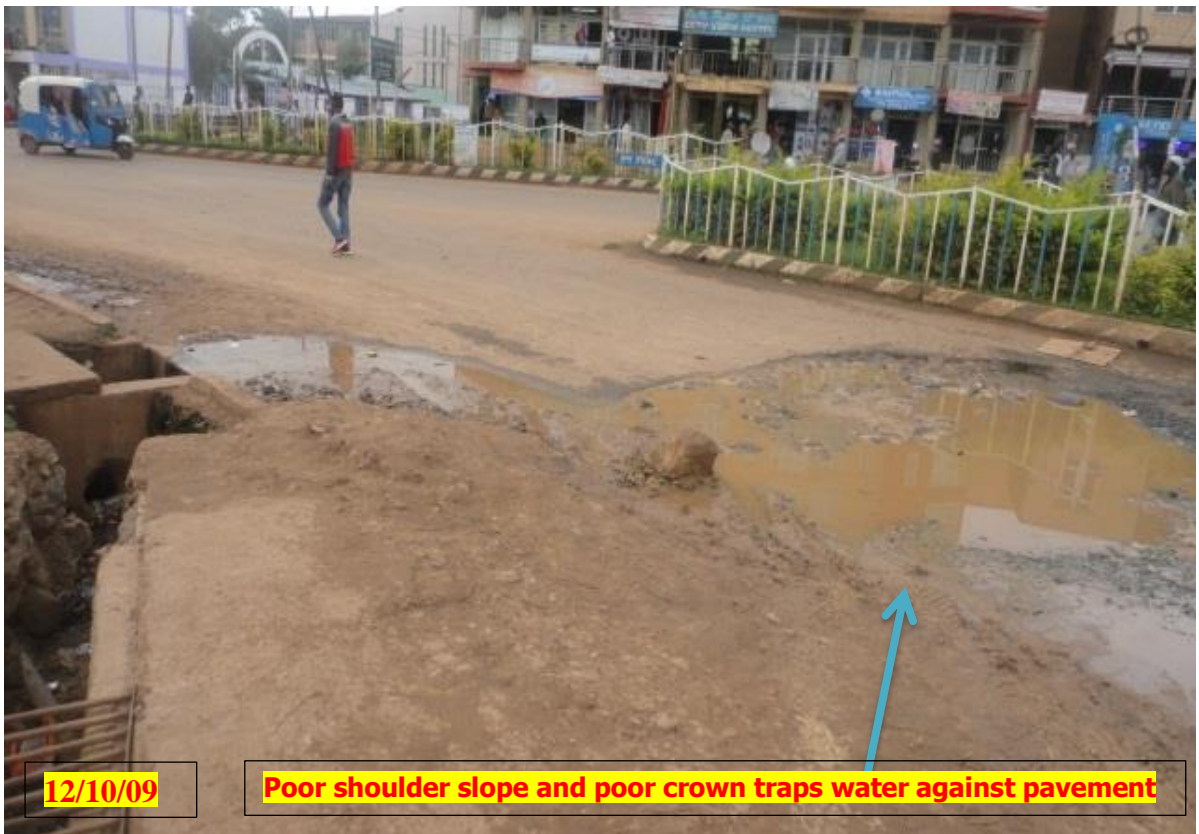
According to field observation made, severe distresses were observed on the road surface. It was found that the runoff water over flow on surface and as a result road material was eroded. Significant cracking, potholes, edge failure as shown in figure below

Figure 4.19 Formation of potholes due to Poor Drainage around genu hotel

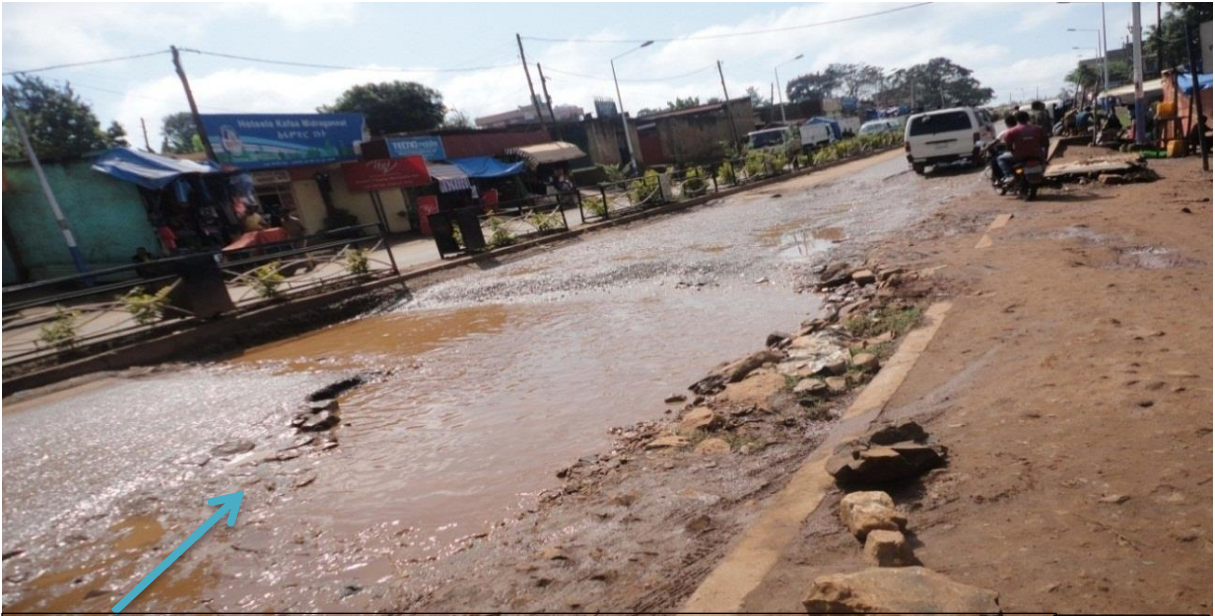
- ❖ Pavement settlement causes ponding.

Severe failures of road edges due to water ponding on surface and obstructed traffic flow

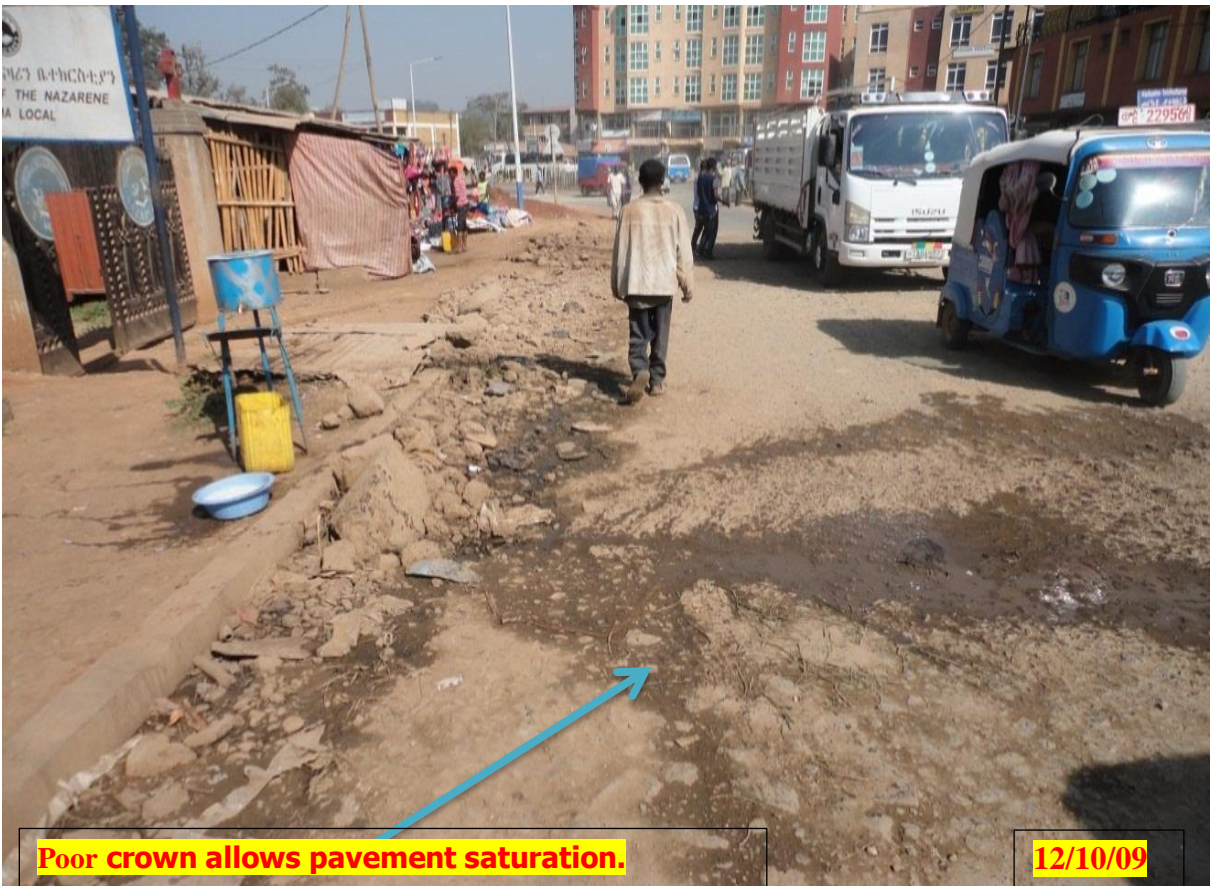
Poor crown allows pavement saturation.

Figure 4.20 shows that pavement failure and inlets doesn't work (in front of genu hotel)
