**Assessment on Cause of Poor Drainage Condition and Its Effect on
Pavement Performance, Jimma City Bocho Bore Kebele**

A final thesis Submitted to School of Graduate Studies of Jimma University,
in partial fulfillment of the requirements for Degree of Master of Science in
Highway Engineering

November, 2017
Jimma, Ethiopia

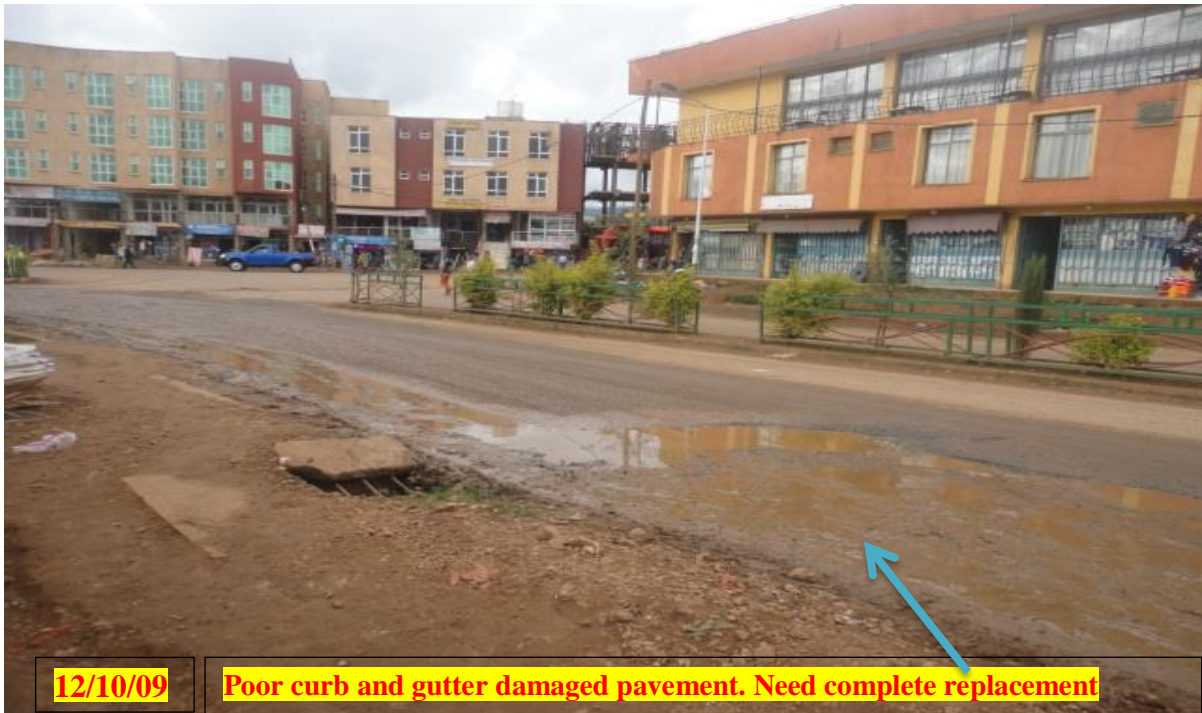
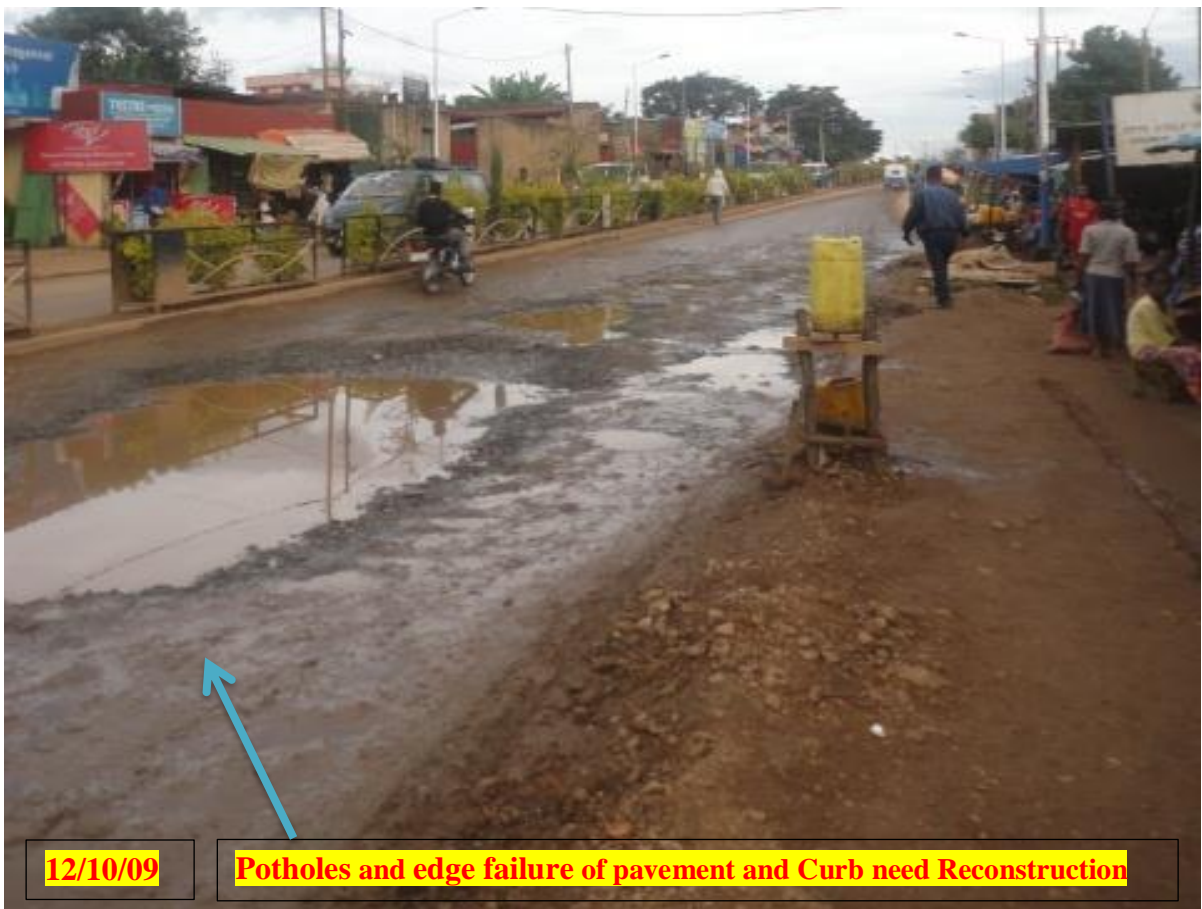
Figure 4.21 shows that pavement failure and inlets doesn't work (in front of genu hotel)

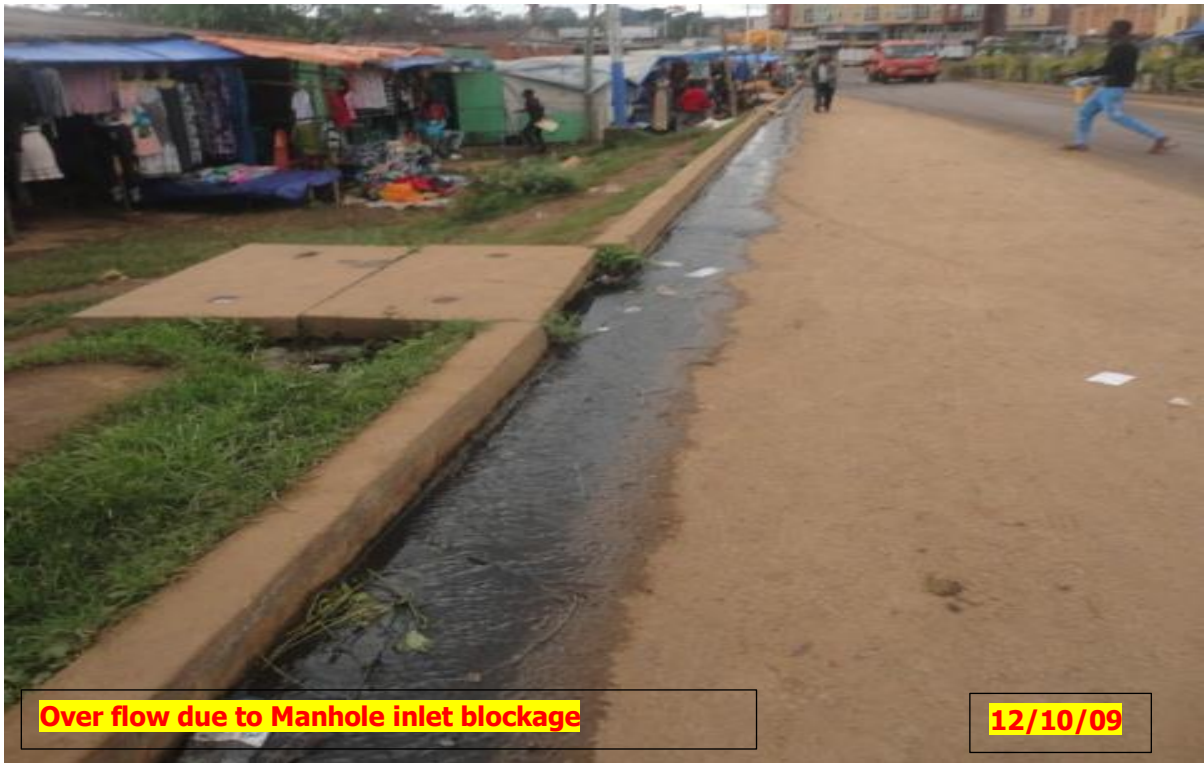
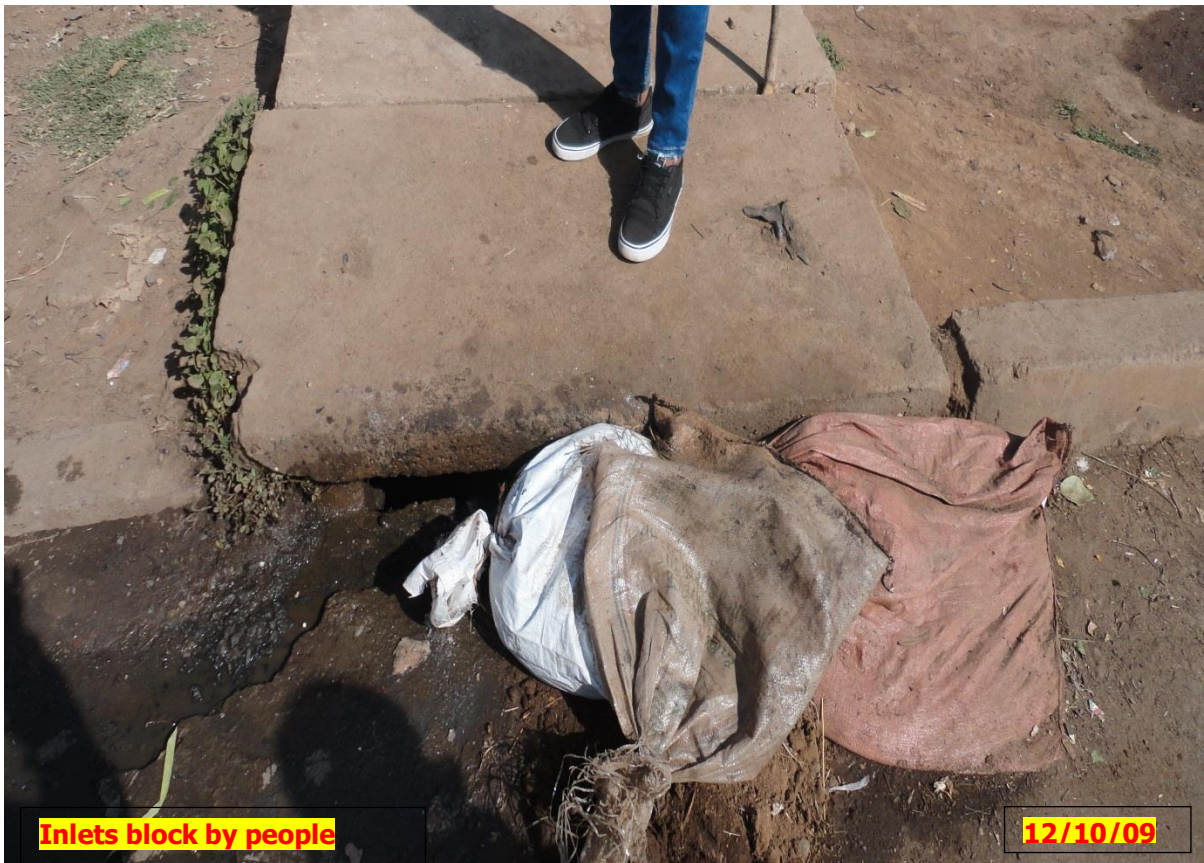
Figure 4.22 Waste water inter to manhole inlets across on pavement structure
