**JIMMA UNIVERSITY
SCHOOL OF GRADUATE STUDIES
JIMMA INSTITUTE OF TECHNOLOGY
SCHOOL OF CIVIL AND ENVIRONMENTAL ENGINEERING
HIGH WAY ENGINEERING STREAM**

**Causes of Defects of Asphalt Pavement and Its Remedies
A Case Study In Agaro Town**

**A thesis submitted to the School of Graduate Studies of Jimma University in
Partial fulfillment of the requirements for the Degree of Masters of Science in Highway
Engineering**

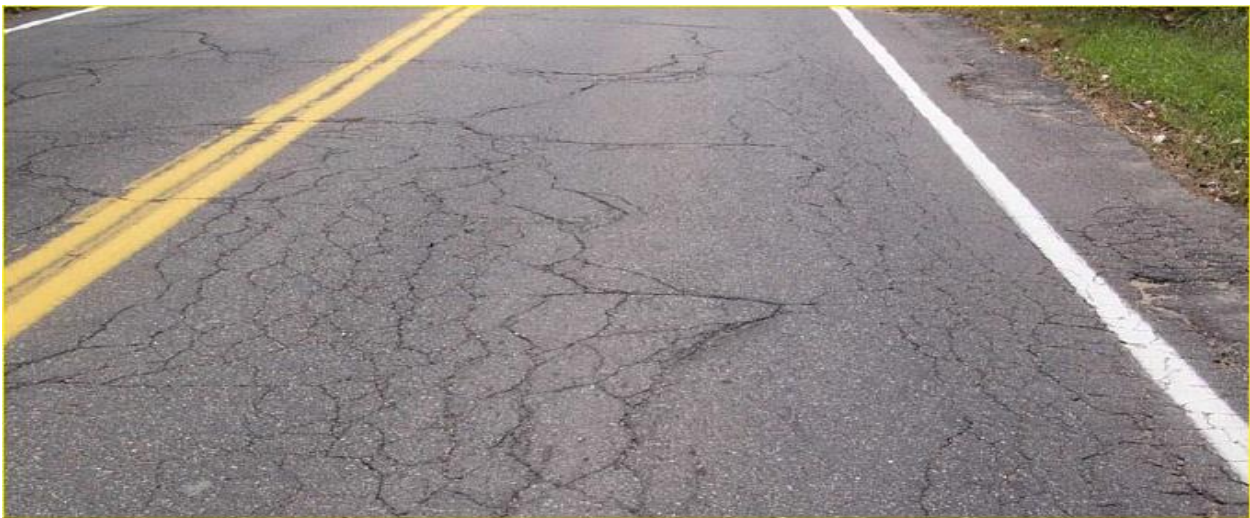
Figure 2.1: Alligator cracks (Pavement Distress Identification Manual, July 2011)

Cracking is commonly called alligator cracking. This is a series of interconnected cracks creating small, irregular shaped pieces of pavement. It is caused by failure of the surface layer or base due to repeated traffic loading (fatigue). Eventually the cracks lead to disintegration of the surface. The final result is potholes. Alligator cracking is usually associated with base or drainage problems. Small areas may be fixed with a patch or area repair. Larger areas require reclamation or reconstruction. Drainage must be carefully examined in all cases. Factors which influence the development of alligator cracking are the number and magnitude of applied loads, the structural design of the pavement (layer materials and thicknesses), the quality and uniformity of foundation support, the consistency of the asphalt cement, the asphalt content, the air voids and aggregate characteristics of the asphalt concrete mix, and the climate of the site (i.e., the seasonal range and distribution of temperatures). drainage effect is not considered.

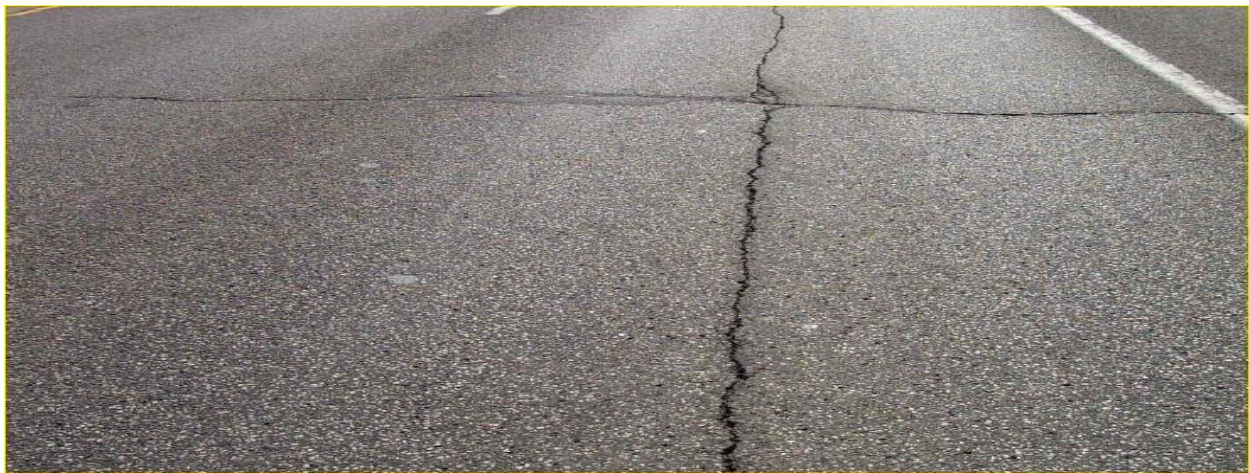
Figure 2.2. Longitudinal cracks (Pavement Distress Identification Manual, July 2011).

Longitudinal cracks are long cracks that run parallel to the center line of the roadway. These may be caused by frost heaving or joint failures or they may be load induced. Understanding the cause is critical to selecting the proper repair. Multiple parallel cracks may eventually form from the initial crack. This phenomenon, known as deterioration, is usually a sign that crack repairs are not the proper solution. Non wheel path longitudinal cracking in an asphalt pavement may reflect up from the edges of an underlying old pavement or from edges and cracks in a stabilized base, or may be due to poor compaction at the edges of longitudinal paving lanes. Longitudinal cracking may also be produced in the wheel paths by the application of heavy loads or high tire pressures.

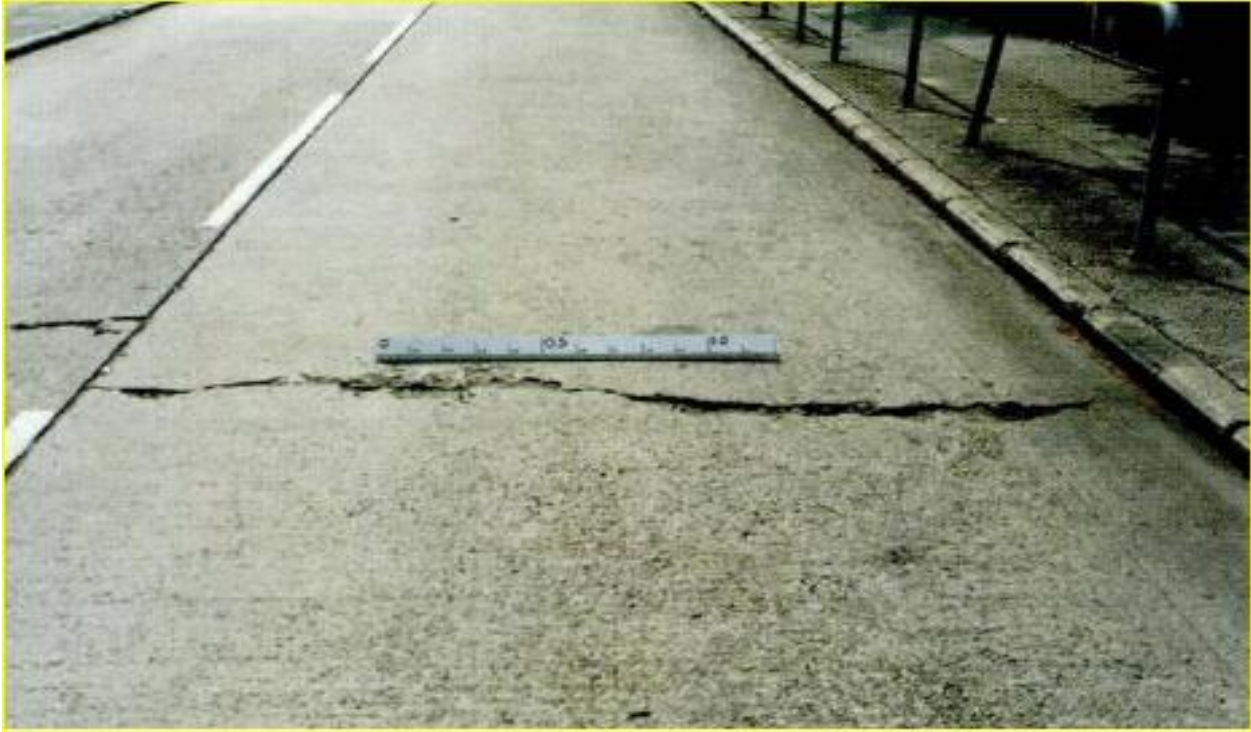
Figure 2.3. Transverse cracks (Catalogue of Road Defects (CORD) January 2013).

develop, parallel to the initial crack. The reasons for transverse cracking, and the repairs, are similar to those for longitudinal cracking. In addition, thermal issues can lead to low-temperature cracking if the asphalt cement is too hard.

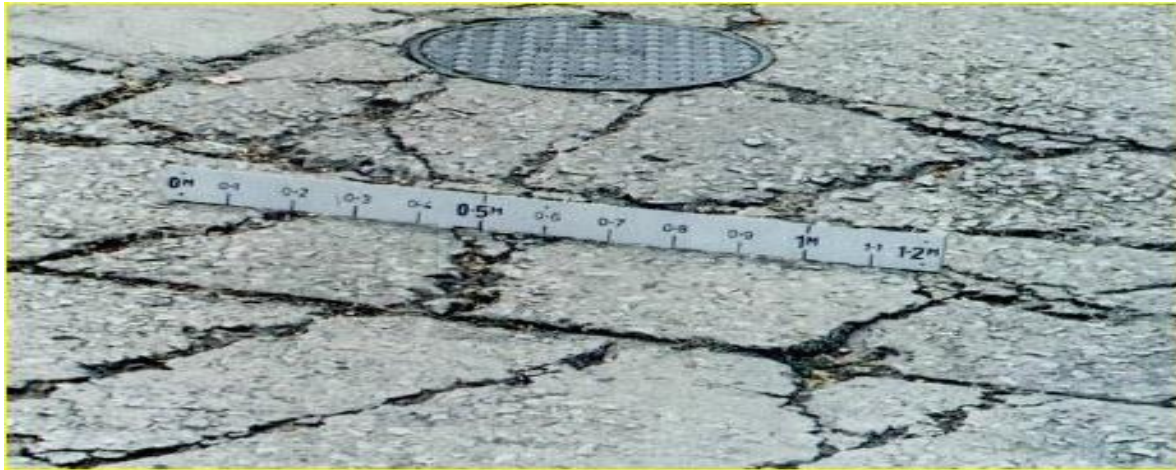
Figure 2.4. Block cracks (Catalogue of Road Defects (CORD) January 2013).

such as parking lots, as well as roadways, primarily in areas not subjected to traffic loads, but sometimes also in loaded areas.

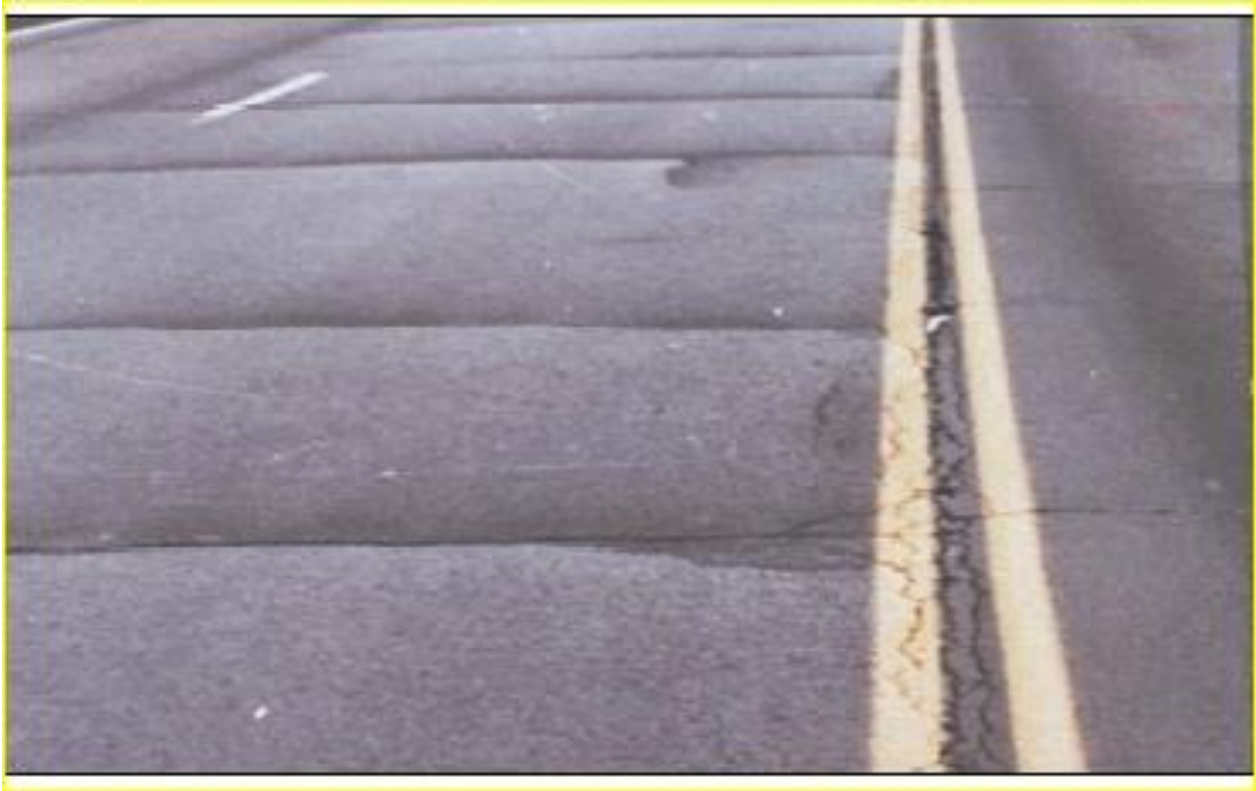
Figure 2.6. Reflective cracking (Pavement Distress Identification Manual, July)

Reflective cracking occurs when a pavement is overlaid with hot mix asphalt concrete and cracks reflect up through the new surface. It is called reflective cracking because it reflects the crack pattern of the pavement structure below. As expected from the name, reflective cracks are actually covered over cracks reappearing in the surface. They can be repaired in similar techniques to the other cracking noted above. Before placing any overlays or wearing courses, cracks should be properly repaired.

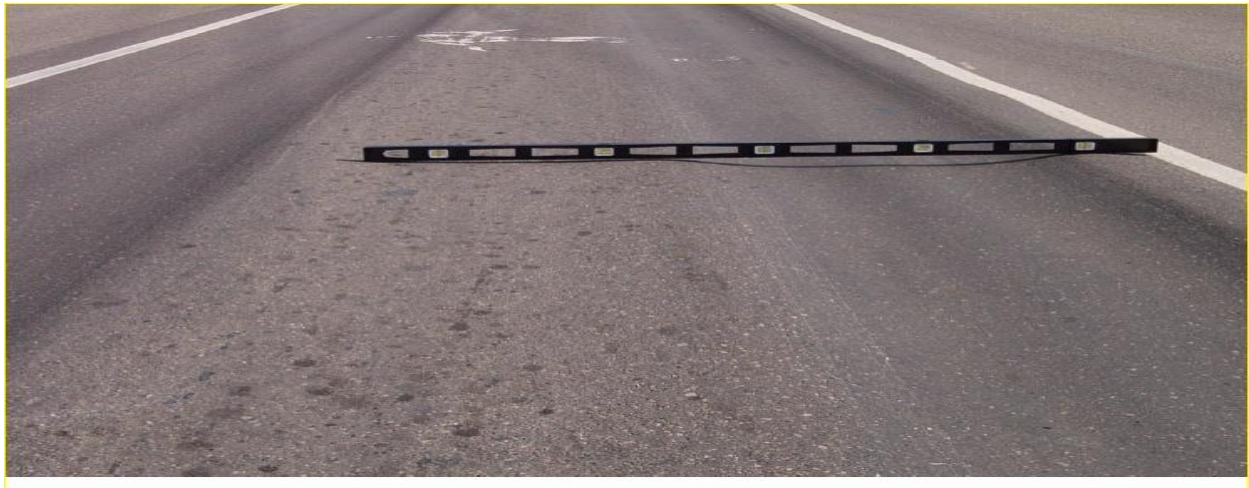
Figure 2.8. Rutting (Miller, J. S., Rogers, R. B. and Rada, G. R., 1993)

Rutting is the displacement of pavement material that creates channels in the wheel path. Very severe rutting will actually hold water in the rut. Rutting is usually a failure in one or more layers in the pavement. The width of the rut is a sign of which layer has failed. A very narrow rut is usually a surface failure, while a wide one is indicative of a subgrade failure. Inadequate compaction can lead to rutting. Minor surface rutting can be filled with micro paving or paver-placed surface treatments. Deeper ruts may be shimmed with a truing and leveling course, with an overlay placed over the shim. If the surface asphalt is unstable, recycling of the surface may be the best option. If the problem is in the sub grade layer, reclamation or reconstruction may be needed. This type of surface deformation is also explained according to Miller, J.S., Rogers, R.B. 1993. Rutting is the formation of longitudinal depression of the wheel paths, most often due to consolidation or movement of material in either the base or sub grade or in the asphalt concrete layer. Another, unrelated, cause of rutting is abrasion due to studded tires and tire chains.

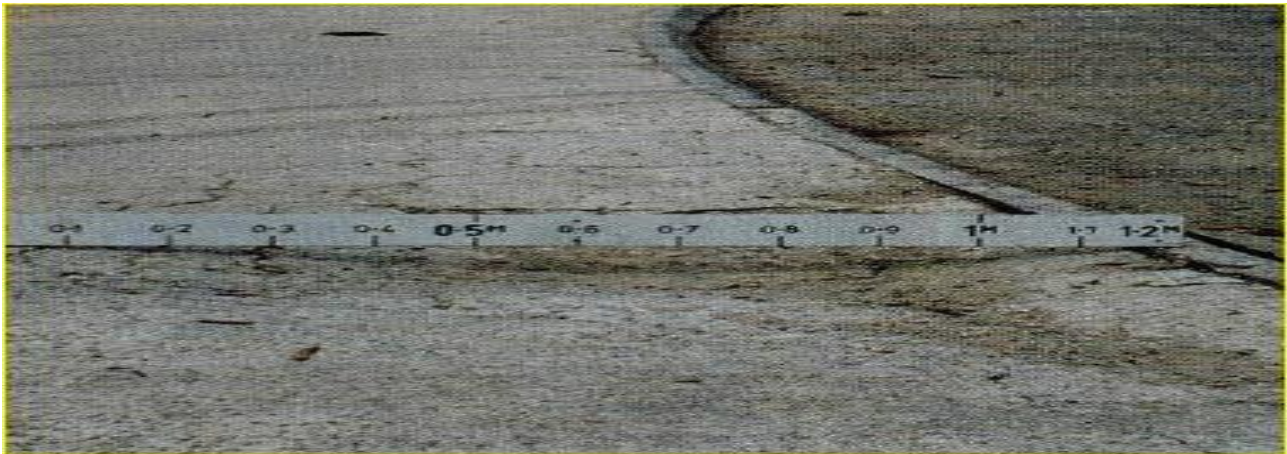
Figure 2.10. Depressions (Catalogue of Road Defects (CORD) January 2013).

Reconstruction is required for extensive depressions. According to Transportation Research Board, Guide to Earthwork Construction, 1990. Settlements/depressions in asphalt pavements may be due to frost heave, swelling or collapsing soil, or localized consolidation (such as that which occurs in poorly compacted backfill material at culverts and bridge approaches). Frost heave, soil swelling, and soil collapsing produce longer-wavelength surface distortions than localized consolidation.

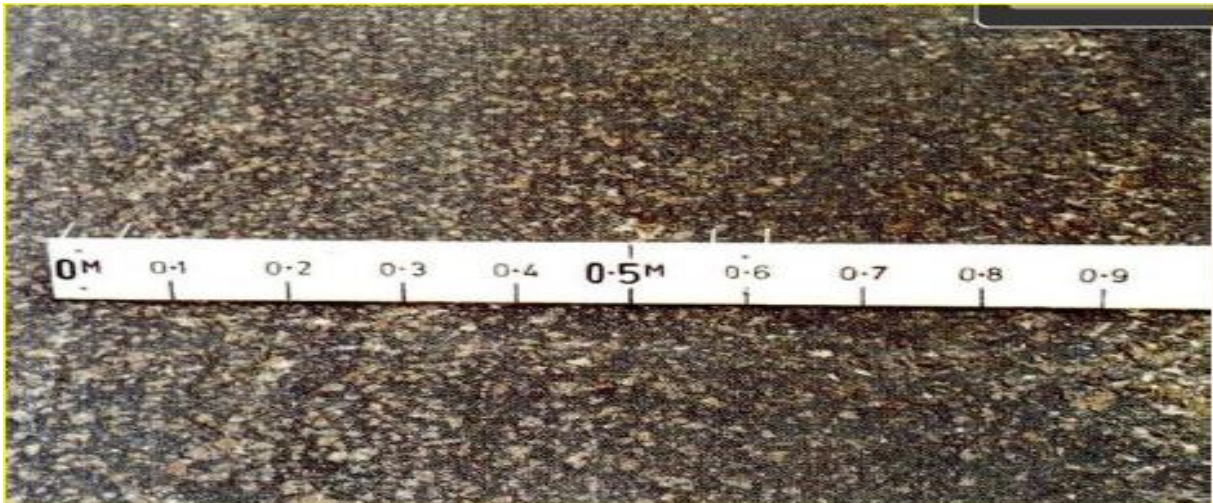
Figure: 2.15 Polishing (Catalogue of Road Defects (CORD) January 2013).

Polishing is the wearing of aggregate on the pavement surface due to traffic. It can result in a dangerous low friction surface. A thin wearing course will repair the surface[2].

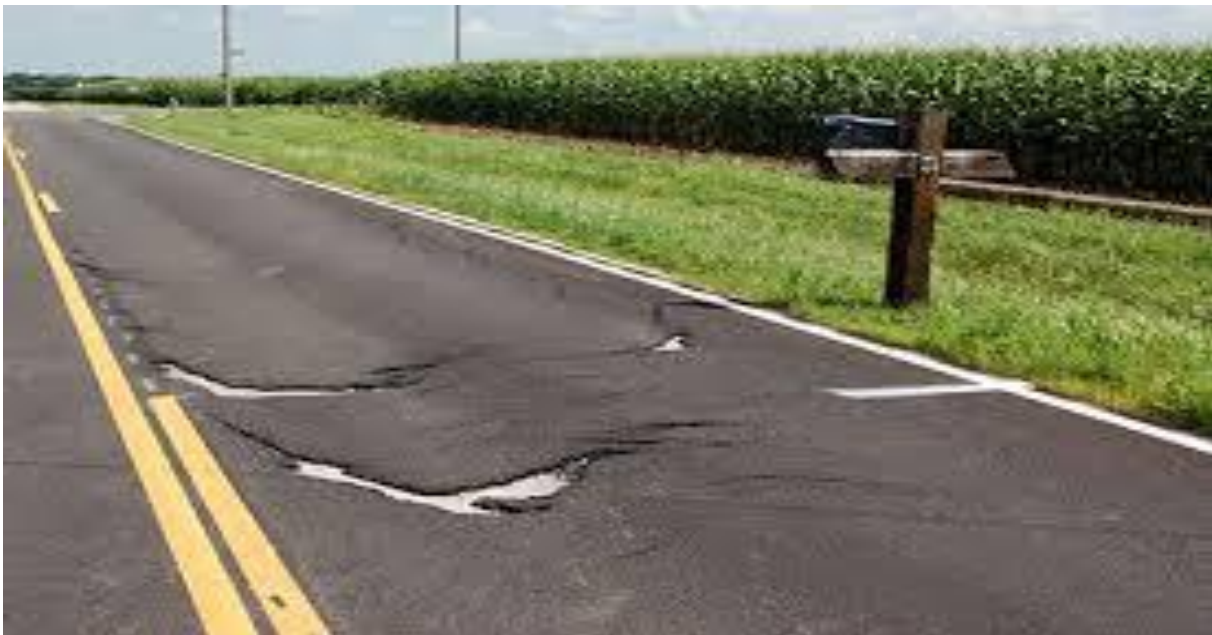
Figure 2.16: Delamination of an overlay (Miller, J. S., Rogers, R. B. and Rada, G. R., 1993)

Cleaning the old surface and applying a light asphalt emulsion tack coat will go a long way toward alleviating this problem. A tack coat is especially helpful when the overlay thickness is two inches or less.

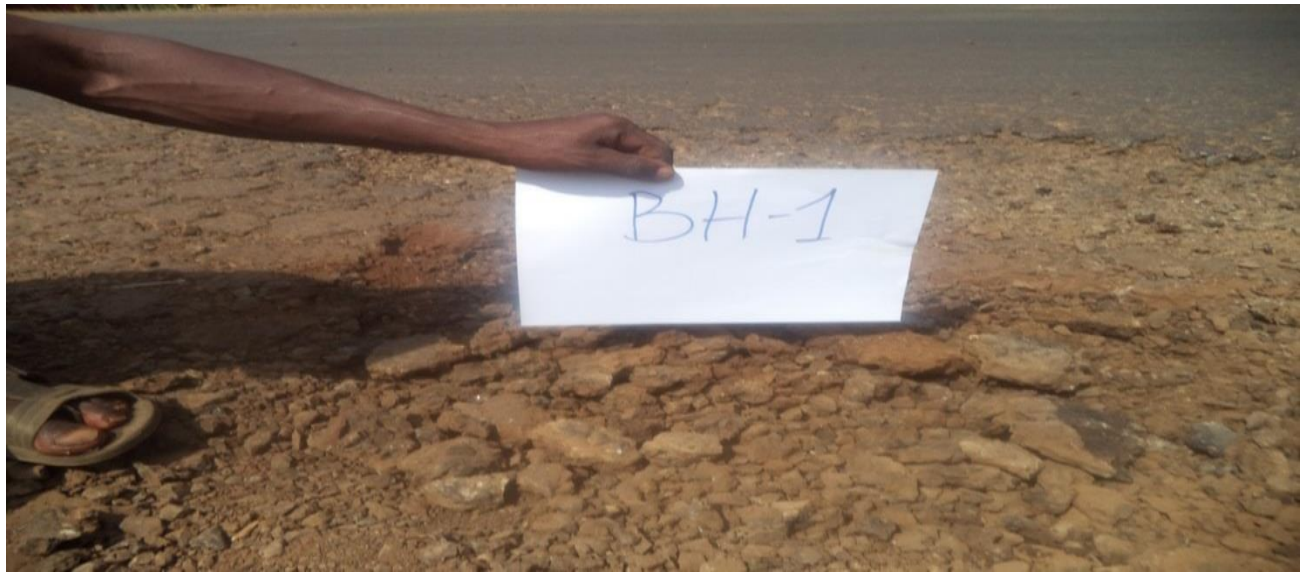
Figure 3.1 Borehole BH-1 at station 385+000(Nov-15)

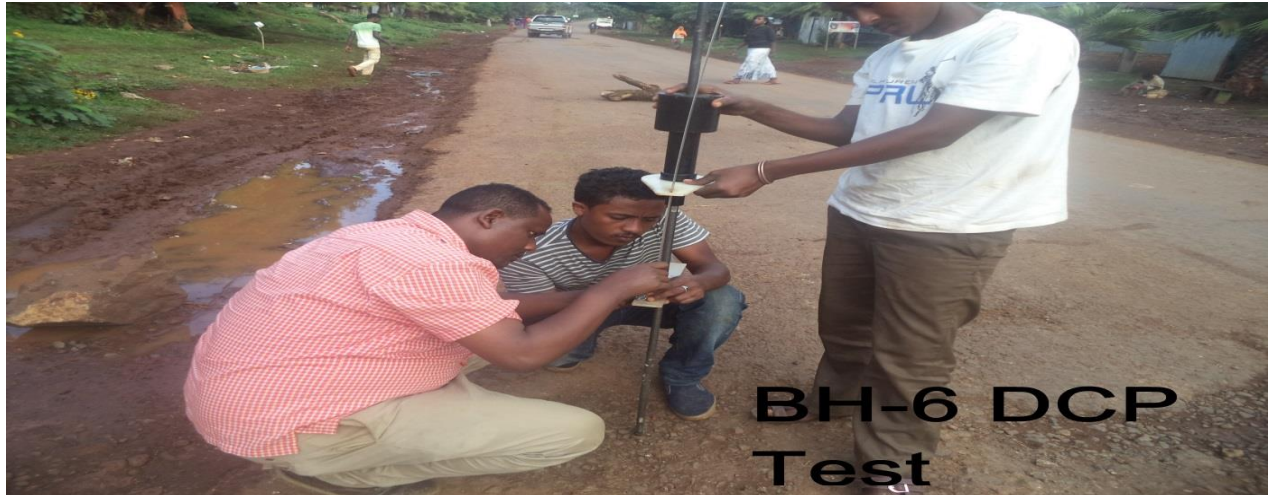
Figure 3.6: Borehole Number BH-6 (Lat7°51'12.5568'N & Lon. 36°35'46.1859'E) DCP test (9 December 2015)

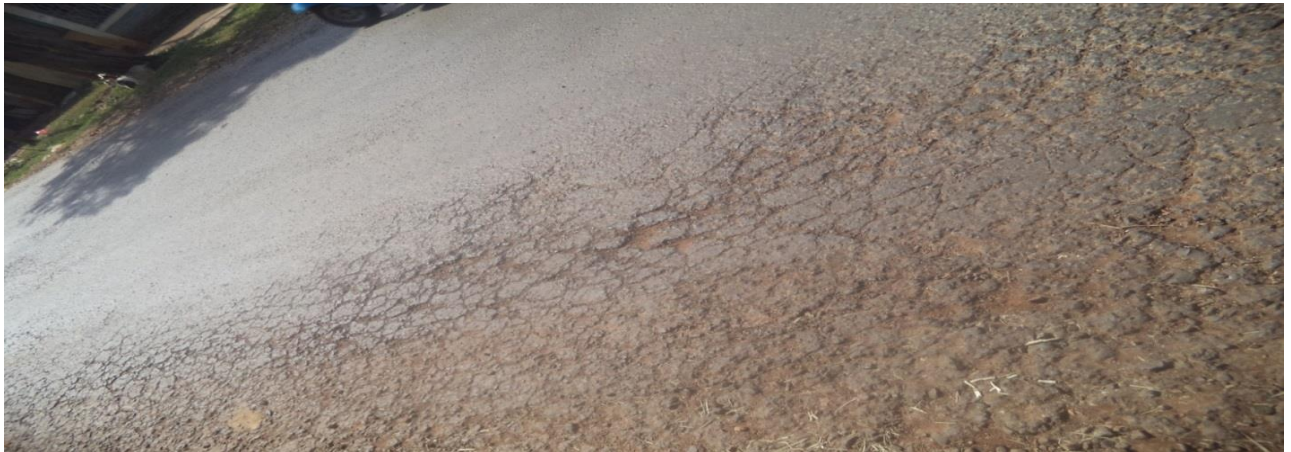
Figure 4.2: Alligator cracks (29-Nov-15)

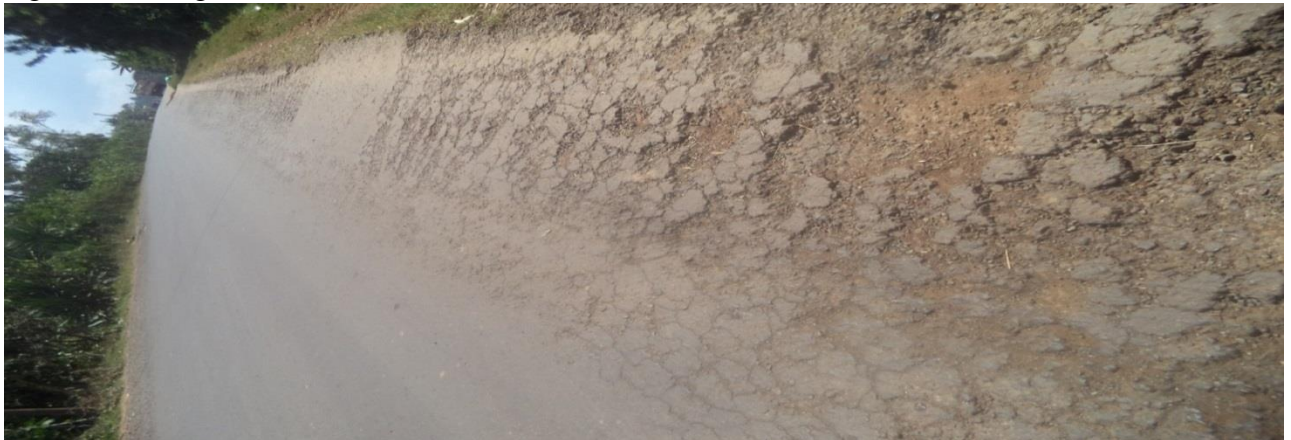
Figure 4.3: Edge cracking (29-Nov-15)

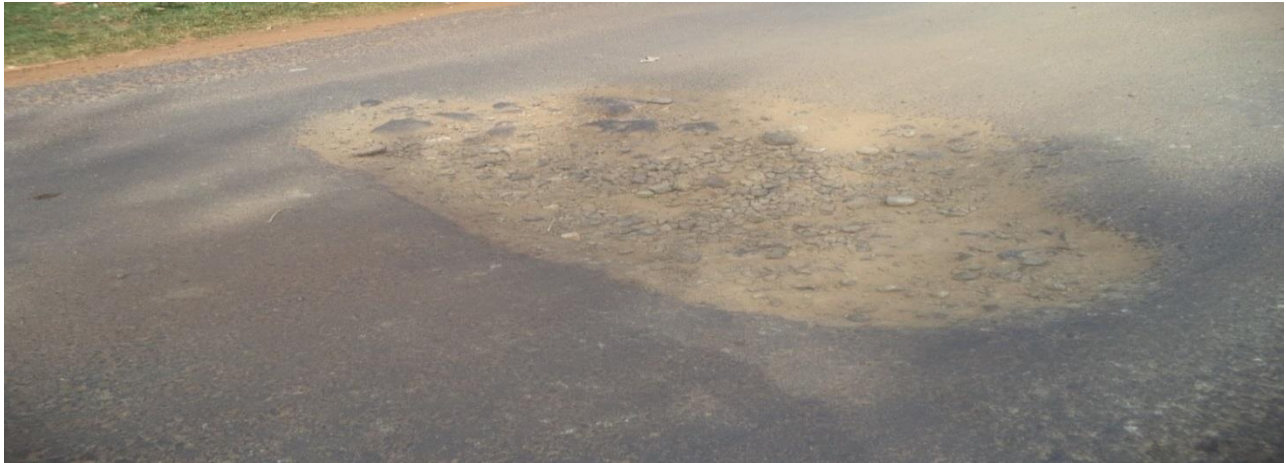
Figure 4.4: Potholes (29-Nov-15)

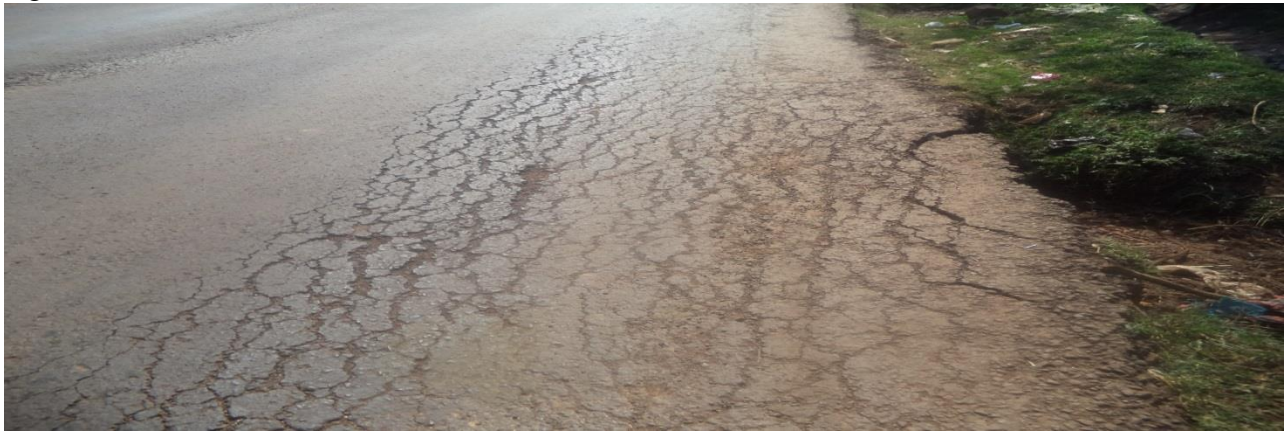
Figure 4.5 longitudinal cracks and edge cracks (29-Nov-15)

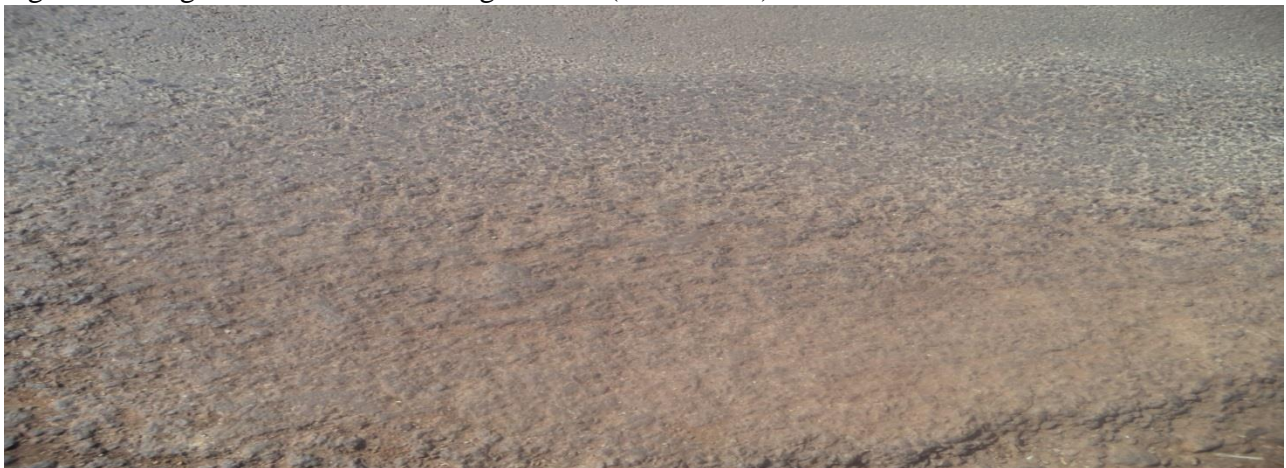
Figure 4.6: Ravelling (29-Nov-15)

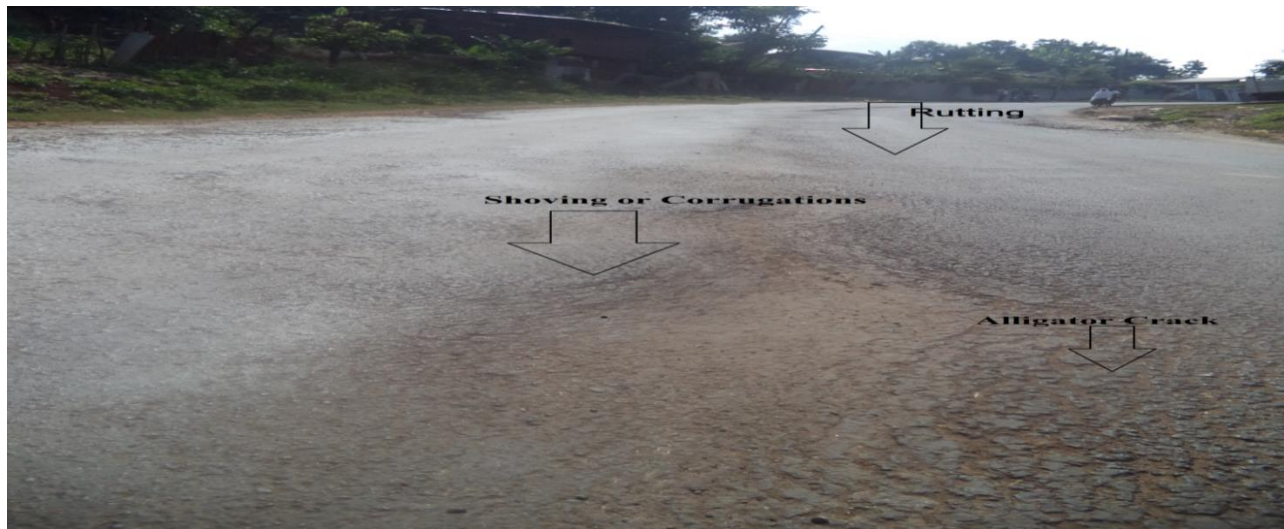
Figure 4.7: Rutting, alligator cracks and shoving (29-Nov-15)

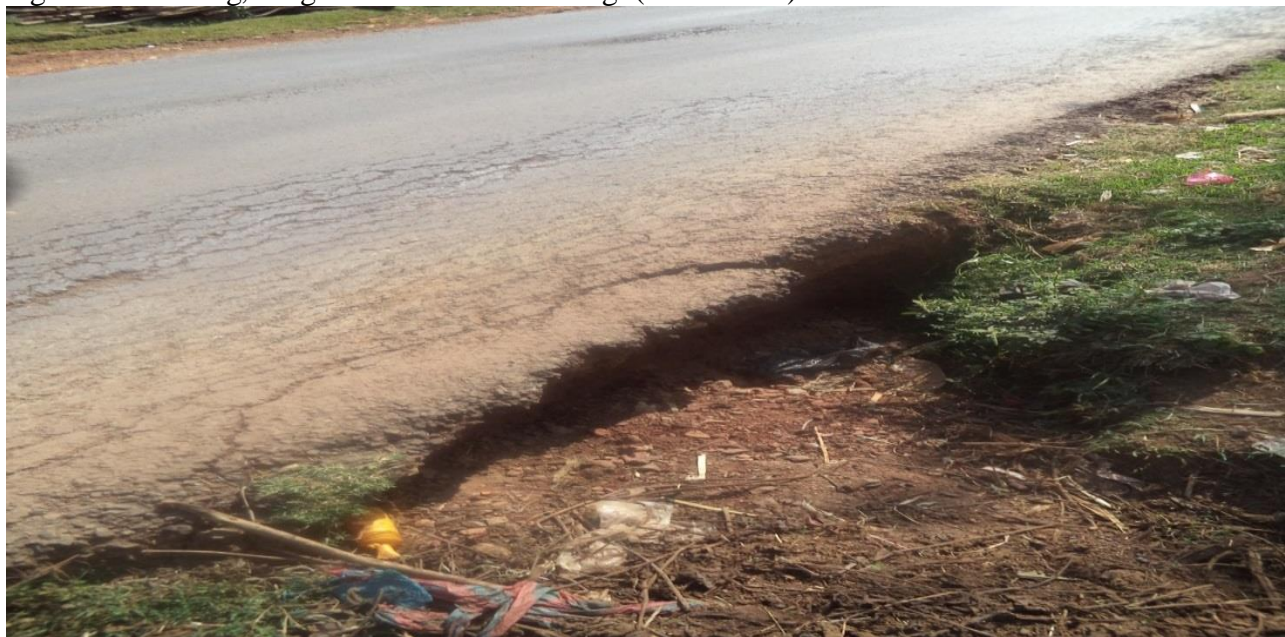
Figure 4.8: Edge cracking (29-Nov-15)

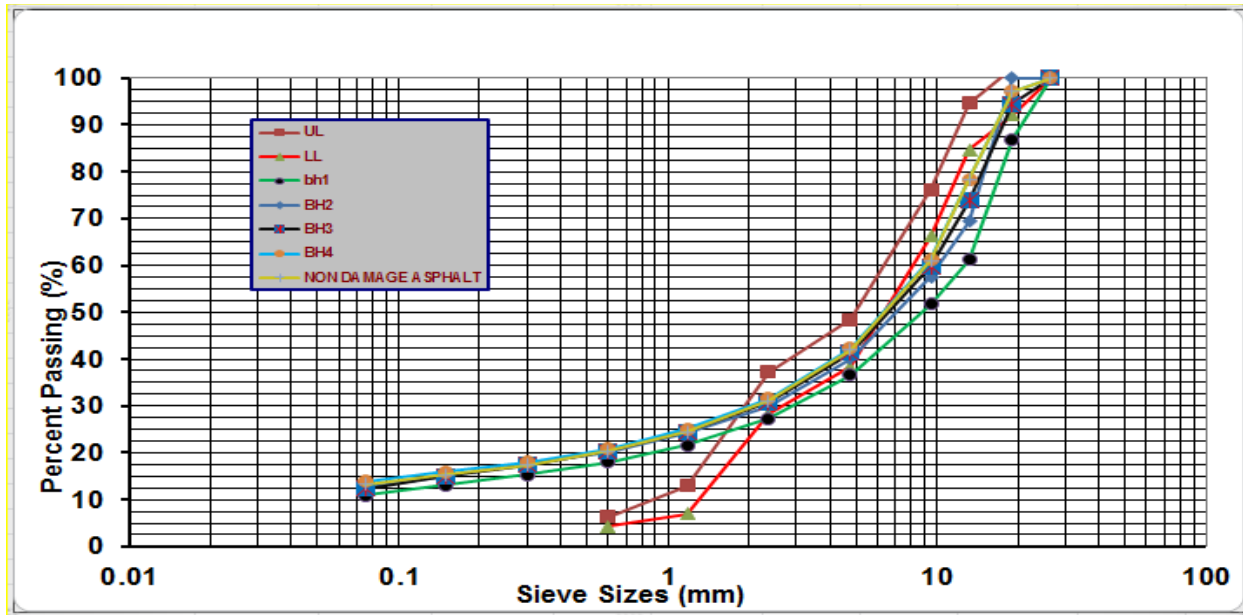
Remark: Average Uniformity coefficient(Cu) and Coefficient of curvature(Cc) of the four borholes of base course materia are 0.11 and 10.62 respectively.

Figure 4.12 Gradation result for four boreholes and non-damage asphalt.

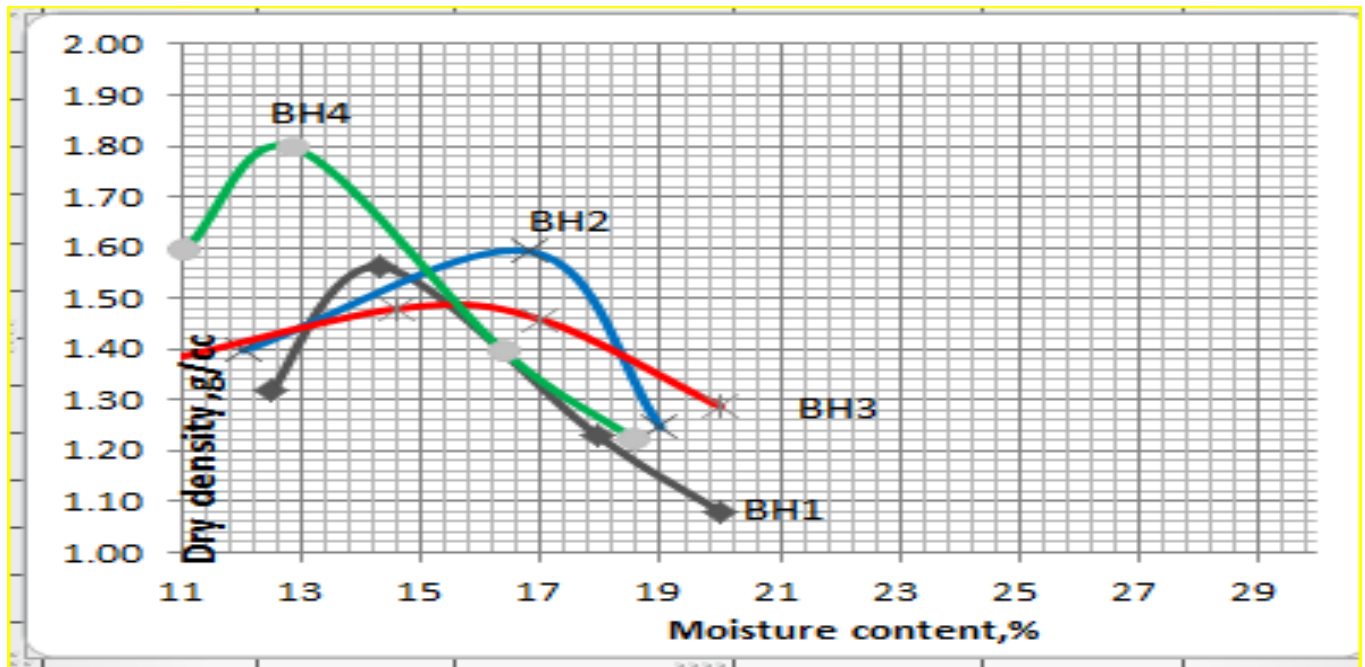
Figure 4.13 The Laboratory Test Result for OMC & MDD of Subgrade Layer

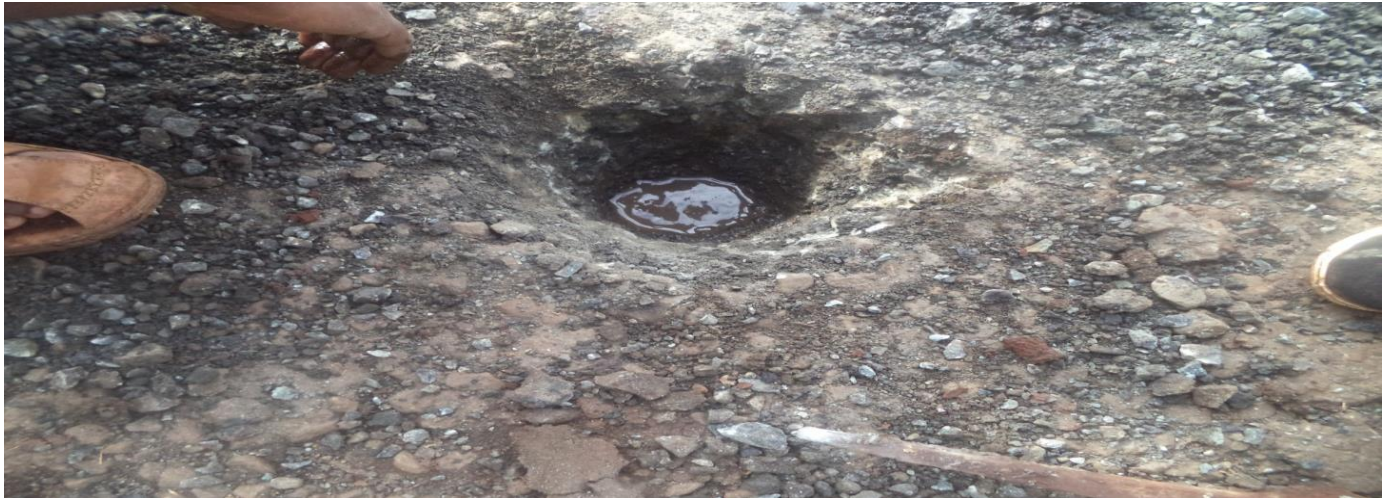
Moisture condition on pavement layer

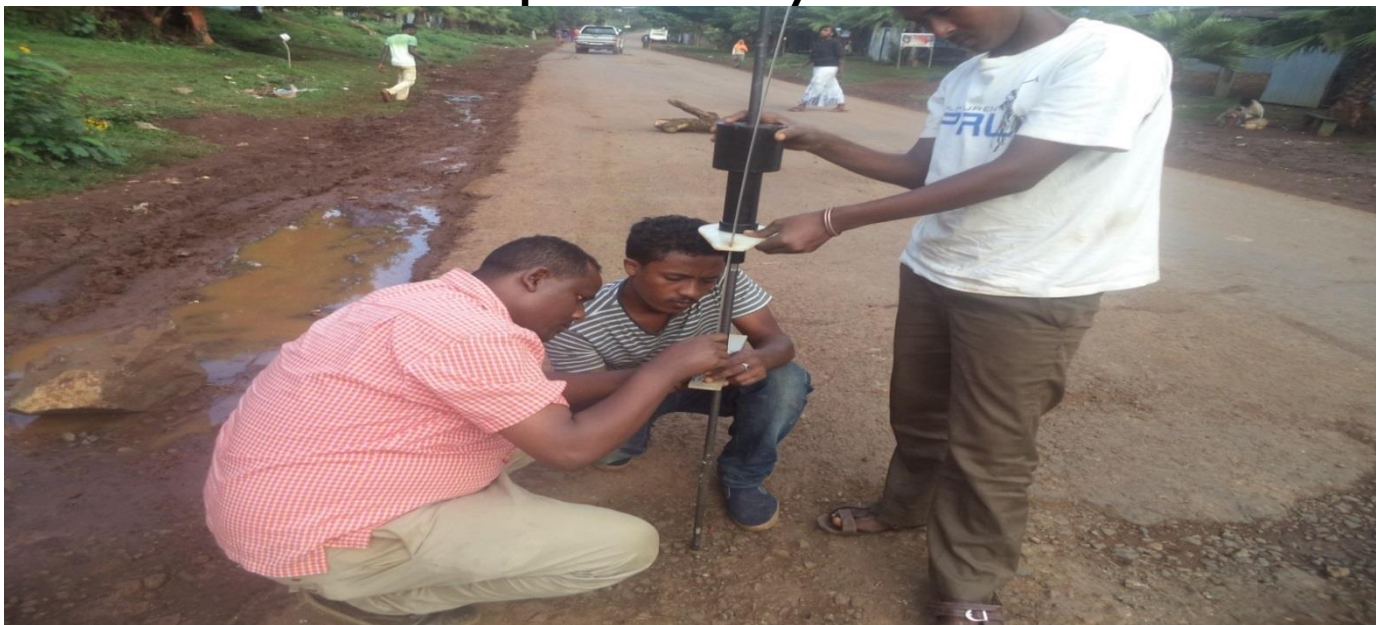
DCP test

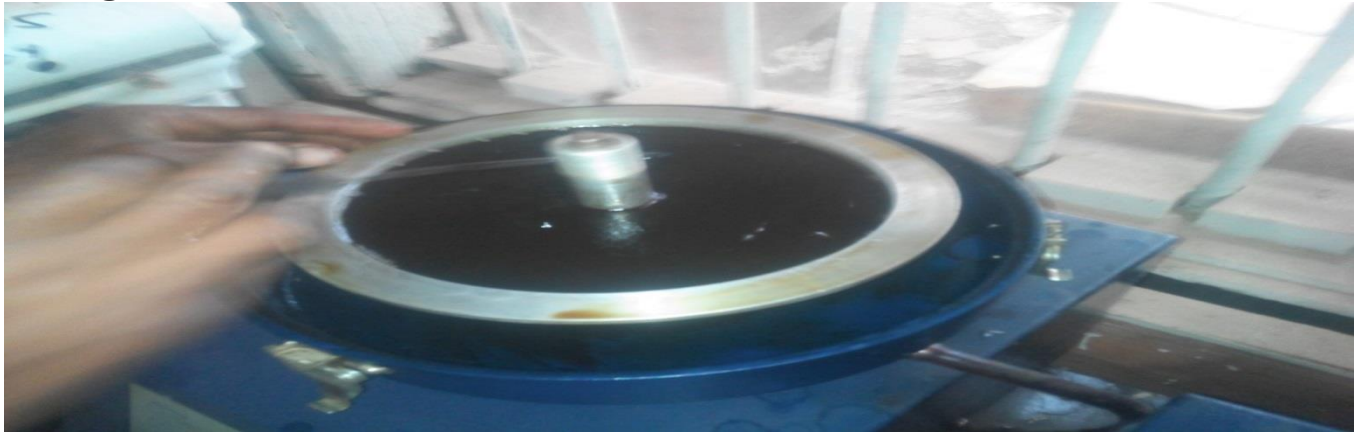
Asphalt extraction using Centrifugal machine

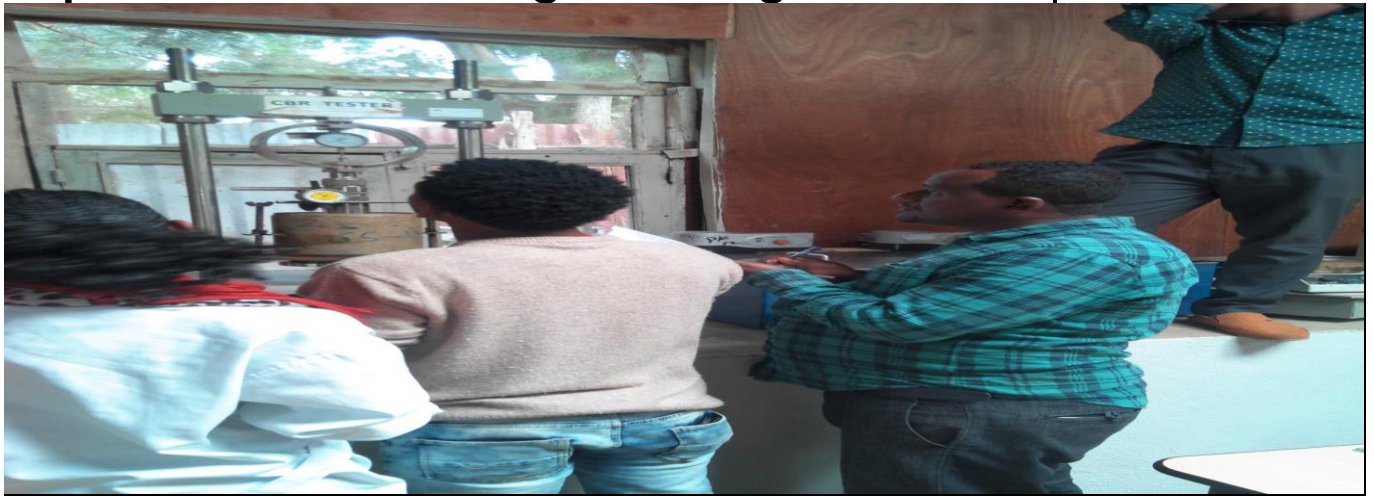
CBR testing with the laboratory team
