I, the undersigned, declare that this thesis entitled “Causes and control mechanisms of road traffic accident: A case study from Shashemene to Adaba road.” is my original work, and has not been presented by any other person for an award of a degree in this or other University, and all sources of material used for thesis have been duly acknowledged.

The rate of road traffic accidents increase from time to time in Shashemene to Adaba road sections. In this study the aim is to identify the cause and control mechanisms of road traffic accident along Shashemene to Adaba.

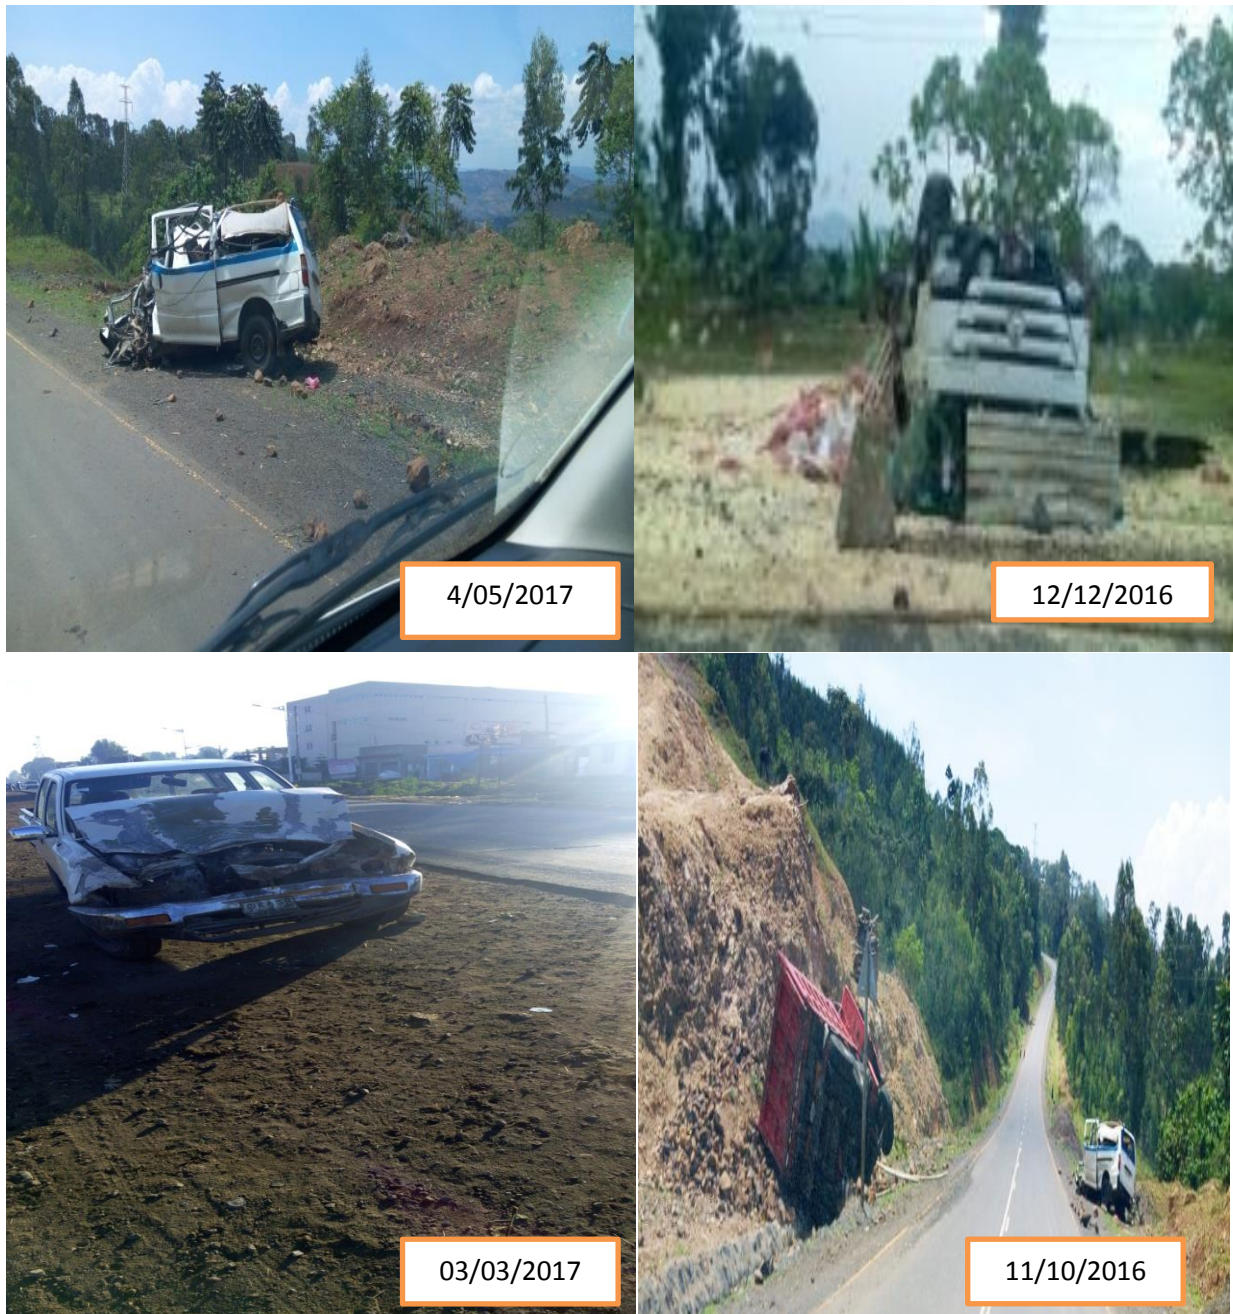
Figure 4:1 Sample property damage in Edo kebele and Feji hursa kebele

Based on the findings of this research study, Feji hursa district has dominated the event of property damage among the districts as shown in Table 4.6. Property damaged in Shashemene to Adaba road from 2012 to 2017 Edo 11.47% ,Shashemene 11.29% , Wabe 10.96% ,Adaba 10.95% , Herero 10.22% ,Dodola 10% , Kofele 9.78% and Ashoka 9.38% respectively high property damage order.

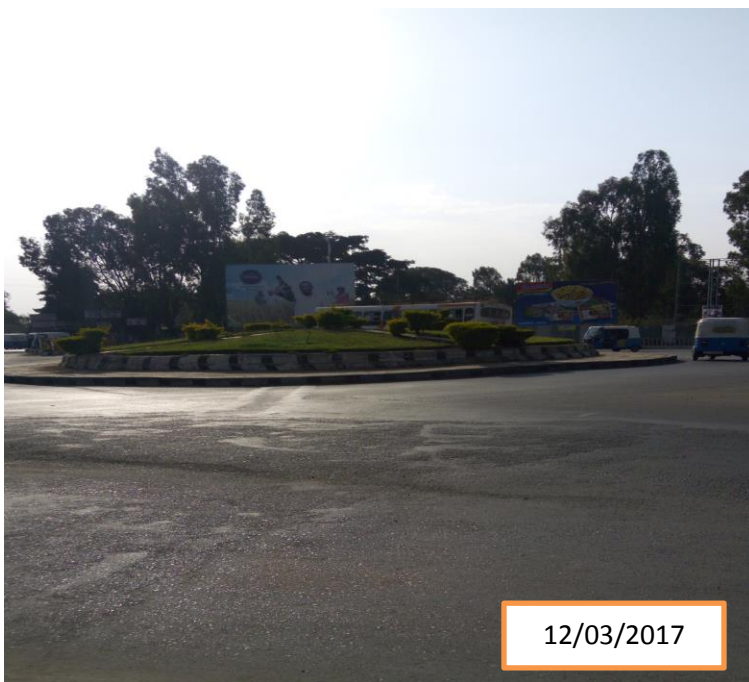
Figure 4.3 Feature of roundabout below Awasho bus station

Site inspection: At the time of inspection, public transport vehicles used the junction for picking and dropping of passengers. Specially, drivers of Bajaj did not respect traffic rules at the spots. There were no traffic signs around the junction also vehicles operated above the speed limits.

Proposed Control mechanisms: As mentioned earlier, an accident prone spot was four legs priority junction. The following measures should be applied to improve the situation at the priority junction.

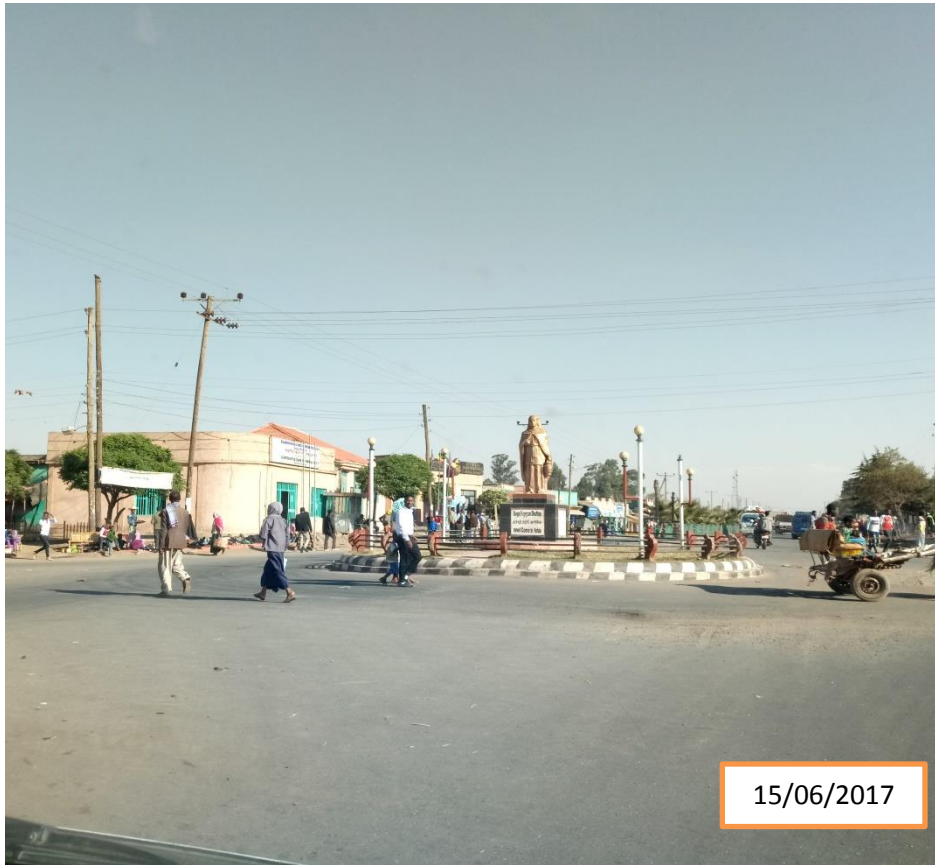
Figure 4.7 Feature of kofele town roundabout

Site inspection: There is a market place near the junction .Many pedestrians and animal drawn carts cross the road at this point. Public transport mini –buses use the shoulder and road side spaces for picking and dropping passengers. The other phenomenon was that daily laborers gathered together and stand looking for manual labor at the junction. The main problem is mix of traffic within the influence area.

Proposed counter measure: The following control mechanisms are proposed to reduce focused on reducing accidents.

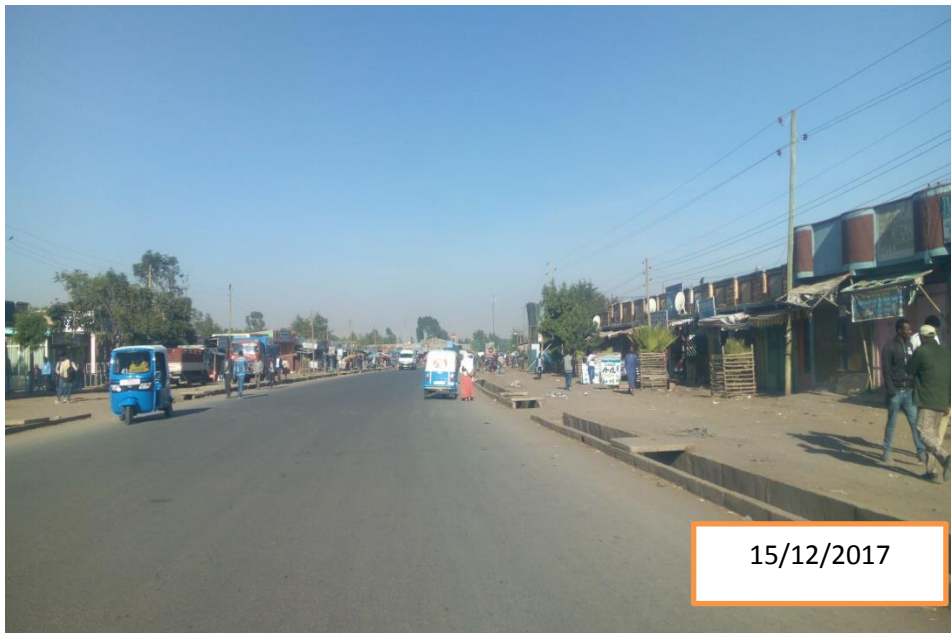
Figure 4.10 Adaba town road section

The study road incorporates Adaba town that requires reduction and improvement of pedestrian facilities. The following are proposed in order to alleviate the problem of the road section.

- a) A speed limit sign (30km/hr) should be placed where town begins, before 100-150 meters.
- b) 1-2 sets of rumble stripes should be furnished before entering the town to notify reckless drivers
- c) Road side parking should be prohibited and provide off-road packing for heavy trucks
- d) Zebra crossing for pedestrian should be marked in 50 -70 meters interval
- e) 1-2 sets of rumble stripes should be furnished before zebra crossing
- f) Strict traffic police enforcements should be required during day time because more 70 percent of the recorded accidents occurred during this period. Special attention should be given on Wednesday and Saturday in controlling traffic because these two days is market day many people become form village.
- g) For problem of lane discipline, improper overtaking and the like. Re-painting of the road should be given much attention.
