Blackspot Identification and the Possible Countermeasures: Case Study in Addis Ababa to Ambo Road

A thesis submitted to the School of Graduate Studies of Jimma University in Partial fulfillment of the requirements for the Degree of Masters of Science in Civil Engineering (Highway Engineering)

Eyob Mekonnen

February, 2016
Jimma, Ethiopia

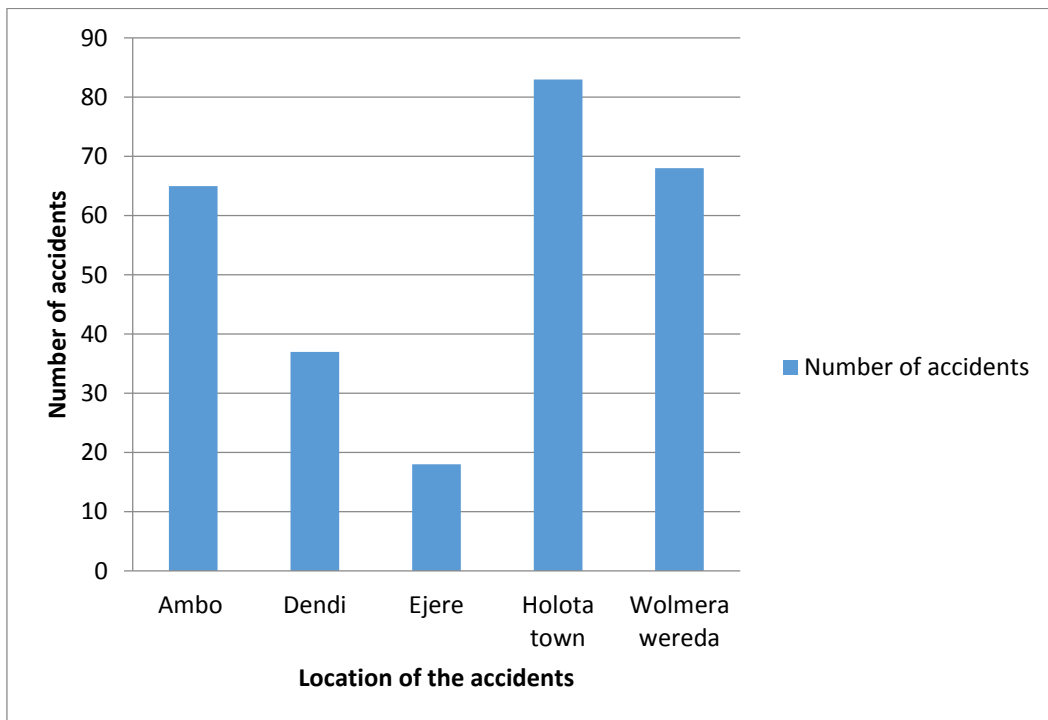
Fig.4.1 Accidents happened on the road from Ambo to Addis Ababa From September 2012-2015

Total of 271 accidents happened on the road from Ambo to Addis Ababa. This accident includes fatal, injury and property damage accidents. Figure 4.1 shows the location together with number of accidents and the percentage of accidents for each location. 30.63% of accidents happened in Holota town, 25.09% in Wolmera wereda, 23.99% in Ambo Wereda, 13.65% of the accidents in Dendi Wereda and the lowest number of accidents 6.64% happened in Ejere Wereda.

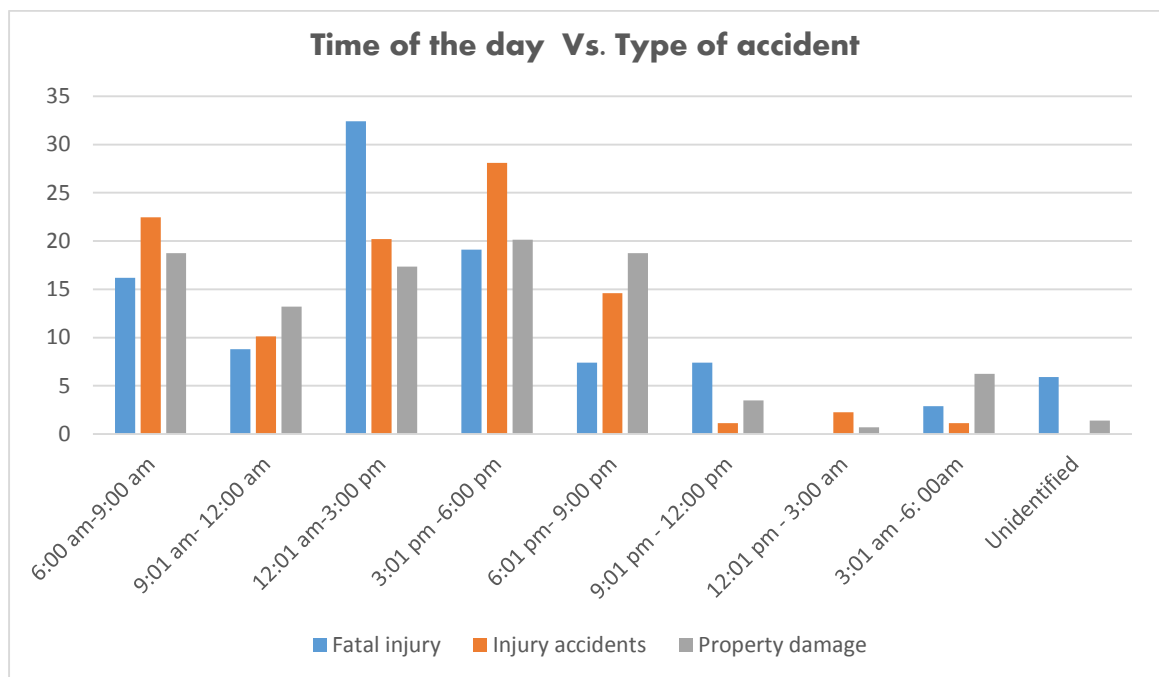
Figure 4.3 Time of the day vs. type of accidents from September 2012-2015

Figure 4.3 shows the time of the day together with the injury accidents. Most of the accidents were happened during day time, which is from 6:00 a.m. (morning) to 9:00 P.m. (afternoon). The highest number of accidents happened during 12:01 am-3:00 pm.

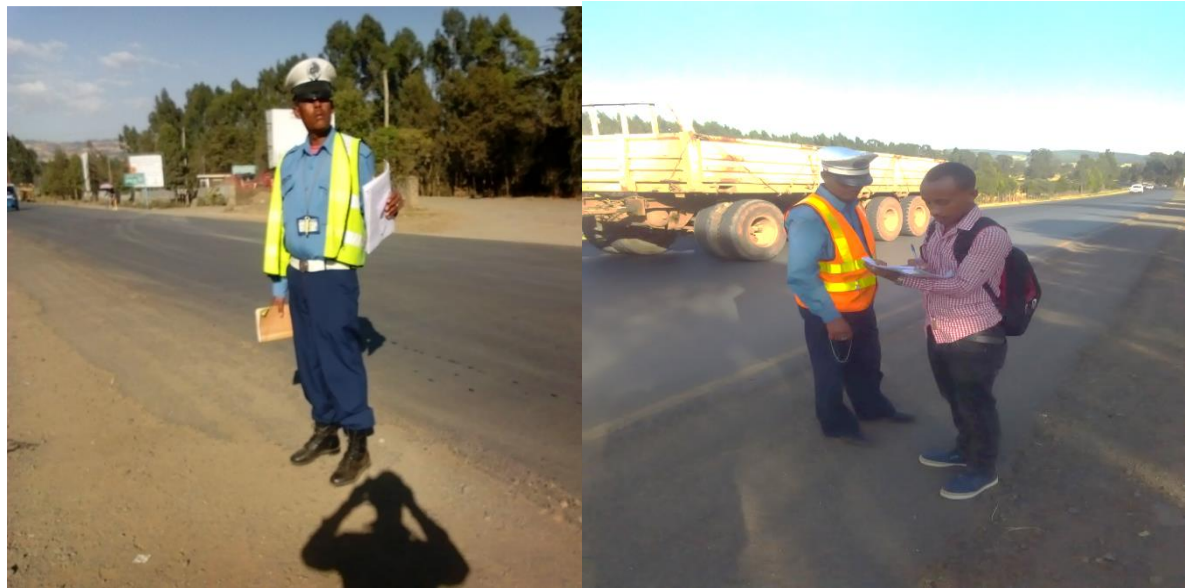
The counter measure is provided by site visiting the black spot locations with traffic officers (police inspectors) and is provided based on the check list provided .The road configuration of the area is properly studied and the sample images were taken at each black spot locations.

Figure 4.8 Site visits of Black spot locations

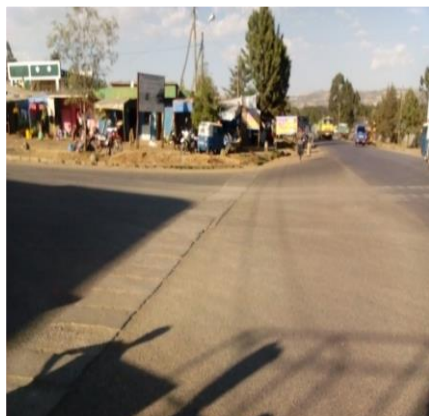
Figure 4.9 Gabriel before Counter measure is applied

The black spot location identified is Gabreelii (Miizanaa). This location is found around Ethiopian road authorities size and weight control station. Its location is inside town section. The counter measure that should be applied on this road are:- Edge side and Central traffic marking should be painted, in addition ,Island should be provided inside the intersection area. Sufficient pedestrian walking lane should be provided and also speed limit post should be installed.

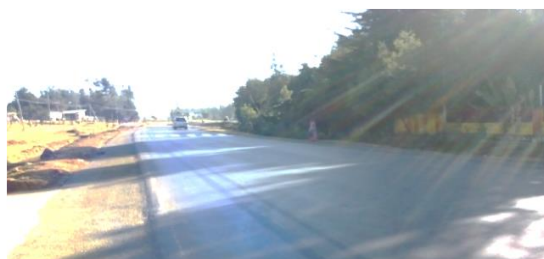
The counter measure that should be applied is: a) the lane width is not sufficient, so that it should be widened, b) There are Equilaptus trees surrounding the curve that obstructs the vision of the drivers, so that it should be cleared, c) There is steep gradient along the road stretch so that speed limit posts should be installed along the road, d) There is already existing concrete road side delineator but destroyed by accidents, so that it should be

Figure 4.11 Menagesha (20km) before counter measure is applied

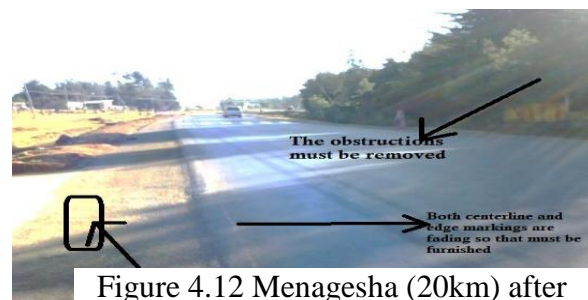
Figure 4.12 Menagesha (20km) after counter measure is applied

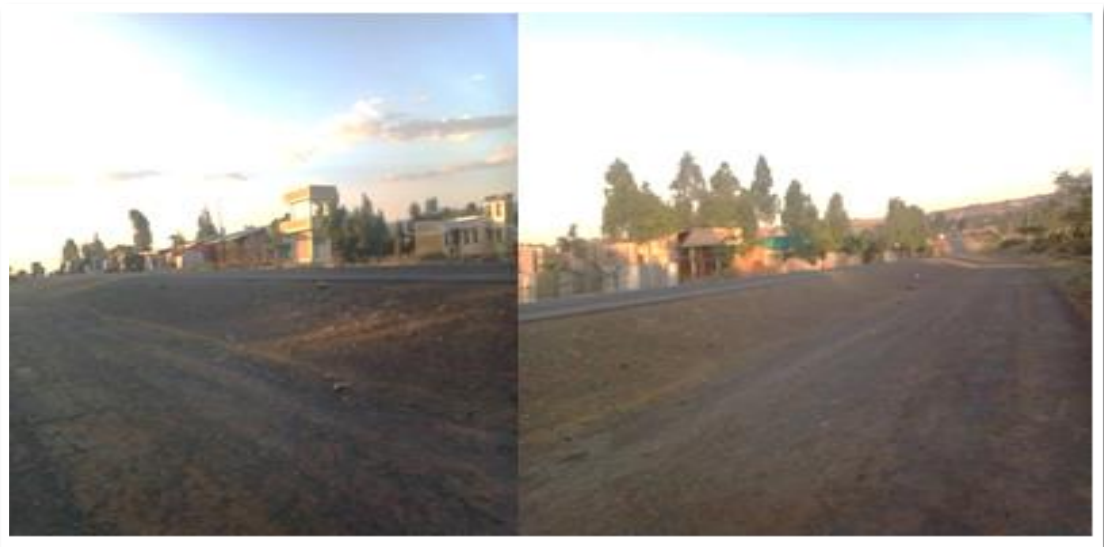
Figure 4.17 Awaro Before counter measure is applied

The curve is broken back type of curve, so that it needs design revision, pedestrian walking, Speed limit post and kerb should be provided since it is an entrance to town section, Road side landscape should be leveled to flat, Obstructions inside the curve should be removed, Road side delineator should be placed.

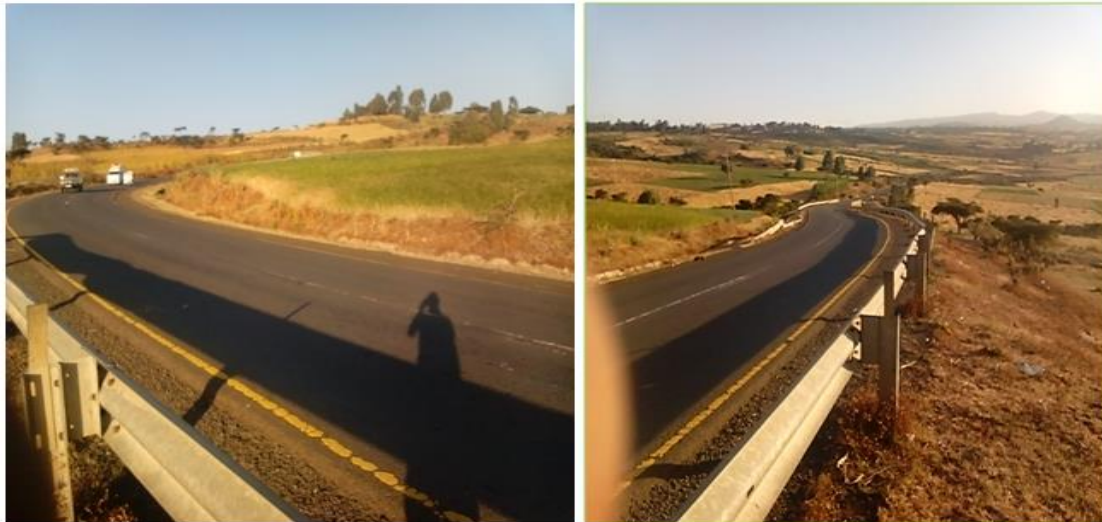
Figure 4.19 Existing Road Configuration at Minini

There is obstruction inside the curve so that it should be removed (trees are obstructing the drivers vision). The existing guard rail is not functioning and sufficient along the left side, so that it should be re-installed; Traffic signs are needed inside the curve, so that it should be provided, since the road geometry is like zigzag speed limit posts should be installed.

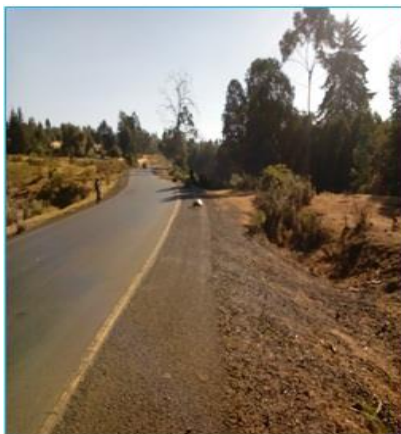
Figure 4.21 Chiri before Countermeasure Is applied

Obstruction near the curve should be removed (trees are around). Speed limit posts should be installed. Since the shoulder width is not sufficient should be increased. Road side delineator should be installed along the road.
