CAUSE AND CONTROL OF CRACKING IN REINFORCED CONCRETE HIGHWAY
BRIDGE DECK: A CASE STUDY IN BONGA TOWN, SHETA RIVER BRIDGE DECK

A thesis submitted to the school of graduate studies of Jimma Institute of Technology in
partial fulfilment of the requirement for the degree of Master of Science in Civil
Engineering (Major Structural Engineering)

Berhanu Tefera

August 2016

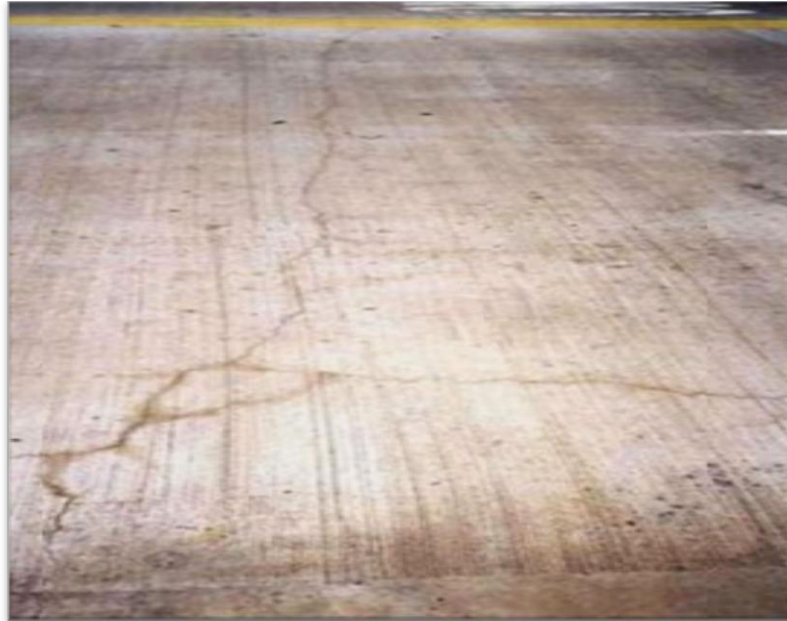
Figure 2.1: Transverse cracking [4]

Transverse cracks are cracks that are perpendicular to the longitudinal axis of the bridge deck, and they are the main type of cracking found on reinforced concrete bridge decks. These cracks generally form at the surface of the bridge deck under which the transverse reinforcement is placed [3]. Cracks widths often exceed 0.05 mm and can reach widths 0.6 mm, leading to an increased probability of water and chloride ion penetration. Transverse cracking develop when longitudinal tensile stresses in the deck exceed the tensile strength of the concrete. The tensile stresses are caused by temperature changes, concrete shrinkages and bending from self–weight and over traffic loading [4].

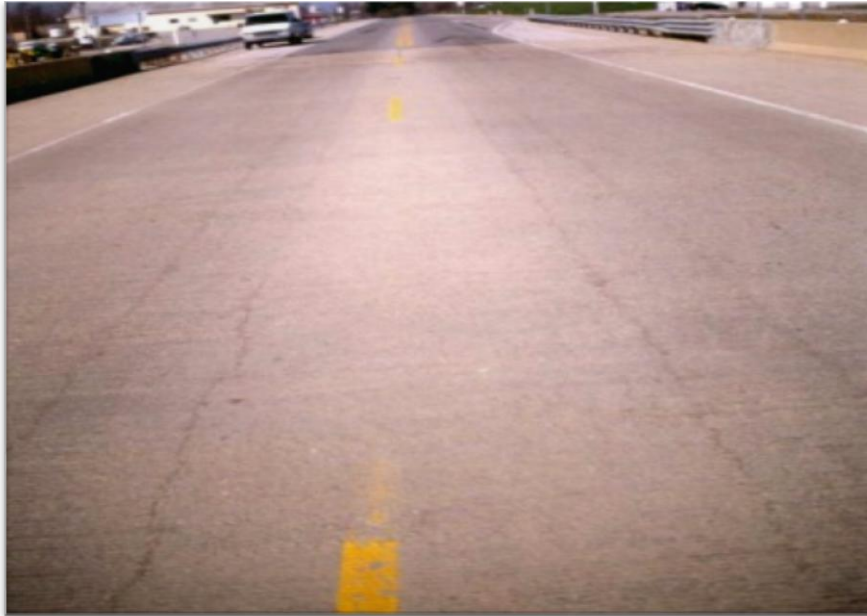
Figure 2.2: Longitudinal cracking [5].

Longitudinal cracking is parallel to the longitudinal direction of the bridge deck. Like transverse cracks, longitudinal cracks have also been shown to occur directly above top main longitudinal reinforcement. According to Curtis R. H. and White H. discovered that longitudinal cracking is caused by the differential movements along the girders, and they believe the cause of the differential movement is from the rotation of the beams about their longitudinal axis [6]. However, based on their research, that longitudinal deck cracking typically occurs above the edge of the girders.

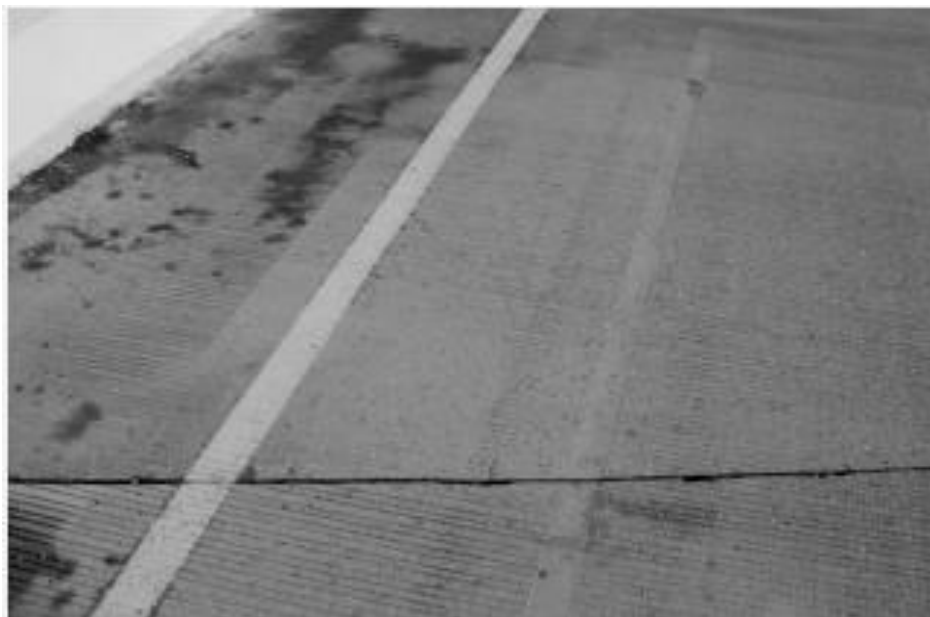
Figure 2.3: Diagonal cracking [8]

Although diagonal cracks can be found in all types of concrete bridge decks, these cracks are commonly associated with bridge decks with a skew. Through their research, decks with a skew have much more of a tendency to have diagonal cracking than their straight counterparts. In bridge decks with a skew, diagonal cracking occurs more in the corner areas as a result of restraint provided by the abutments and piers [5]. These cracks typically start with a right angle to the deck edge that is along the direction of the supports.

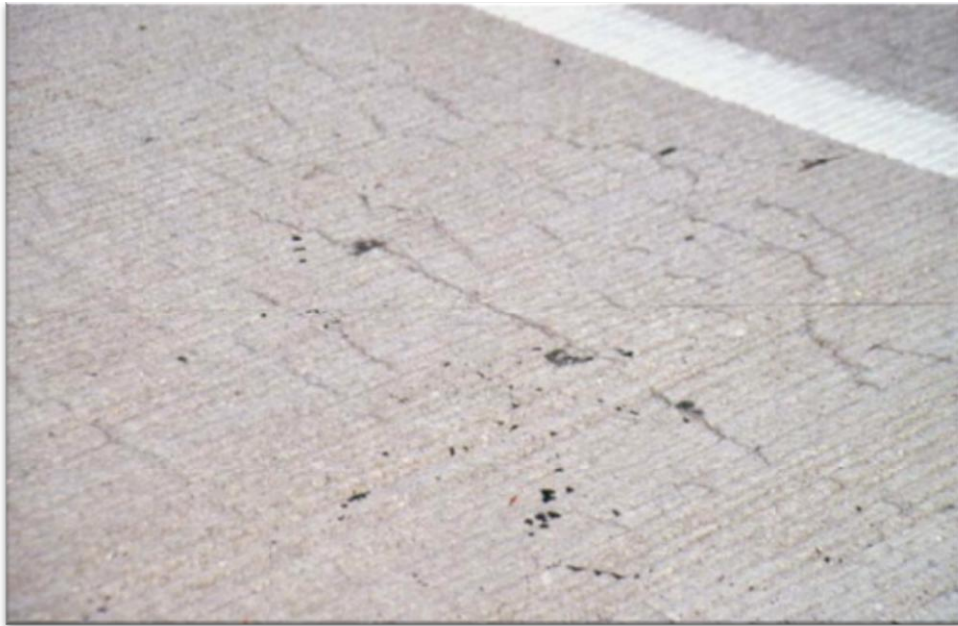
Figure 2.4: Map/Pattern cracking [5]

Map cracking forms in a random pattern of intersecting transverse, longitudinal and diagonal cracks. For this reason, map cracking is also referred to as pattern cracking. These cracks begin at the bottom of the deck and move upwards through the deck towards the surface [12]. Map or pattern cracks are often the product of improper curing because the surface moisture on the concrete evaporates too quickly, and the volumetric change of the concrete is restrained [7]. However, it must be noted that there are secondary effects map cracking such as delaminating and concrete spalling.

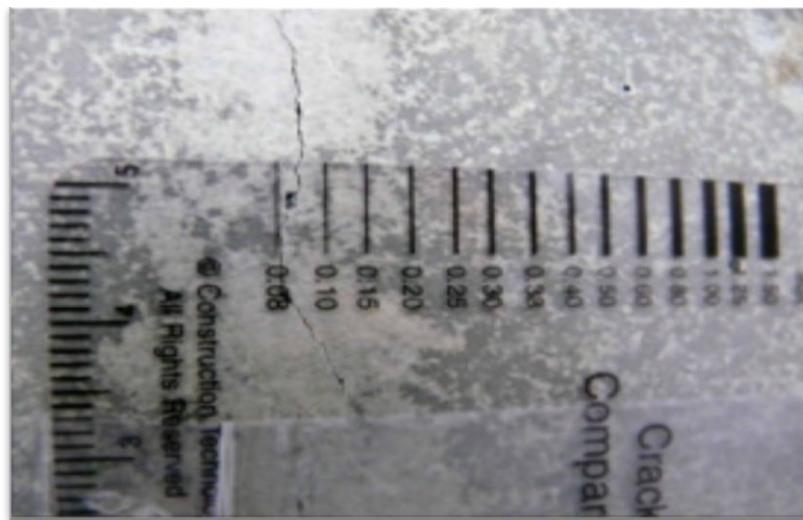
Figure 2.5: Typical crack width measurement on bridge deck [12]

Visual inspection is the first step in assessing the condition of a bridge deck. During inspection, the type and extent of deterioration are documented, and coloured photographs may be taken to document any significant damage. Prior to the surveying of the bridge, lanes were temporary closed by the assistance research personnel using a simple flag lane closure and using traffic cones to keep the traffic away from the lane that was being inspected. Bridge decks were cleared of any debris and dirt using an air blower or dust brush, so that the cracks could be seen without difficulty [15].

Cracks were identified by their size, location and orientation. Both the lengths and widths of visible cracks were recorded, where the crack width was measured using a crack width comparator card. Crack widths were categorized into three general groups: fine cracks generally less than 1mm; medium cracks—between 1mm and 2 mm and wide cracks—over 2mm [23]. Crack widths can be affected by different factors such as spacing of rebar, stress in the reinforcement, rebar diameter, and the effective depth. According to the ACI 224 report crack width specifications [23], are listed in Table 2.1.

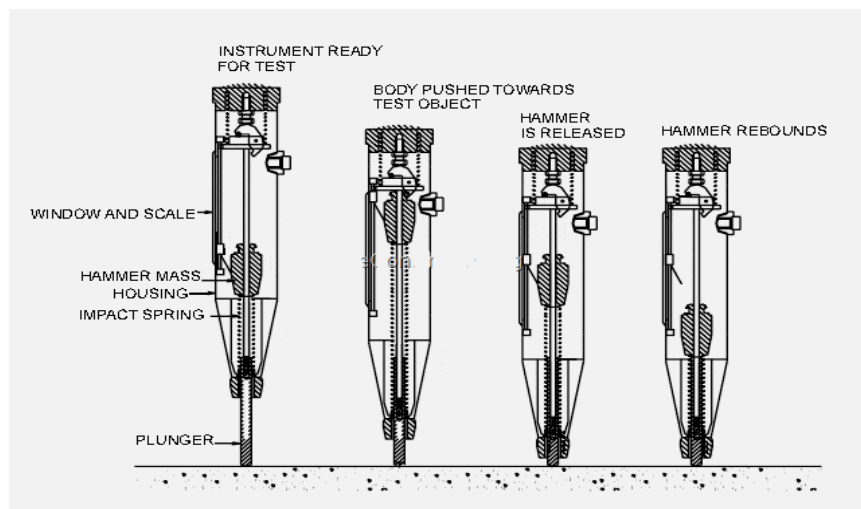
Figure 2.6: Operation of the rebound hammer [15]

Alternately, tests performed on the same concrete that has a hard, smooth texture will typically result in a higher R-number [15].

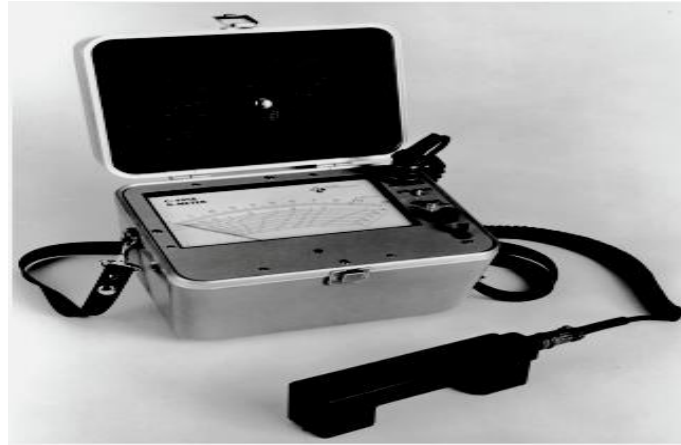
Fig. 2.7: Pachometer used to locate reinforcing in bridge deck [16]

Pachometer survey is used to determine the depth of cover by measuring variations in magnetic flux caused by the location of steel. For the pachometer to be accurate, the size of reinforcing steel has to be known so that the readings can be interpreted for depths. Alternative method to determine the depth of cover: by drilling small diameter holes to expose reinforcing steel for direct measurement, or by measuring the cover depth in extracted cores [16].

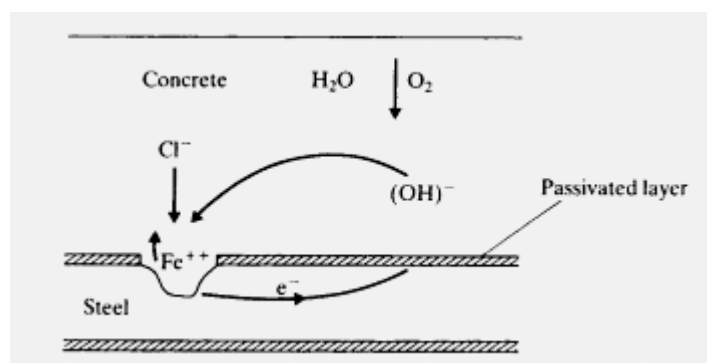
Figure 2.8: Electro-chemical corrosion in the presence of chlorides [17]

The principal cause of corrosion of steel reinforcement in bridge decks is due to chloride in the concrete. The chloride originates in the concrete ingredients and from de-icing chemicals applied to the bridge deck. Chloride ions present in the cement paste surrounding the reinforcement react at anodic sites to form hydrochloric acid which destroys the passive protective film on the steel. The surface of the steel then becomes activated locally to form the anode, with passive surface forming the cathode; the ensuing corrosion is in the form of localized pitting [17]. To initiate corrosion in the concrete, the concentration of chloride ions in ordinary Portland cement (type-1) concrete when the maximum water soluble chloride ion (Cl^-) content is greater than 0.3 percent by mass of cement. The presence of chlorides in the steel reinforcement bars, the schematic reactions, as shown in the Figure 2.8 below.

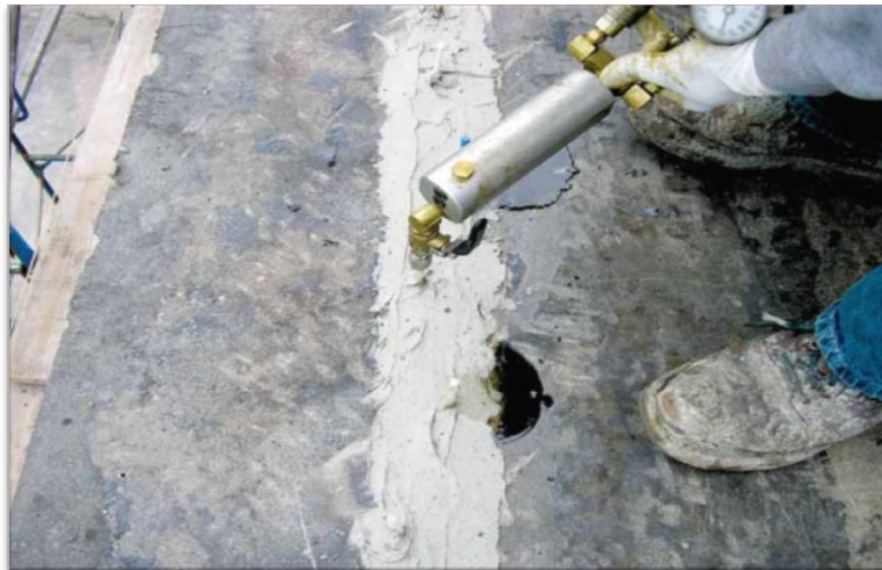
Figure 2.11: Epoxy crack injection [16]

- ⊕ Cleaning the cracks
- ⊕ Sealing the surfaces
- ⊕ Installing the entry and venting ports
 - Fittings inserted into drilled holes
 - Bonded flush fitting
 - Interruption in seal
- ⊕ Mixing the epoxy
- ⊕ Injecting the epoxy
- ⊕ Removing the surface seal

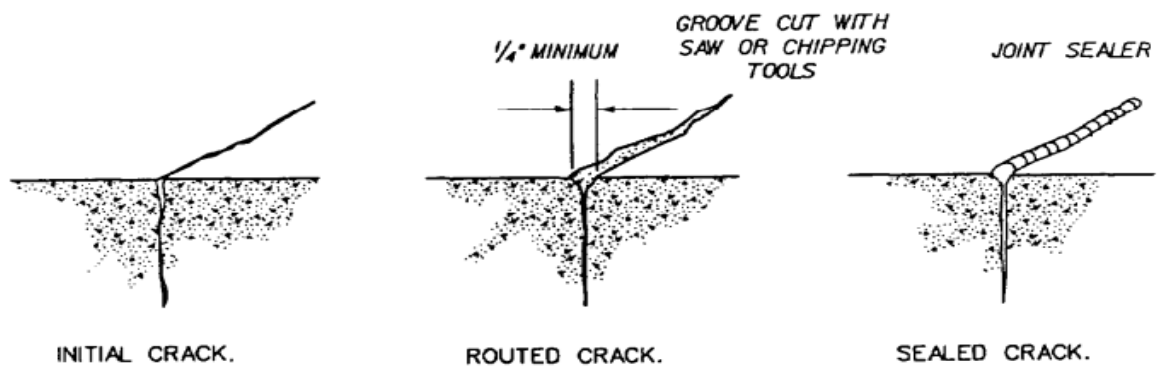
Figure 2.12: Repair of Crack by routing and Sealing [16]

The procedure is most applicable to approximately flat horizontal surfaces such as bridge deck. Routing and sealing is used to treat both narrow and wide cracks. A common and effective use is for waterproofing by sealing cracks on the concrete surface where water stands or where hydrostatic pressure is applied. This treatment reduces the ability of moisture to reach the reinforcing steel or pass through the concrete, causing surface stains or other problems. The sealants may be any of several materials, including epoxies, urethanes, silicones, polysulfide, asphaltic materials, or polymer mortars. Cement grouts should be avoided due to the likelihood of cracking [16]. A concrete saw, hand tools or pneumatic tools may be used. The groove is then cleaned by air blasting, sand blasting or water blasting and dried. A sealant is placed into the dry groove and allowed to cure.

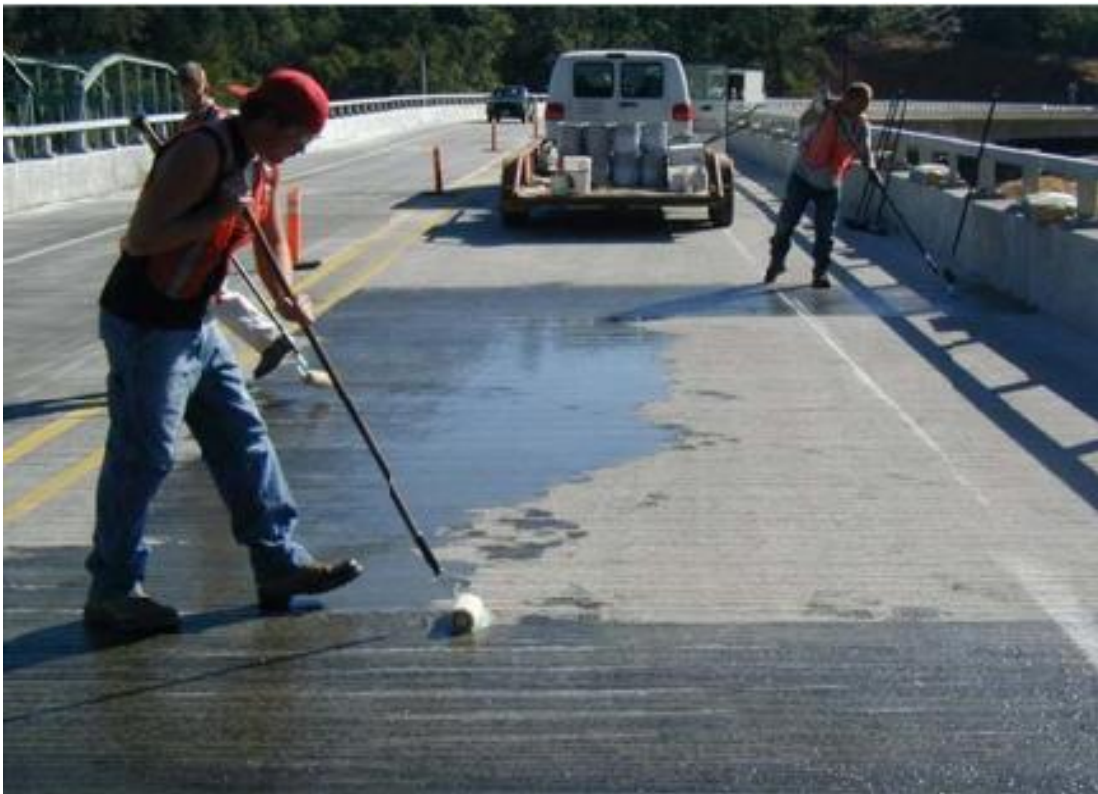
Figure 2.13: Application of a gravity feed repair method [4]

Low viscosity monomers and resins can be used to seal cracks with width of 0.03 mm to 2 mm by gravity filling. High molecular-weight methacrylates, urethanes and some low viscosity epoxies could be used successfully. Lower the viscosity, finer the cracks that can be filled. The typical procedure is to clean the surface by air blasting, water blasting, or both. Wet surfaces should be permitted to dry for several days to obtain the best crack filling. The monomer or resin can be poured onto the surface and spread with brooms, rollers, or squeegees. The material should be worked back and forth over the cracks to obtain maximum filling because the monomer or resin recedes slowly into the cracks. The use of this method on elevated slabs will require sealing of the cracks on the bottom of the slab to contain material from leaking through the crack. Excess material should be broomed off the surface to prevent slick, shining areas after curing.

If surface friction is important, sand should be broadcast over the surface before the monomer or resin cures [16].

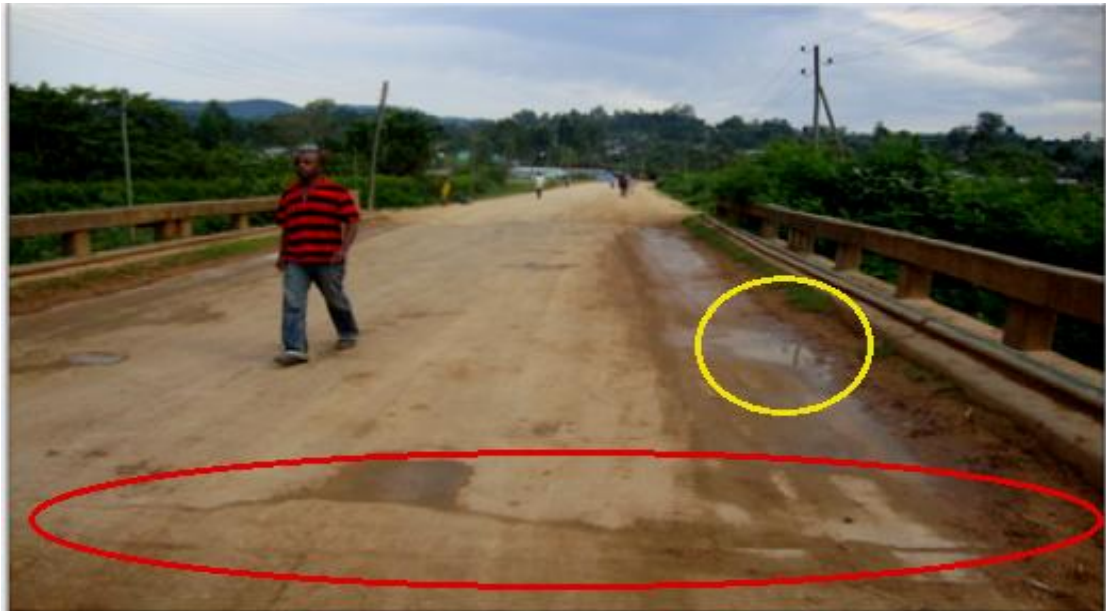
Figure 4.1: Visible transverse bridge deck cracking and deposited silt

In this study, surface of the bridge deck slab cracks widths are measured by using a tape rule and crack comparator card which have lines of specified thickness marked on it. Once the underneath bridge deck was cleared of debris and dirt, the bridge deck surface was string line marked at 3 meter intervals in longitudinal and transverse direction. At the end all things were determined, the crack surveys on the bridge deck were conducted and the extension of the crack was marked if it was visible to the researcher as they mark the cracks. Cracks in bridge deck should be documented on a scaled map of the deck, as shown in the Figure 4.3 below. Additionally, the researcher was taken coloured photographs for visible concrete cracks which have occurred in the deck surface for documentation in this study.

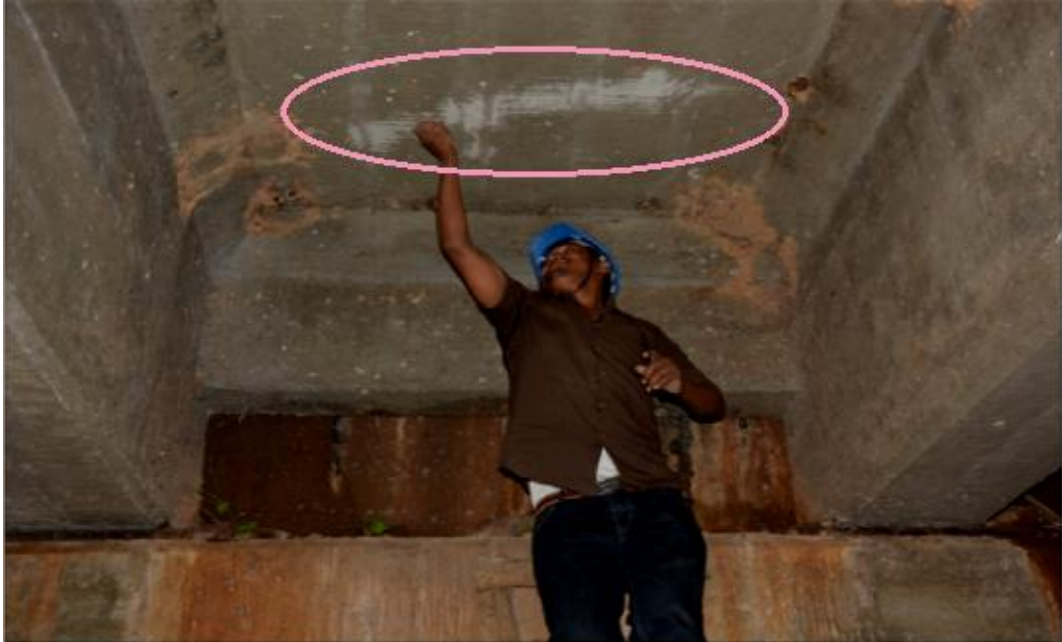
Figure 4.4: Smoothing with a carborundum stone of underneath deck test surface

To obtain greater accuracy of test results in this study, test areas with a rough surface are ground to a uniform smoothness. This can be achieved easily with a Carborundum/abrasive stone, as shown below in the figure below.

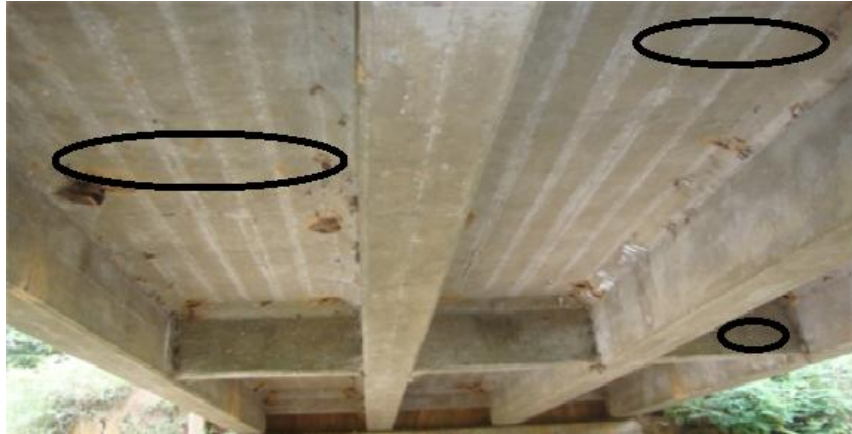
Figure 4.6: Marked delaminated areas of Sheta River Bridge deck

Hitting it with carpentry hammer is generally used for this study; the operator struck the concrete with a standard carpentry hammer and listened to the response. This method has two limitations that applied to hammer sounding including the subjective judgment and hearing sense of the operator. Areas of delaminations are then marked directly on the surface of the concrete. After delaminated areas are marked on the Sheta River Bridge deck, the percentage of delaminated areas can be computed. Therefore, 150 cm² of delaminated areas Sheta River Bridge deck slab surface was recorded during site investigation.

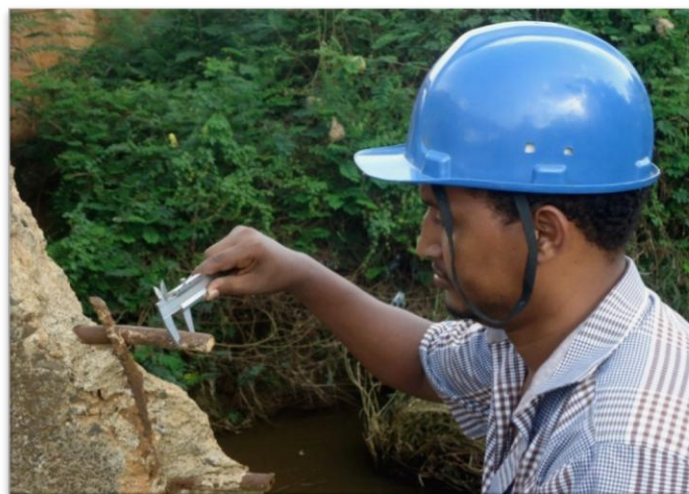
Figure 4.7: Measuring bare undeformed steel reinforcement bars

In this study, depth of concrete cover easily obtained after measuring bare undeformed reinforcement bar projected at the end of wing wall, as shown in the figure below and peels off concrete at the bottom of deck slab.

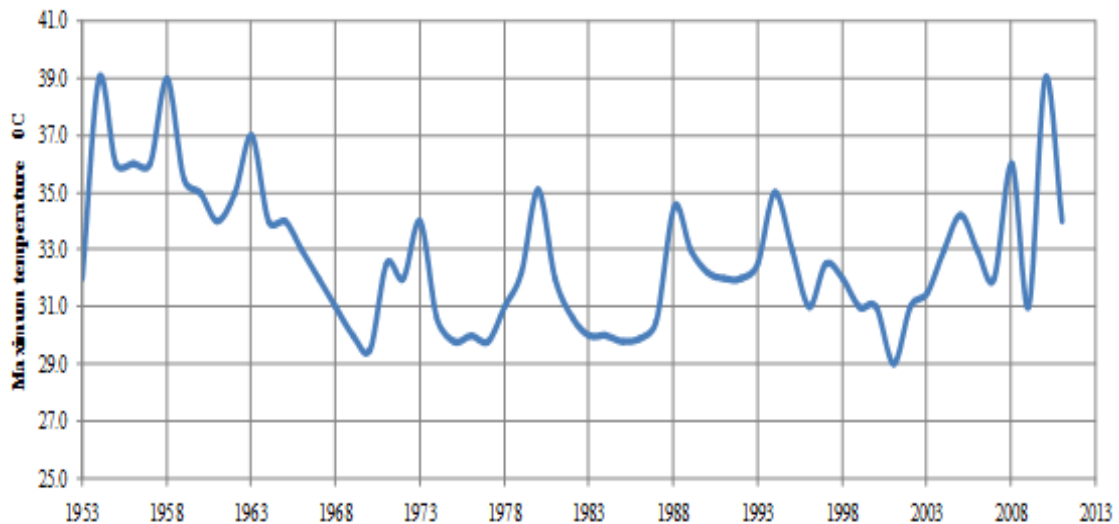
Figure 4.8: Maximum daily temperature in Kaffa Zone, Bonga town

The effect of maximum temperature changes was assessed with the daily and seasonal temperature ranges specific to the environment surrounding Kaffa Zone, Bonga town in Sheta River Bridge location, maximum daily temperature plotted in the figure below.

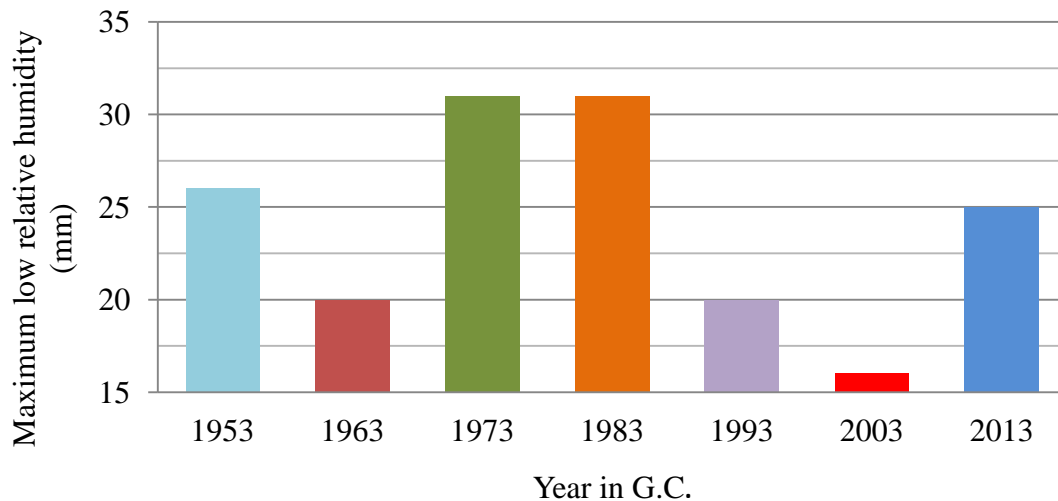
Figure 4.9: Maximum low relative humidity in Kaffa Zone Bonga town

Relative humidity has a major influence on ultimate shrinkage and the rate of shrinkage. Low relative humidity is generally thought to contribute to bridge deck cracking by increasing the rate at which surface moisture evaporates from hardened concrete. According weather data logbook of Ethiopian Meteorology Agency, Jimma Branch Directorate data, the maximum low relative humidity Kaffa Zone, Bonga is 31 mm.

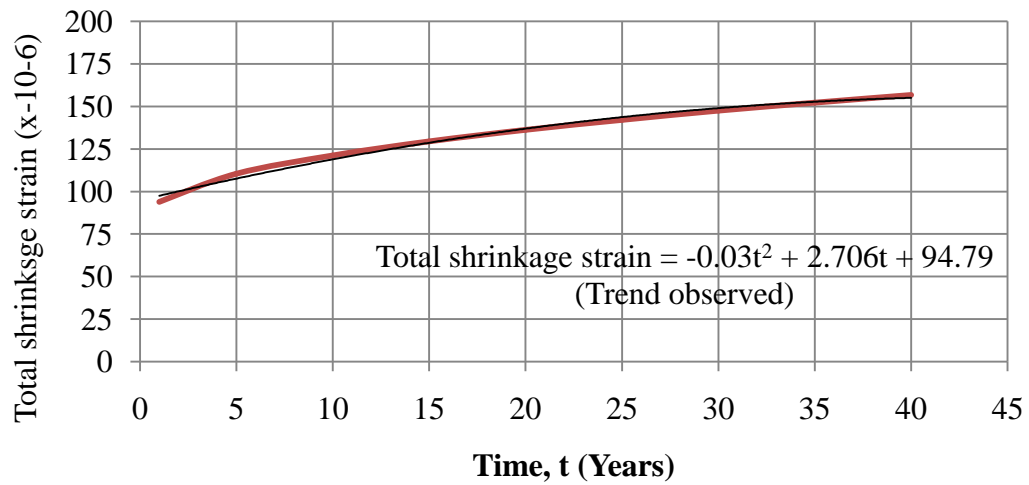
Figure 4.10: Total shrinkage strain prediction of Sheta River Bridge deck

For anytime-dependent dry shrinkage strain of Sheta River Bridge deck for calculated strength of concrete is plotted as a function of time, in the following figure.

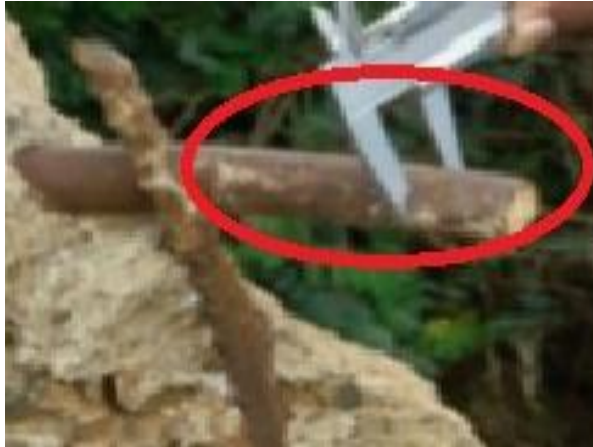
Figure 4.11: Undeformed bare rebar

Steel reinforcement bars are usually round with regularly spaced rib-shaped deformations on the surface to provide a better bond between the concrete and steel. However, Sheta River Bridge was constructed by undeformed steel reinforcement bars that leads weak bond between concrete and steel reinforcement bar. Moreover, undeformed steel reinforcement it may cause of bridge deck cracking.

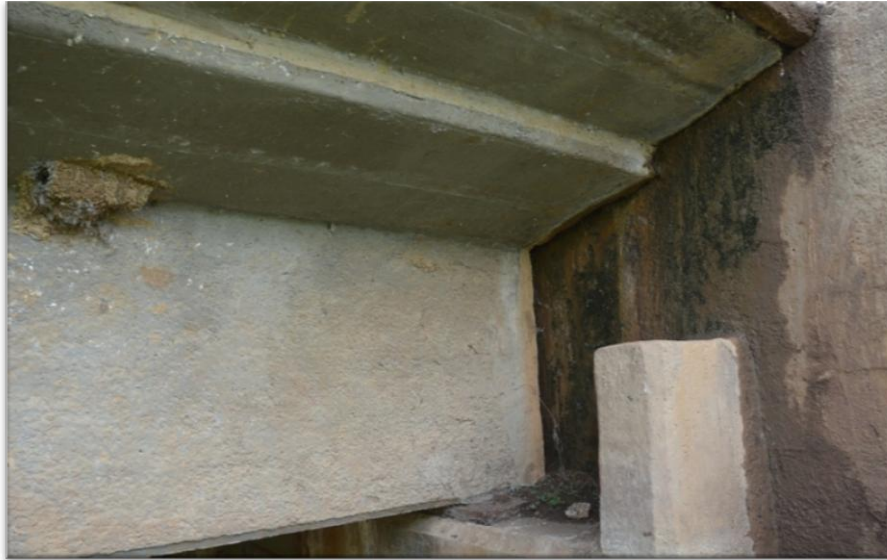
Figure 4.12: Girder end restraint condition

Restraint condition is denotes the restraint against free deformation of the deck slab, provided by the structural system. Specifically; in this study, mainly the primary restraint parameter of the girder end restraints associated with abutment connections of the corroded steel line plate bearing.

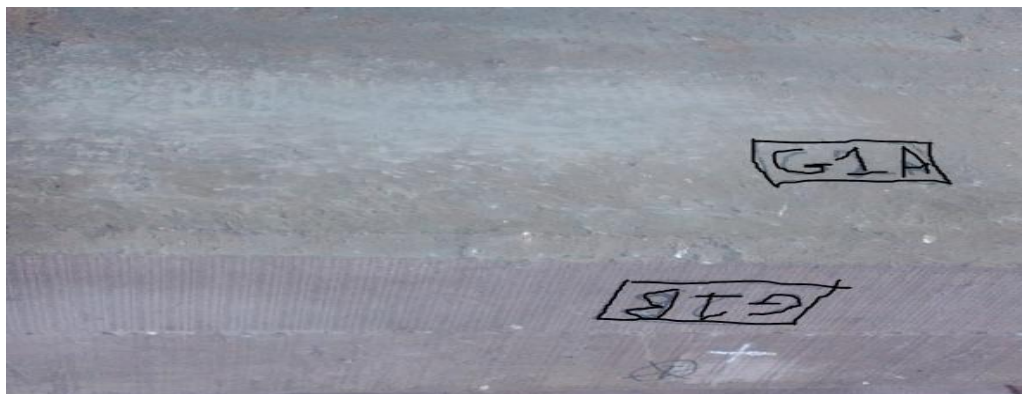
Figure A.1: Surface preparation and coding of exterior girder (G1)

Generally, during in – place rebound hammer test on the girders, first coded the four girders just like G1, G2, G3 and G4 from upstream to downstream, respectively. Tests performed on the smooth texture of girders independently, take the average of about 30 readings from one girder, as shown above.

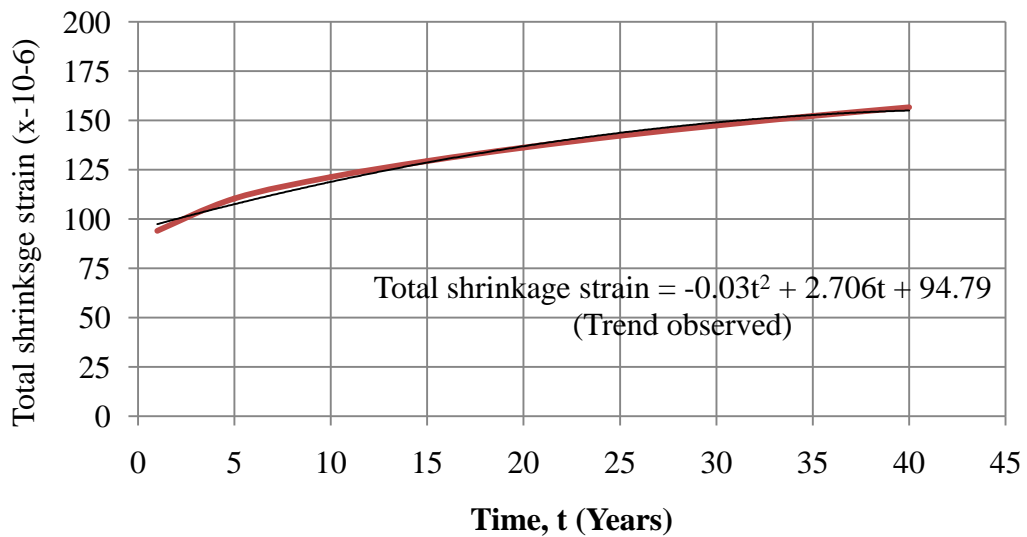
Figure A.3: Total shrinkage strain prediction

The time-dependent shrinkage strain for above calculated strength of concrete is plotted as a function of time, in the following figure.

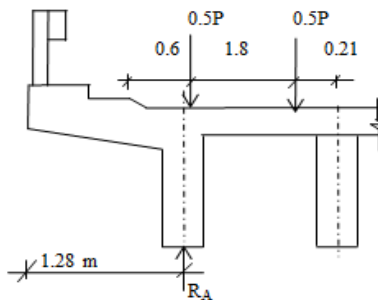
Fig B.2: Definition of Lever rule

When one design lane is loaded, the lever rule is used to determine the distribution factor, mg
 For computing the distribution factor by the lever rule, a simple structural member such as the one shown below is analyzed

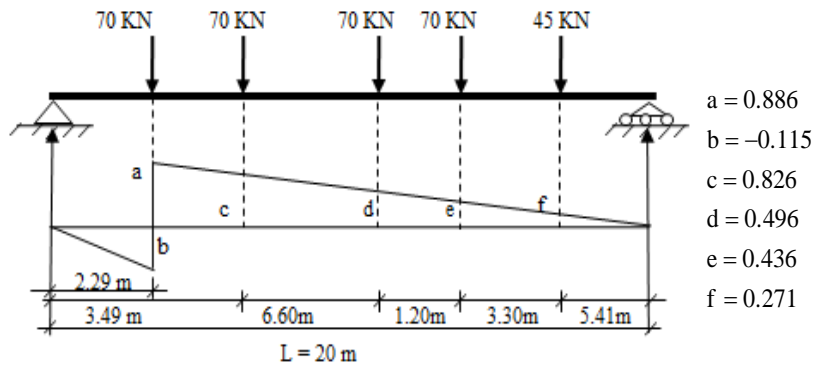
Figure B.15: Shear force Influence line diagram: @ 2.29 m

An influence line analysis shown in Figure B.15 is used to compute the shear force at 2.29 m from the support where the stirrup spacing changes from 350 mm to 450 mm.
