Assessment on Pavement Performance and Remaining Life cycle Analysis Using Integrated HDM-4  
Software: Case Study within Kombolcha-Harbu Road section

This thesis is submitted to the School of Postgraduate Graduate Studies of Jimma University in a Partial  
Fulfillment of the Requirements for the Degree of Master of Science in Civil Engineering

(Highway Engineering)

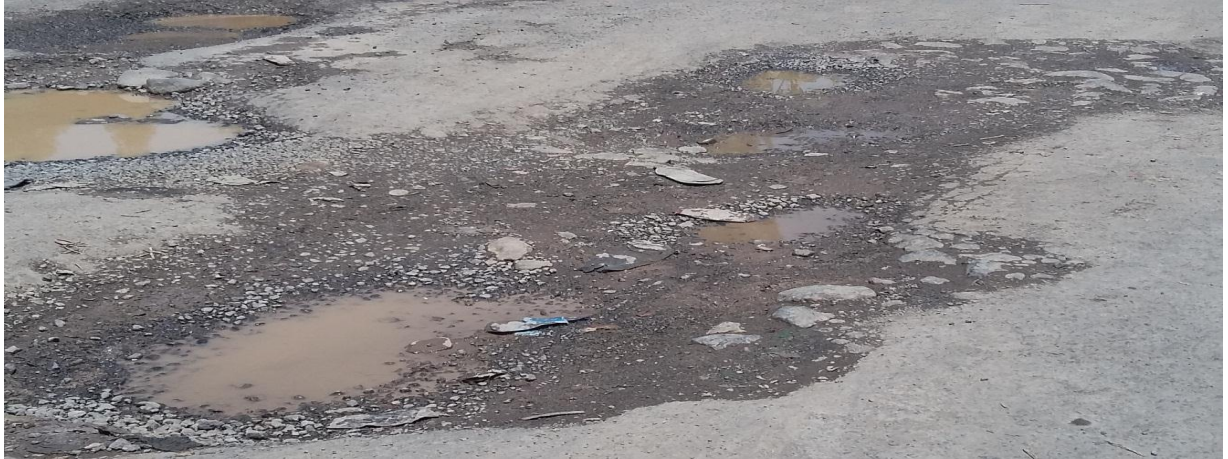
Fig.1.2 Location of the problem of kombolcha-Harbu road

In this study, kombolcha-Harbu road was one of the road section constructed in the past that deteriroted before finish its design life. Therefore; for cost effective and pavement

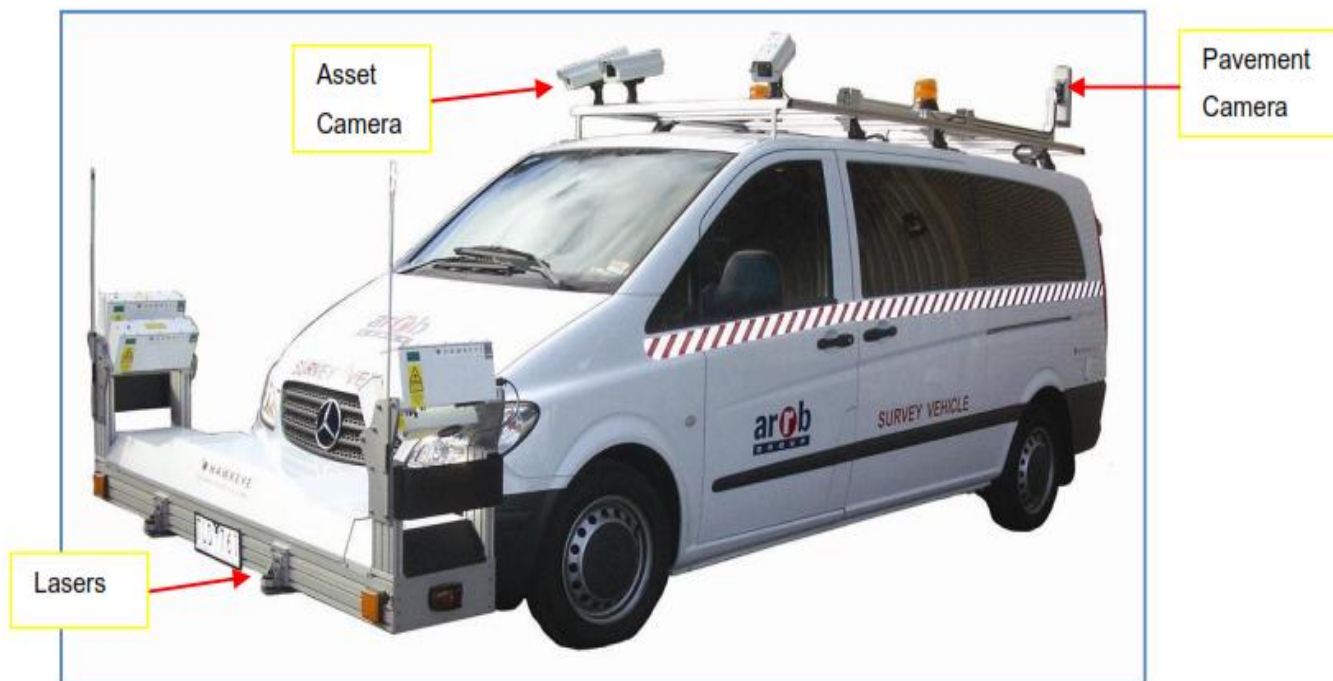
Fig.2.1: ARRB Automated Survey Vehicle (source: kassa;pavement performance evaluation)

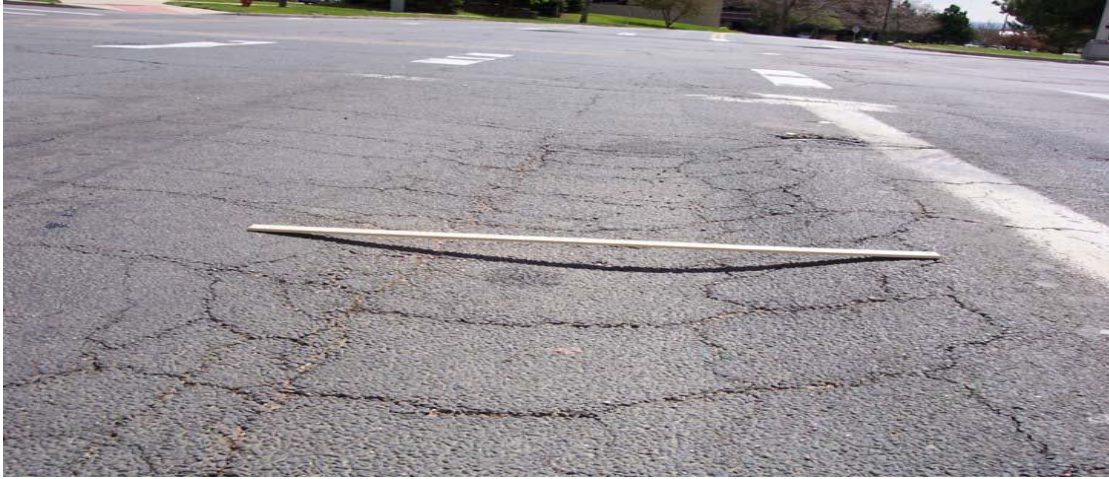
Fig.2.2: High severity rutting

**Measure:** Take measurements in as many locations as is practical and average them.

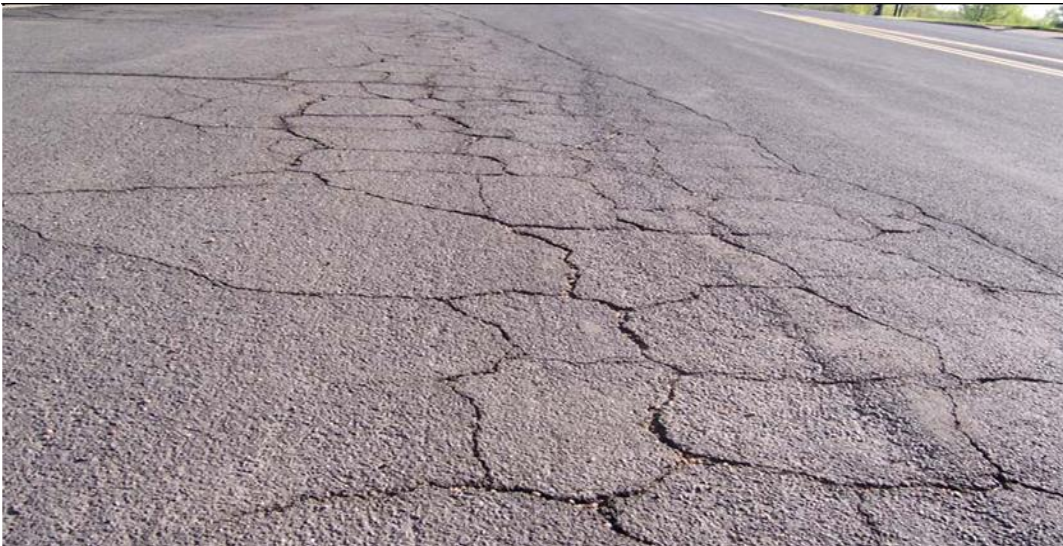
Fig.2.3: High severity alligator cracking

**Measure:** Accumulate the lengths along the surveyed lane of each severity of the alligator cracking as it occurs in both wheel paths. Divide the accumulated lengths by twice the length of the segment (two wheel paths per lane). Multiply by 100 to get percent, and round to a whole number.

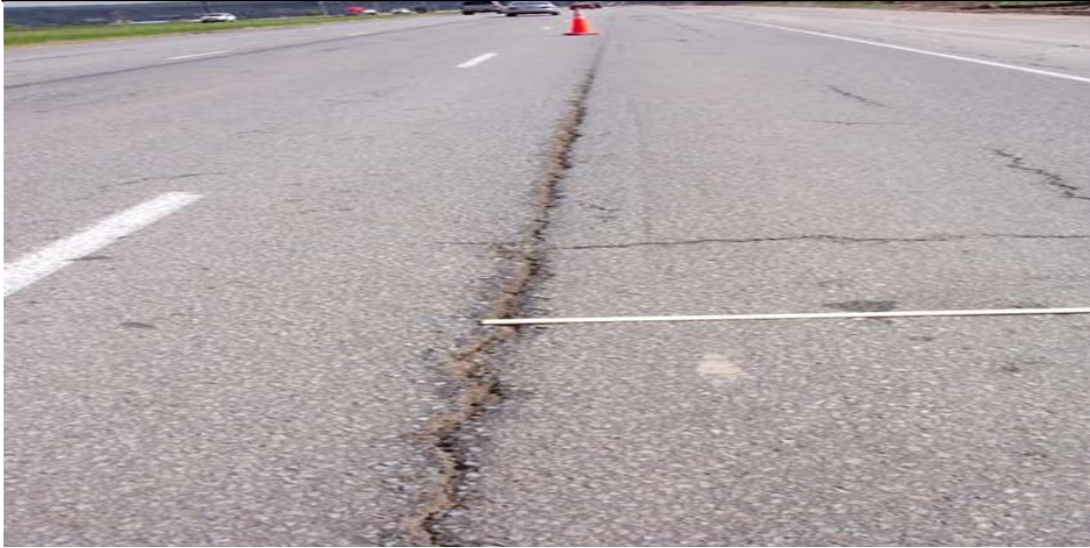
*Fig. 2.4: High severity Longitudinal Cracking*

**Measure:** Accumulate the lengths along the surveyed lane of each severity of the longitudinal cracking as it occurs. Divide the accumulated lengths by the length of the segment. Multiply by 100 to get percent, and round to a whole number. [18]

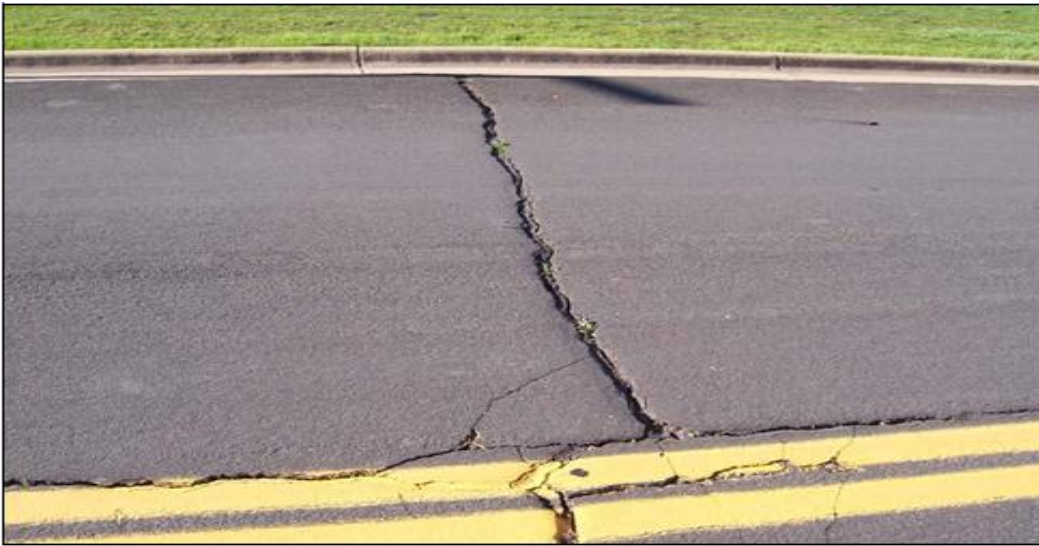
*Fig. 2.5:High severity Transverse Cracking*

**Measure:** Accumulate the count along the surveyed lane of each severity of transverse crack as it occurs. Divide the accumulated counts by the length of the segment. Multiply by 100 to get the frequency, and round to a whole number.

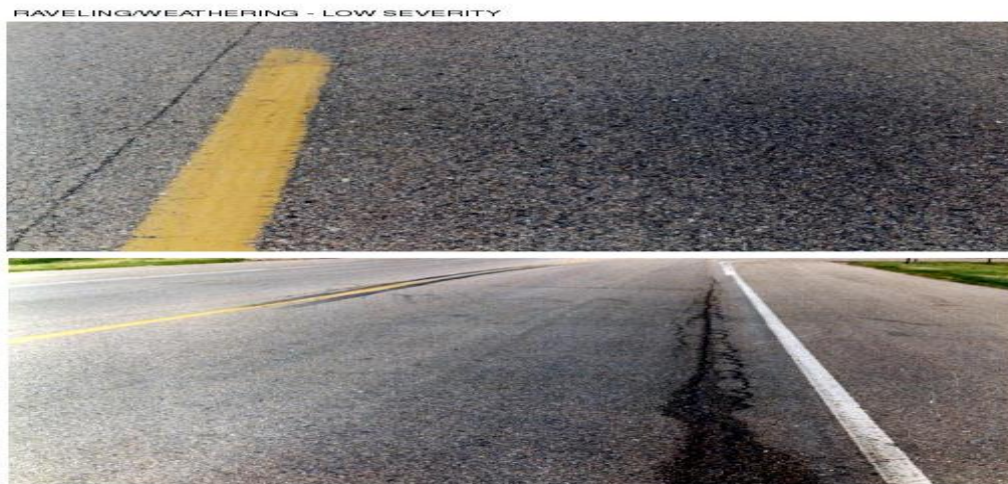
*Fig.2.6: High severity Raveling*

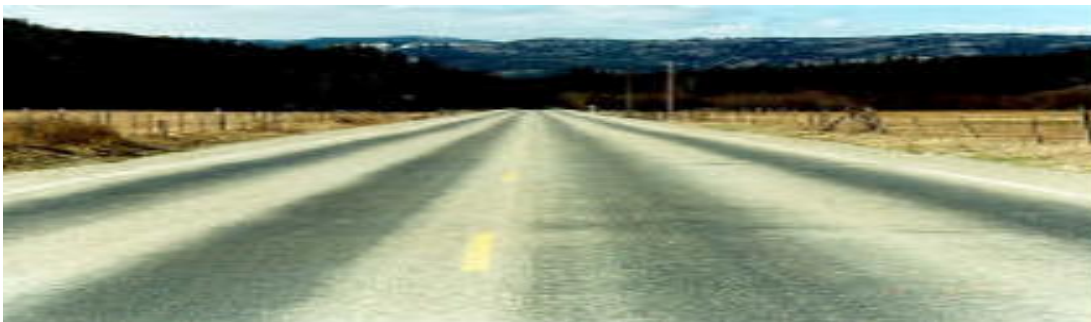
*Fig. 2.7: High severity bleeding*

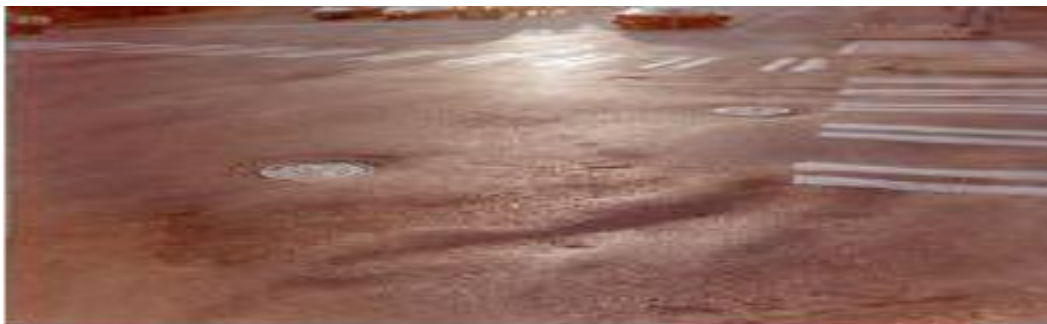
Fig.2.8: High severity Corrugation

Measure: Determine severity by measuring the maximum difference in elevation that occurs within a 3.1m straightedge length centered over the area of displacement. Rate the overall distress by using the highest observed level. [18]

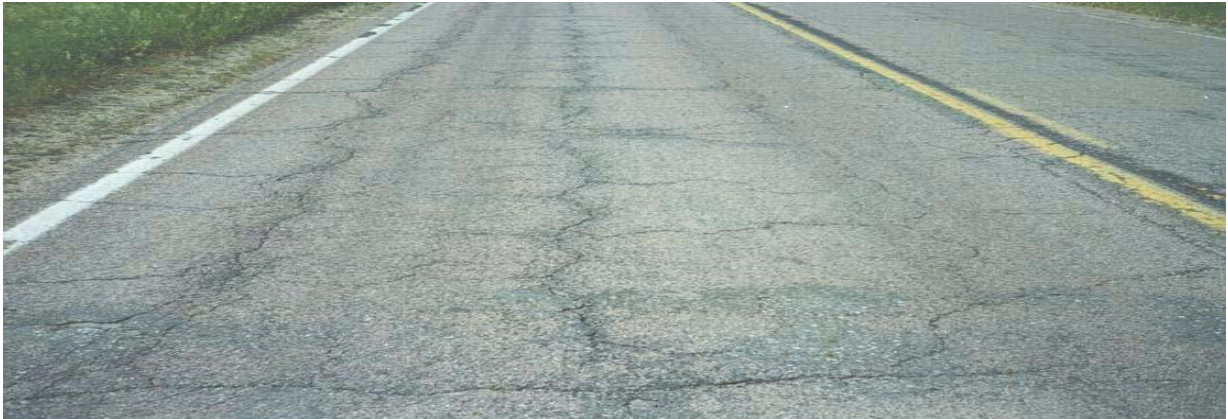
Fig. 2.9: High severity block cracking

**Measure:** Estimate the typical size of the blocks and select the appropriate standard block size and crack size. [18]

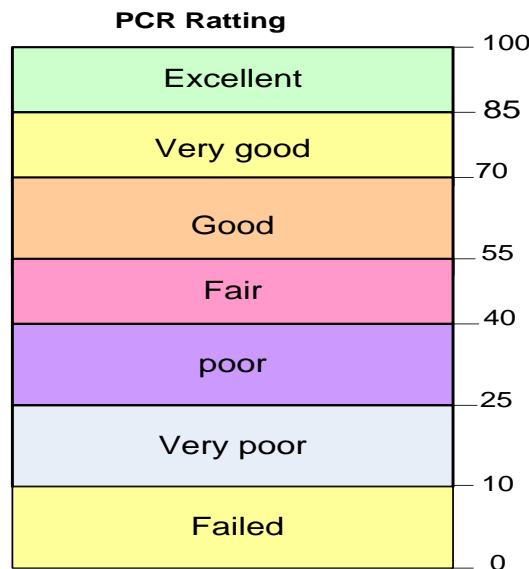
Fig.2.10 Pavement condition Rating Scale

A Pavement Condition Rating (PCR) Scale was developed to describe the pavement condition using the PCR numbers calculated from previous Equation. This scale has a range from 0 to 100; a PCR of 100 represents a perfect pavement with no observable distress and a PCR of 0 represents a pavement with all distress present at their -High levels of severity and extent levels of extent. Figure illustrates the PCR Scale and the descriptive Condition of a pavement associated with the various ranges of the PCR values[7]

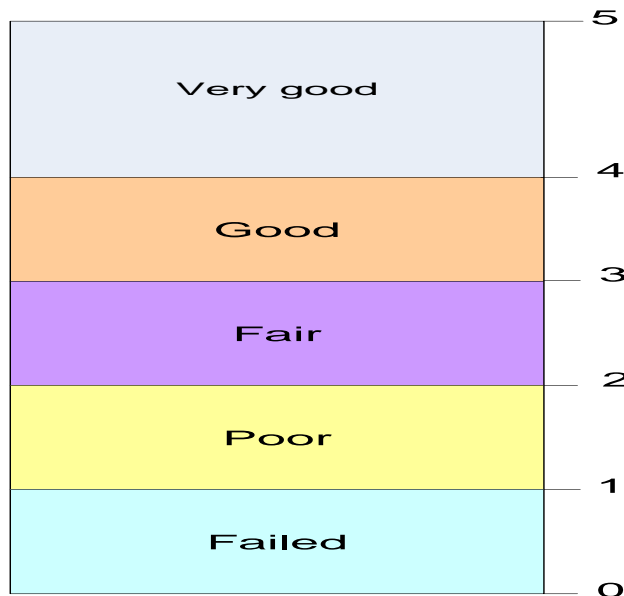
The Present Serviceability Rating (PSR) is a subjective and ride-based observation interms of the roughness of the pavement inorder to estimate deterioration, deficiencies, and needed improvements based on early AASHO Road Tests. The higher the PSR value, the smoother the riding surface. The PSR is a grade numbe is shows rate of ability the sections to serve the designed traffic loads. Its rating scale is raging from 0-5; where 0 signifies very poor and the number 5 signifies “very good” as illustrated in below.

Fig.4.11: Pavement Serviceability Ratting (PSR) scale

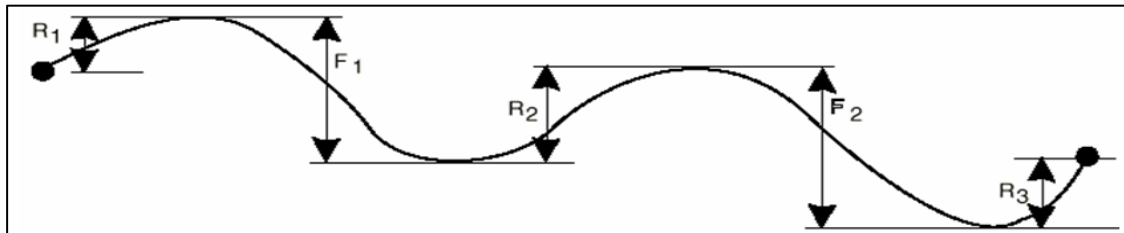
Rise plus fall is defined as “the sum of the absolute values of total vertical rise and total vertical fall of the original ground along the road alignments over the road section in either direction divided by the total section length. This is shown in Figure given below and can be calculated using the equation.

Fig.4.12: Rise+fall measurement representation

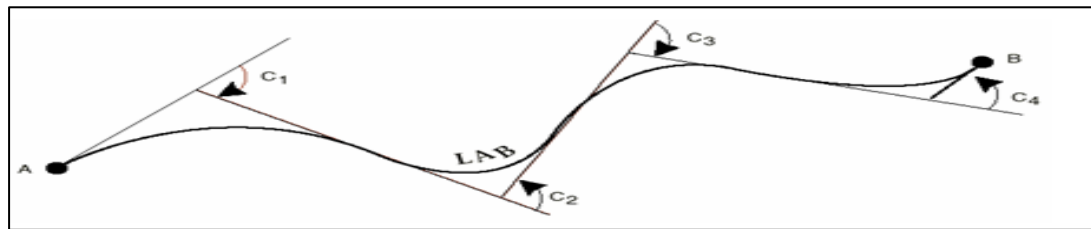
Another geometric characteristic that is used to describe the road section is super elevation. Super elevation of a curve section is “the vertical distance between the heights of the inner and outer edges of the road divided by the road width.” [17] The horizontal curvature is defined as the weighted average of the curvatures of the curve sections of the road. This is shown in Figure and the Equation below is used to calculate the curvature.

Fig. 4.13 Horizontal Curvatures [17]

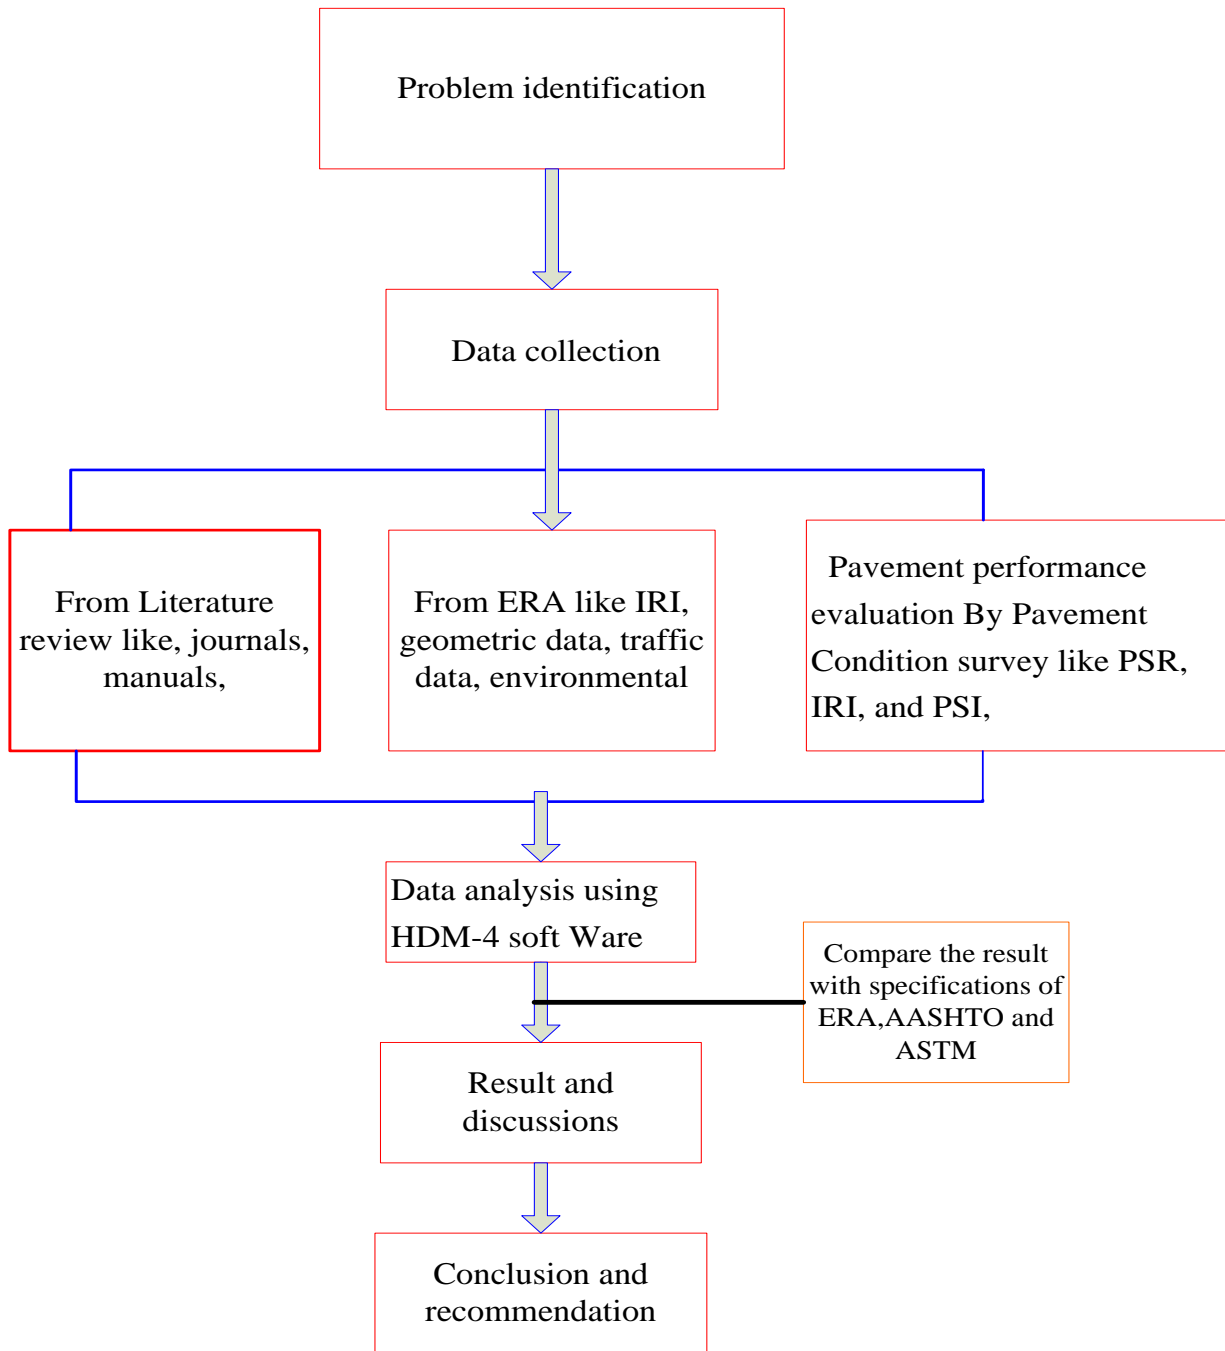
Fig. 3.2 Study Procedure

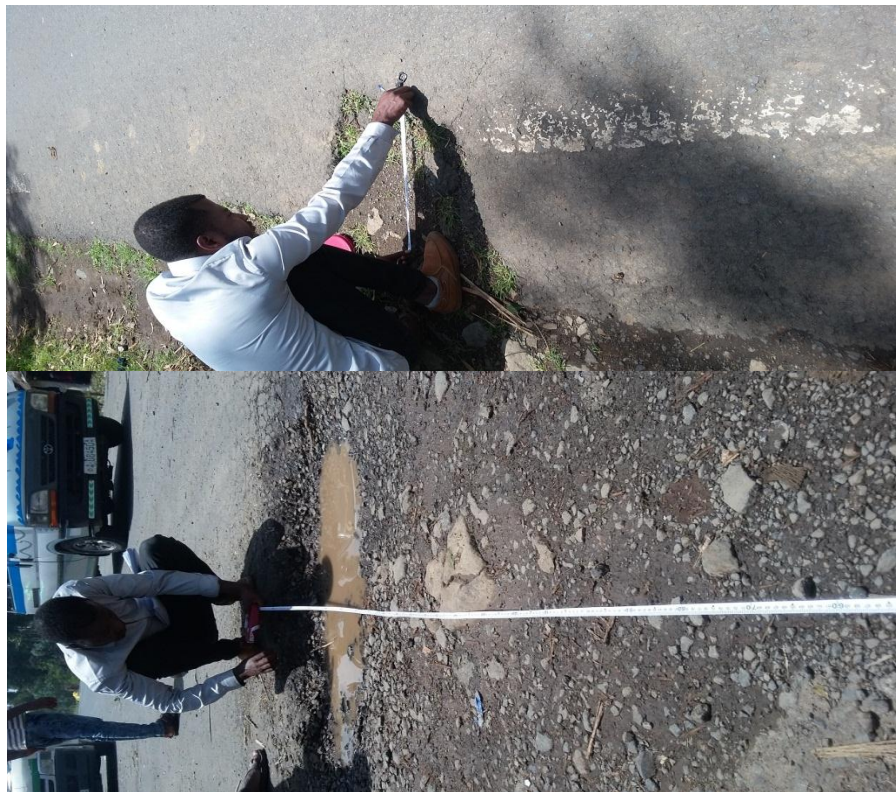
During pavement condition survey the measurement was undertaken at the interval of 100m which started from 0+000 station to 17+000. But this station was classified to three sections for the purpose of simplifying the measurement. The stations that covered for measurement of first, second and third sections were 0+000 to 4+000, 6+000 to 10+000 and 11+000 respectively. The edge cracks area were measured for the three sections of this study area given on the appendix part of this study.

Fig. 3.3 Edge cracking measurement

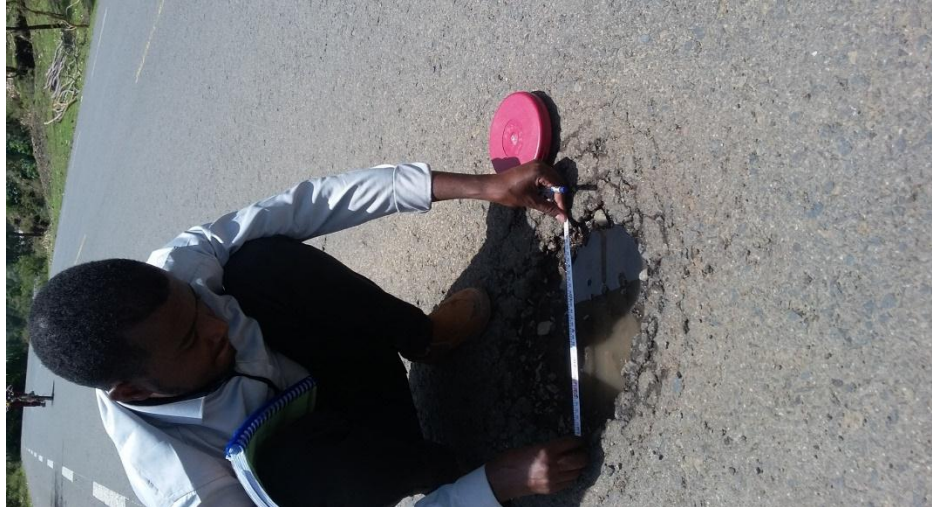
The potholes along this road section were counted through out the length of the road at the time of condition survey.

**Fig. 3.4 Potholes counting and measurement**

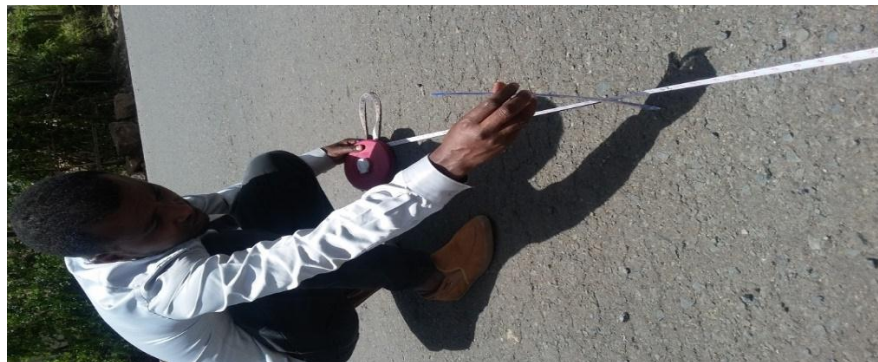
The rutting along this road section was measured from wheels path of the pavement. This road failures was measured at some part the stations occurred along road length. Because rutting was not the major problem for the damage of this road section.

**Fig. 3.5: Rutting depth measurement**

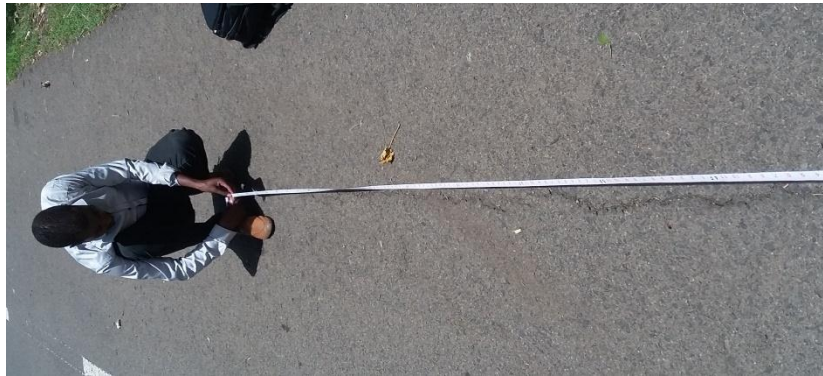
defected area of the road section. The measurement of those cracks and their total values has given at the appendix part of this study.

Fig. 3.6: Cracking area measurement

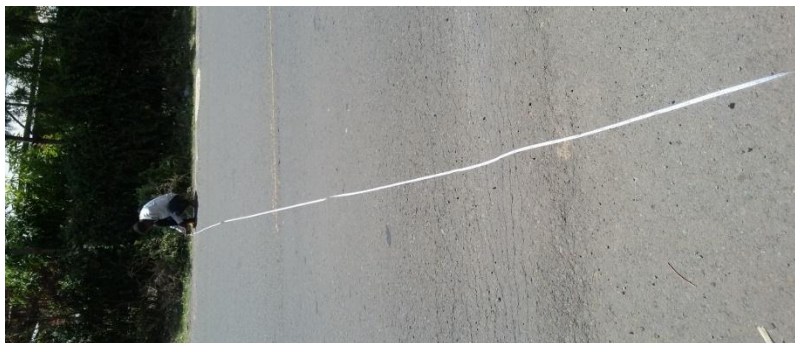
The width and thickness of the road at each 100m interval of stations was measured. After measured the width and thickness at the stations, the average width were determined for the alnalysis purpose of life cycle of the pavement using HDM-4 calibrated software. The masurment was occure at the appendix.

fig. 3.7: Road Width and thickness measurement

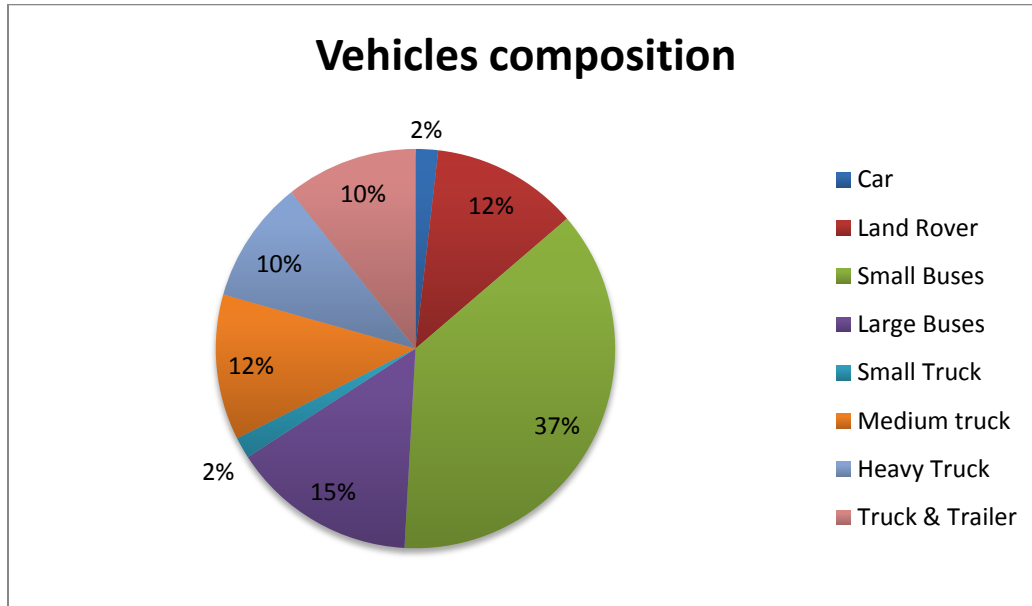
Fig. 3.8: Diagrammatical representation of vehicles composition

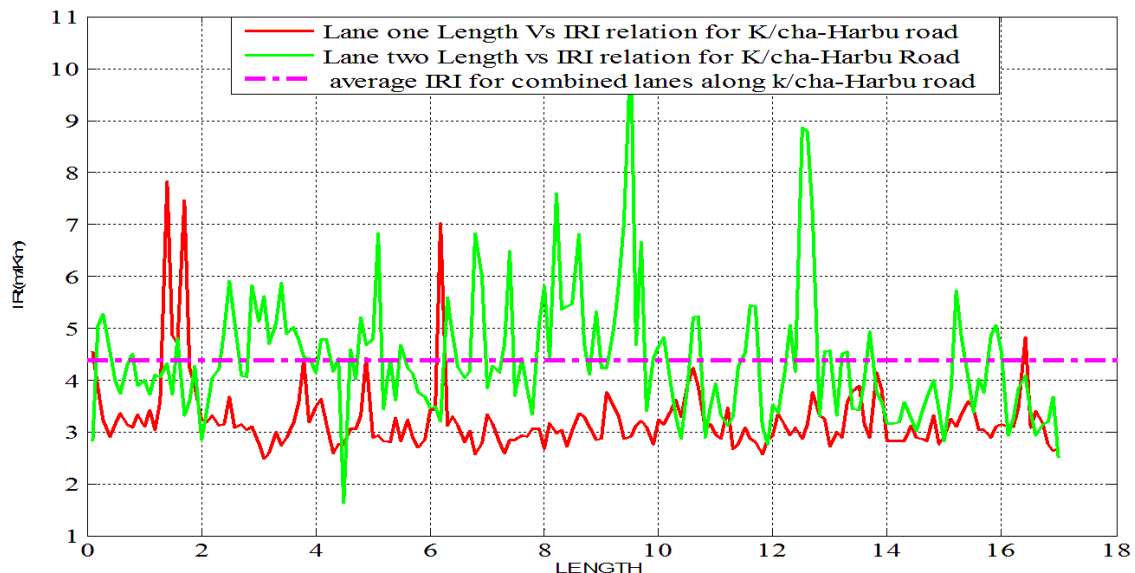
This road section was occurred between Kombolcha-Habru towns. The analysis was conducted on 17 km of the road section. The measured IRI value was surveyed by ERA automotive vehicle at the two lane of road section for the maintenance purpose. To analysis the future condition of the pavement, its current condition should be determined depending on the average IRI value along the length of the road section. The performance of the pavement was evaluated depending on the specification given on the ERA manual 2011.

Fig.4.1 Lane one IRI values along Kombolcha- Habru road section

From the graphical representation of the road length and international roughness index of Kombolcha-Habru road section, the mean value of IRI value was determined as 4.24 m/Km. from the graphical relation of this road section, the road was more deteriorated approximately at length of 0.8-12.6Km. Then depending on the average values of IRI the condition of the pavement along this section was evaluated as fair condition. Because the IRI value 4.24 m/Km was occurred between 2.87 and 5.95.

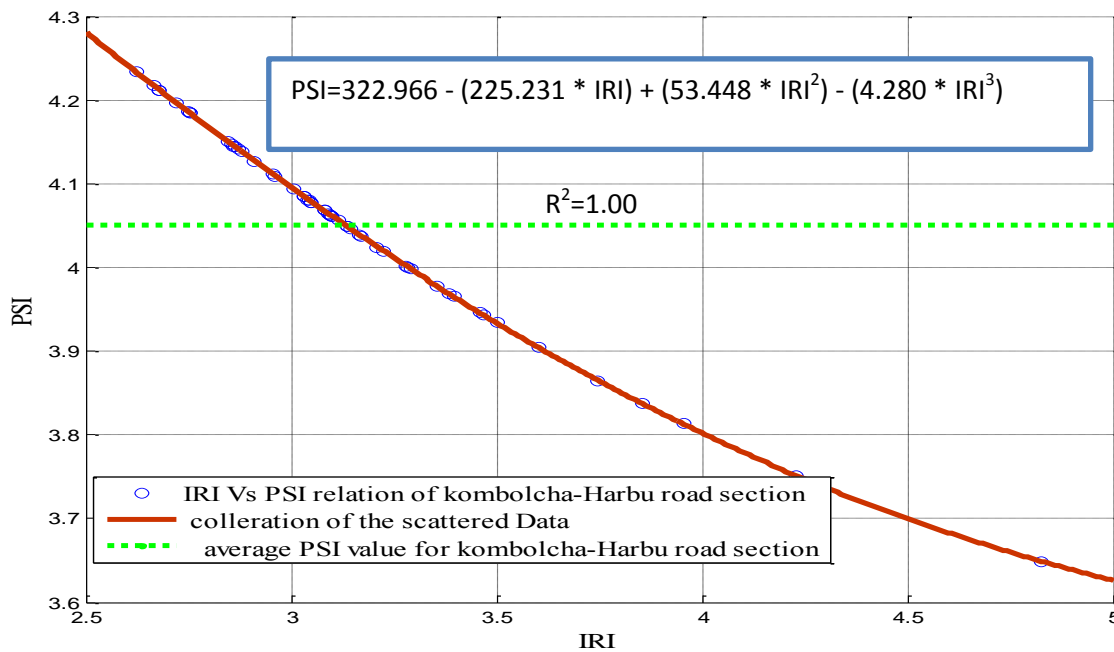
Fig.4.2 The relation between PSI and IRI for kombolcha to Habru road section.

The relation between IRI and PSI of the scattered plotting can be related by fourth degree polynomial function shown on the graph. From this linear relation as the value of present serviceability index increase, the international roughness index becomes decrease. And also from the scattered data the concentration of high pavement roughness were occurs below 4 of the PSI. The regression relation between the two parameter was determined by MatLab software is gives:

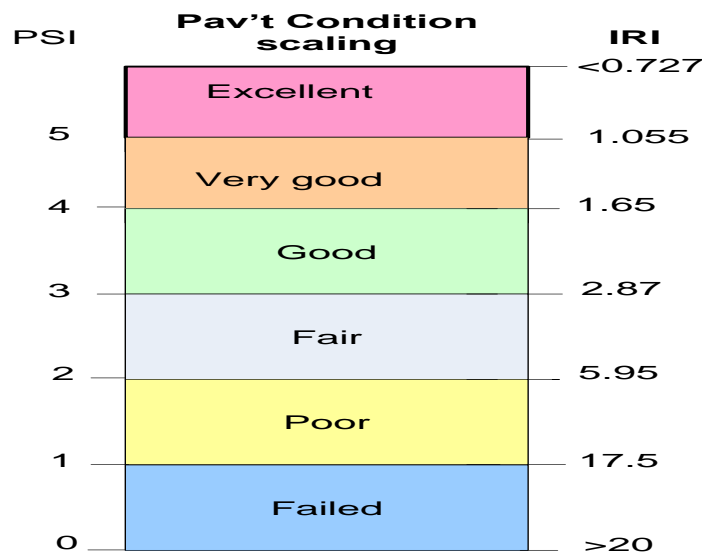
The scaling of the present serviceability index is ranging from 0 to 5.

Fig.4.4: PSI and IRI scaling specification

From the above values of pavement serviceability index the condition of pavement is evaluated using the scale of 0 to 5. Therefore; to know the performance of the pavement at section of this study was determined from the average values of pavement serviceability index. The average value of PSI for Kombolcha-Habru was 4.052. Therefor from the above pavement condition scaling values the condition of the road at section of the study are evaluated as very good.

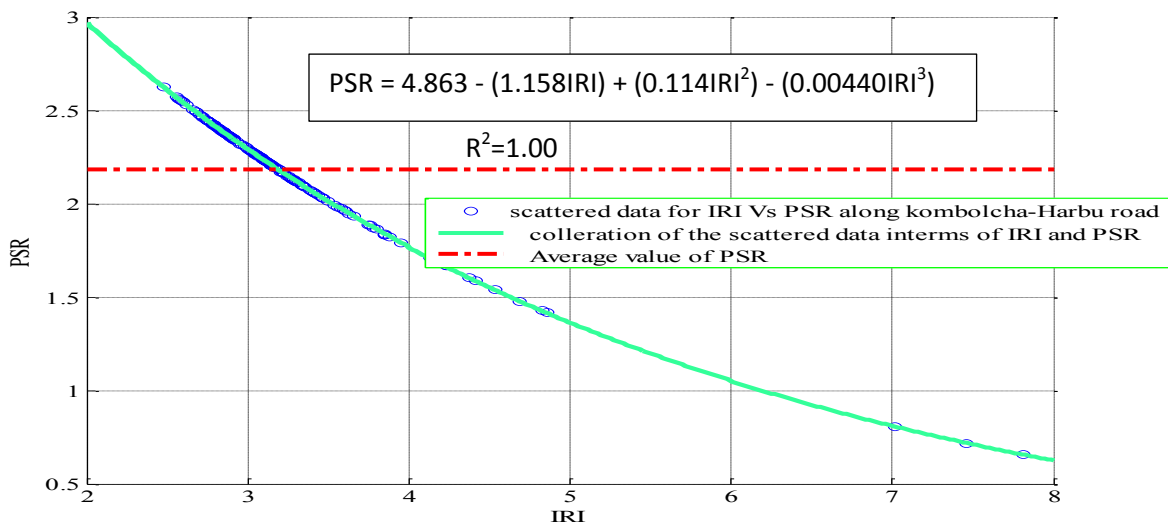
Using the equation illustrated at literature review of this study the performance of the road along kombolcha-Harbu road section of this study can be analyzed in terms of PSR. The equation used for the analysis of the PSR was given below and the whole analysis was present the appendix of this study. But using the graphical relation of the two pavement evaluating parameters i.e. PSR and IRI, and also from the average value of PSR the performance of the pavement was evaluated.

Fig.4.5 Graphical relation of IRI and PSR

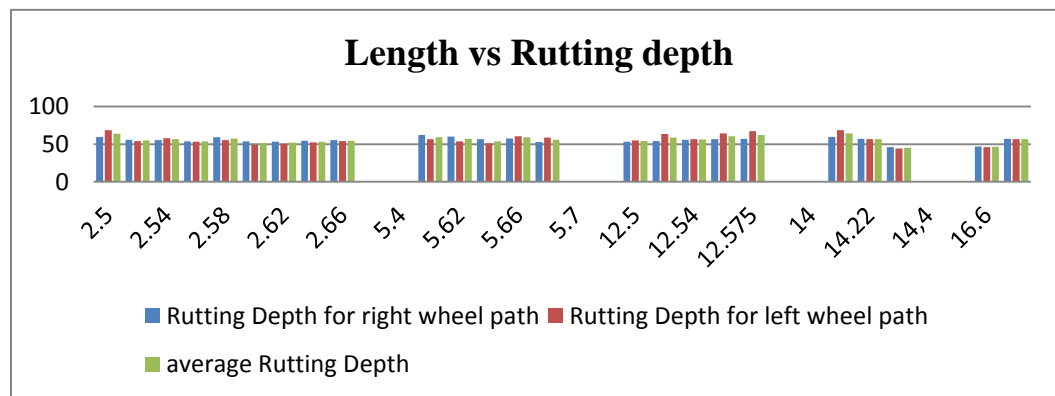
Rutting is Permanent traffic-associated deformation within pavement layers along the wheel paths. This can be measured using condition assessment or survey at the field. The rut depth measured on the study of road section was occurred at five stations of the road length. This road defect was located around 2.5-2.7 km, 5.6-5.7 km, 12.5-12.75 km, 14.2-14.25 and 16.6-16.63 road length. From this stations of rutting length, the rutting depth was measured at the interval of 20m for each area of rutting length.

Fig.4.6: Location of measured rutting point along Kombolcha-Harbu road section

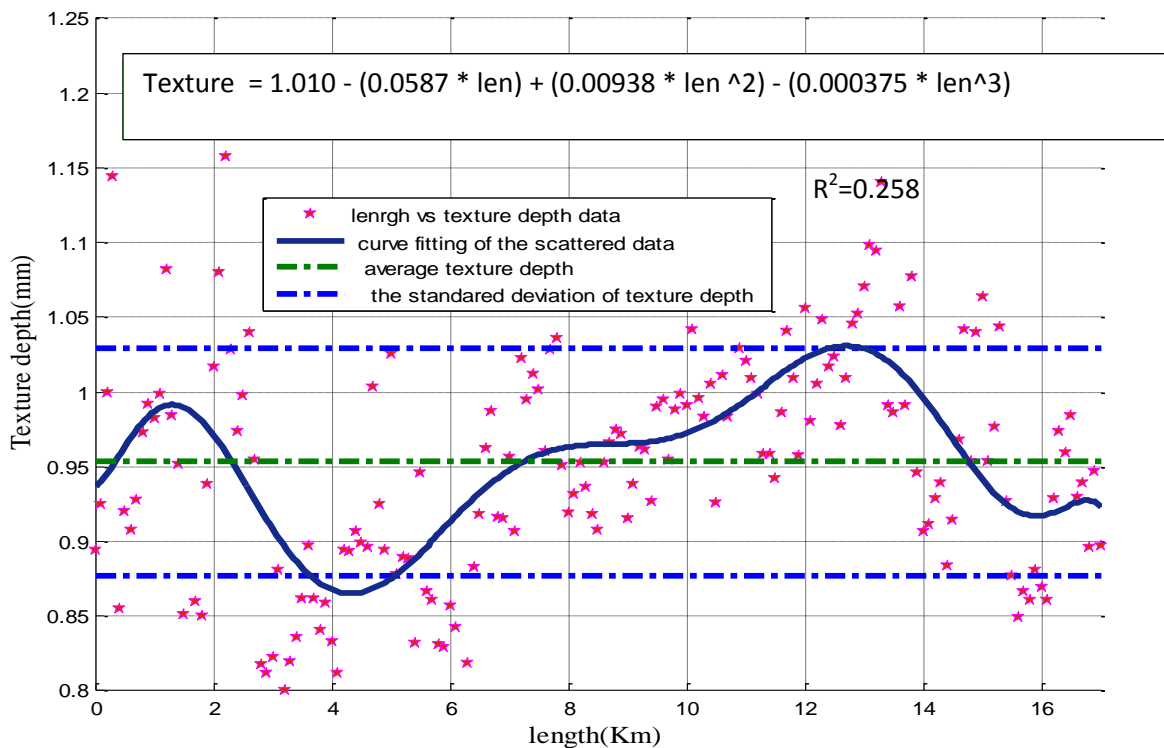
Fig.4.7: The plot of texture depth kombolcha-Harbu road section

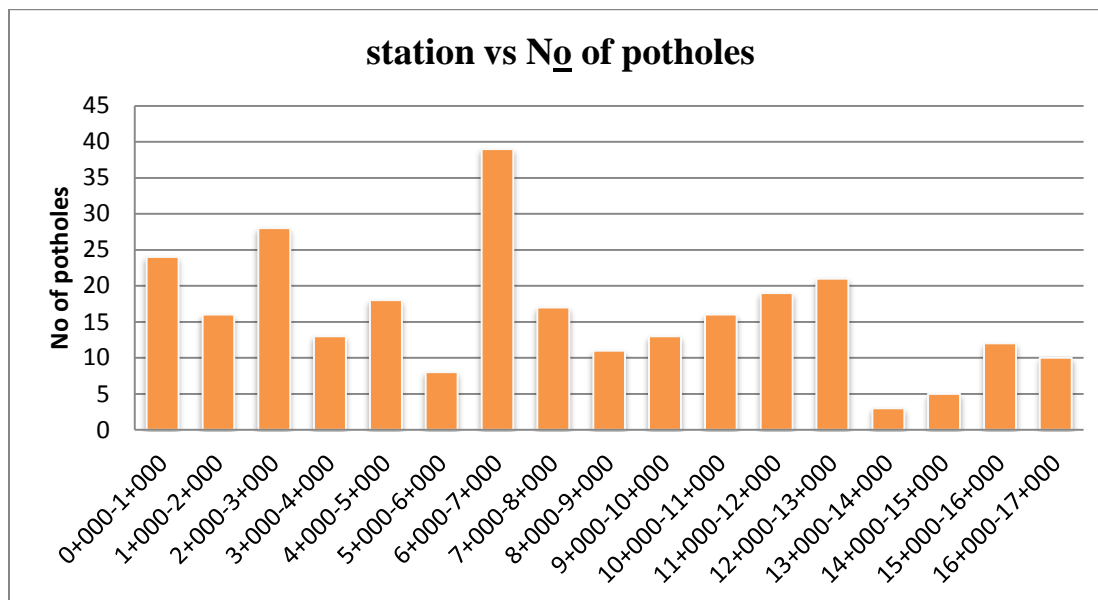
The numbers of potholes can be counted using manual condition survey along this study area. Then the numbers of the potholes per kilometer of the road section was used as an input for HDM-4 calibrated software. Their numbers were counted from the video recorded during condition survey of the study section and also the representative potholes were measured for knowing their extent and severity. But only consider three representative potholes for measurement for 1 km of road length. Therefore; the road was classified for 17 sections which have about 1km length for each. The measured values and their numbers were given at the appendix of this study. From the measured values the total numbers potholes counted during condition survey were about 273 No/km.

Fig.4.8: No. of potholes along kombolcha-Harbu road section

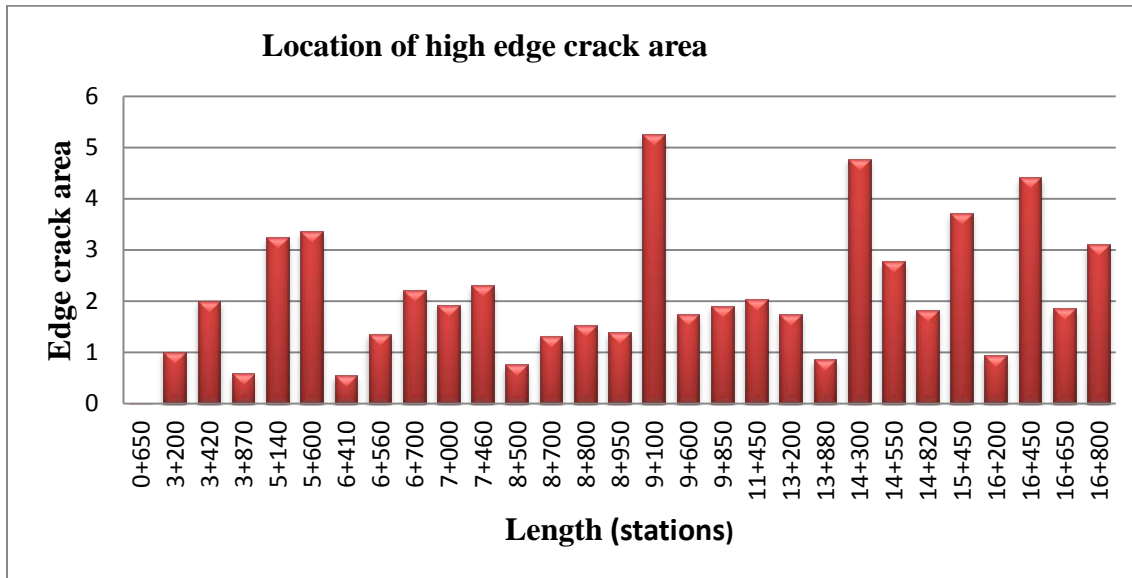
the left and right sides of the pavement. During this measurement only consider high severity edge crack for the analysis of the future pavement condition. Therefore; the measured edge cracks were consider about around 21 points that located at different station and at both side of the road edges. The overall measured values of edge cracks were given at the appendix-A of this study.

Fig.4.9: Location of dominant edge cracking area along kombolcha- Harbu road section

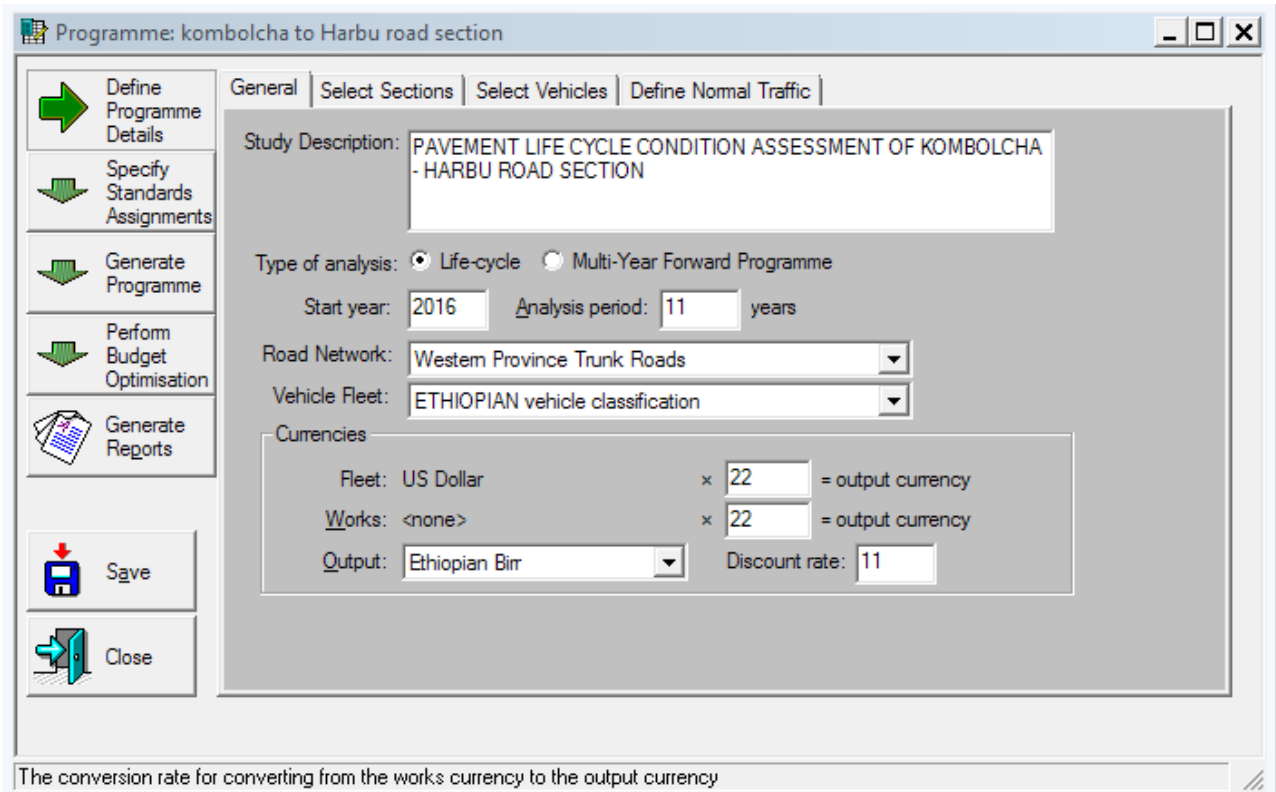
Pavement life cycle analysis is performed depending on the current condition of road along kombolcha-Harbu road section. In this analysis only consider the pavement deterioration condition like edge crack, rutting depth, raveling, skid resistance, international roughness index within the future or remaining service life of the pavement. To analysis this parameters of pavement condition the key modeling or Software was used HDM-4 calibrated software especially at the life cycle analysis approach of the road. This life cycle analysis approach was included under program analysis of road project using application of HDM-4 calibrated software.

Fig. 4.10: HDM-4 lifecycle analysis window

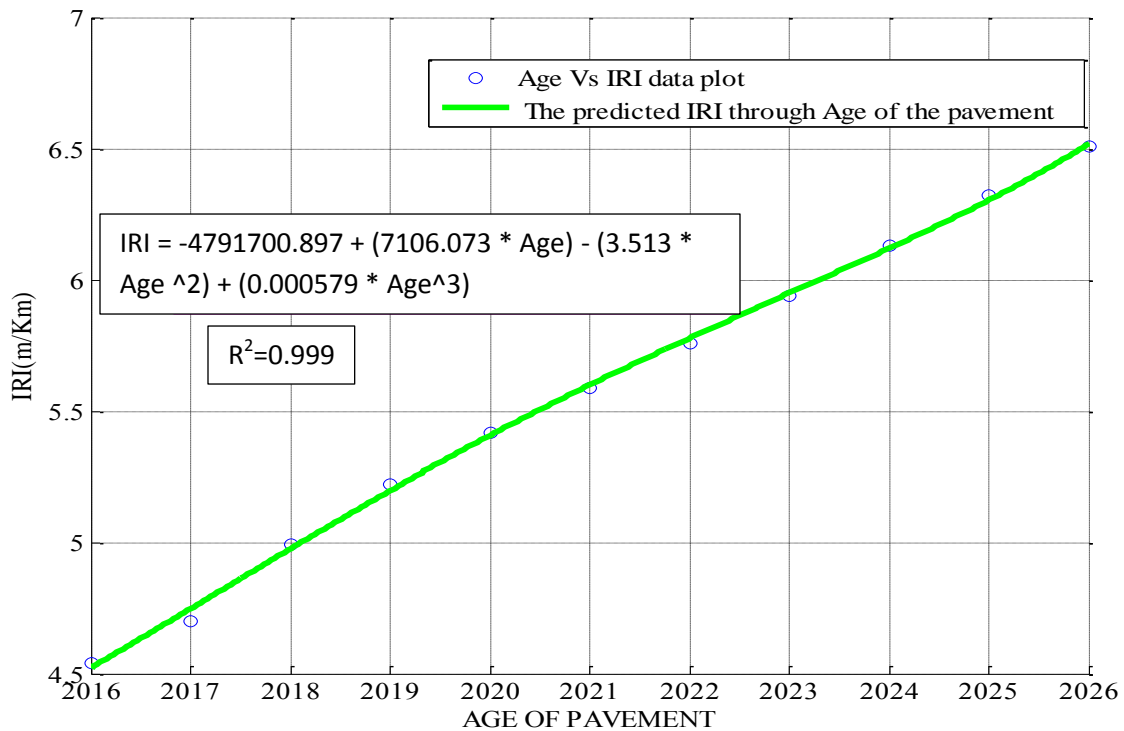
The future IRI condition of the pavement along this road section was represented by the sample of 17Km length of the road. From the output of HDM-4 analysis the estimated condition were international roughness index, axial loading, rutting condition, cracking area, structural numbers, edge break area, texture depth, skid resistance and also the future traffic volume also estimated by using HDM-4 software. But the focused for the first study was international roughness index which was the basic pavement performance indicator. The predicted value of the international roughness index was presented at the appendix-A of this study.

Fig.4.11: Graphical relations of the age of pavement and predicted IRI

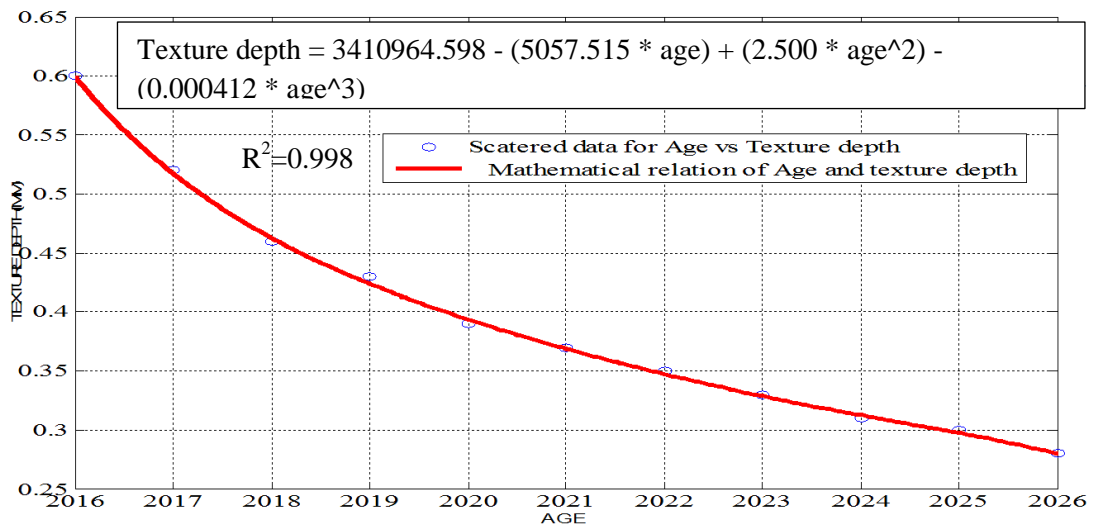
From the result of texture depth, the condition of pavement throughout the remaining design life was became decrease. This shows that the consistency the smoothness of the road surface is more affected by enemy the pavement and its performance is become decrease along the age.

Fig.4.12: Predicted representation of average texture depth

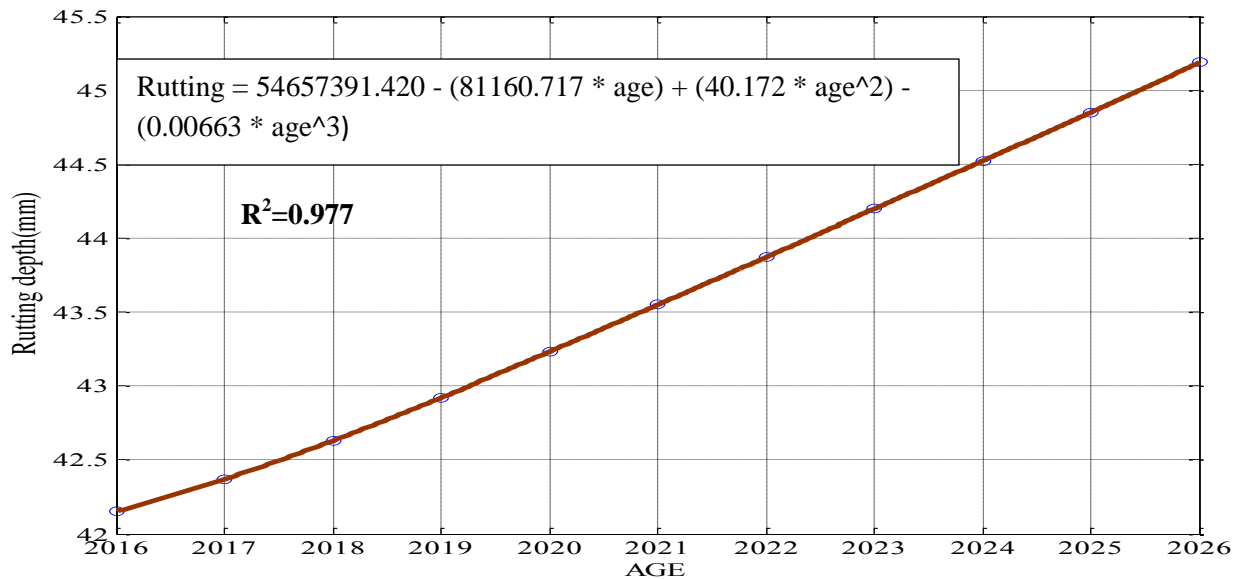
The rutting depth of kombolcha- Harbu road section that predicted over the remaining service life of was also became increase as the age of the pavement increase. But from this study, the rutting depth was predicted and then its condition throughout age was suggested depending on the specification.

Fig.4.13: Predicted rutting depth of kombolcha-Harbu road section
