Assessment on Pavement Performance and Remaining Life cycle Analysis Using Integrated HDM-4  
Software: Case Study within Kombolcha-Harbu Road section

This thesis is submitted to the School of Postgraduate Graduate Studies of Jimma University in a Partial  
Fulfillment of the Requirements for the Degree of Master of Science in Civil Engineering

(Highway Engineering)

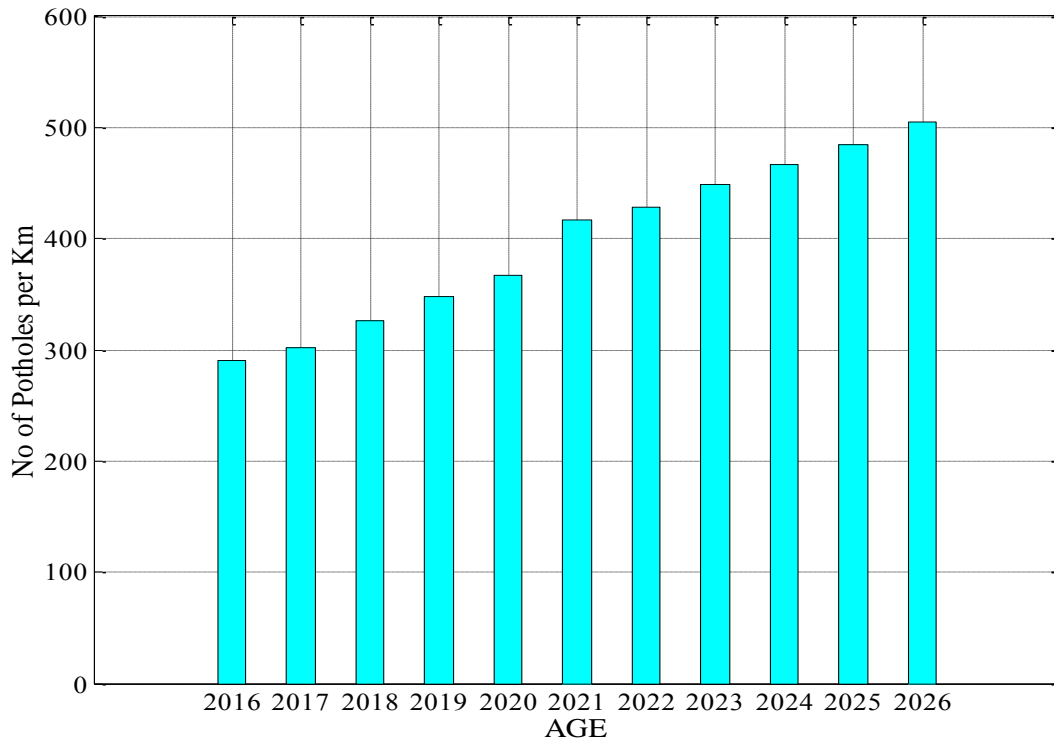
The numbers of potholes along this section of the road will gradually increase. From the result of HDM-4 the numbers potholes were range from 291 to 505 at 2016 and 2026 respectively.

Fig.4.13: The predicted numbers of potholes for kombolcha-Harbu road section

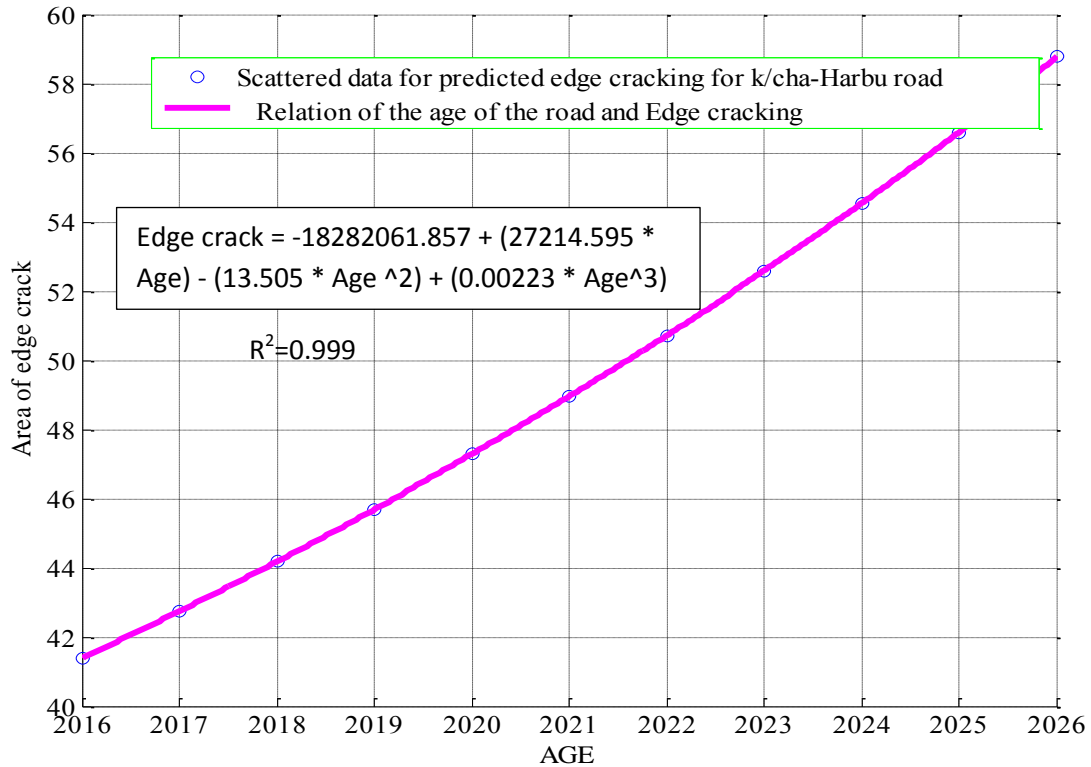
The area of the predicted cracking area was also determined by HDM-4 calibrated software.

Fig.4.14: Area of edge crack along the age of the pavement
