Assessment on the Impacts of Road Geometry and Route Selection on Road
Safety: A case study on Mettu-Gore Road

A Thesis submitted to the School of Graduate Studies of Jimma University
in Partial fulfillment of the requirements for the Degree of Masters of
Science in Highway Engineering.

November, 2016

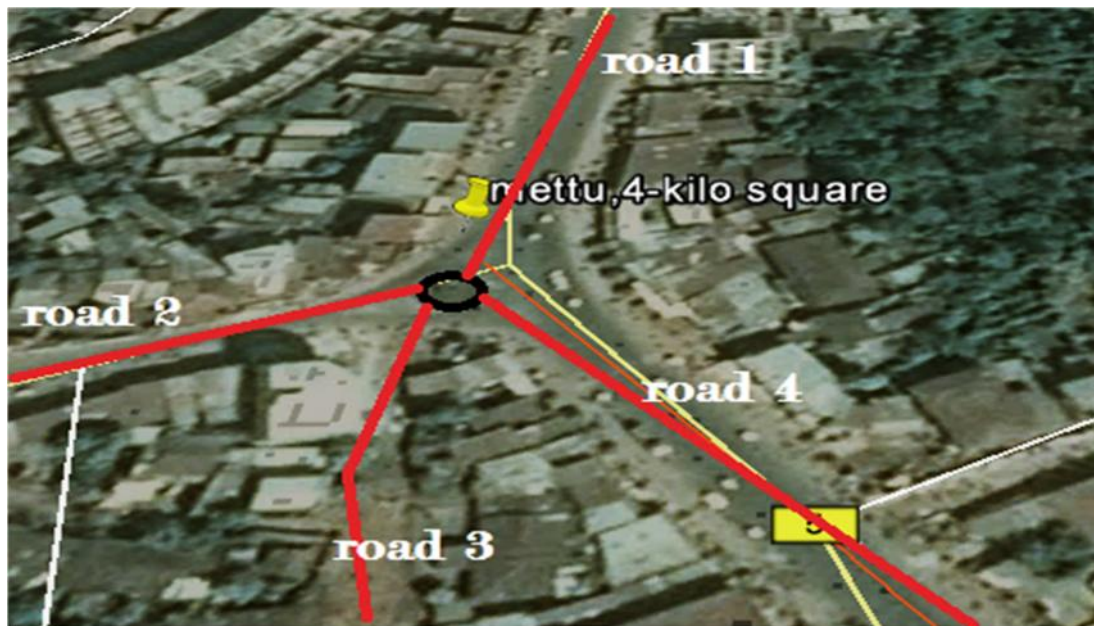
Figure 1.1: Image of Arat-kilo, Mettu (Source: Google Earth)

For instance, a place locally named “Arat-kilo” square is a segment with an observed geometric and route selection problems.

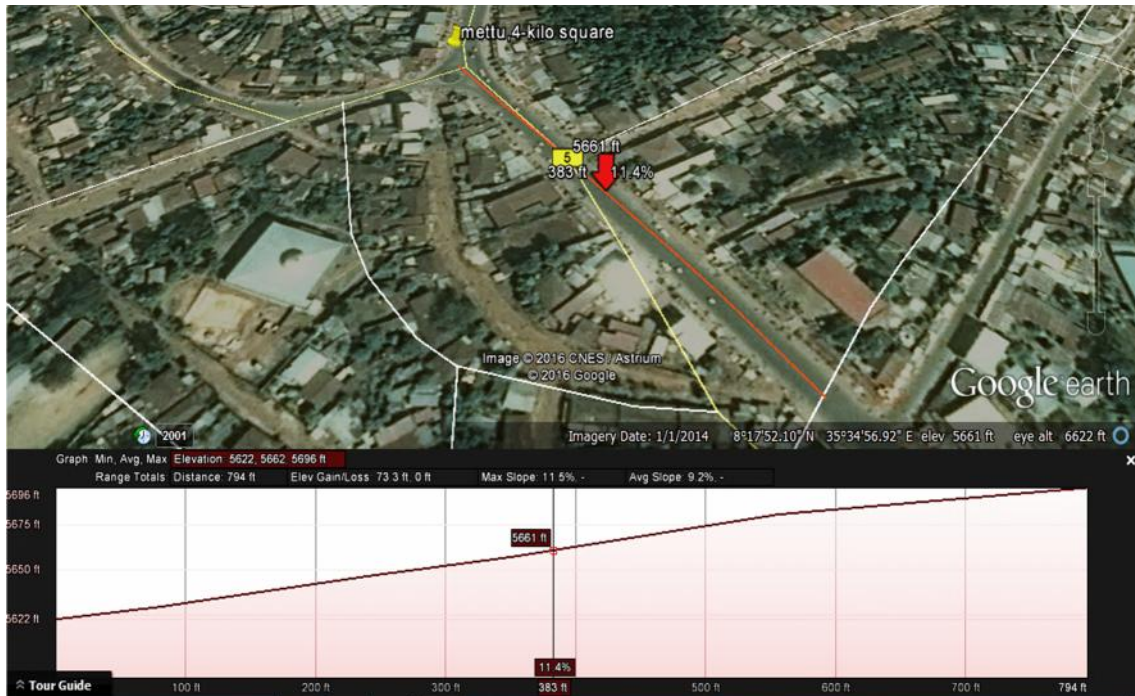
Figure 1.2: Image of the road from Gore joining Arat-kilo square (Source: Google Earth)

Also this place may have been observed with a problem of vertical grade. Road-4 coming from Gore joining “Arat-kilo” square has an average grade of greater than 9% which may cause traffic accidents and road users discomfort near the junction due to high gradient. The figure below shows this road with rough vertical profile from Google earth.

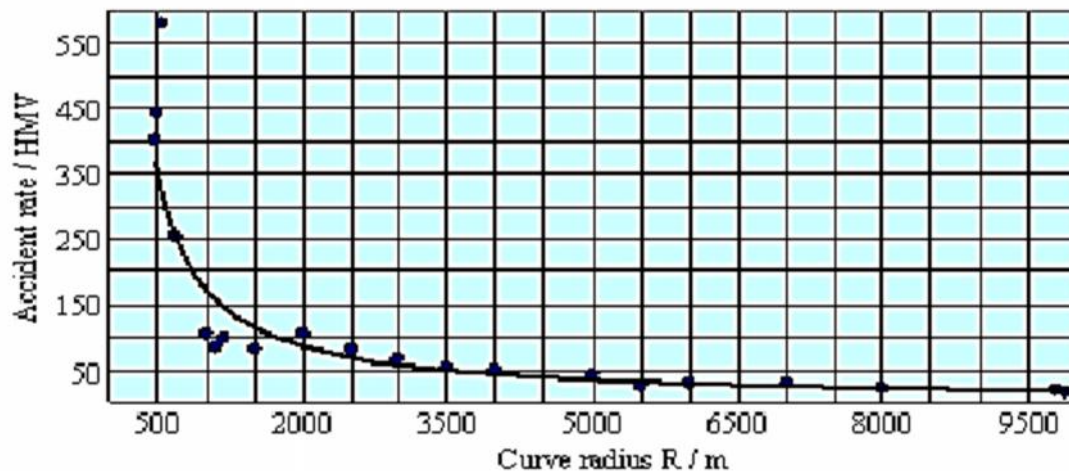
Figure 2.1: Relationship of accident rate and curve radius (Source: Ding jianmei & Pei yulong, 2000 study on Shenda Freeway in China)

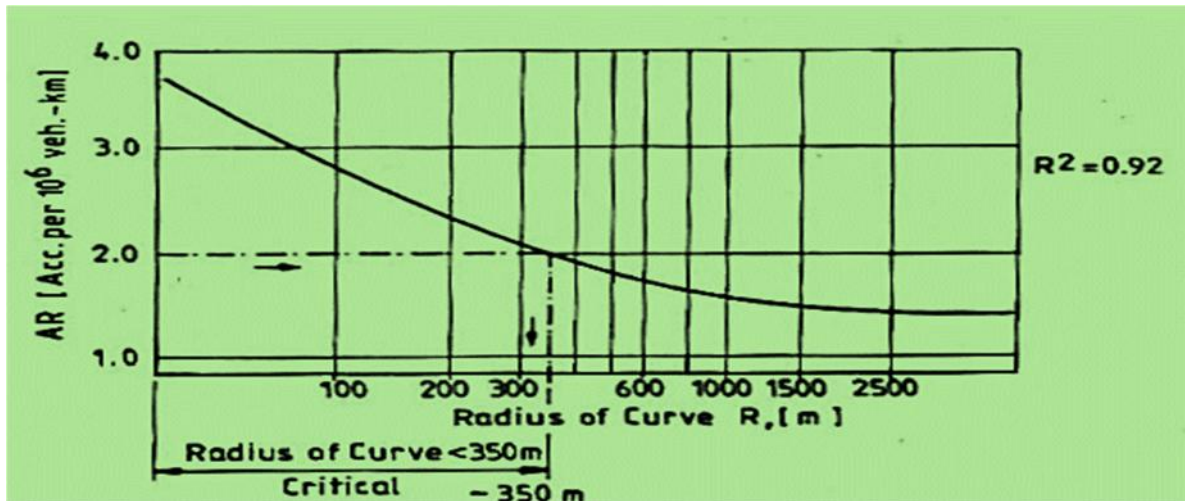
Figure 2.2: Relative accident rate on curvature change rate and radius of curve (Source: Iyynam, A.F., 1997)

with left curve radius of less than 100 m has accident rates that are four times as high as those on section with curve radius greater than 500 m.

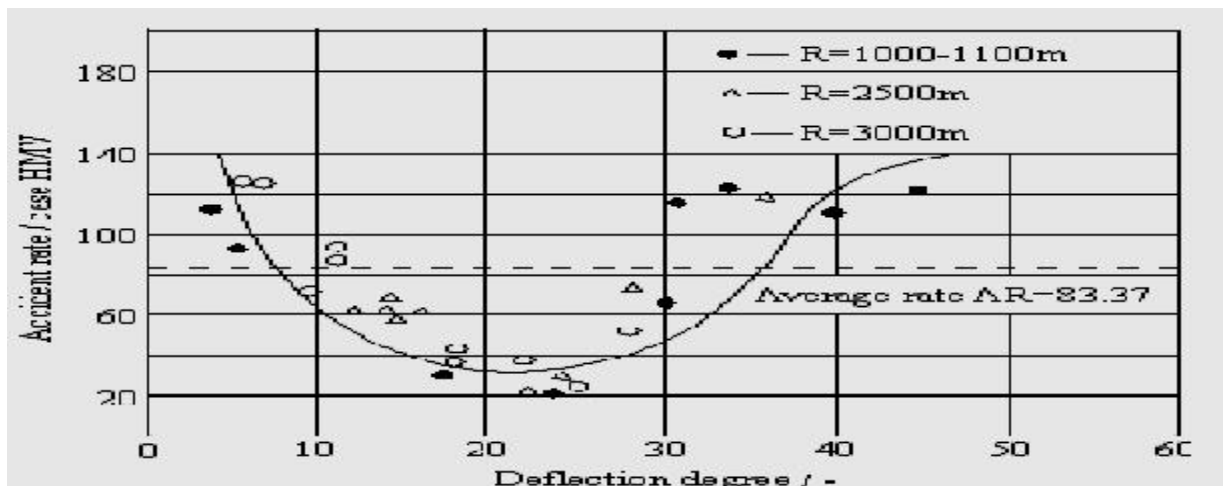
Figure 2.3: Relationships of accident rate and deflection angle (Source: Ding jianmei & Pei yulong, 2000)

According to studies by Ding Jianmei & Pei Yulong of at Shenda, freeway small angle or deflection leads to steep curves to drive and unfavorable to traffic safety. Figure 2.3 shows accident rate vs. deflection degree.

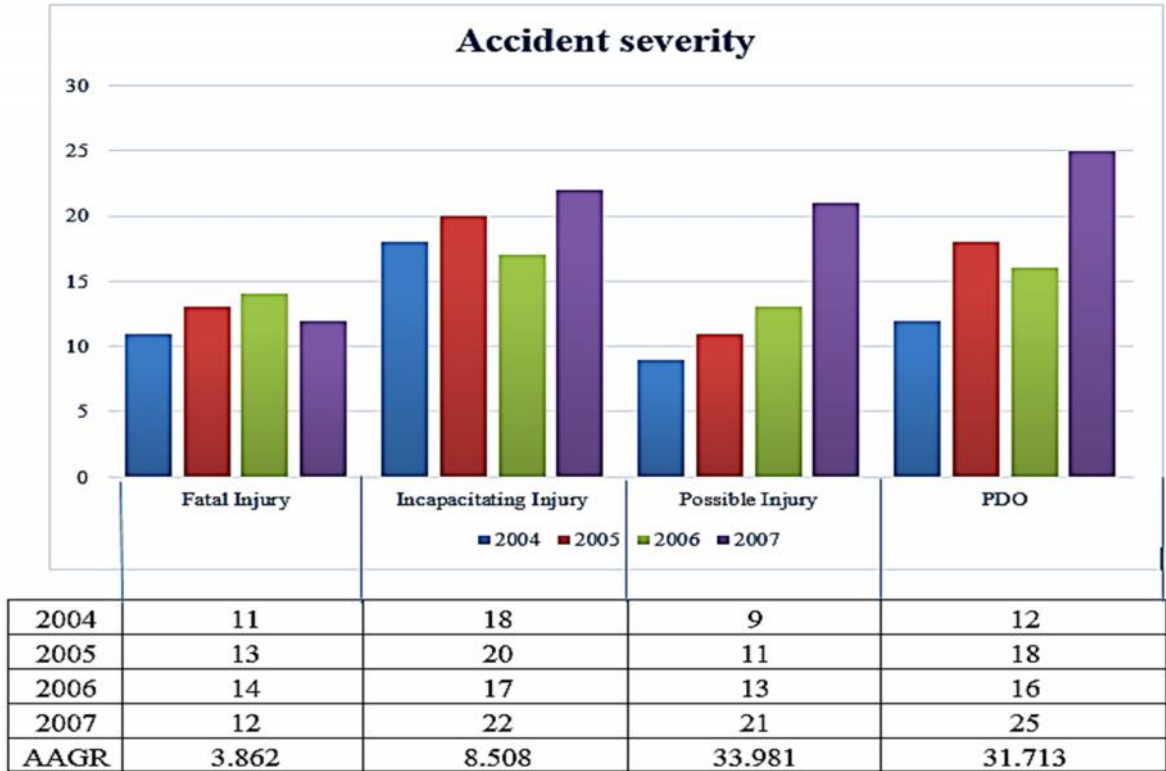
Figure 4.1: Accident severity on Mettu-Gore road

Figure 4.1 below shows the number of accident that occurred on Mettu-Gore road in the period of four (4) years from 2004 to 2007 E.C. with increasing trend from year to year. Slight accidents have decreasing tendency though; possible injury accident rates have tremendous growth. Fatal reports, in turn, show fluctuation and start decreasing in 2007.

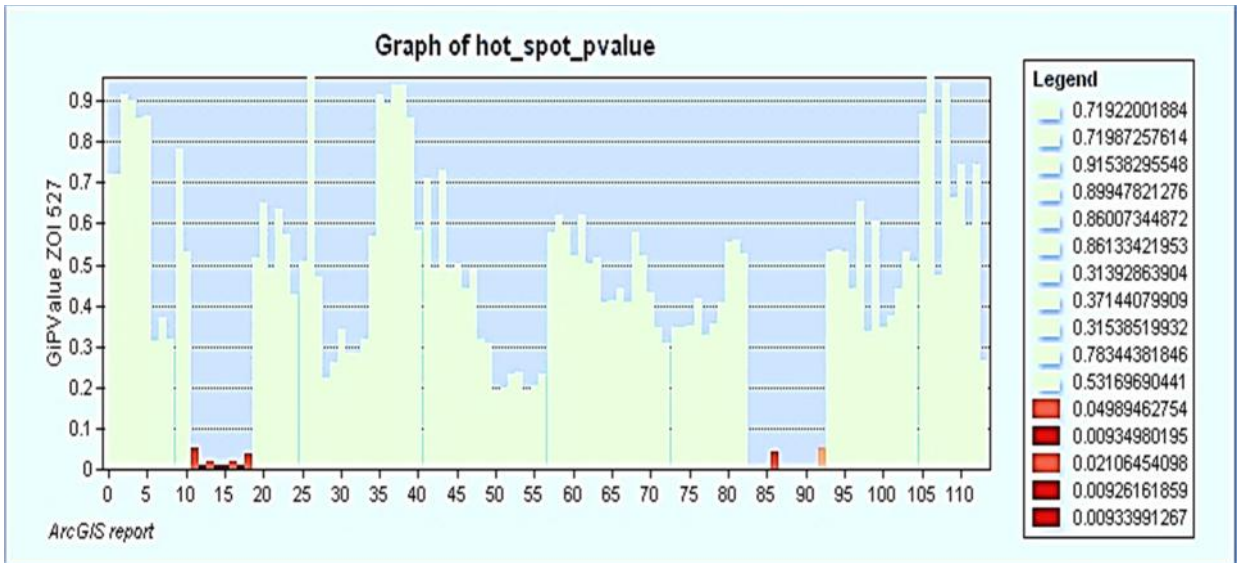
Figure 4.8: P value chart

The results from ArcGIS for Z-score and P-values were conducted and as shown in Appendix A: Table 4.3. In this section the results are shown graphically in Chart form in Figure 4.7 and Figure 4.8 below respectively for Z-score and P-value.

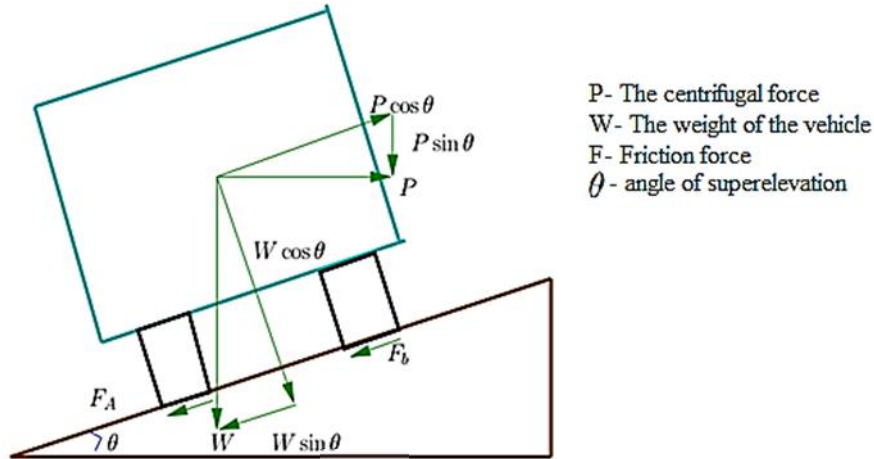
Figure 4.19: Forces acting on horizontal curve of radius R (m) at a speed of V (Km/hr)

$$R = \frac{V^2}{127(e+f)}$$

The presence of horizontal curve imparts centrifugal force which is a reactive force acting outward on a vehicle negotiating it. Centrifugal force depends on speed and radius of the horizontal curve and is counteracted to a certain extent by superelevation and transverse friction between the tyre and pavement surface.

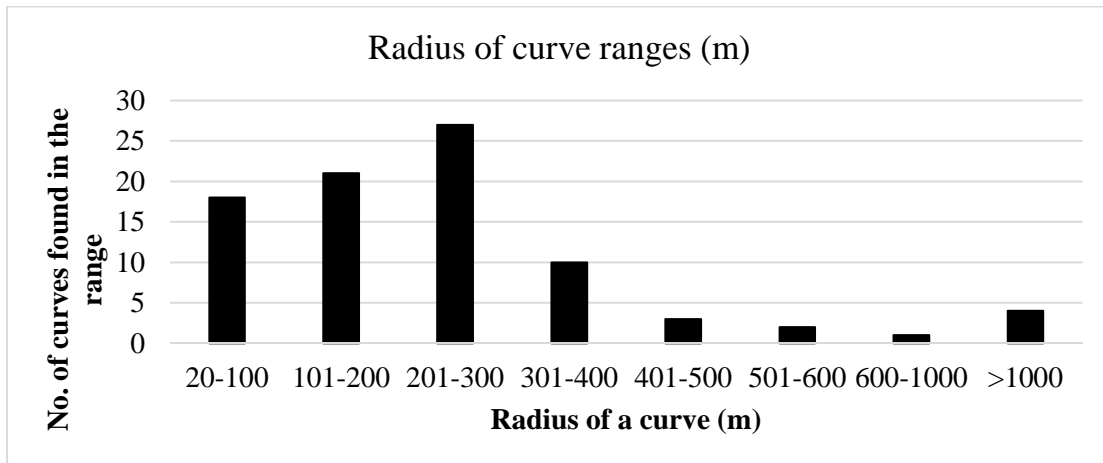
Figure 4.20: Radius value ranges of Mettu-Gore road

All of the final As-built horizontal curve parameters are attached in Appendix A: Table A-2 of this report and in this section the existing curve radius ranges are presented in Figure 4.20 and Figure 4.21 to show the dominated curve radius value.

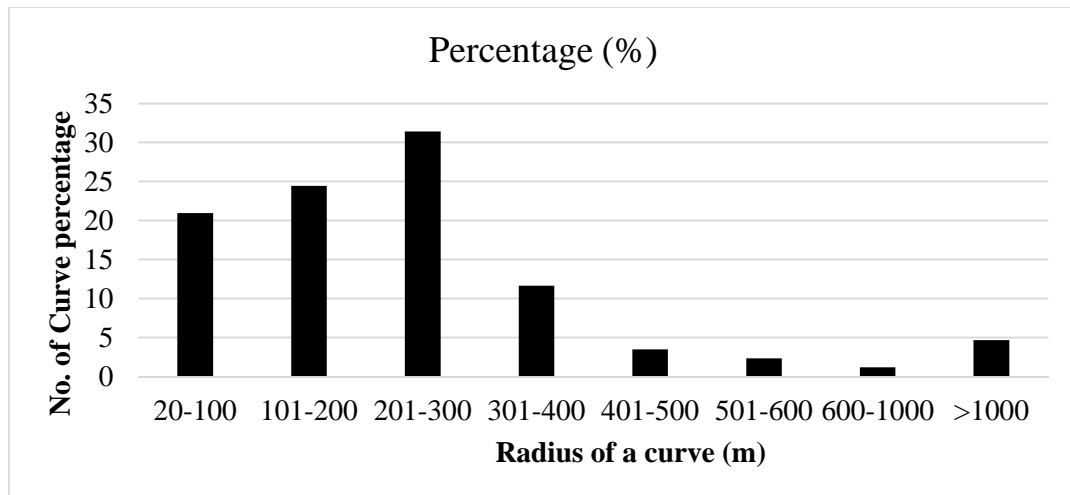
Figure 4.21: Percentage of existing curve range

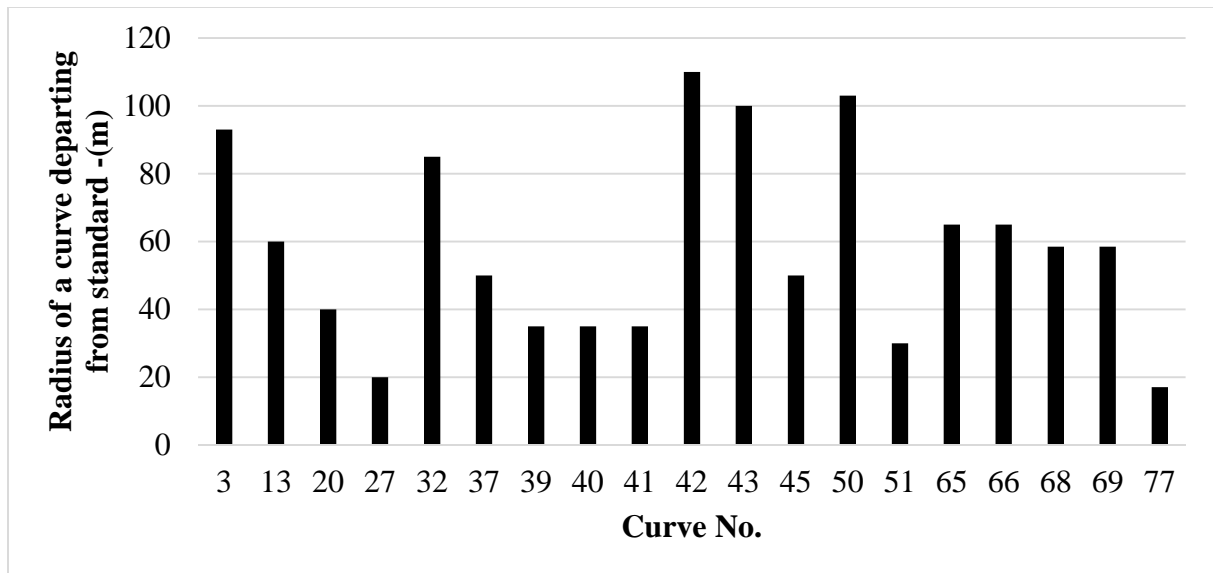
Figure 4.22: Sharp Horizontal curves and their variation from Standard

Curve No.	R min (m)	Result	Variation from Standard (m)
3	175	out-of-S	-93
13	145	out-of-S	-60
20	215	out-of-S	-40
27	120	out-of-S	-20
32	175	out-of-S	-85
37	175	out-of-S	-50
39	120	out-of-S	-35
40	120	out-of-S	-35
41	120	out-of-S	-35
42	175	out-of-S	-110
43	175	out-of-S	-100
45	175	out-of-S	-50
50	175	out-of-S	-103
51	175	out-of-S	-30
65	120	out-of-S	-65
66	120	out-of-S	-65
68	120	out-of-S	-58.5
69	120	out-of-S	-58.5
77	80	out-of-S	-17

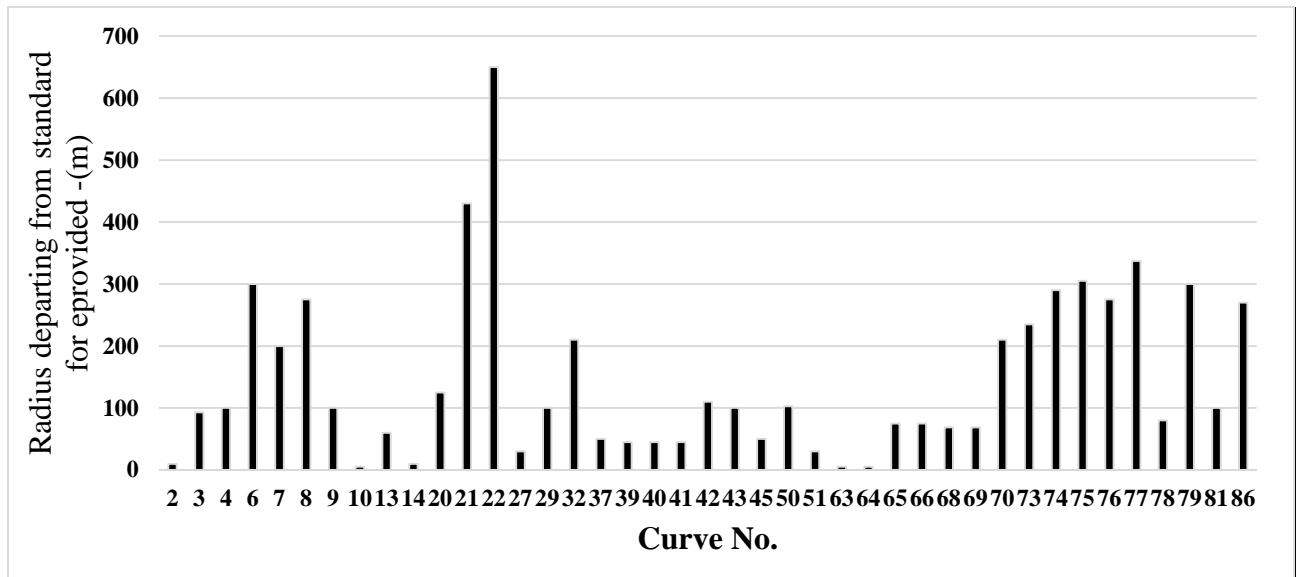
Figure 4.23: Horizontal curves with inadequate Radius and superelevation with their bend values

70	400	out-of-S	-210
73	400	out-of-S	-235
74	400	out-of-S	-290
75	400	out-of-S	-305
76	400	out-of-S	-275
77	400	out-of-S	-337
78	400	out-of-S	-80
79	400	out-of-S	-300
81	400	out-of-S	-100
86	400	out-of-S	-270

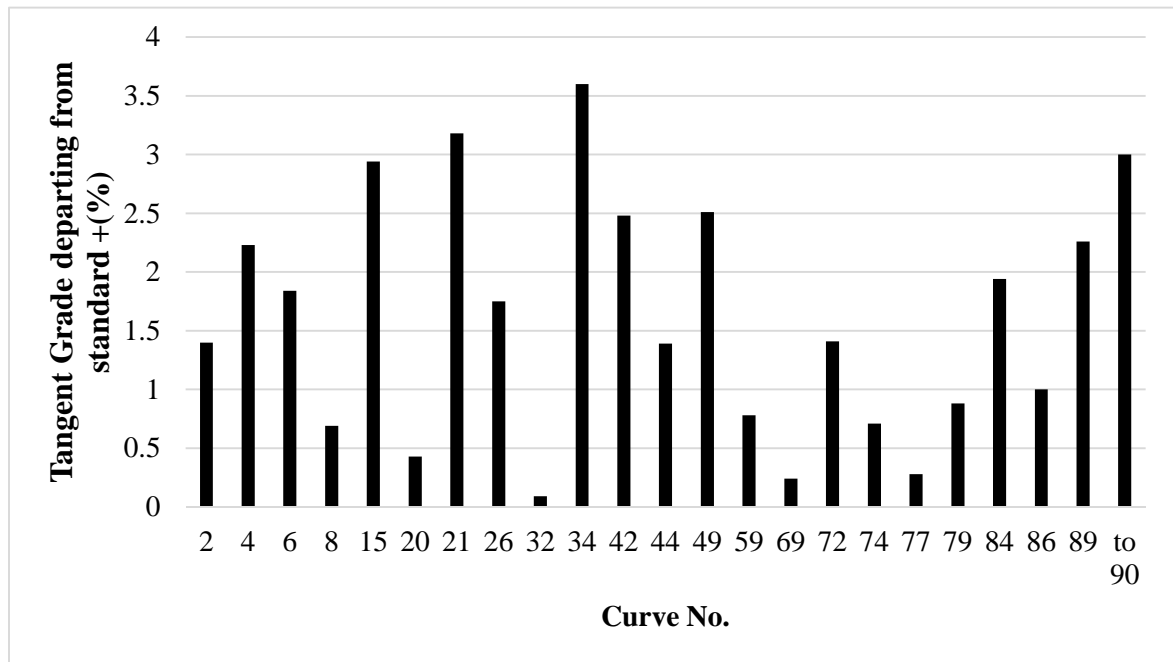
Figure 4.28: High gradient vertical tangents and departure values

Curve No.	Maximum standard value (%)	Variation (%)	Result
2	6	1.4	out-of-S
4	7	1.23	out-of-S
6	7	1.84	out-of-S
8	7	0.69	out-of-S
15	7	2.94	out-of-S
20	7	0.43	out-of-S
21	6	3.18	out-of-S
26	6	1.75	out-of-S
32	8	0.09	out-of-S
34	6	3.6	out-of-S
42	6	2.48	out-of-S
44	6	1.39	out-of-S
49	6	2.51	out-of-S
59	6	0.78	out-of-S
69	8	0.24	out-of-S
72	8	1.41	out-of-S
74	8	0.71	out-of-S
77	8	0.28	out-of-S
79	8	0.88	out-of-S
84	8	1.94	out-of-S
86	8	1	out-of-S
89	7	2.26	out-of-S
G2 of 89	7	3	out-of-S

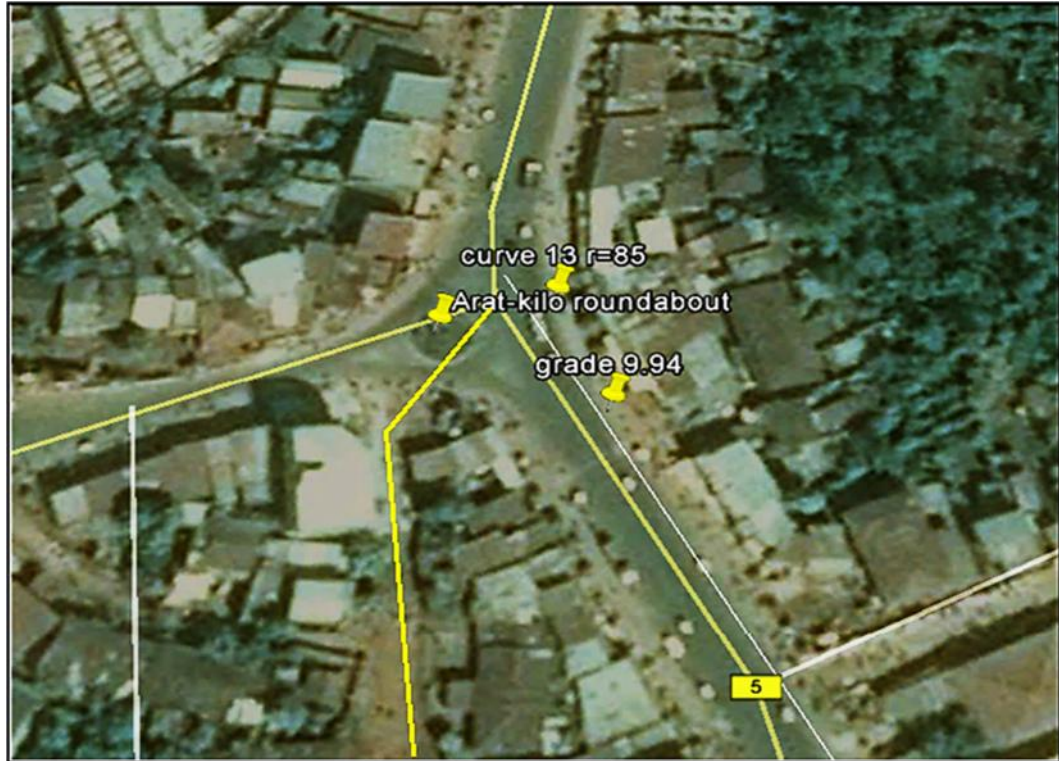
Figure 4.33: Image of “Arat-kilo” square showing a Roundabout with no Rotary
(Source: Google Earth)

- The fourth problem identified were, In “Arat-kilo” square a small Roundabout is found but a roundabout with no rotary while roundabout was must have to be rotated counter clock wise, which doesn’t fulfill one of the basic roundabout design principle. The weaving width and lengths of this roundabout is very small so as to turn track-trailers. And unfamiliar or new drivers in this area getting in trouble of rotating the roundabout since there is no any sign of showing that the roundabout is not for a rotary. The satellite image of the square is shown in Figure 4.33 below.

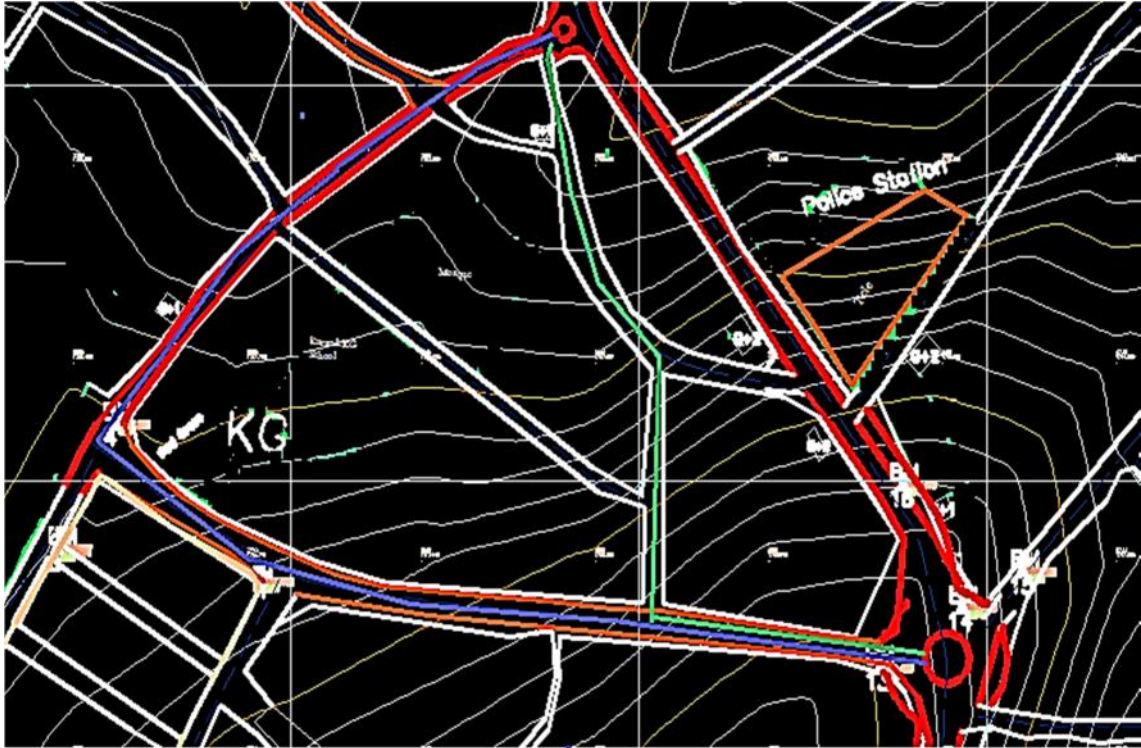
Figure 4.34: Safe Alternative routes at “Arat-kilo” square (Source: Structural plan map of Mettu town)

Mettu Structural Plan Map shows that there are an existing flatter minor roads which starts at “Arat-kilo” square and joins a roundabout named “Mettu square” which is found on Mettu-Gore road. Thus, this alternatives road were been decided to be the first and prime most alternative solutions for future upgrading. It were found that there are two possible alternative routes which are possibly ensure road safety on this area. Figure 4.34 below shows the structural plan map of Mettu town with the drawn alternative routes.

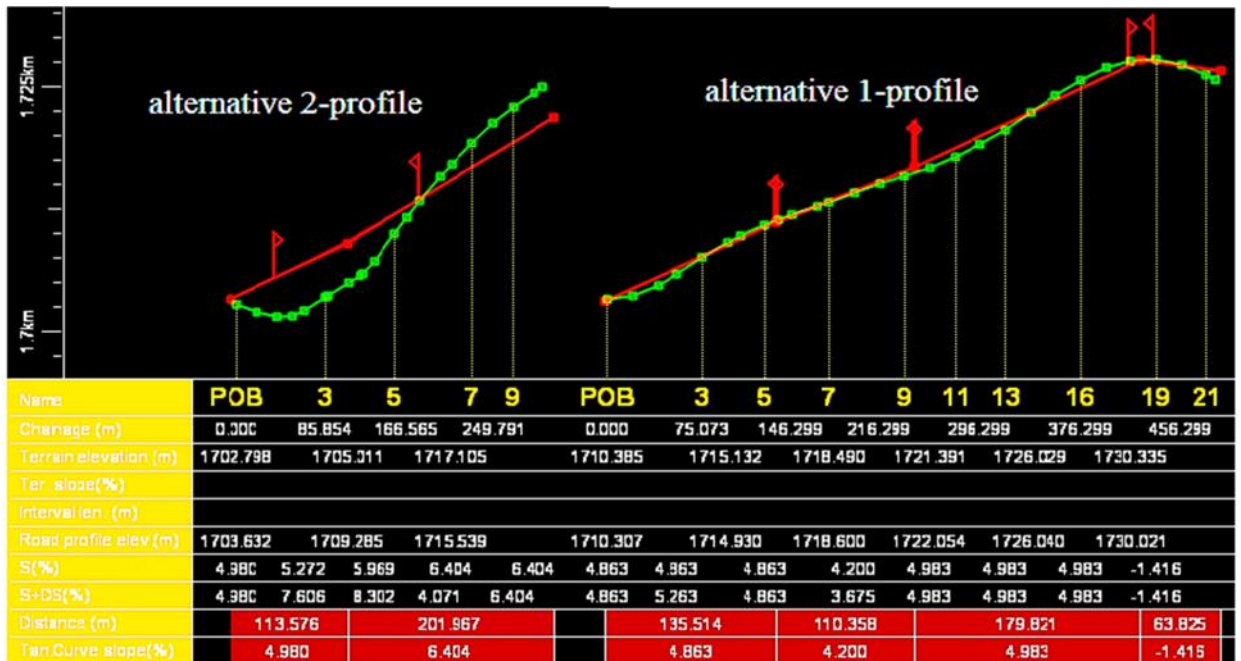
Profile drawing

Figure 4.36: Profile drawings of safe alternative roads at “Arat-kilo” square

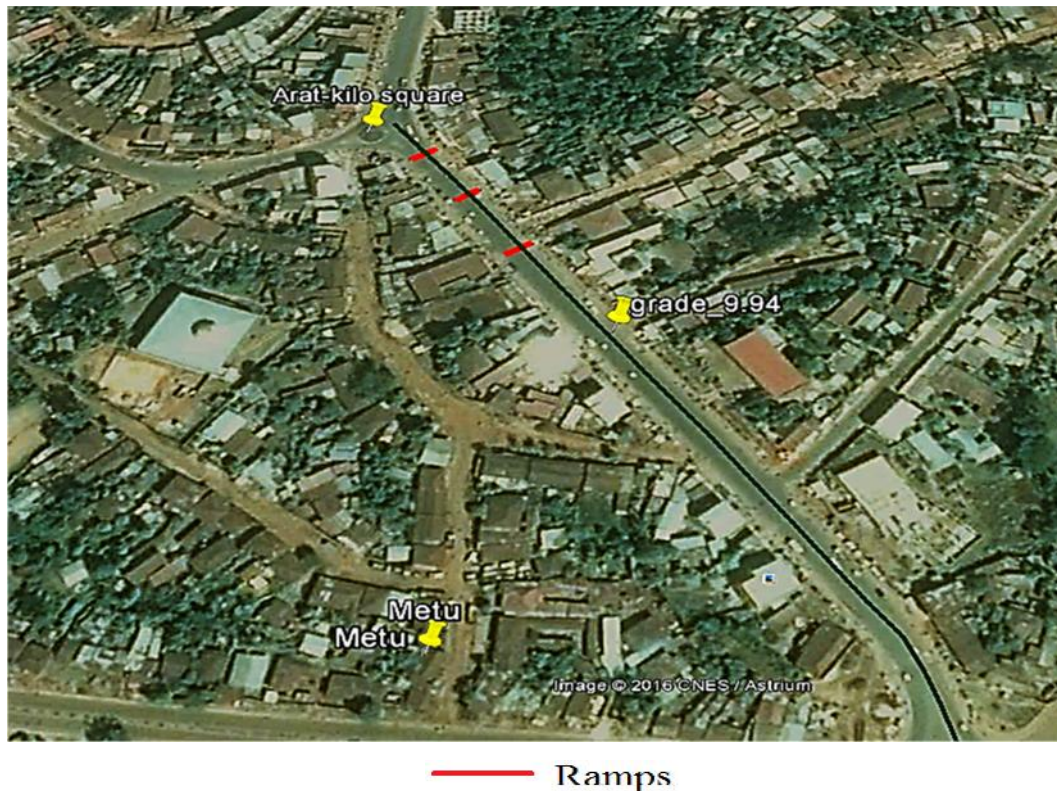
Figure 4.37: Ramp Provision proposal at “Arat-kilo” square

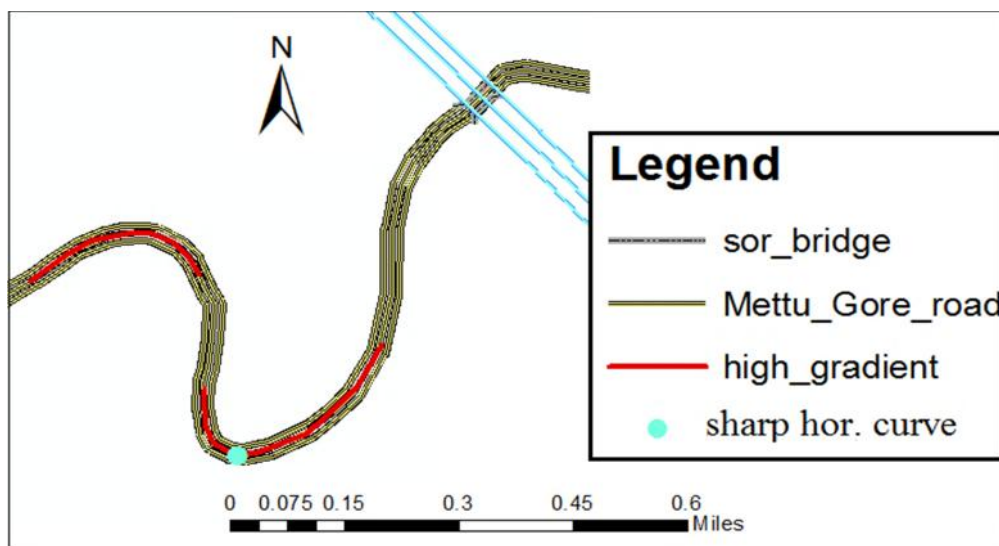
Figure 4.40: Map of the road around “Sor-bridge” with defective Geometry
