**CAUSES OF PAVEMENT EARLY DETERIORATION AND ITS
REMEDIAL MEASURES: CASE STUDY IN AGARO – DEDESA
ROAD**

**A final thesis submitted to the School of Graduate Studies of Jimma
University in Partial fulfillment of the requirements for the Degree of
Master of Science in Civil Engineering (Geotechnical Engineering)**

This study has been conducted in Agaro-Dedesa Road segment which is located in western Oromiya regional state to identify causes of pavement early failure and to recommend remedial measures.

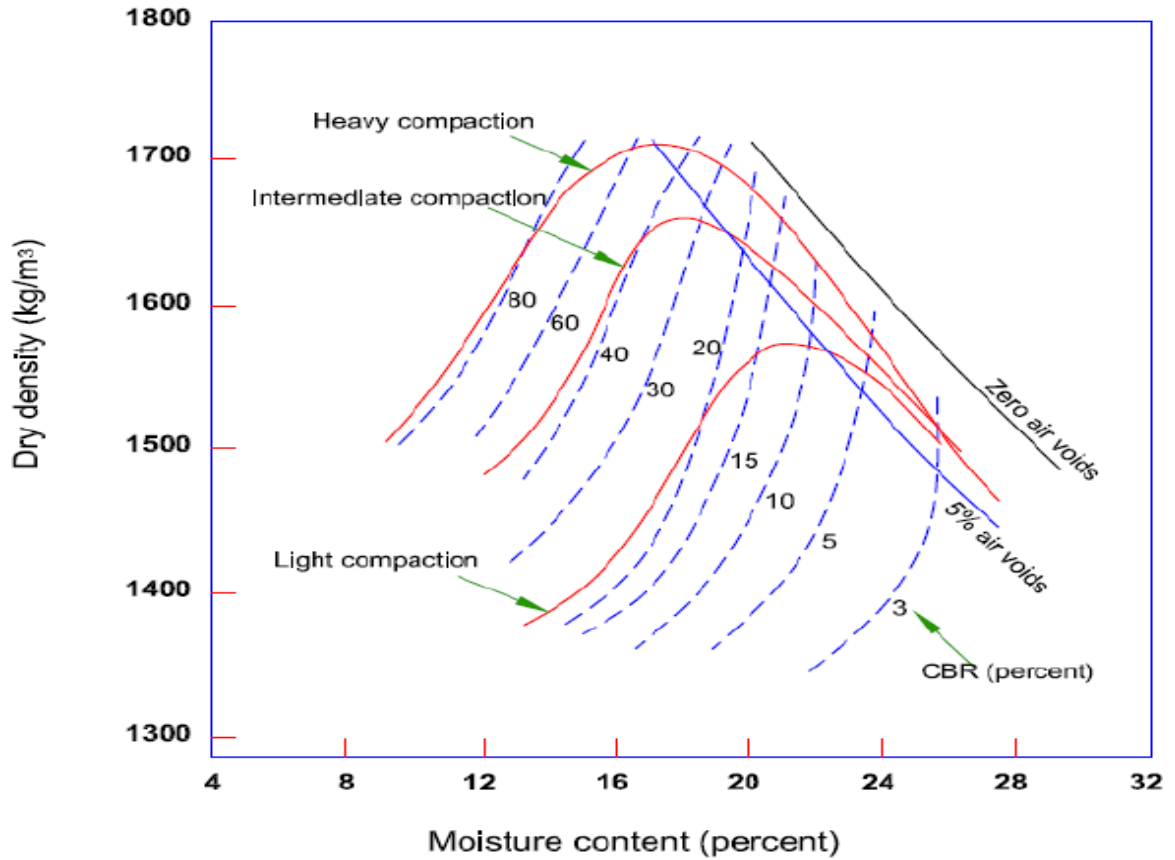
Figure 2. 3: Dry Density, Moisture Content-CBR Relationships for Sandy-Clay soil (ERA, 2013)

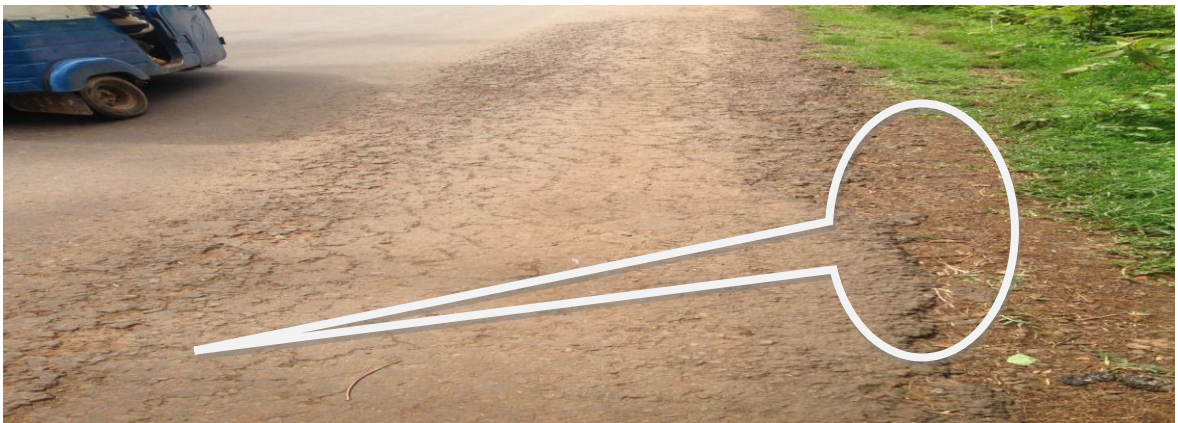
Figure 4 1: Alligator Crack at the edge

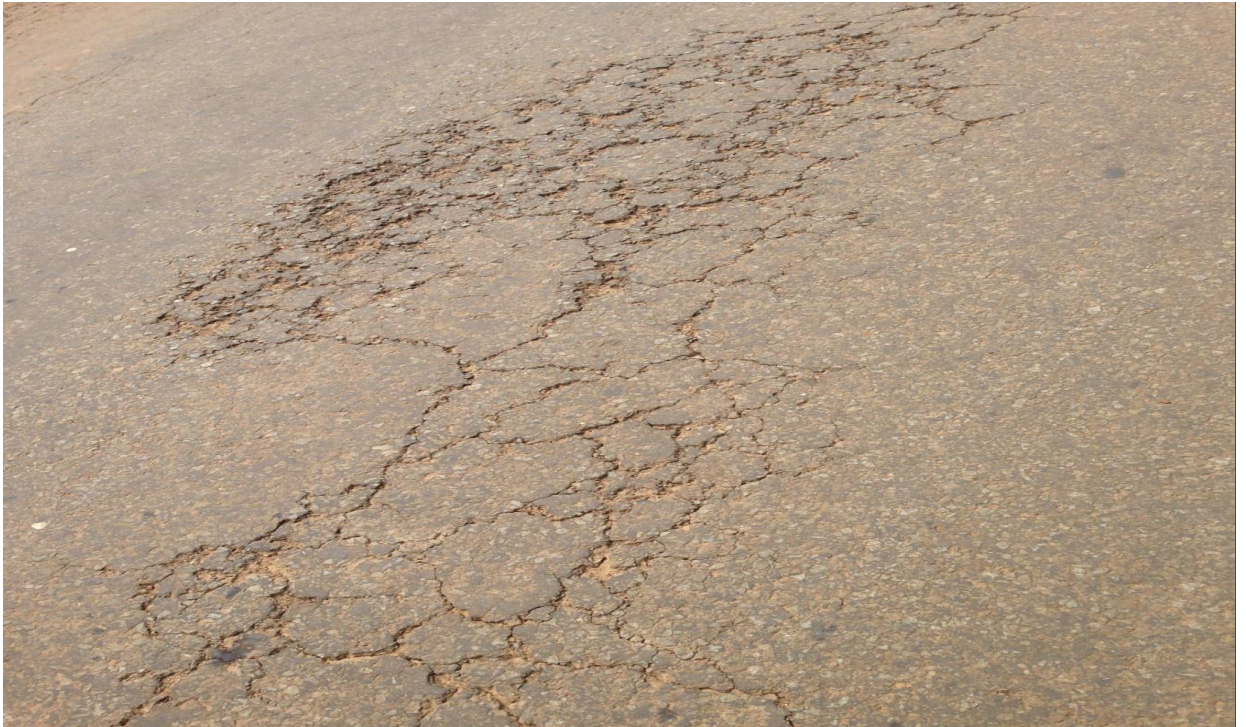
Figure 4 2: Alligator Crack at the center

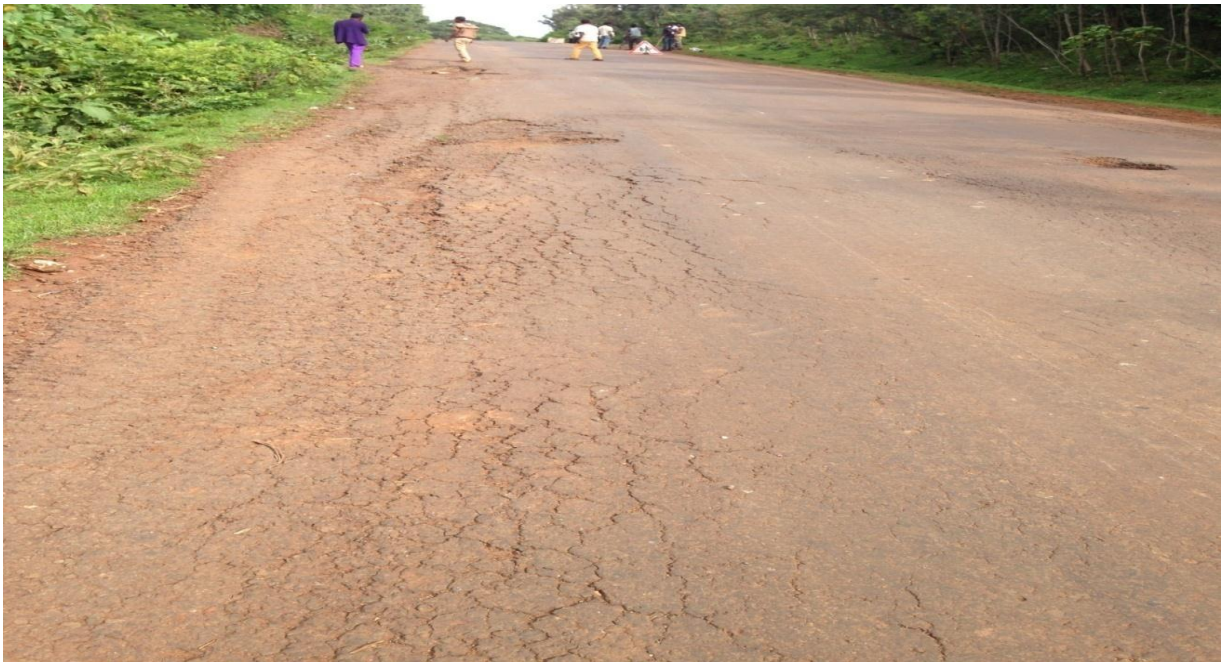
Figure 4 3: Crack, Potholes, vegetation cover at side walk and shoulder

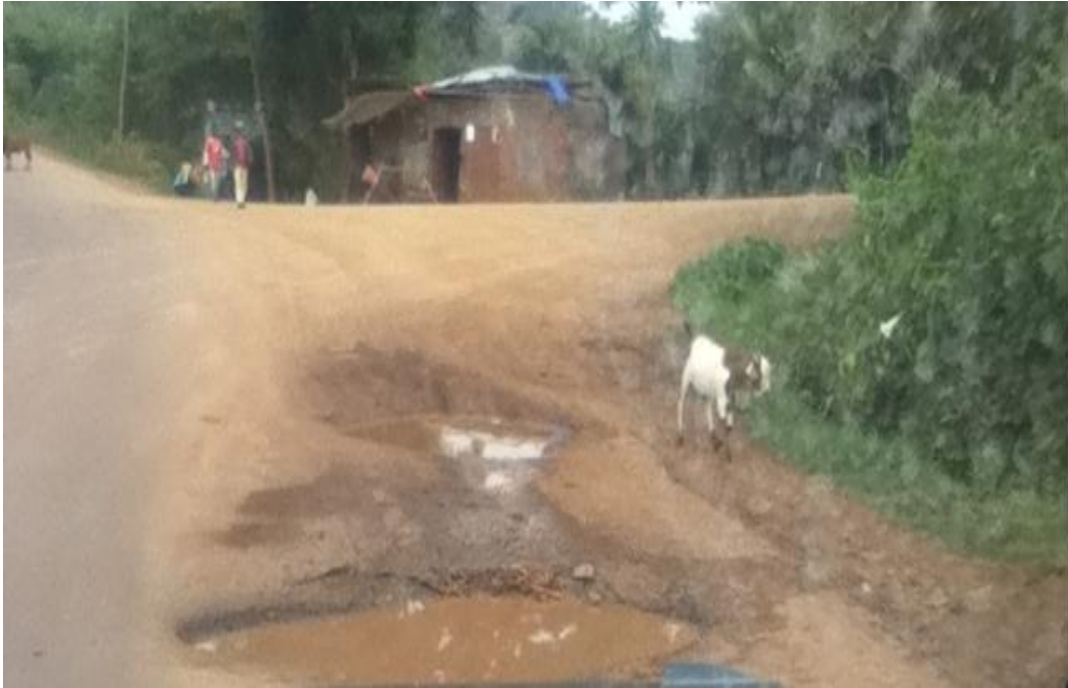
Figure 4 4: Potholes at the edge of the road

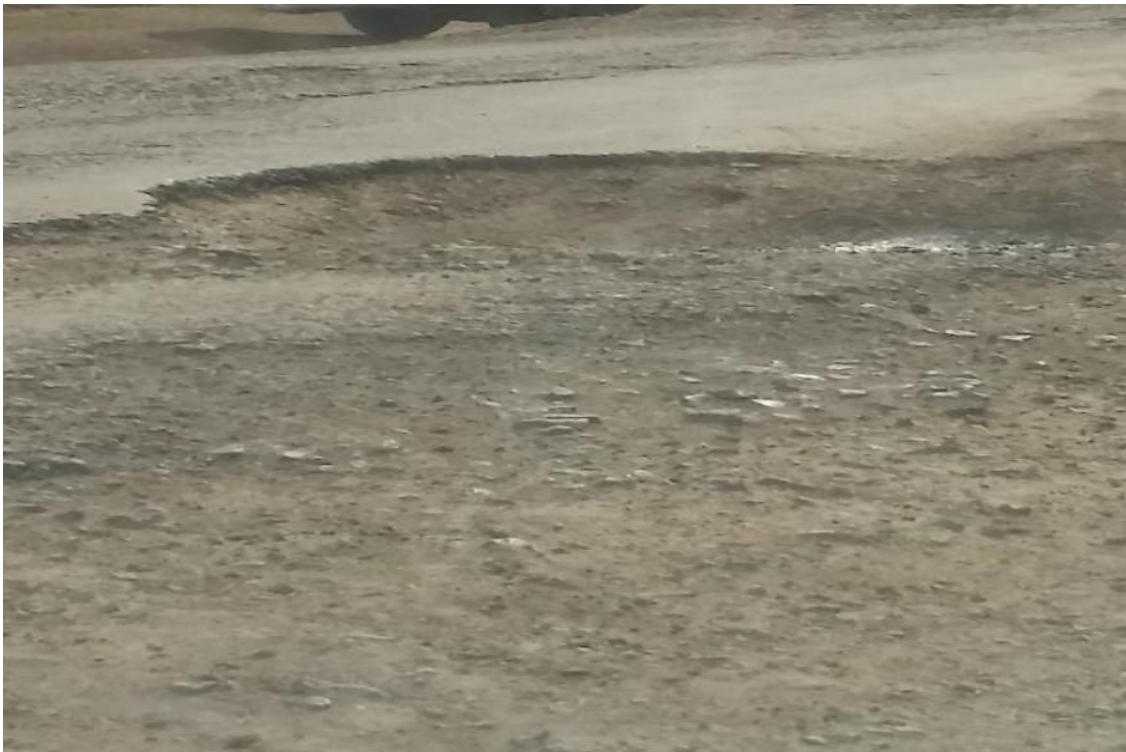
Figure 4 5: Exposed base material of road at station 44+200

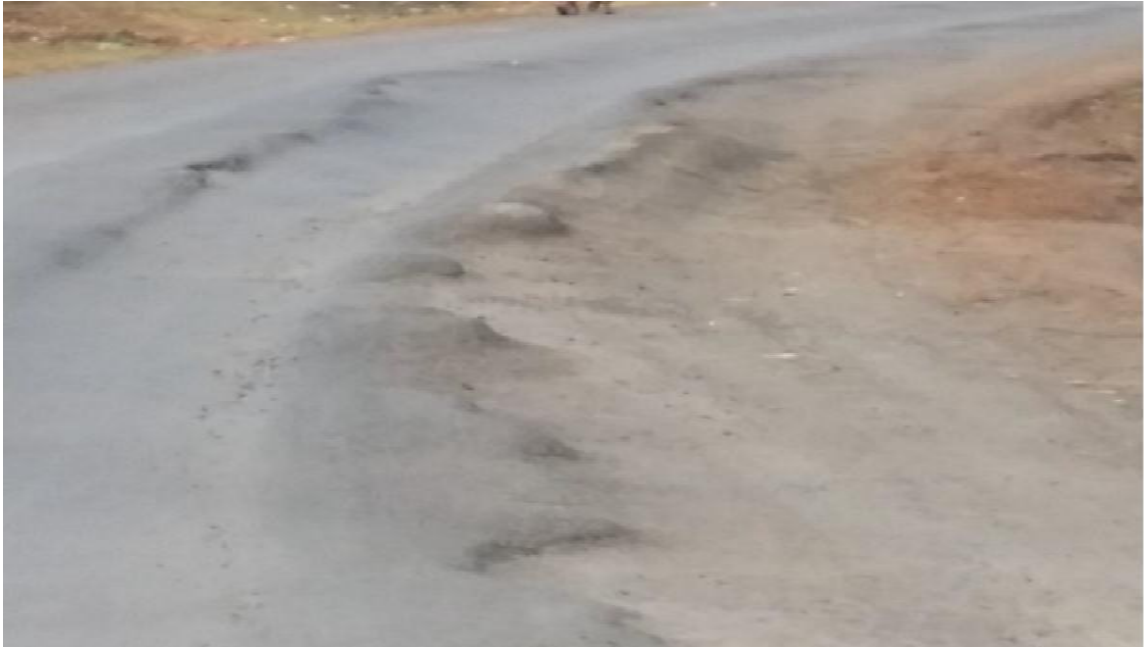
Figure 4. 6: longitudinal deformations, settlements and Rutting in asphalt pavements at 65+000.

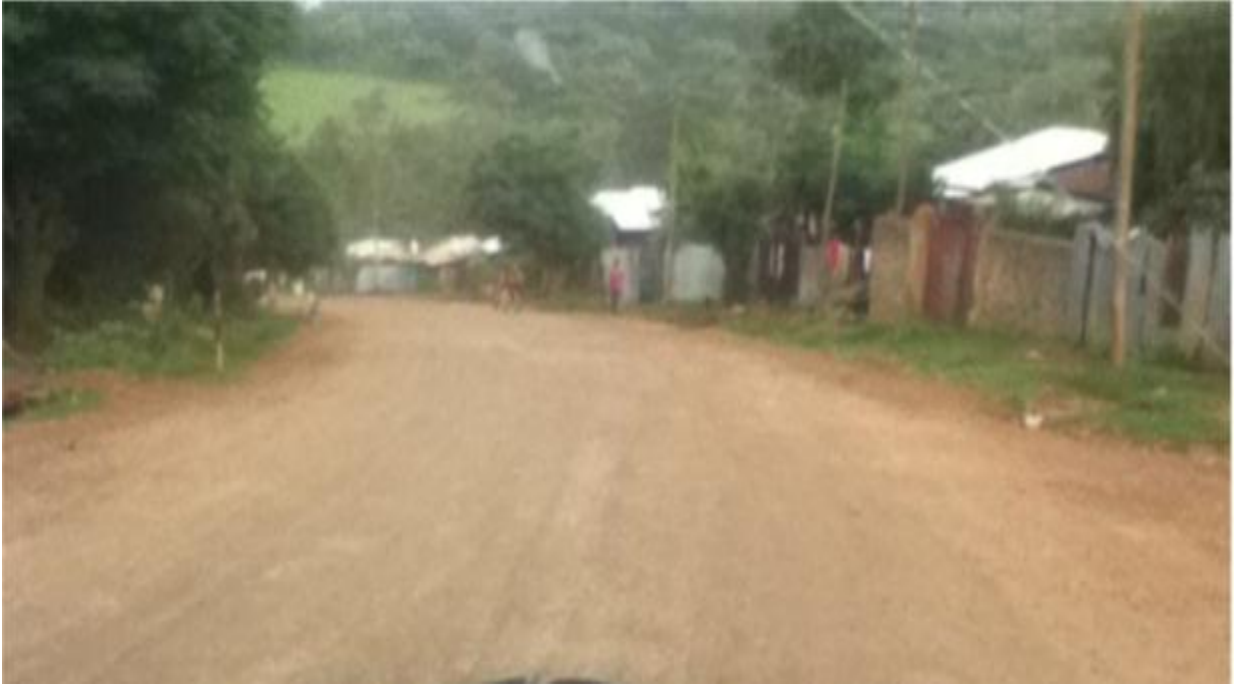
Disintegration of road at station 65+300

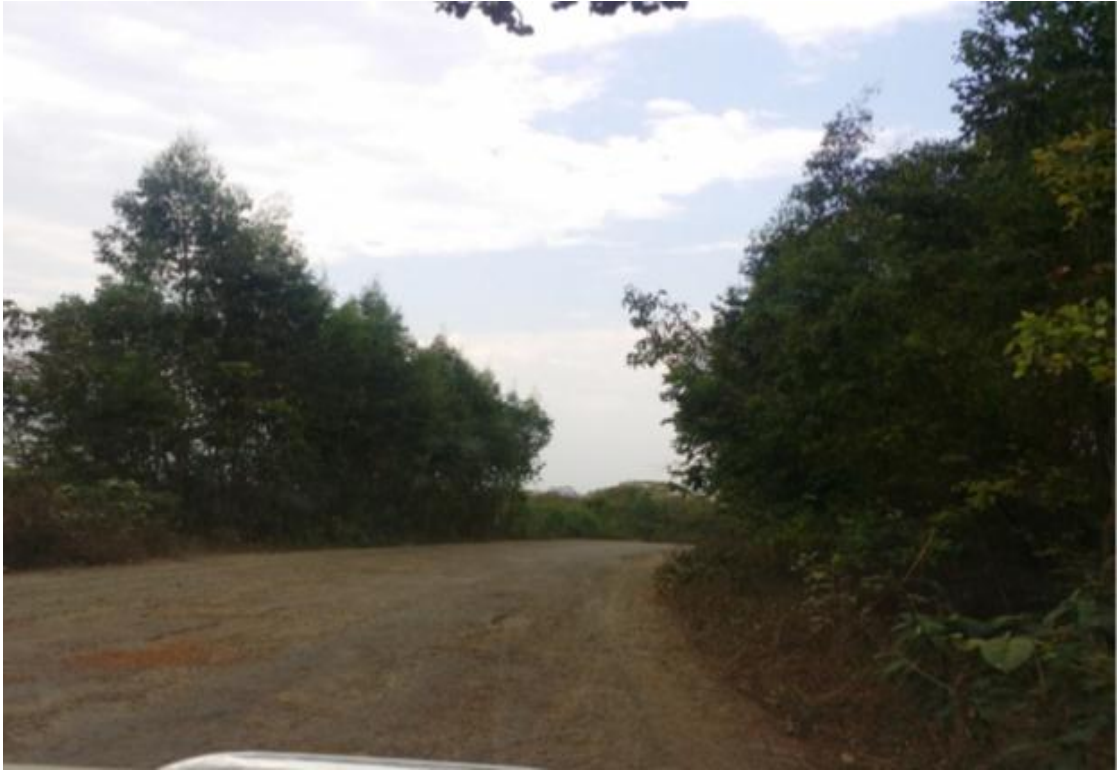
Disintegration, Raveling, loss of pavement material along the pavement at station 65+000

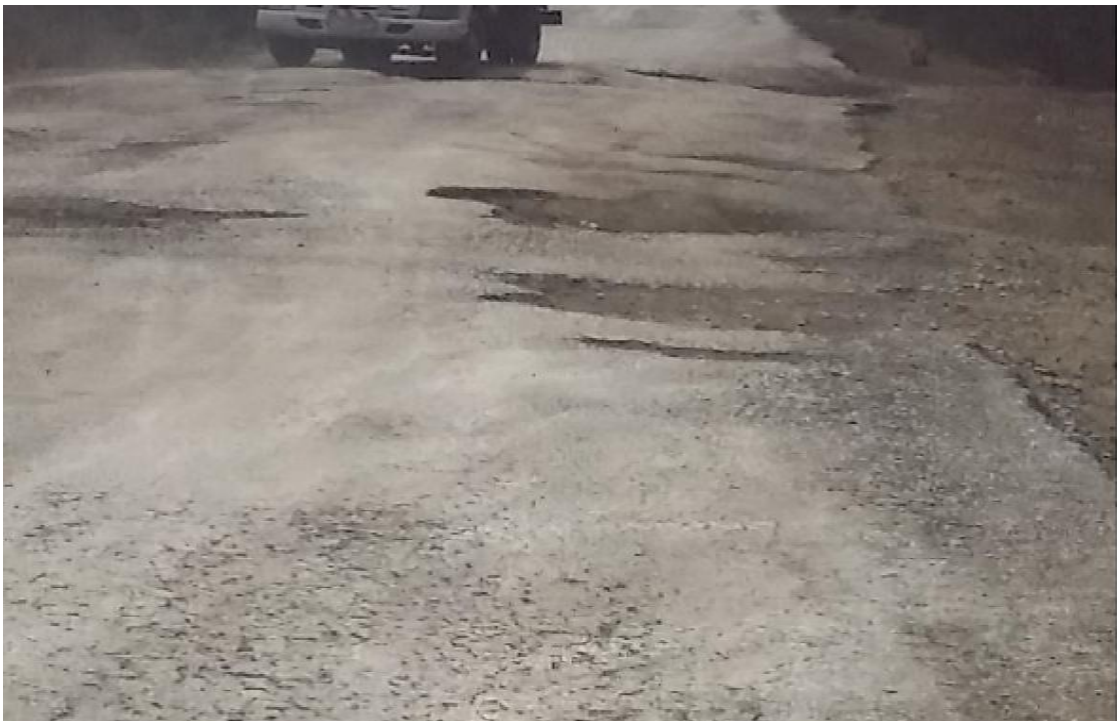
Crack, Potholes and loss of pavement material along the pavement at 43+600.

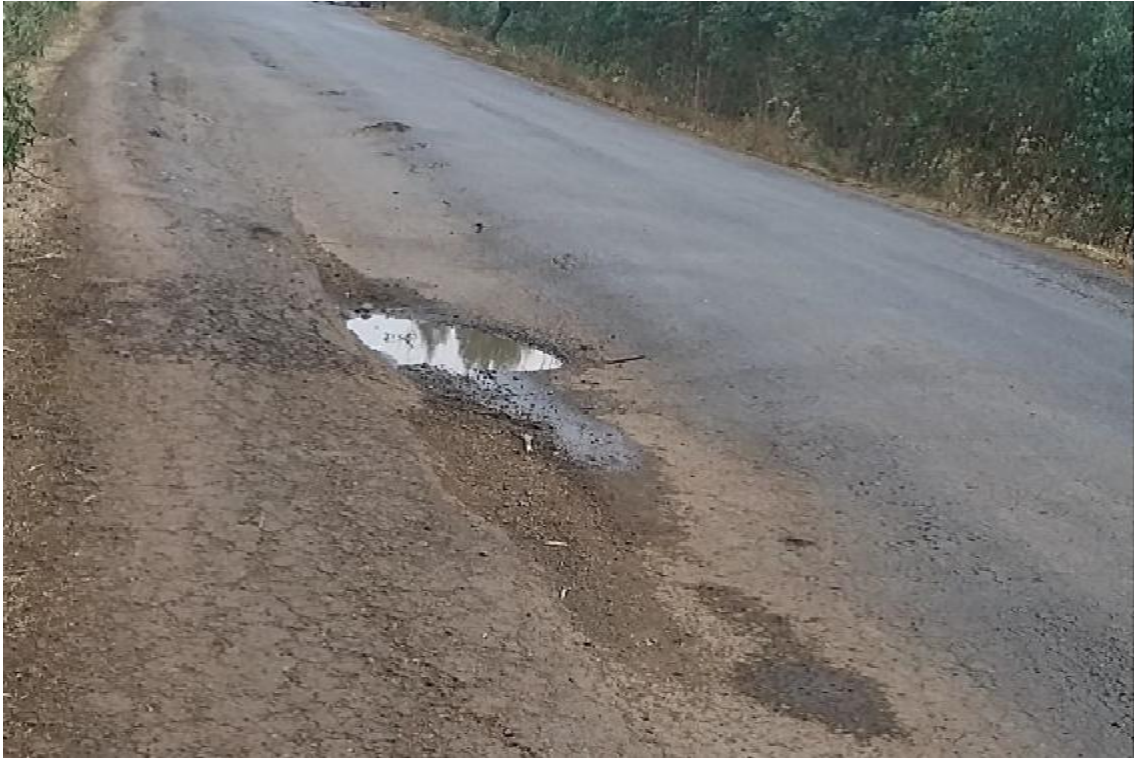
Potholes, settlement and cracks at 62+900

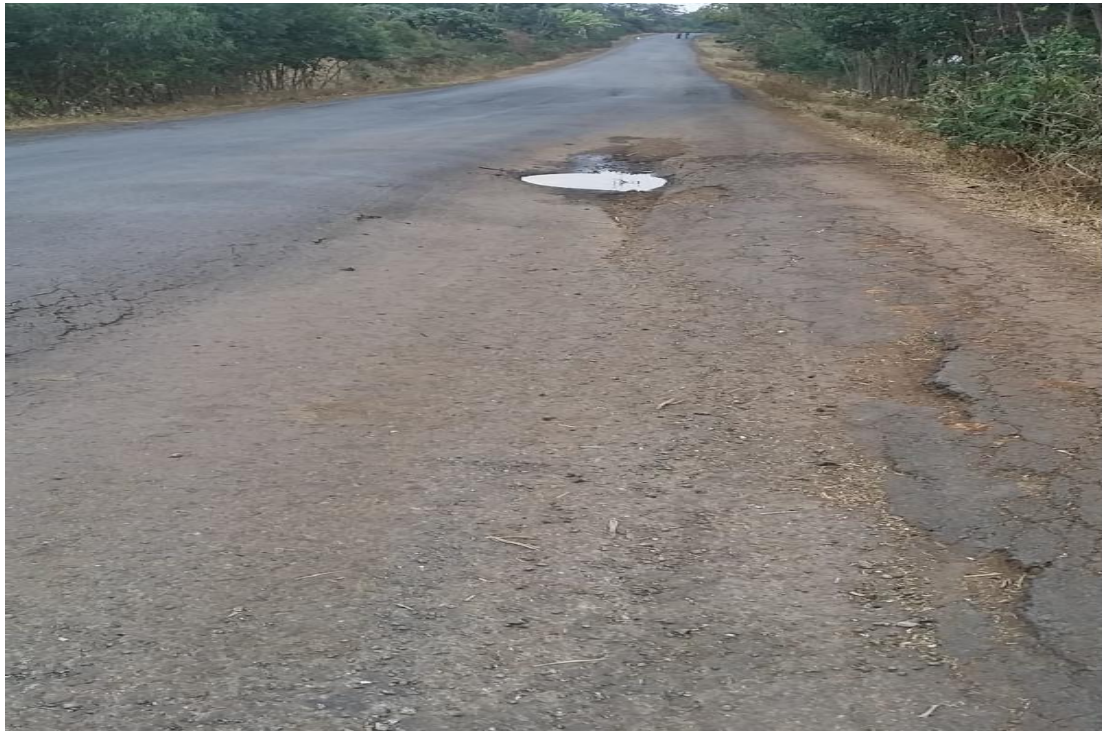
Pothole cracks and Sag in asphalt at 62+300

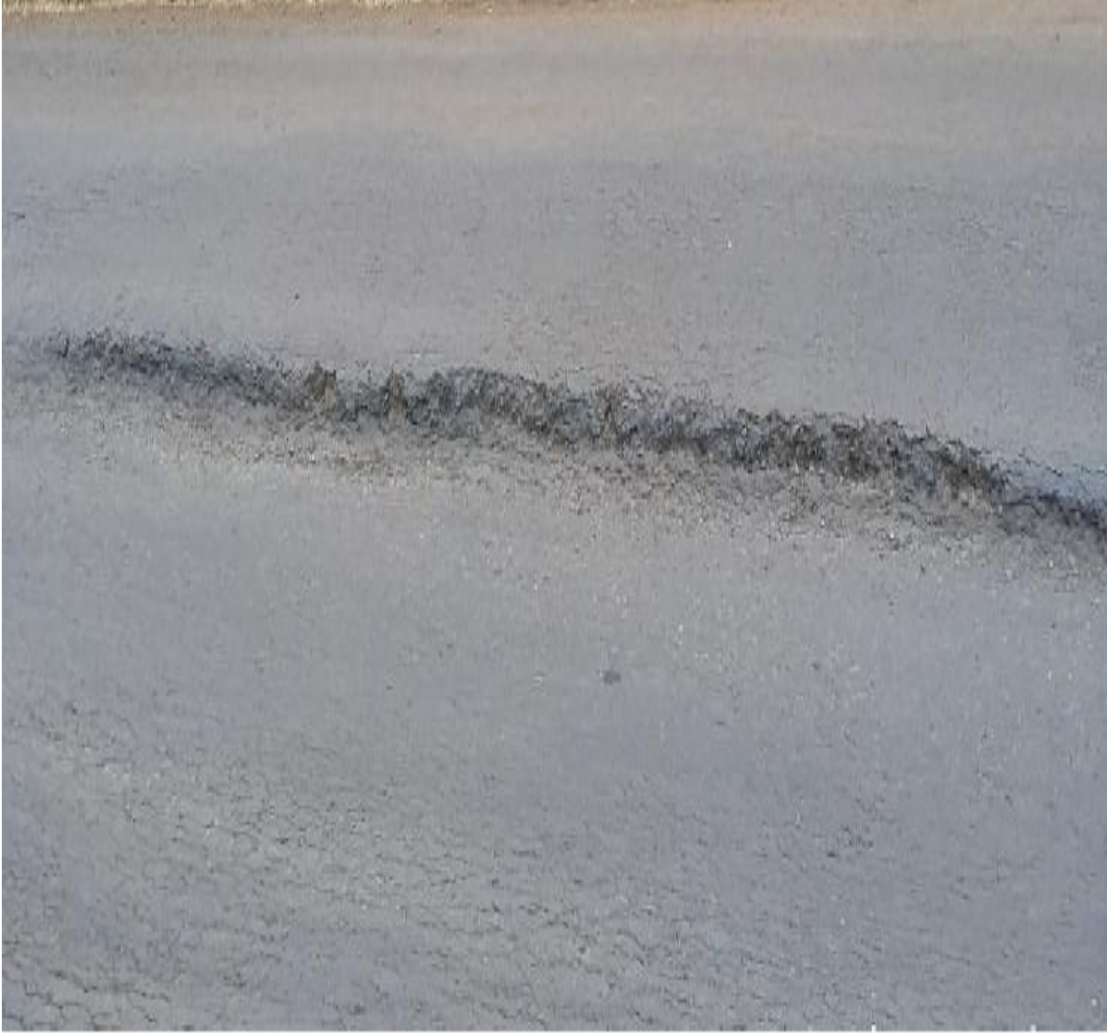
Cracks and settlement at 62+600

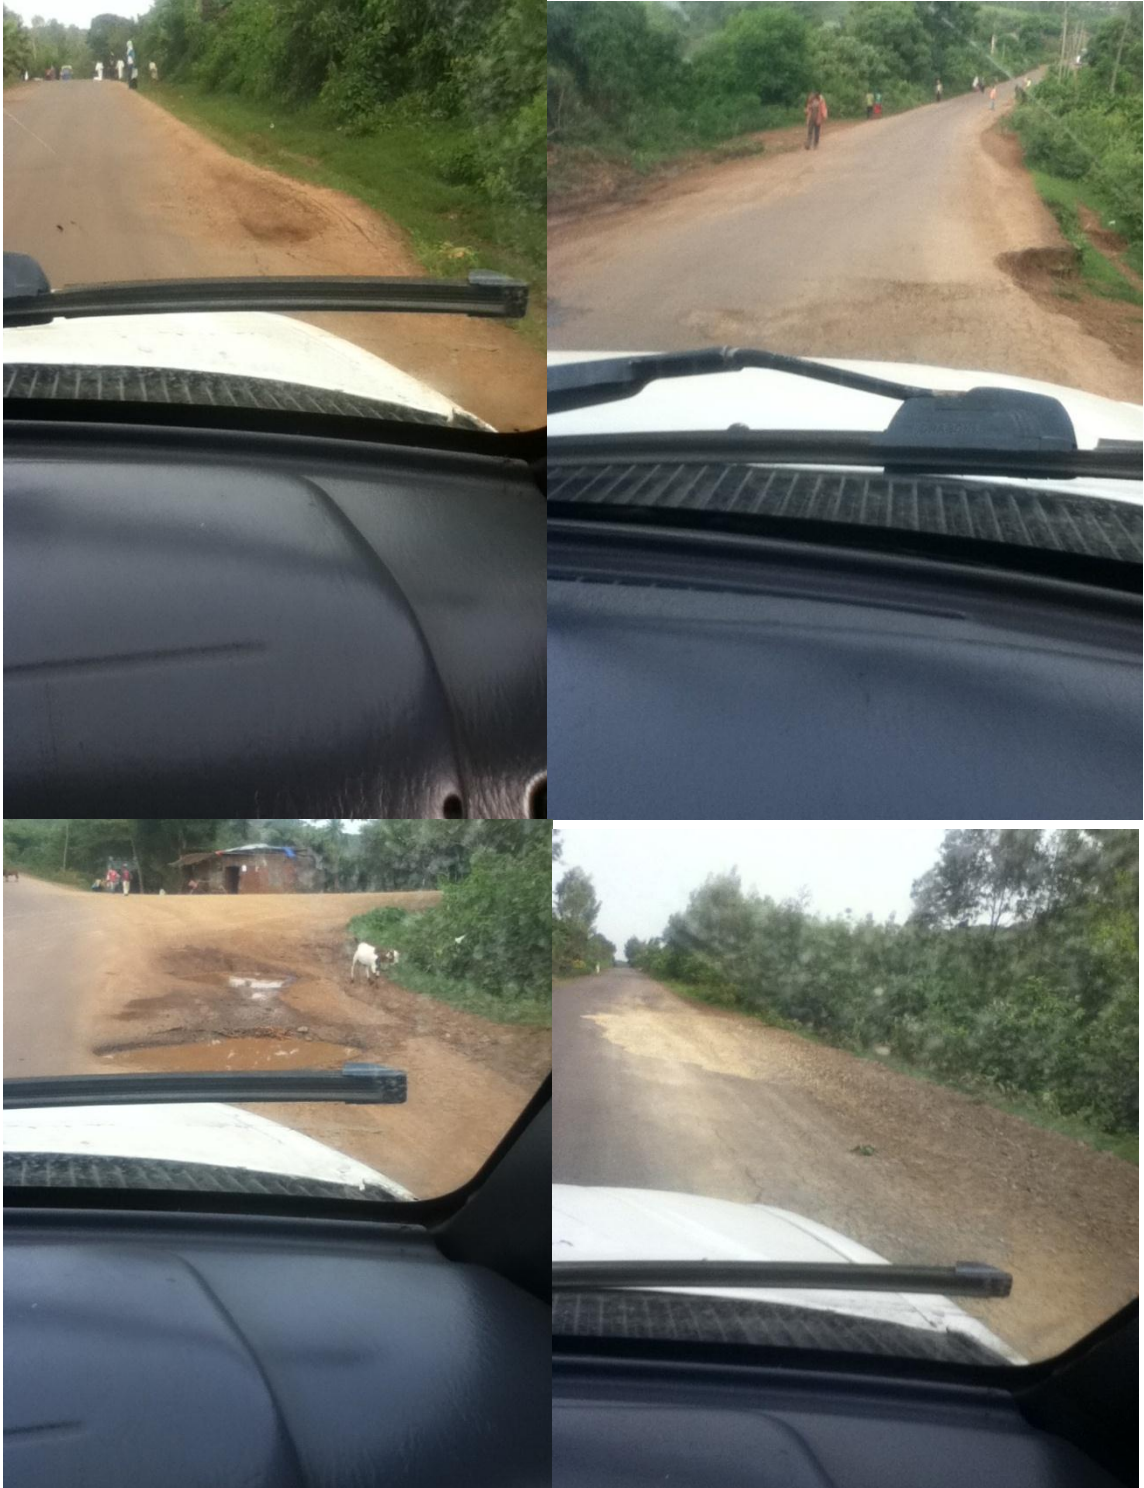
Drainage and vegetation problems

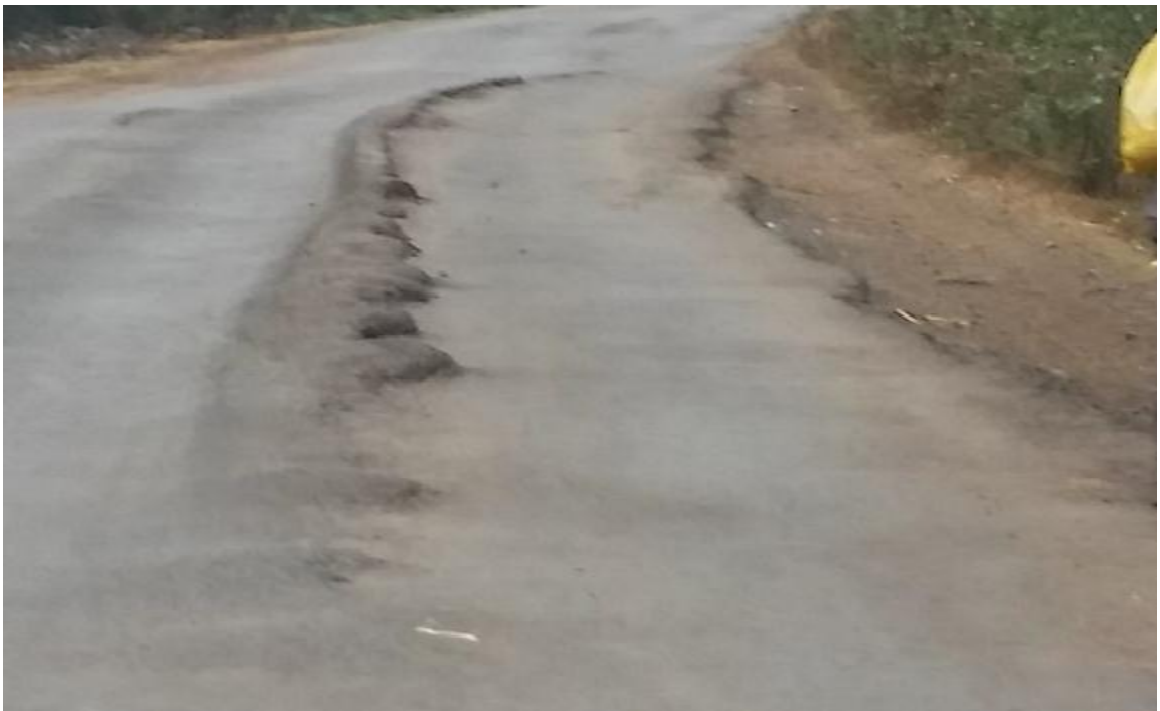
Settlement, Shoving and material movement at 65+100
