Effects of Subgrade and Sub-Base Materials Quality on Flexible Pavement: A Case Study along Ajip to Gebrel Church of Jimma Town

A Thesis Submitted to School of Graduate Studies of Jimma University, In Partial Fulfillment of the Requirements of Degree of Master of Science in Civil Engineering (Highway Engineering Stream)

By: GetuTamiru

June, 2017
Jimma, Ethiopia

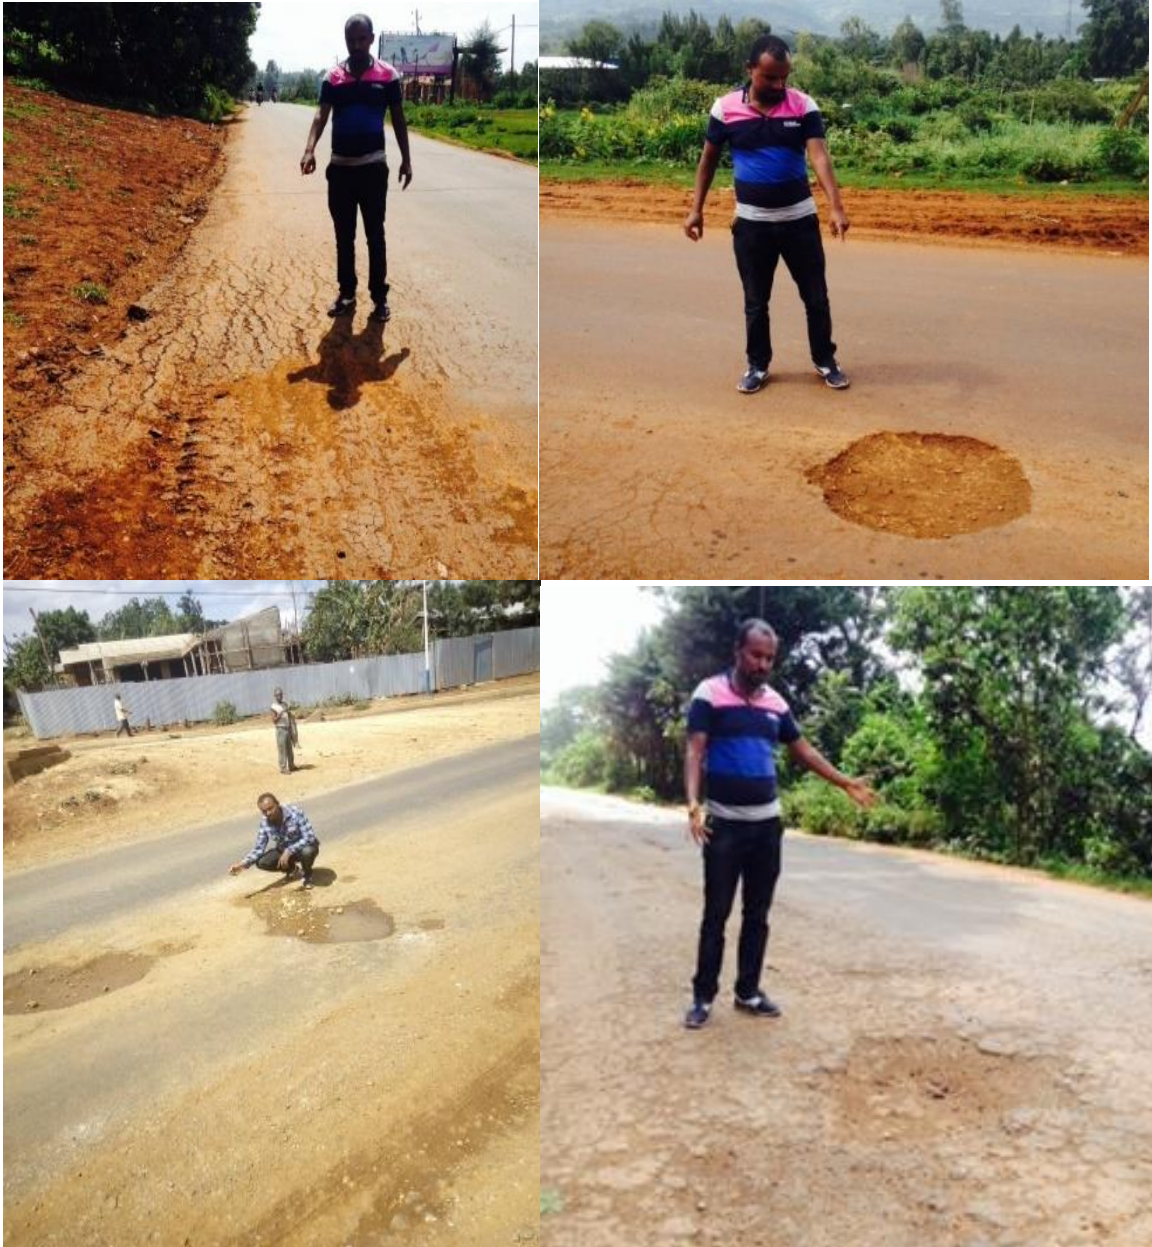
Figure 1.1 Photos for the current existing condition of the studied stretch pavement (photo captured date 08-04-2017 @2:00 – 5:00p.m.)

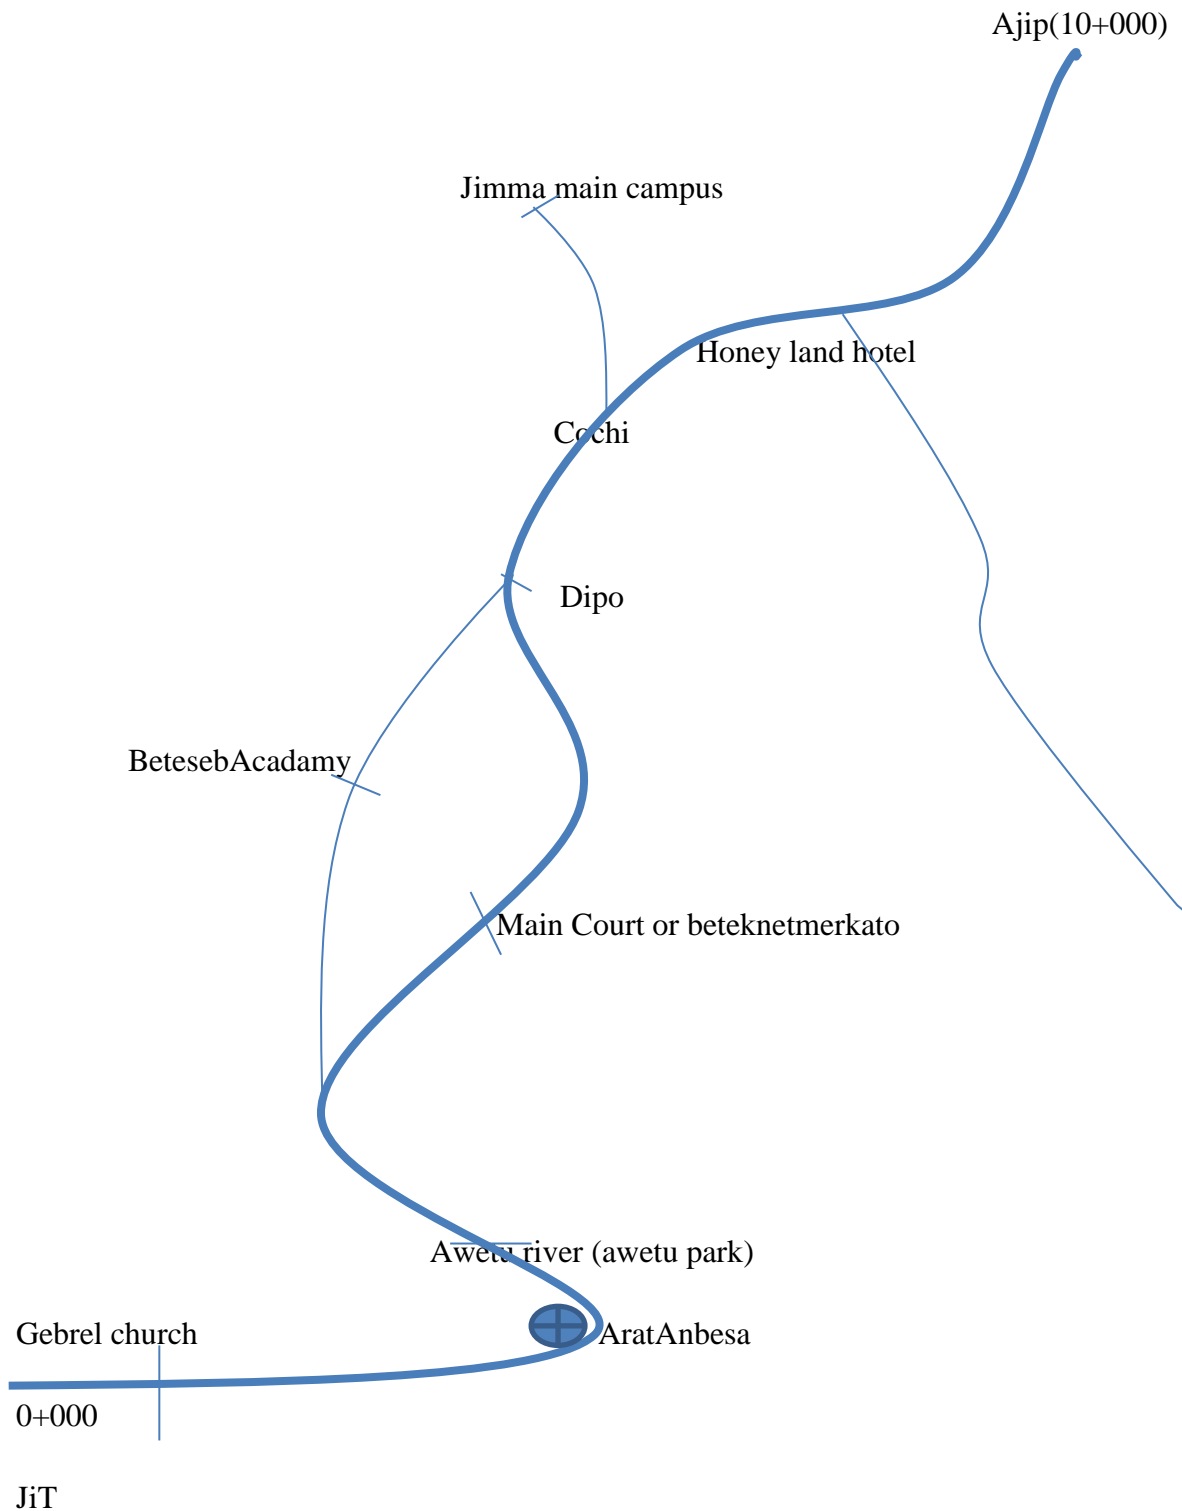
Figure 3.2 the Horizontal alignment of existing road (studied area) from Ajip to Gebrel church of Jimma town.

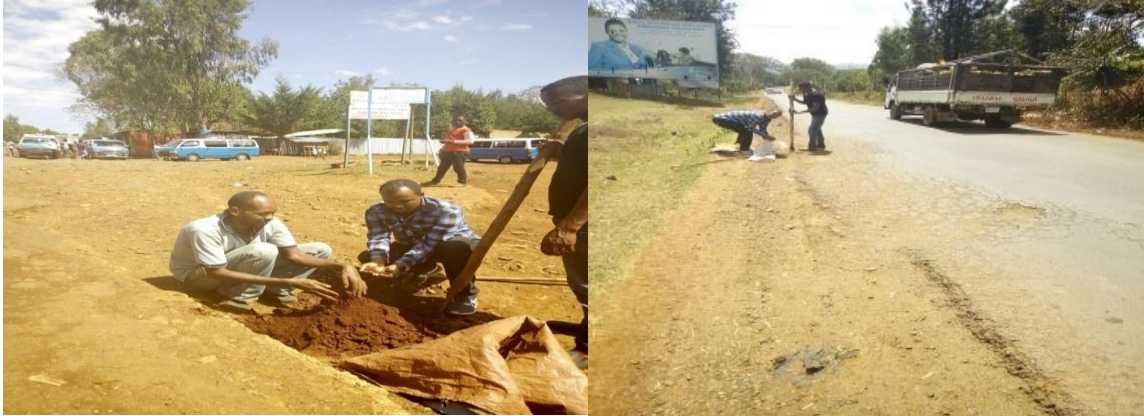
Figure 3.3 Sample extracted photos captured date 08/04/2017@3:00p.m

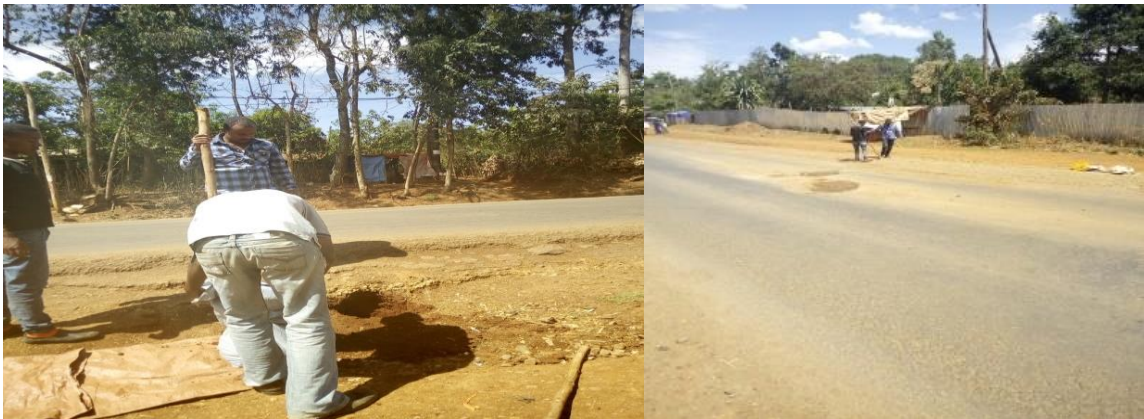
Figure 3.4 Sample extracted photos captured date 08/04/2017@3:00p.m

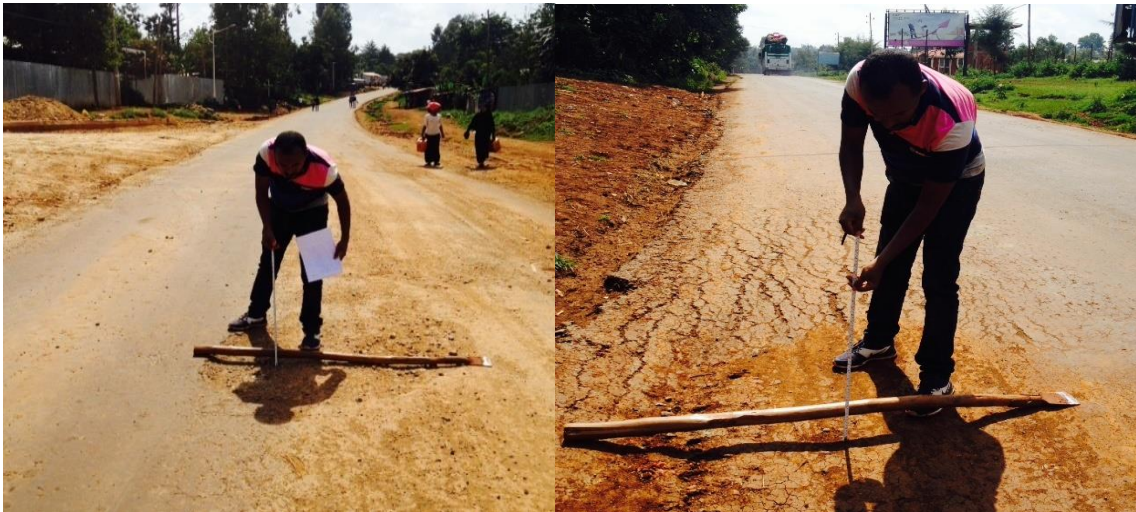
Figure 3.5 photos for measuring the Current Existing pavement Distress (Photos captured date 15/04/2017 @ 8:00 a.m.)

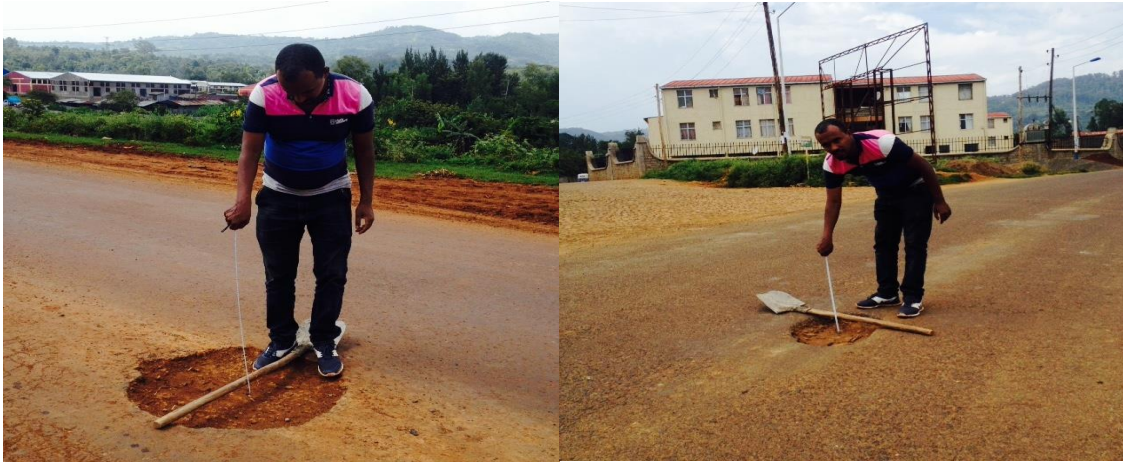
Figure 3.6 photos for measuring the Current Existing pavement Distress (Photos captured date15/04/2017@8:00 a.m.)

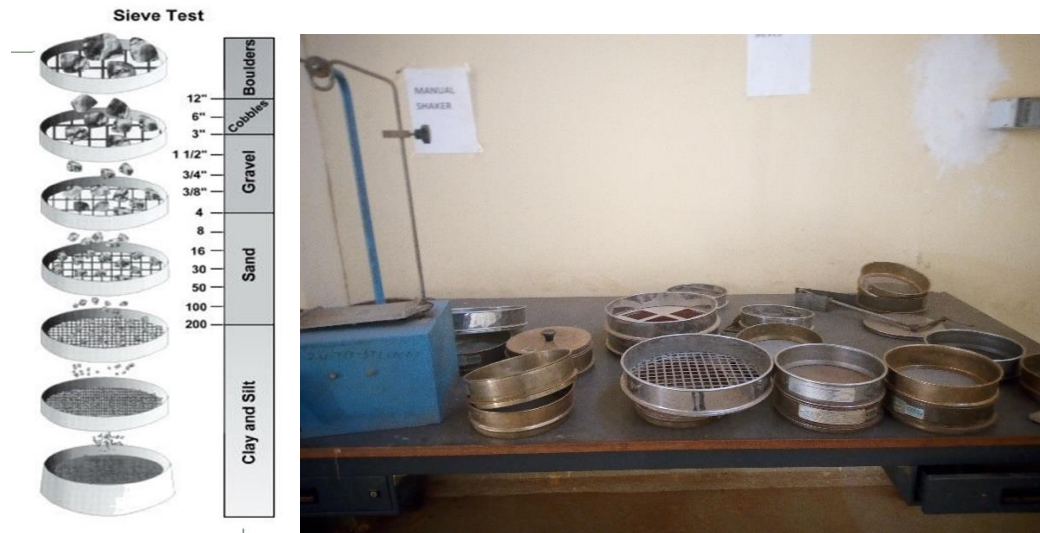
Figure 3.7: Apparatuses for grain size analysis test

Purpose: To determine the grain size distribution curve of soil samples and is useful for soil fraction larger than 75 μ m.

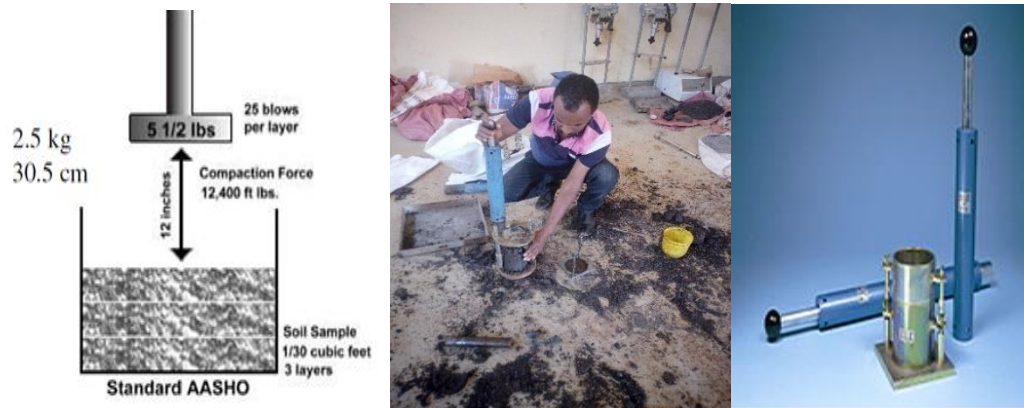
Figure 3.8: Apparatuses for compaction test

Purpose: To get the maximum dry density (MDD) for the soil and optimum moisture content (OMC).

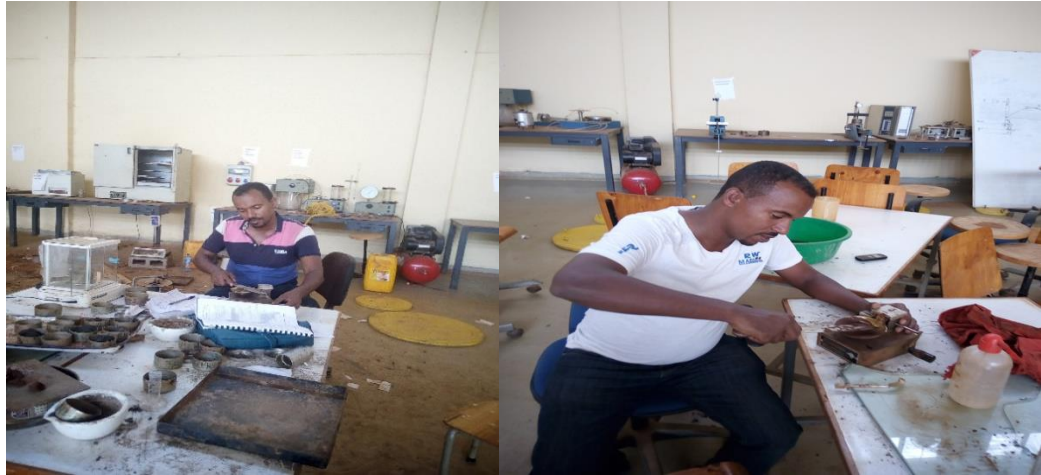
Figure 3.9:Apparatuses for atterberg's limit test

Purpose: To measure the plasticity and shrinkage nature of the soil.

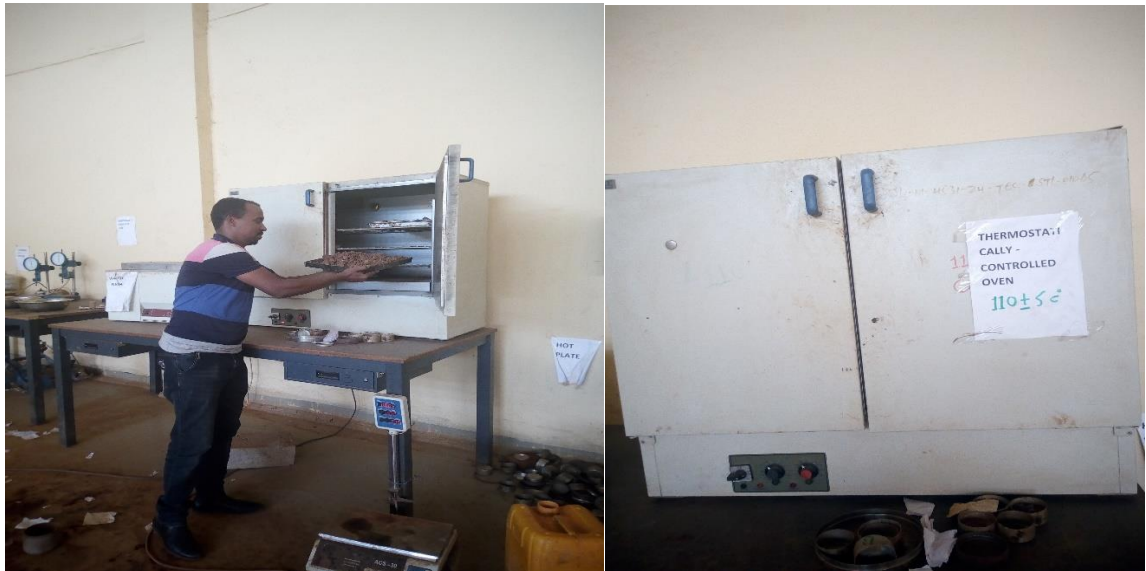
Figure 3.10:Apparatuses for natural moisture content test

Purpose: The amount of water exists in a given subgrade and sub-base materials mass.

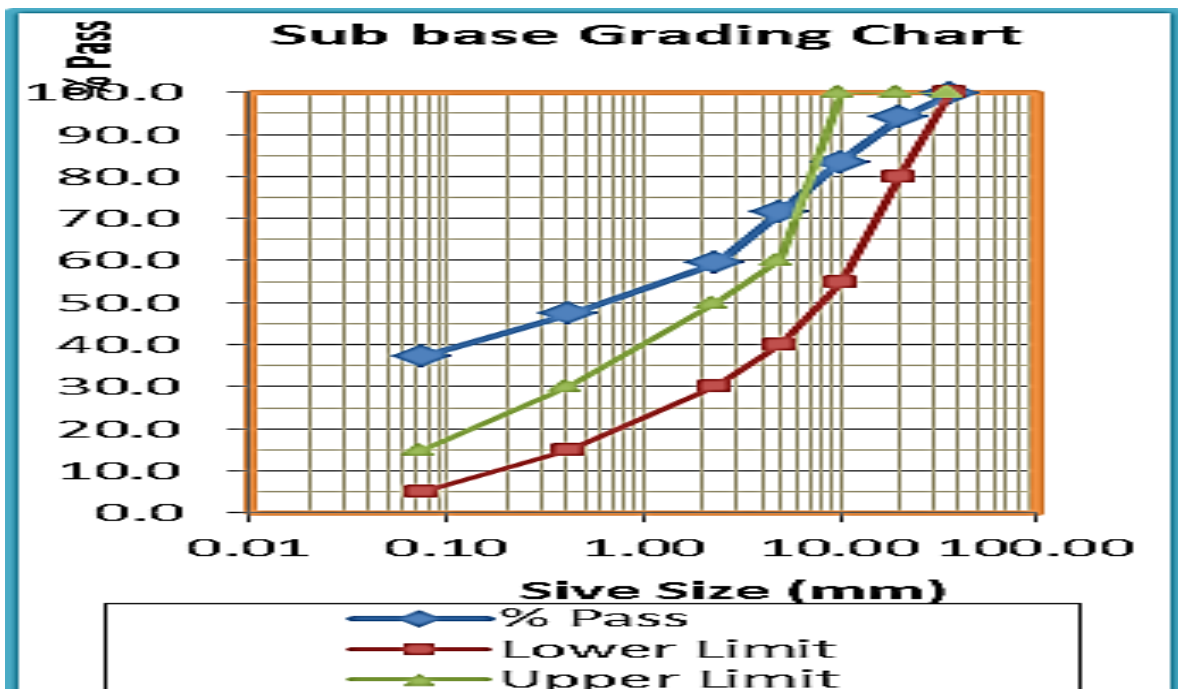
Chart4.1 Laboratory test result for the grain size analysis of sub base.

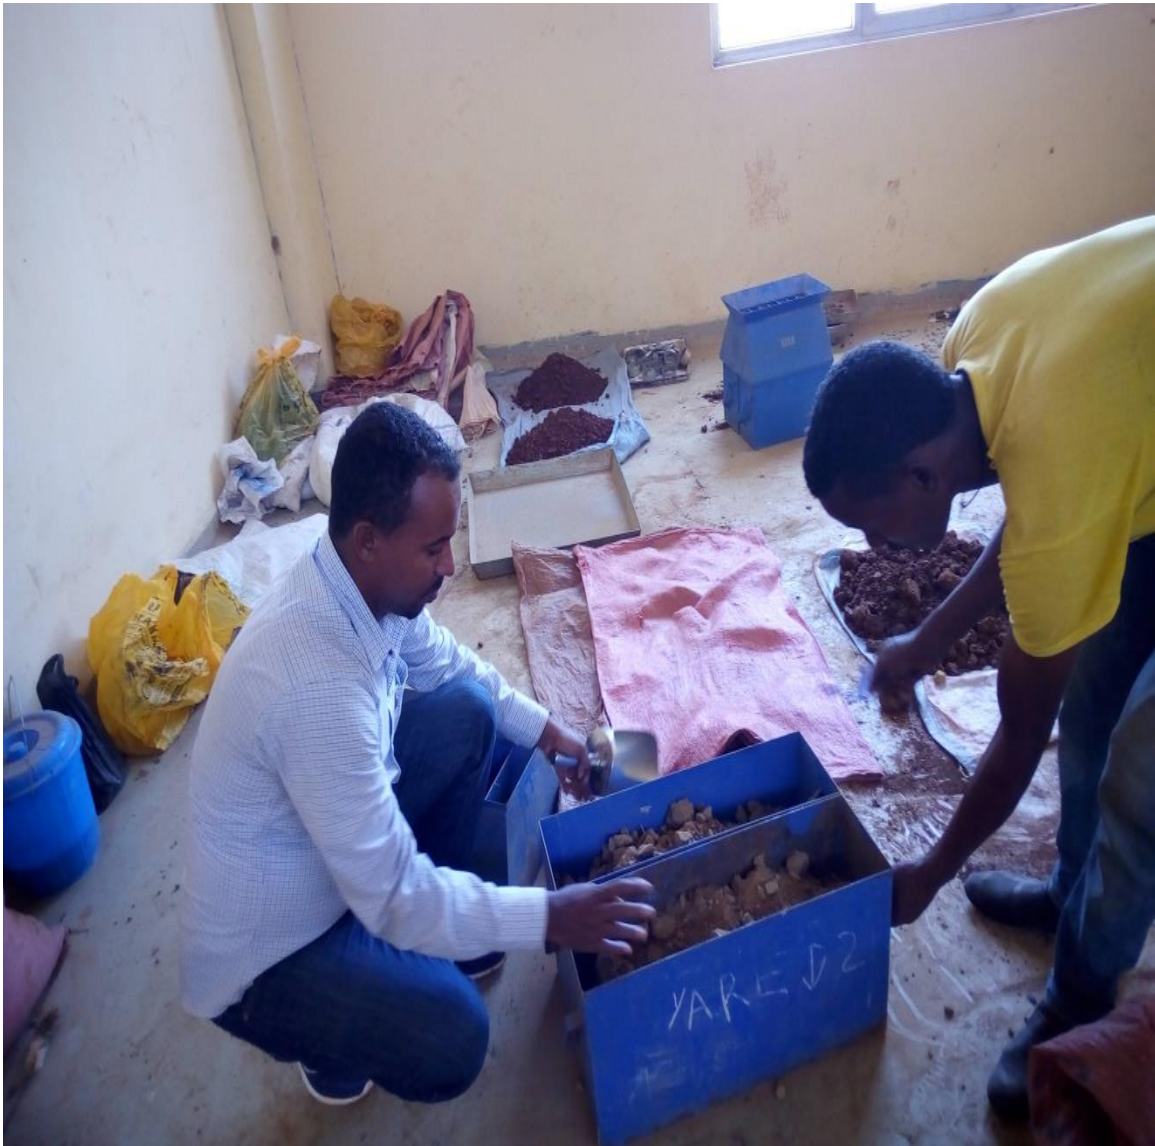
Laboratory test of preparation for particle size analysis (photo captured date 10-04-2017 @ 3:00 p.m)

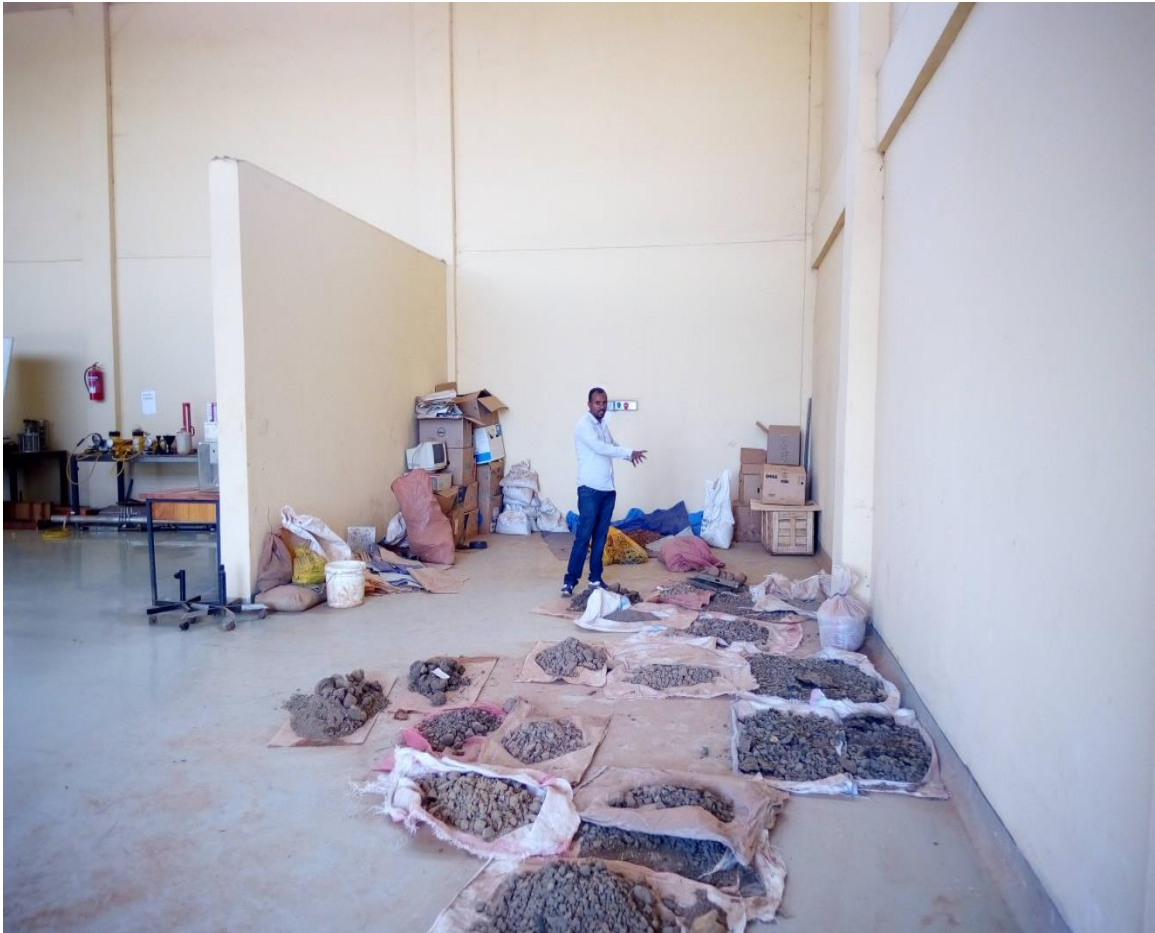
Laboratory test after particle size analysis (photo captured date 10-04-2017 @3:00 p.m)

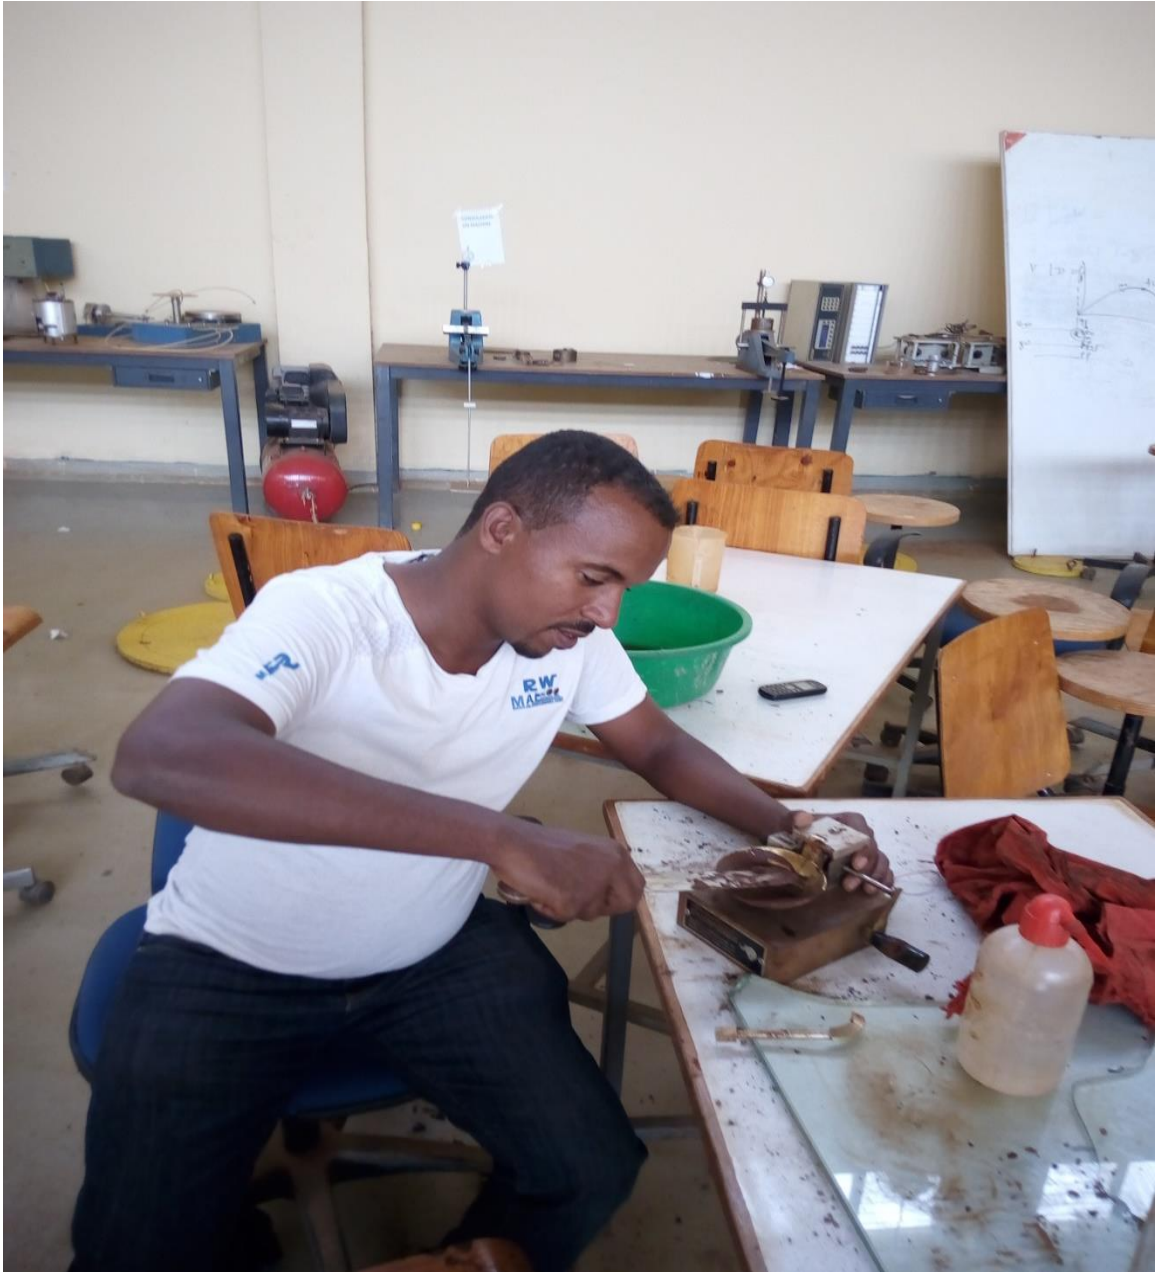
Laboratory test of Atterberg's limit (photo captured date 10-04-2017 @5:00 p.m)
