EVALUATION OF ROADSIDE DRAINAGE PROBLEM AND ITS
REMEDIES: A CASE STUDY ON JIMMA TO AGARO

A Thesis submitted to the School of Graduate Studies of Jimma University in Partial
Fulfillment of the Requirements for the Degree of Master of Science in Civil Engineering
(Highway Engineering)

By: Yusuf Negesso

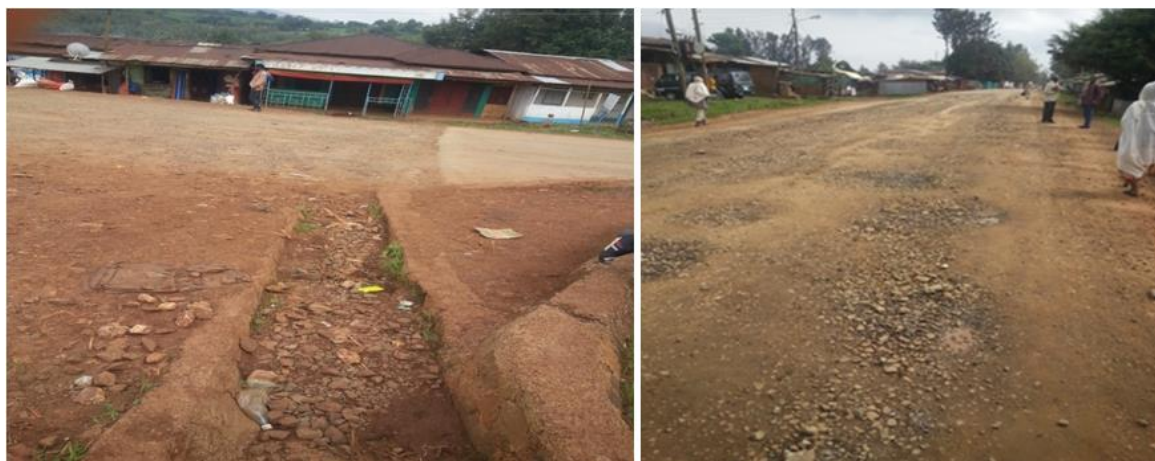
The engineers' from ERA Jimma Branch Office and Ethiopian Road Construction Corporation Office indicated that the roadside drainage provided for Jimma to Agaro road has a problem and as there was no sufficient roadside ditches. They also indicated that studies that were carried out before designing the road were not sufficient to satisfactorily ascertain the amount of water that would cross the road at a point in time and the design lacked capacity to adequately drain the runoffs during the rains. Also, they responded that, the major consideration when coming up with a road and road side drainage is cost of construction. Since topography of the site of design is the second factor considered. However, poor workmanship (seen through poorly worked drainage at Yebu town by the researcher during observation) and poor maintenance also contributed to the drainage problems along the study area road.

Figure 4.4 Taken august 25/2016 roadside ditches aligned directly to asphalt road at Yebu town.

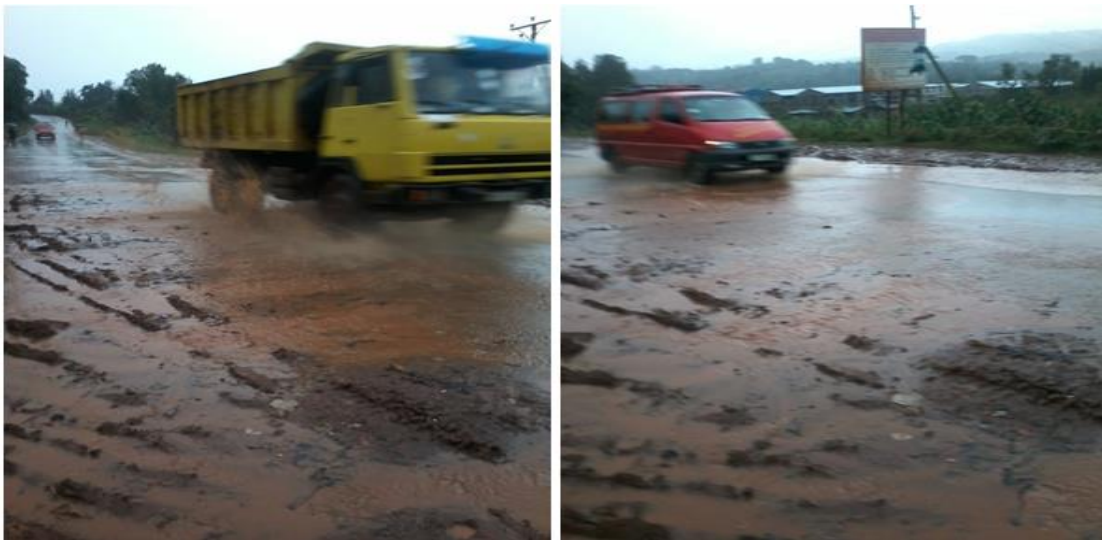
The majority of respondents reported runoff obstructs to move on the road during the rains thereby hindering free movements of vehicles on the road. It also leaves silt soils on the pavement. So sometimes totally making impossible pedestrian to walk on the side of the road; Travelers would then become later in their businesses or other engagements. A significant proportion reported that runoffs famous rain water to overflow, leave debris and the pond on the carriageway. Such problem was seen at Jimma town, Addis keteme kebele, Yebu and Haro town by researcher during field observation.

Figure 4.9 Taken august 25/2016, A vehicle obstructed to move freely, at Jimma town bosa addis keteme kebele

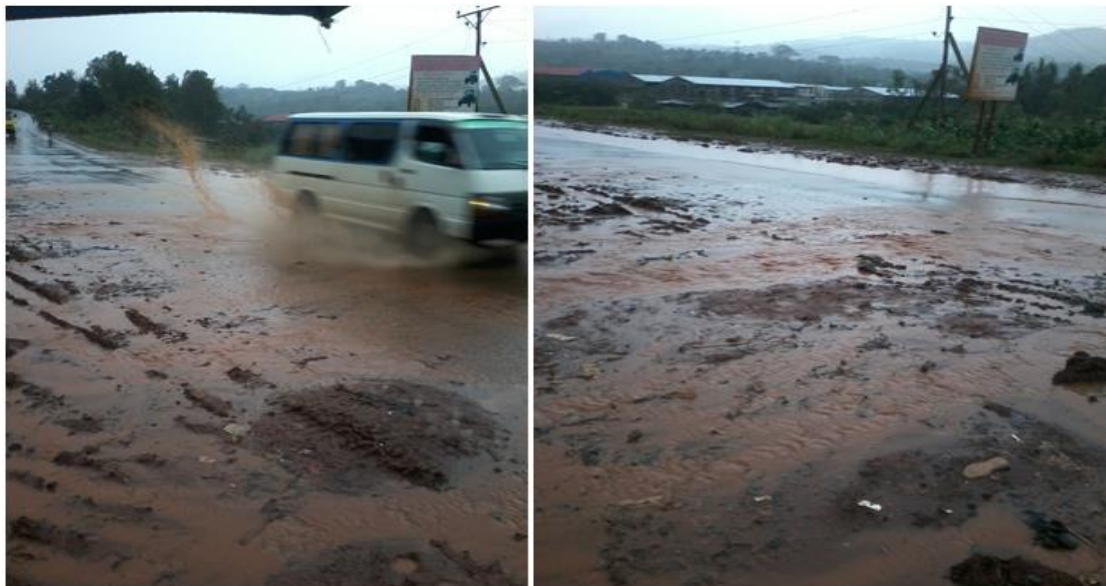
Poor roadside drainage can bring about flooding which in most cases submerges the buildings, roads and makes it hard for people to move about. Recently Jimma to Agaro road is facing extensive water logging during the rainy season (august 25/2016) as result of roadside problem. Inadequate side drainage problems become one of the most common sources of compliance from the residents in towns along the study area and this problem becoming worse in this year. Absence of side drains cause severe flooding which creates distresses to the road pavement and problems for road users. This condition was severely motivated because the natural drainage system, which conveys storm runoff from the areas of the river were not fully operated and the existing drains blocked with huge amount of silt sand accumulation and vegetation.

Figure 4.13 Taken august 25/2016, flooded road obstructed vehicle along the study area at Bosa addis keteme kebele at Jimma town.

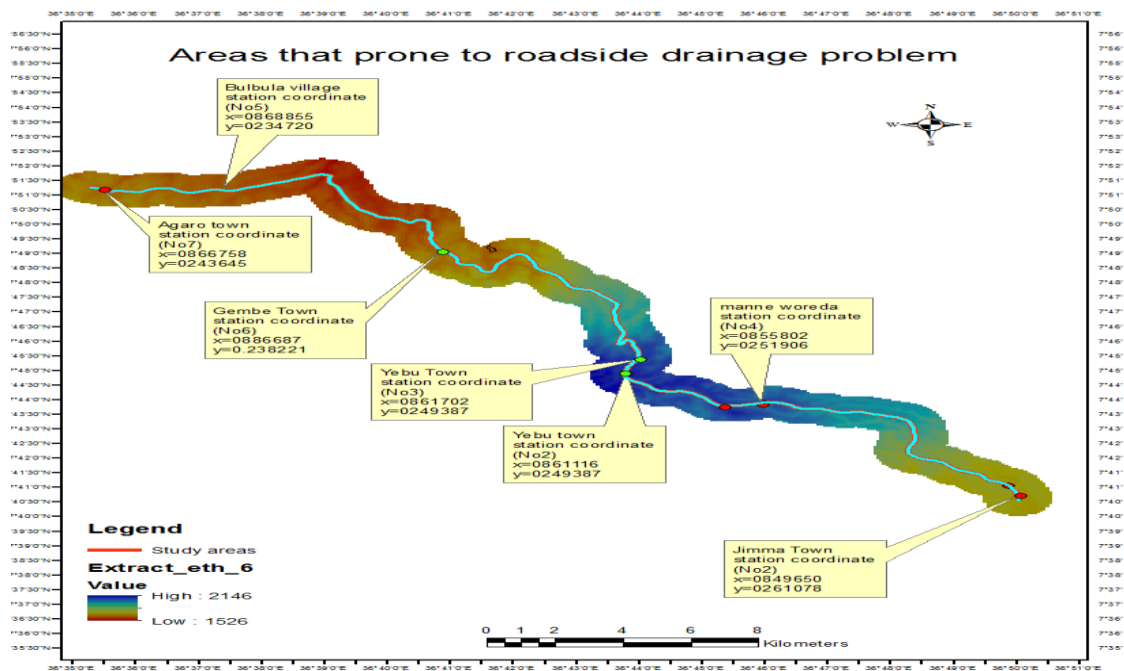
The major flood prone sites in the study area were identified through questionnaires from road users and residents along with field observations.

Figure4.14: Flooding prone areas

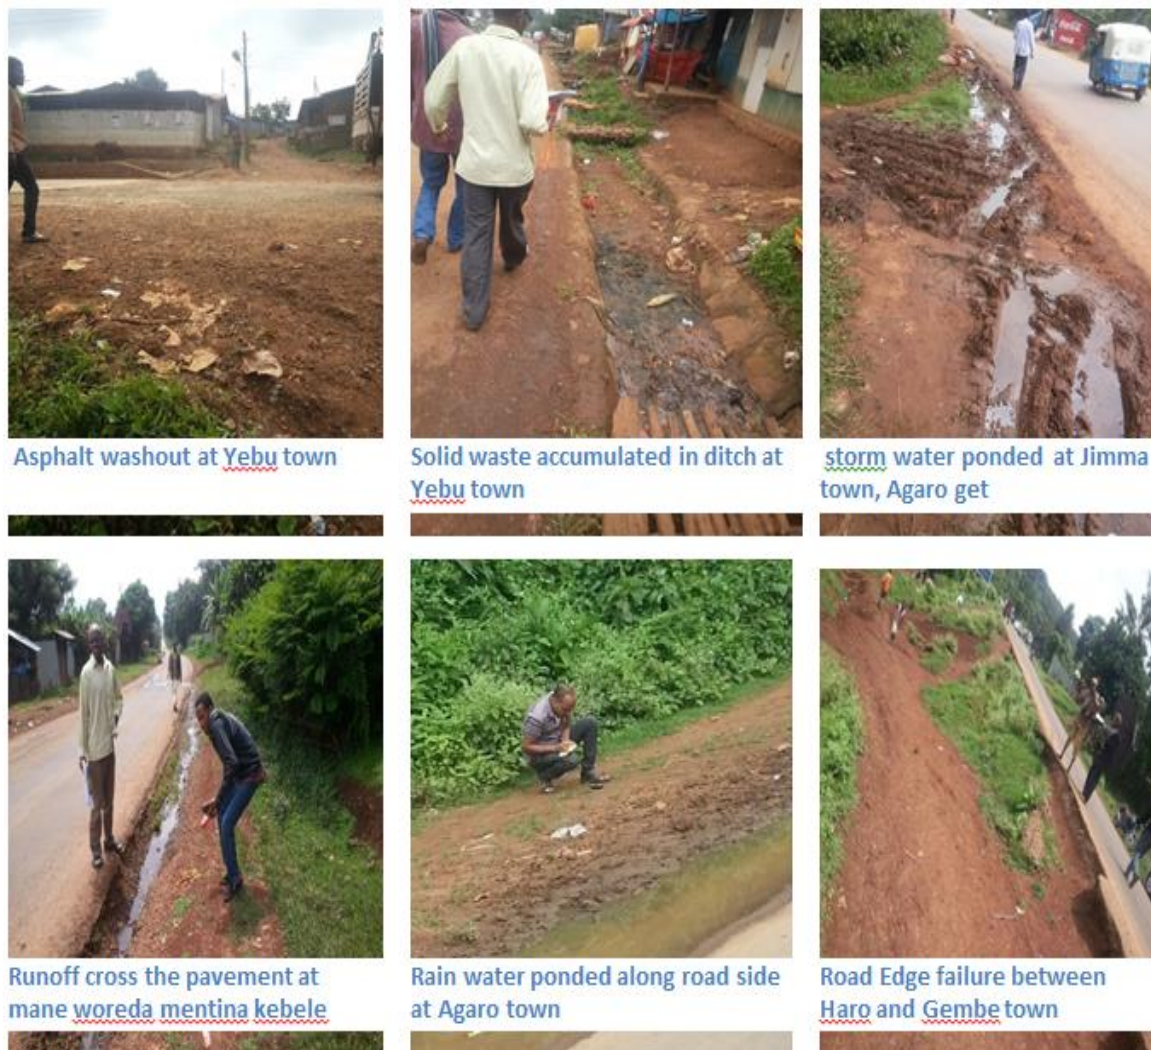
as there is no regular maintenance of roadside drainage along the study area road section and other flood prone areas shown on the figure below has no proper roadside ditch.

Figure 4.15 Taken June 12 to15/2016 the major flood prone areas along Jimma –Agaro road section

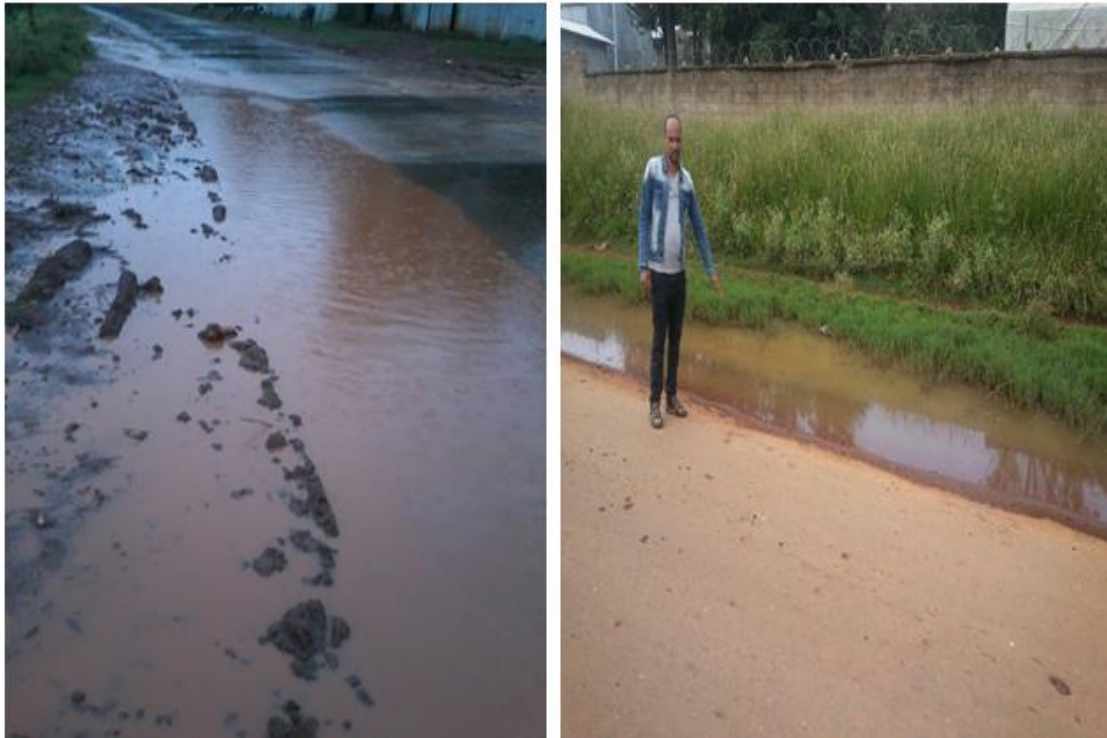
According to field observation the absence of ditches alongside of the road makes rainwater to collect on the pavement surface and the surrounding areas. The side's drains need to have sufficient capacity to collect all rainwater from the road surface and dispose it quickly and in a controlled manner to minimize damage on the road and side properties. But if there is no side drains the storm runoff can damage the pavement. In addition to this it affects the aesthetics of the whole place and it promotes stagnant water in the area as it can understand from the following figure.

Figure 4.16: Taken June 12/2016 Water ponded along the study area road at a Jimma town near the back of Agricultural and veterinary medicine college fence.

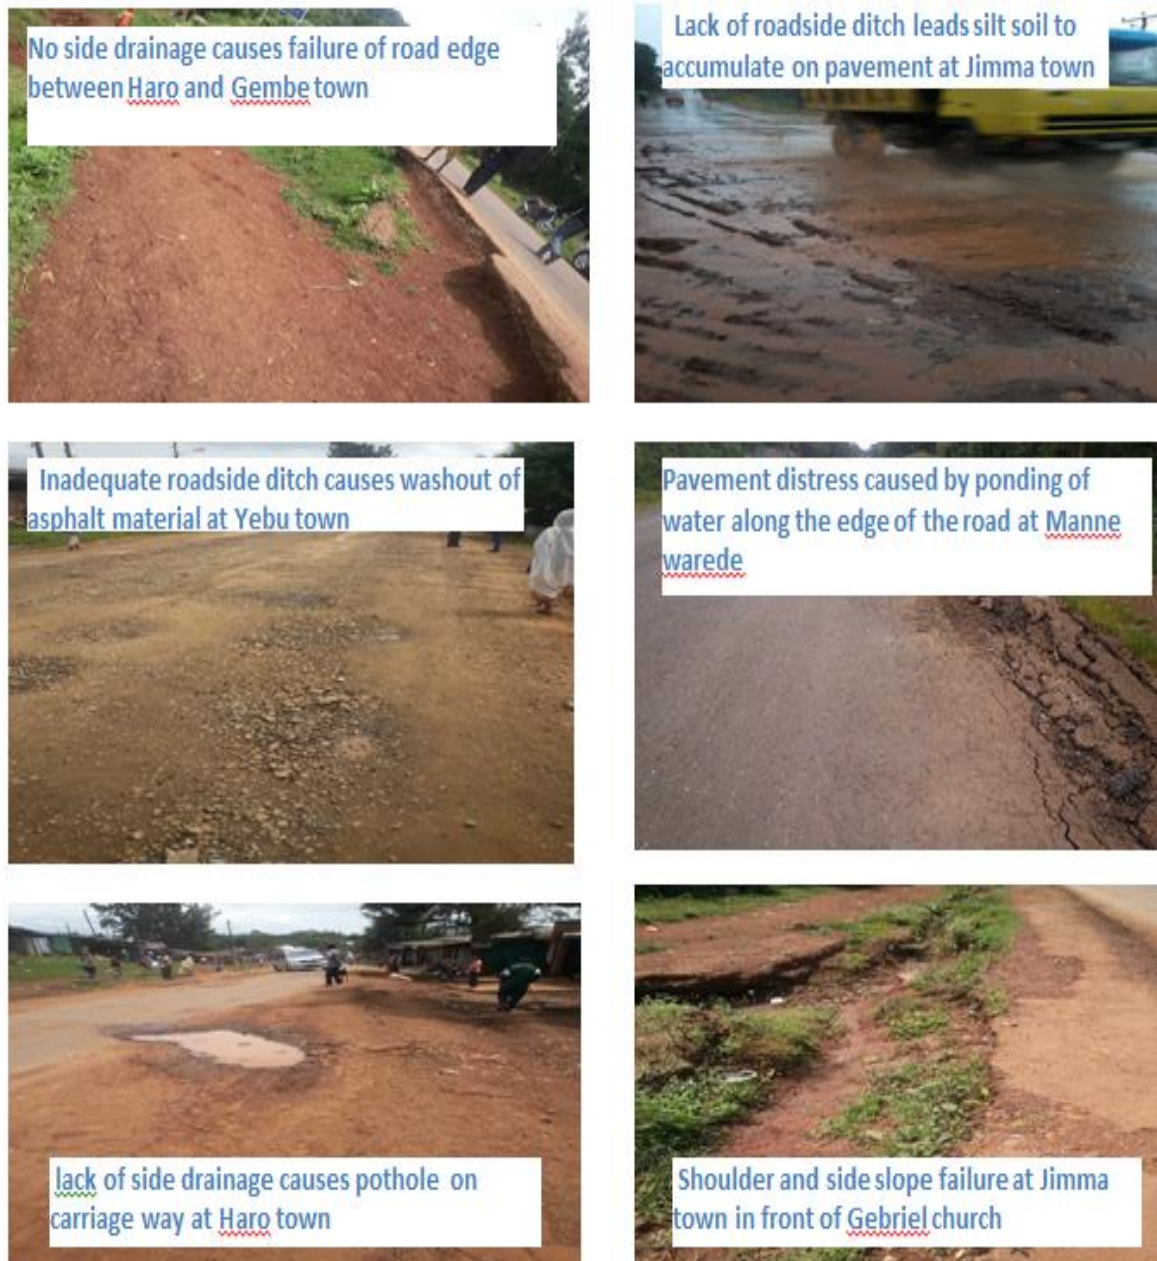
From the investigations conducted, figures 4.15 and 4.16 presents, proof of the reduction in service lifespan of this road and it is evident in the deterioration of drainages and subsequent road pavement conditions which are visibly noticed in the form of edge failures of road pavements, potholes along the driveway of road pavements, stripping of bitumen off the surface of road pavements. Also, a poor maintenance culture result in gullies and gratings being blocked with silt, sand accumulate over time and in the growth of vegetation in and around the side drains which has resulted in total failure of the side drains structures. To check these very poor conditions of side drainages and road pavements, there is need to properly maintain them by regarding organization under which these roadside drainage channels are located. So that they would be able to perform routine cleaning of Silt sand accumulated over time that is visibly seen to have blocked these side drainages.

Figure4.17Taken June 12 to 14/2016, Road Surface Damage observed at study area

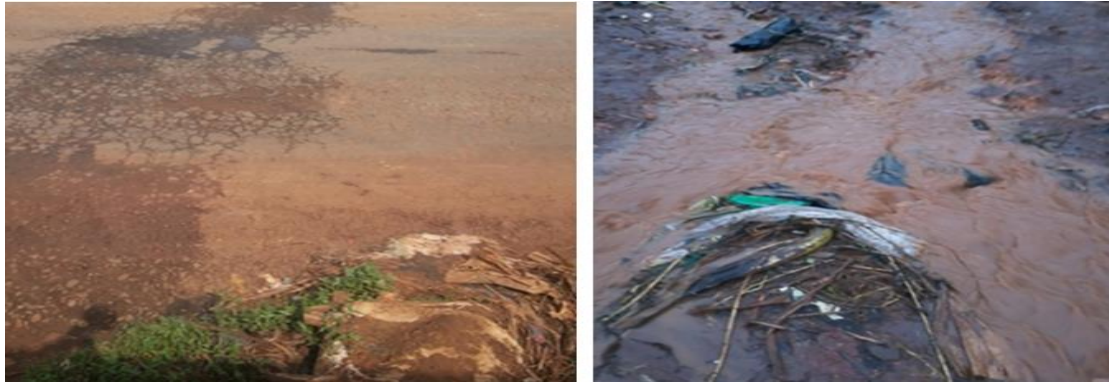
Figure4.18 Taken June 12/2016, Solid waste and polyethylene bags disposed along the road of the study area, at Yebu and Jimma town.

A, Presence of Garbage and polythene bags along the road

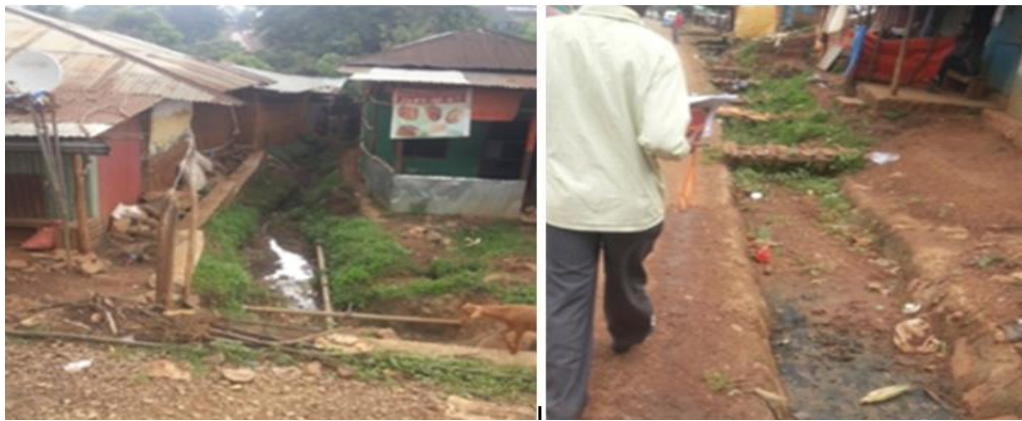
Figure 4.19 Taken June 12/2016, Blockage by silt soil, garbage and upland houses in yebu town along the study area

To solve this problem, relevant government agencies in charge of town planning and development Such as the Ministries of housing and urban development should wake up to their responsibilities of ensuring that only government approved structures in line with the town planning master plan are erected on government approved lands and not on drainage channels. Also the immediate awareness must be given to the communities in which such problems are located. This problem has been seen in the towns such as Yebu, Alamayo and Gembe towns.

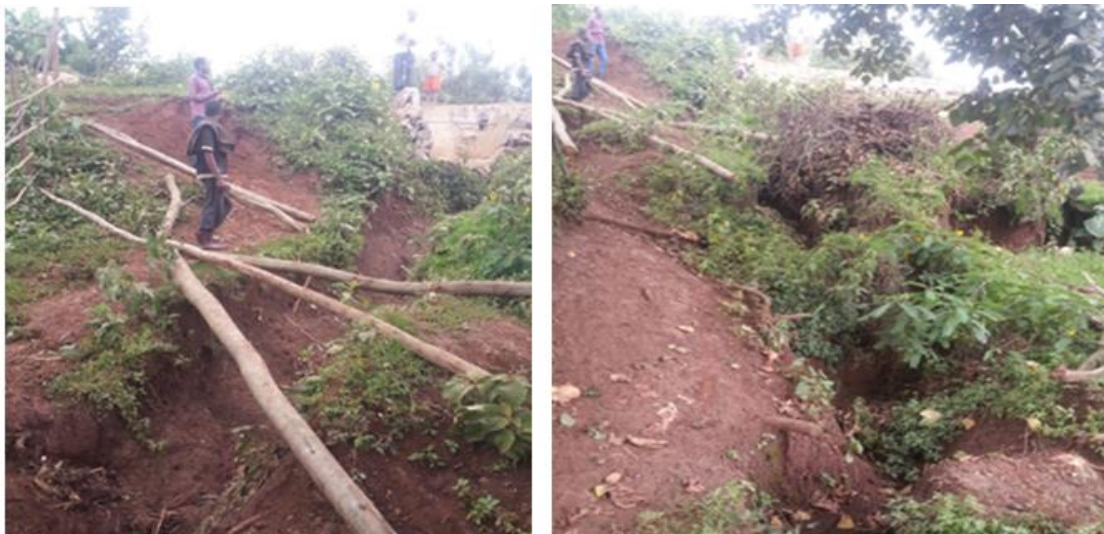
Figure 4.20 problem of roadside drainage outlet at the exit of yebu town

From field observations, the runoff that flows in the side drainage must have good outlets. The inadequate outlet in the surrounding area can result in soil erosion, which leads to environmental and property damages as it can be observed from figure 4.20. As one land owner responded, this soil erosion has around three hundred meter length, which crosses good farm land for crop production.

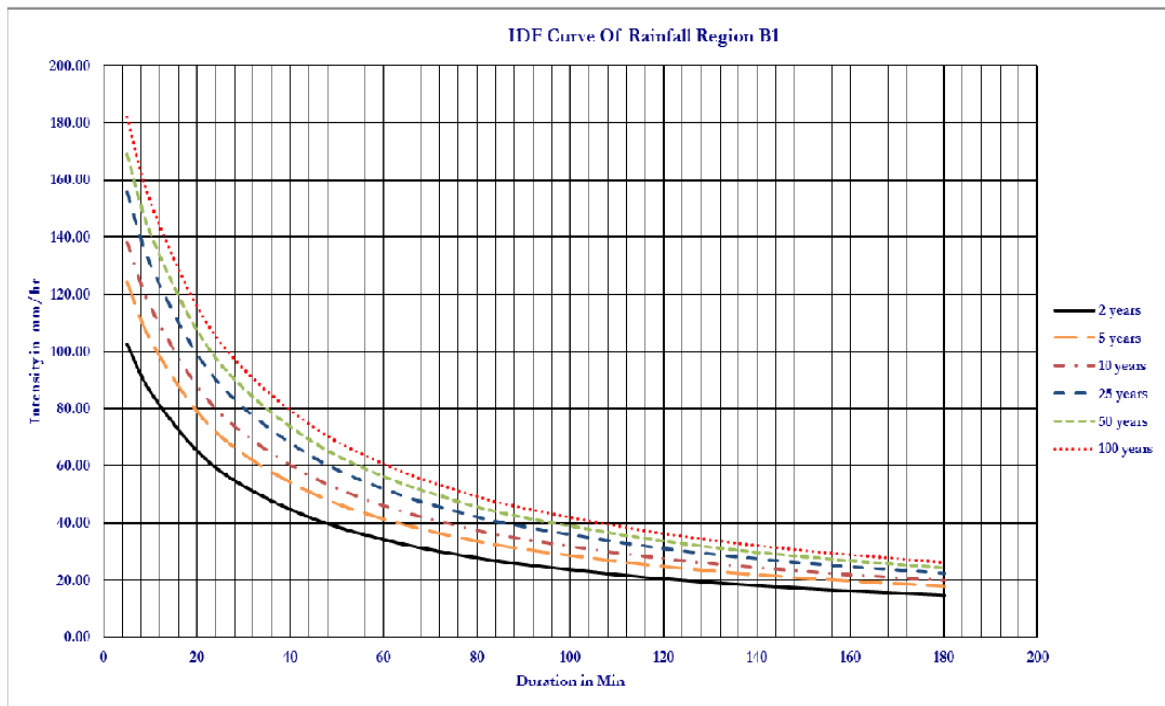
Figure3. IDF Curve of Rainfall Region B1
