**Evaluation of the Distresses and the Performance of Asphalt Pavement
Based on Pavement Condition Index and Engineering Properties of
Layers: A Case Study of Alaba-Sodo Road**

A Thesis submitted to the School of Graduate Studies of Jimma University in partial fulfillment of the requirements for the Degree of Master of Science in Civil Engineering (Highway Engineering Stream)

MAY, 2017

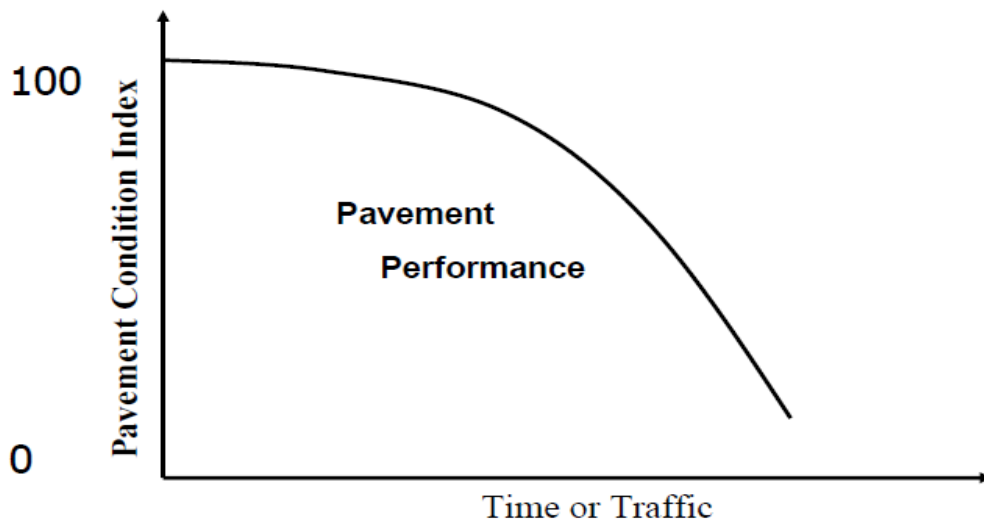
Figure 2-2: Relationship between pavement condition and time (Donald, 2013).

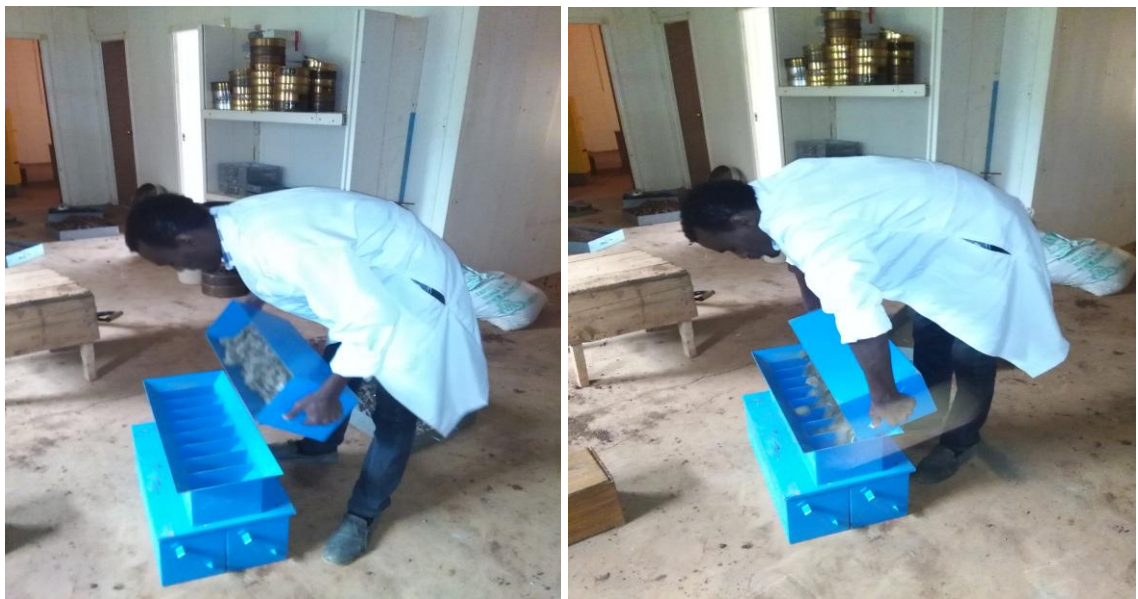
Figure 3-2: Sample splitting in laboratory for tests

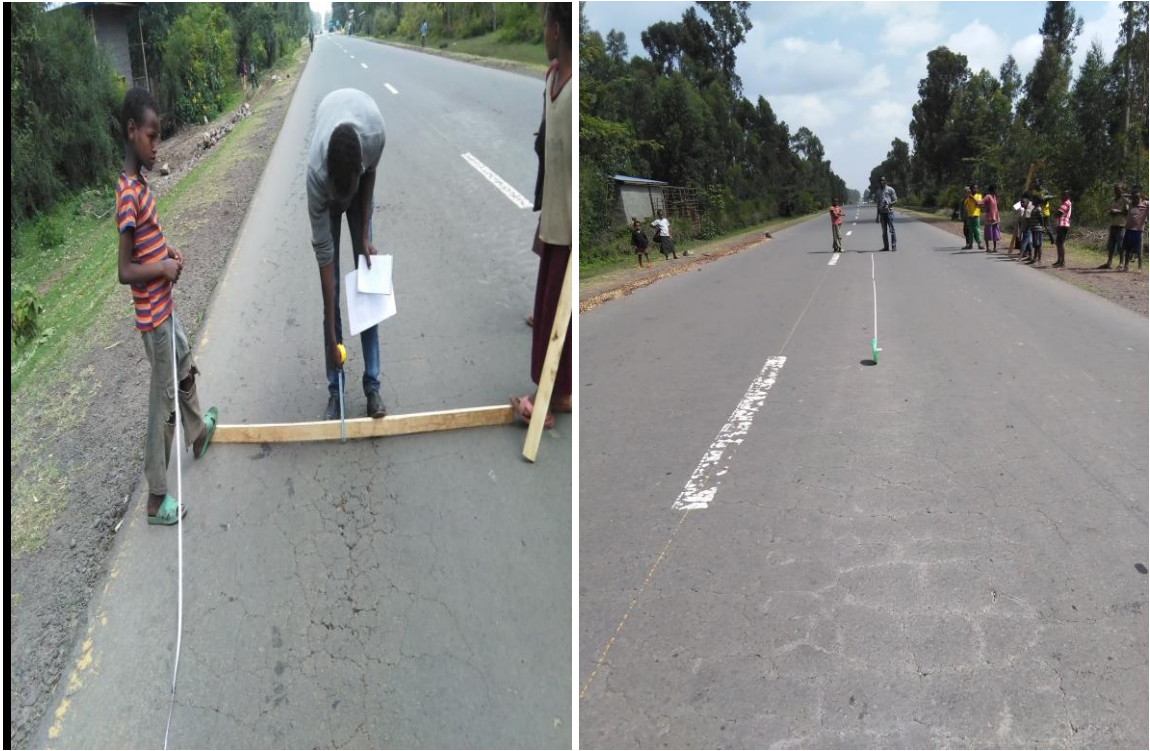
Figure 3-3: Shows the pavement condition surveys on subsection Alaba to Mazoria.

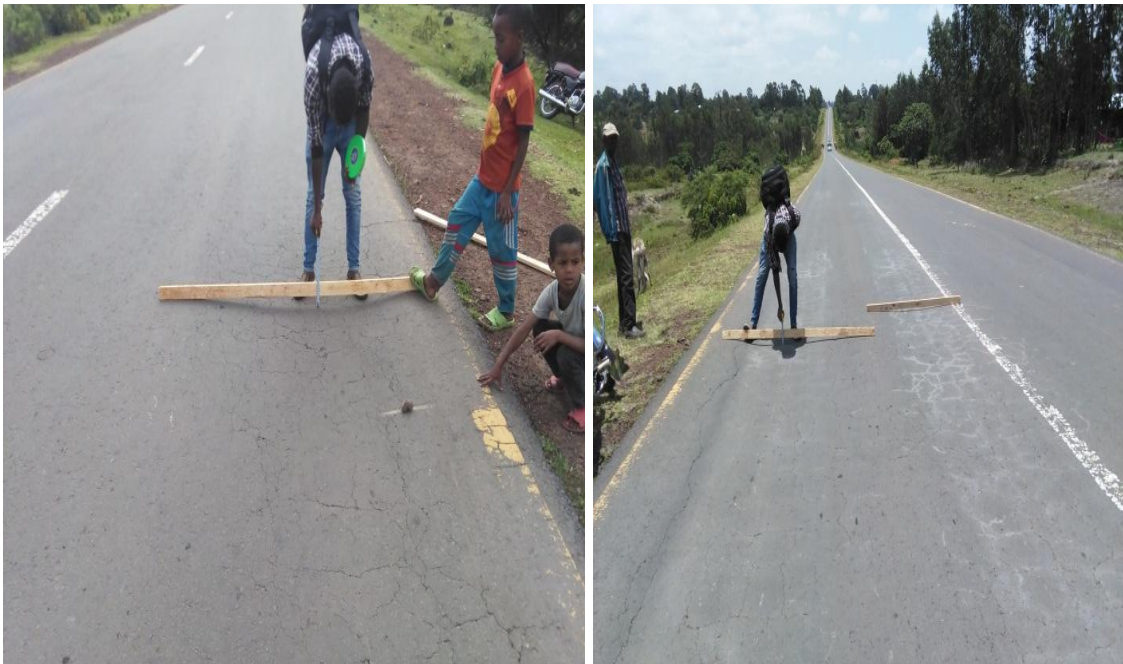
Figure 3-4: Shows the pavement condition surveys on sub section road Buge to Boditi.

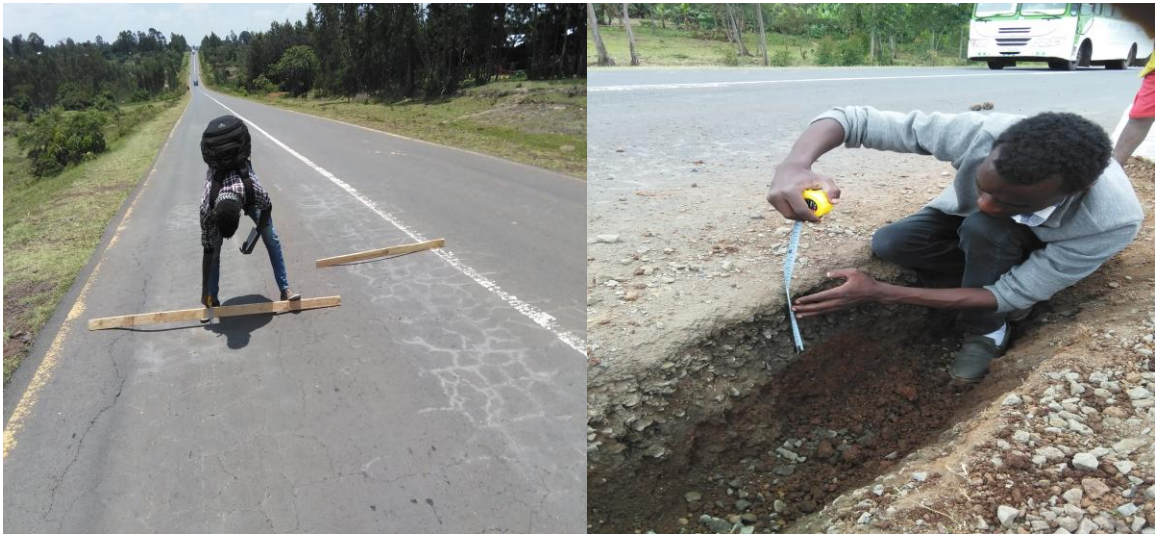
Figure 3-5: Shows the condition surveys and Measurement of thickness of pavement layers on sub section road Buge to Boditi.

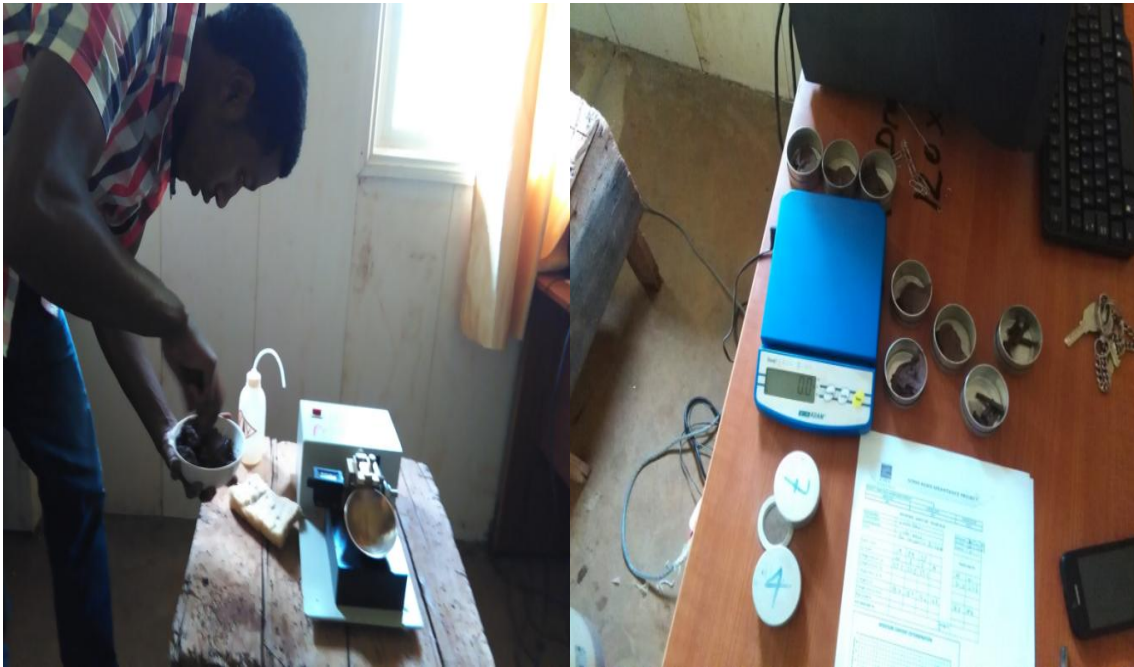
Figure 3-6: Laboratory test for Atterberg limit determination

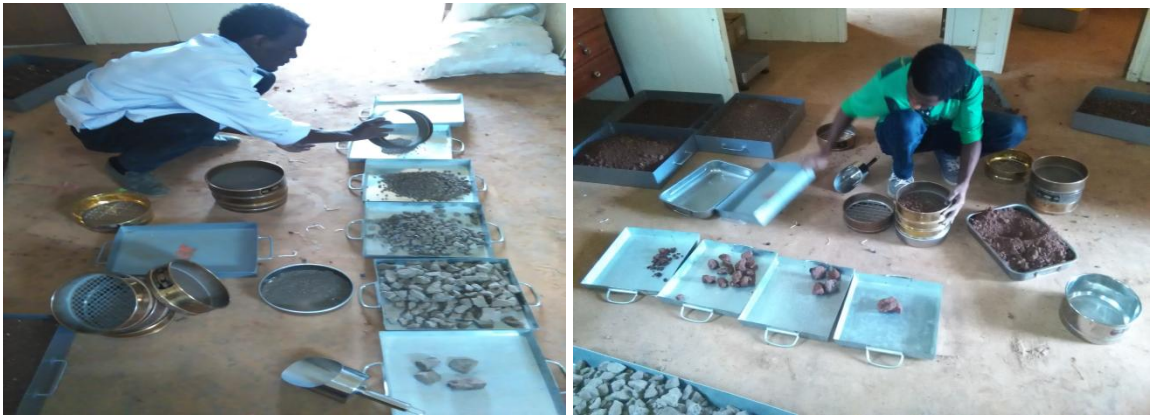
Figure 3-7: Laboratory test for grain size determination

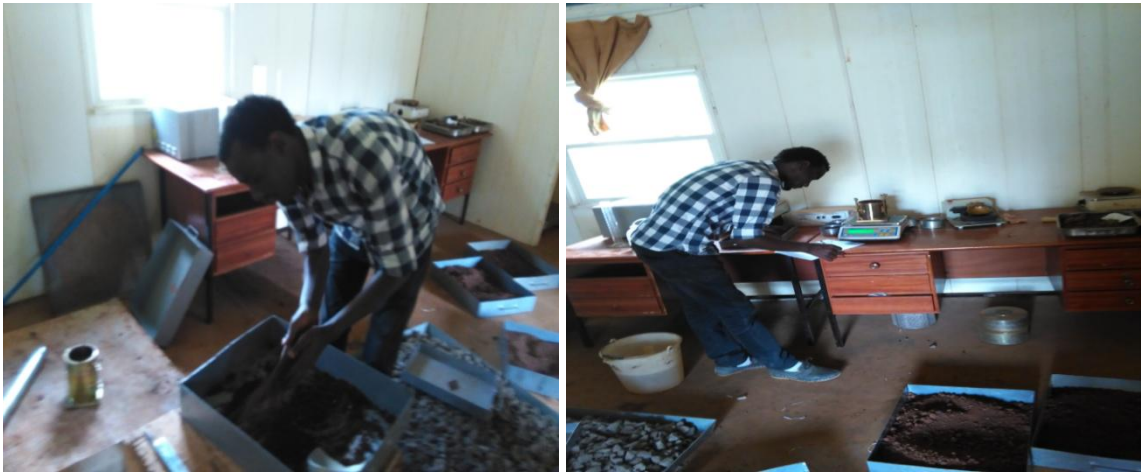
Figure 3-8: Laboratory test for MDD and OMC determination

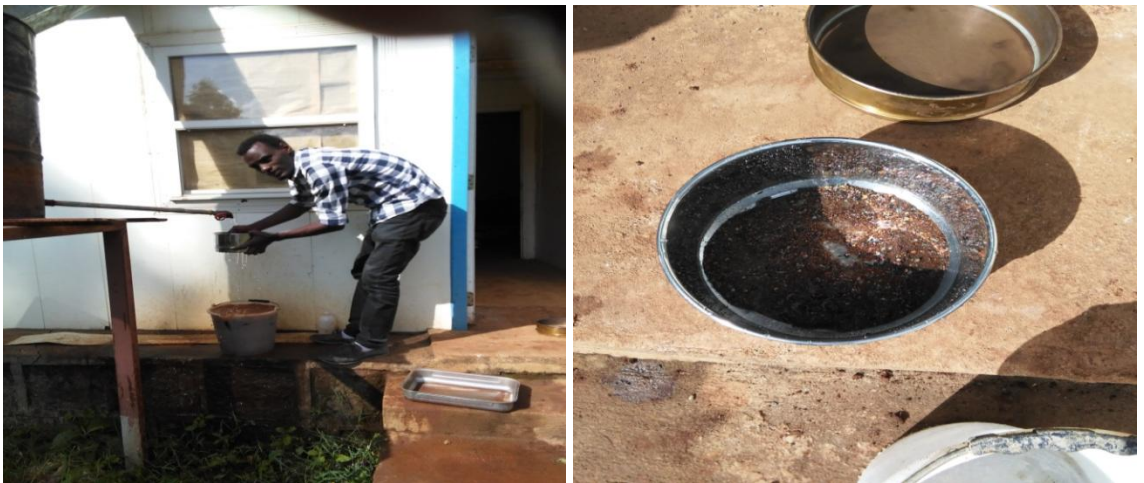
Figure 3-9: Laboratory test for soil classification determination

Therefore, the classification only for subgrade materials was carried out in accordance of classification procedures of AASHTO M 145.

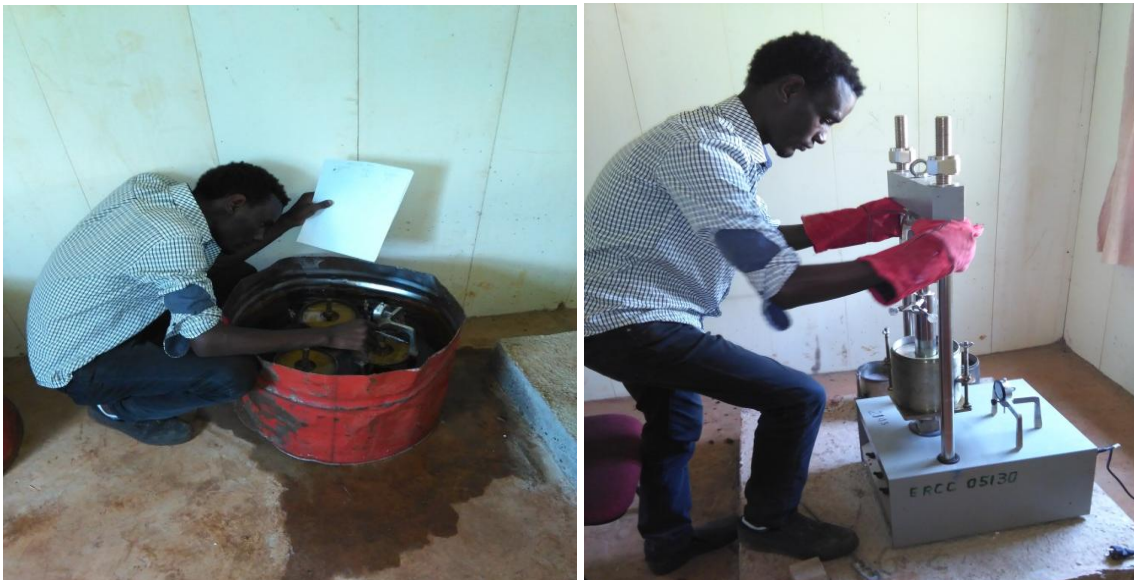
Figure 3-10: Laboratory test for CBR value determination

The different layers such as subgrade, sub-base, and base/course materials strength are classified according to the CBR values. In this research also covers the determination of the CBR of pavement subgrade, subbase, and base/course materials from laboratory compacted specimens. In addition to the AASHTO soil classification tests, the 4 days soaked CBR tests were performed on the material samples to determine the highway construction material shear strengths. The results from the laboratory tests combined with the relevant pavement condition survey provide an evaluation of pavement performance to be made. Therefore, the test was done in the laboratory accordance of test procedures AASHTO T-193.

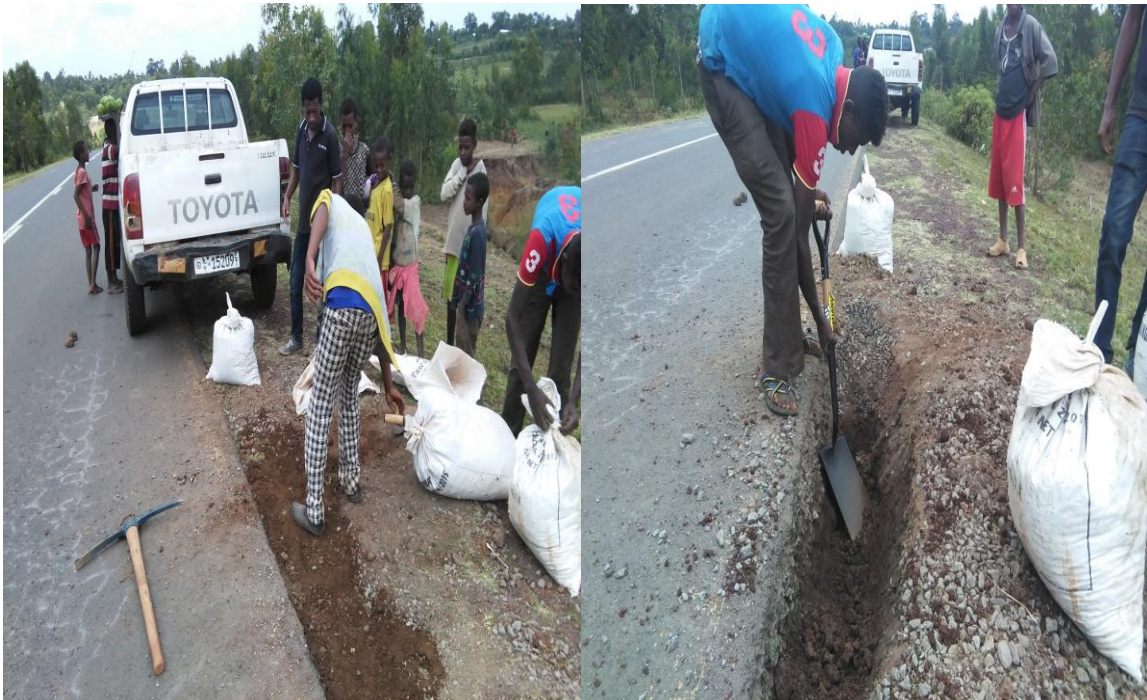
Figure 3-11: Repairing and replacing for excavated pavement layers at section Alaba-Mazoria

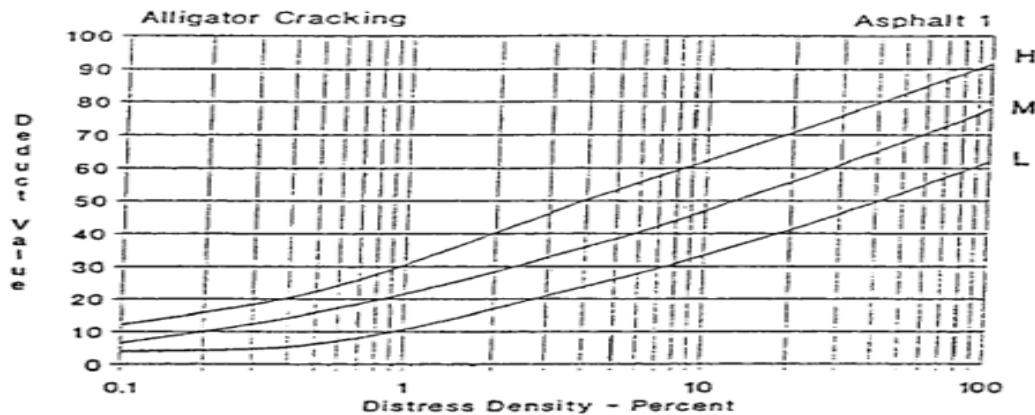
Figure 3-12: Deduct values for Alligator cracking (ASTM D 6433)

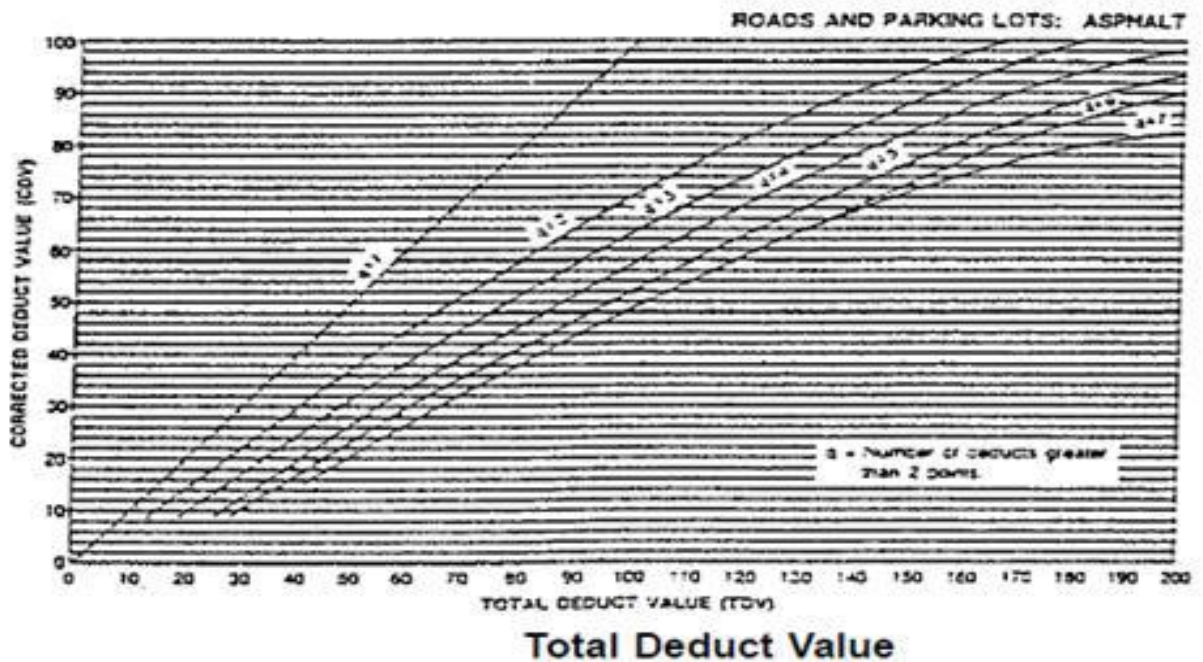
Figure 3-14: Corrected deduct values (ASTM standard D 6433)

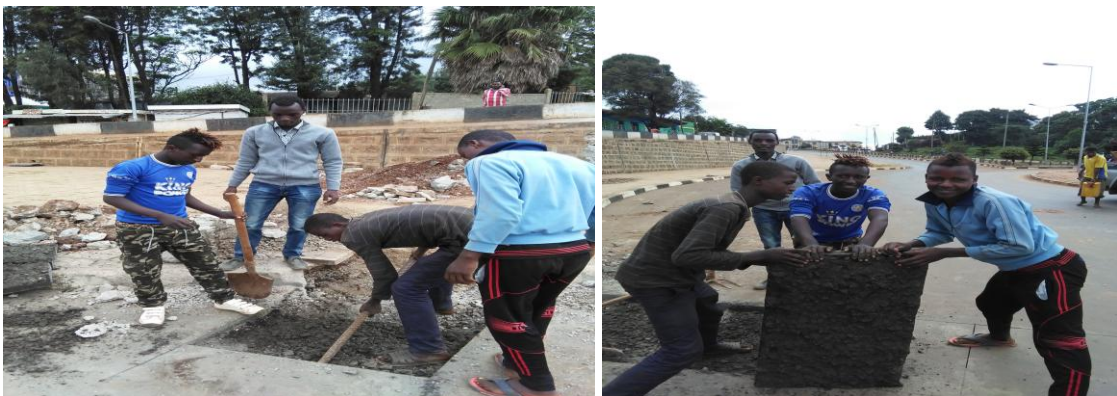
Figure 3-15: Extracting the existing pavement for Sampling of subgrade soil, base course, and sub base materials at Station 67+926 (Sodo Town).

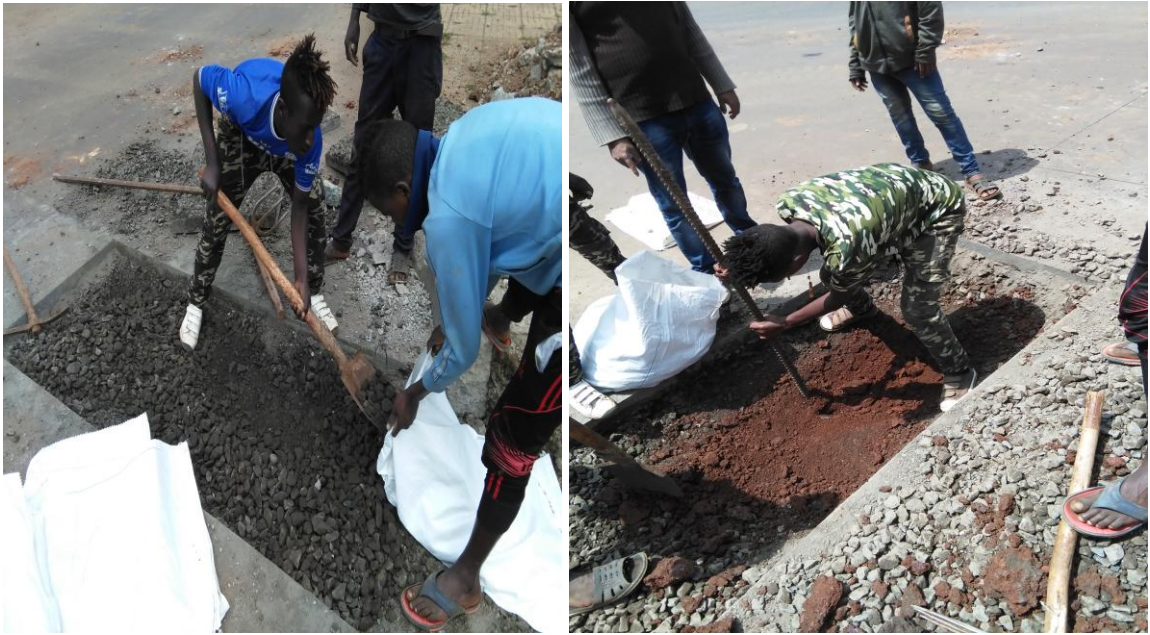
Figure 3-16: Sampling of subgrade soil, base course, and sub base materials from existing pavement at Station 67+926 (Sodo Town).

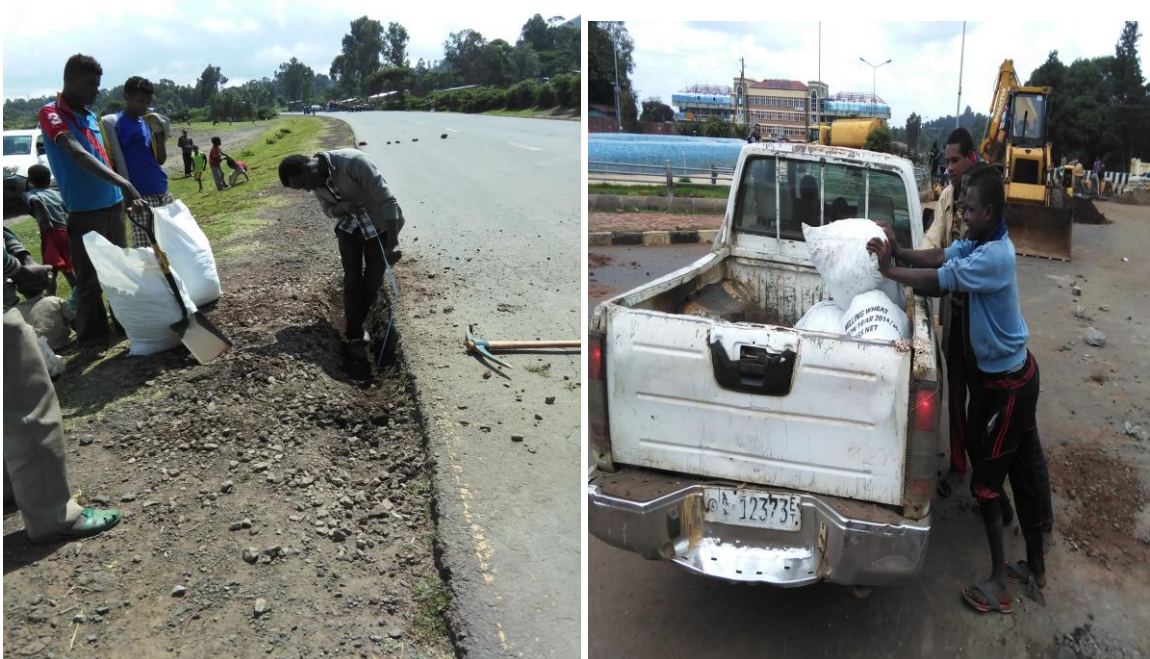
Figure 3-17: Measurement of total depth of excavated pit and transporting it from the stations 13+600-13+800 and 67+926.

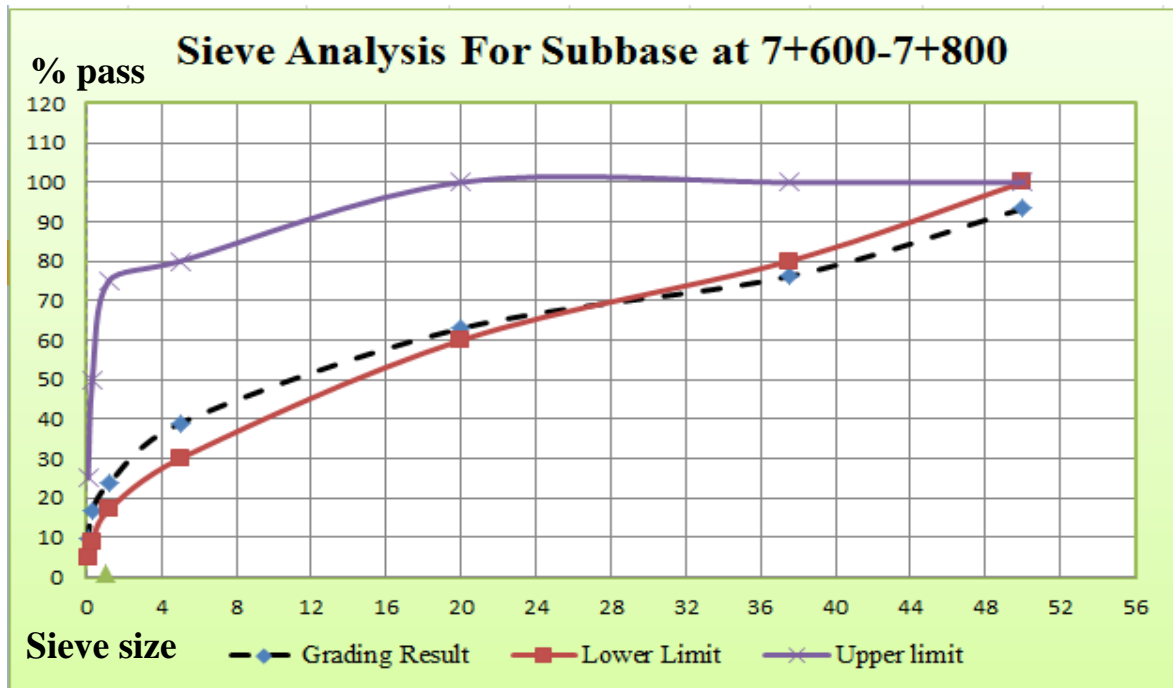
Figure 4-1: Sieve analysis result for sub-base material

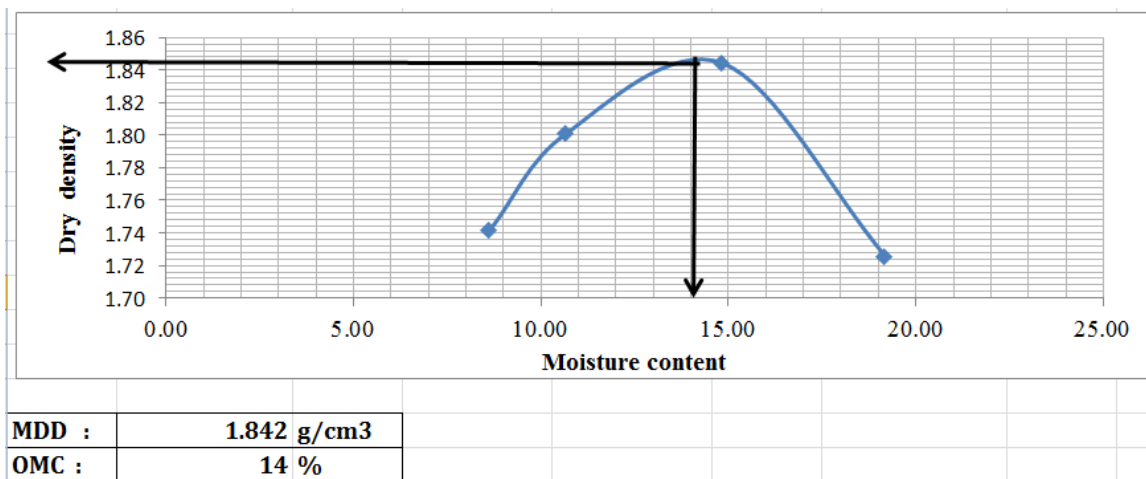
Figure 4-3: Compaction test result for subbase material at station 13+600-13+800

Dry density is determined based on the moisture content and the unit weight of compacted soil. The water content at which this dry density occurs is termed as the optimum moisture content (OMC) and they also determined by reading from graph. Some detail data analysis are shown in Appendix E.
