Jimma University
School of Graduate Study
Jimma Institute of Technology
Civil Engineering Department
Geotechnical Engineering Stream

**Impact of land slide and flood on socio-economic development in DireDawa,
Ethiopia**

A Project submitted to the School of Graduate Study of Jimma University in Partial fulfillment of the requirements for the Degree of Master of Engineering in Civil Engineering (Geotechnical Engineering).

June, 2017

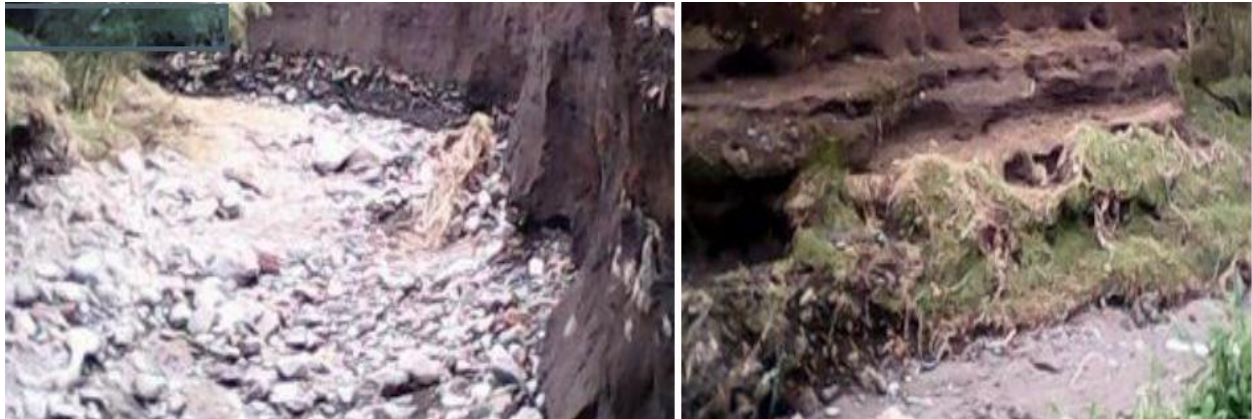
Figure 2 Figure 2.3 photo taken from dechatu river

Soil erosion from the heavy rain water creating wide channels destroyed the agricultural farmlands

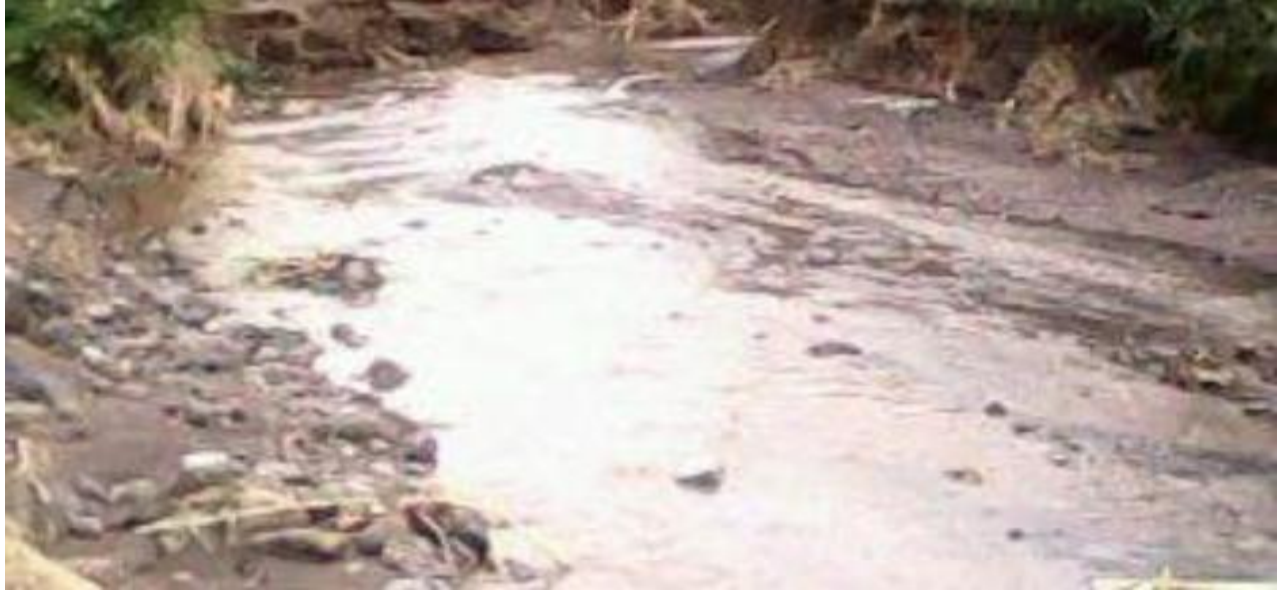
Figure 3 Figure 2.3 photo taken from dechatu river

“The floods have destroyed everything I possessed. The whole area has been cleared of crops we had just planted,” Kedir Aba mecha , a farmer from Melka Area said “It is going to be a hard time to survive because everything we have washed away.” The surging water from Dengego and near area Mountain, changed its normal course and flooded the water channels in sectors which had not experienced floods for decades.
