**INVESTIGATION OF ASPHALT PAVEMENT FAILURE DUE TO  
SUB-BASE AND SUBGRADE SOIL PROPERTIES: A CASE  
STUDY OF KEMMISE – DESSIE ROAD**

A Thesis Submitted to the School of Graduate Studies of Jimma University in Partial Fulfillment of the Requirements for the Degree of Masters of Science in Civil Engineering (Highway)

October, 2016

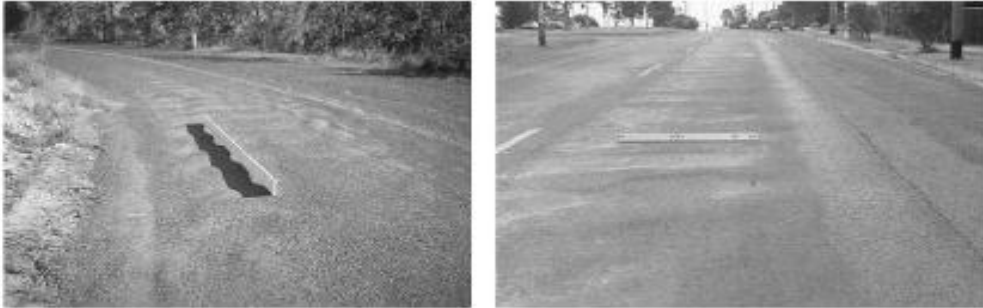
**Figure2.2: Corrugations in flexible pavements (Source: Zahidul, 2006).**

the pavement surface and usually occur where acceleration and deceleration take place such as, bus stop, bends, and intersections. Lack of stability in the surface or base course is the possible cause for corrugations.

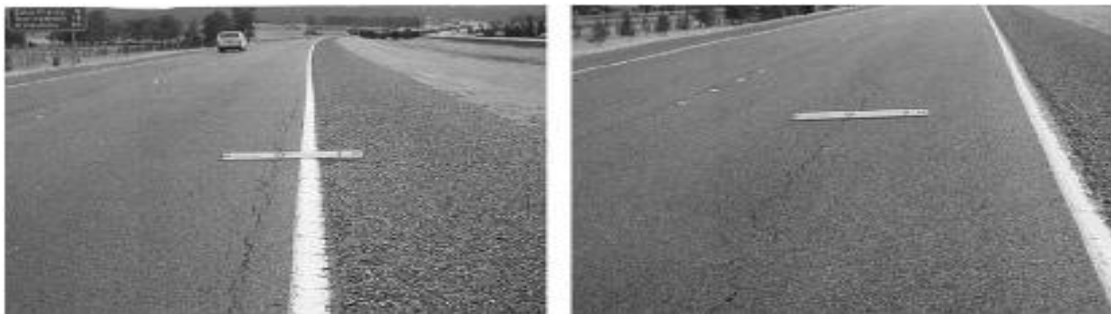
**Figure2.7: Longitudinal Cracks in flexible pavements (Source: Zahidul, 2006).**

Single or a number of parallel cracks appear longitudinally along the pavement due to reflection of a shrinkage crack or joint in the underlying layer, weak bond between pavement lanes, asphalt hardening, volume change in the subgrade, and differential settlement between cut and fill. Poorly constructed lane joint may also cause longitudinal cracks. These cracks do not usually result from load but wide cracks will permit water to enter the pavement structure (Zahidul, 2006).

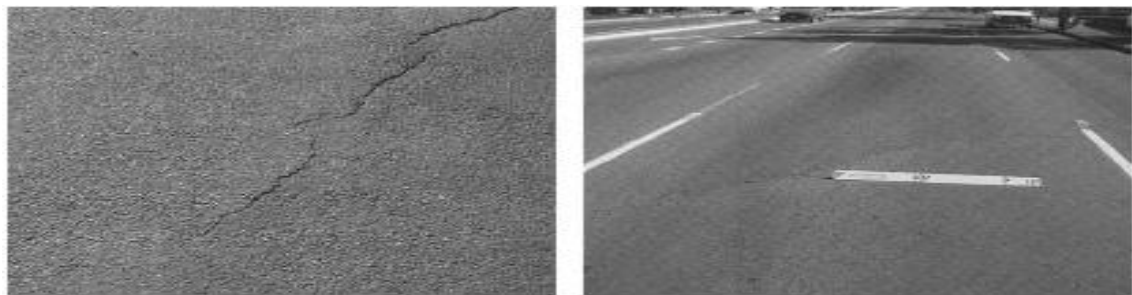
**Figure2.9: Diagonal Cracks in flexible pavements (Source: Zahidul, 2006).**

These are single cracks that form diagonally across the pavement, as shown in Figure 19.14. Differential settlement, service trenches, and shrinkage crack or joint in the underlying layers are possible causes for diagonal cracks (Zahidul, 2006).

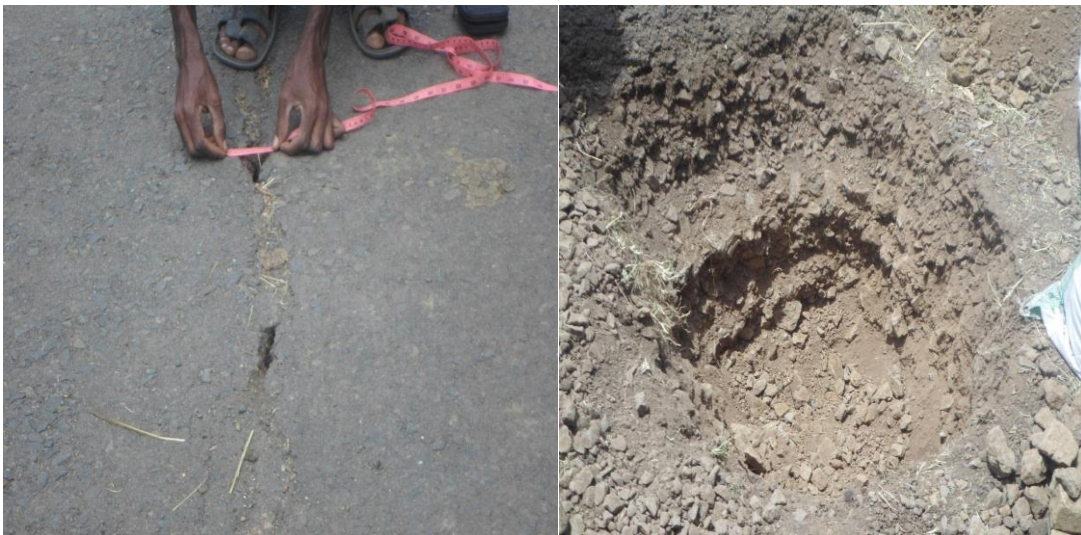
**Figure 3.4 Representative Transverse cracks and their sample (20/09/2008)**

✓ In **sample two** to describe and problem of **transverse crack** type of damaged

**Problem:** Allows moisture infiltration, roughness

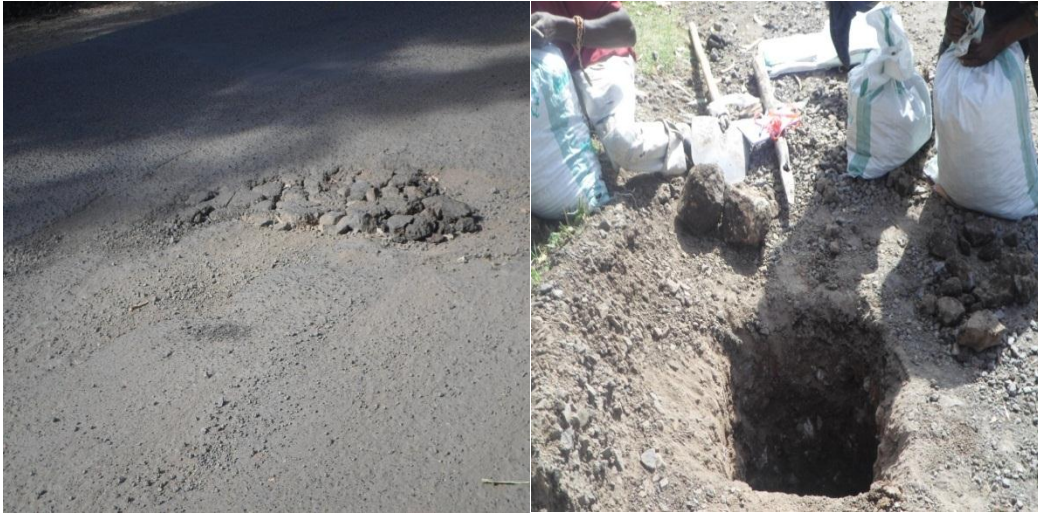
**Figure 3.5 Representative patched damaged and their samples (23/09/2008)**

✓ In **sample three** to describe and problems of **patching** type of damaged

**Problem:** Roughness.

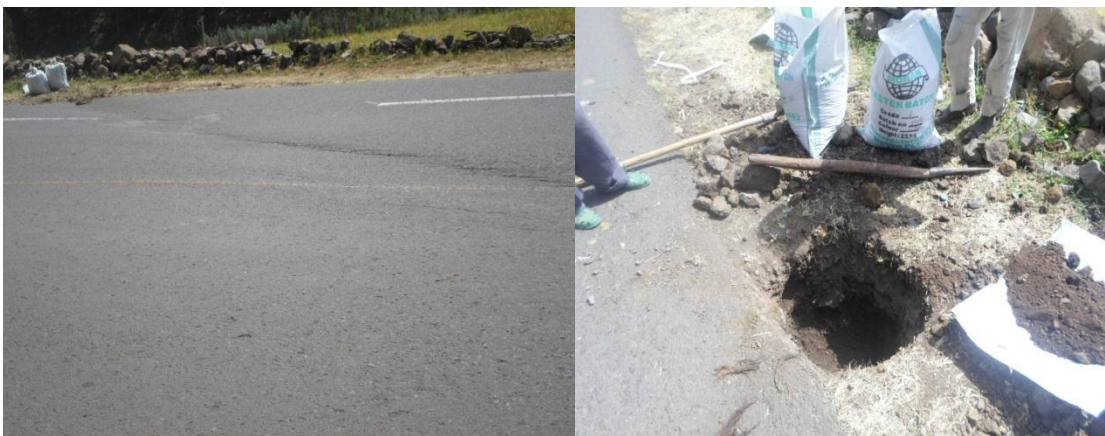
**Figure 3.6 Representative transversal depression and their samples (23/09/2008)**

- ✓ In **sample four** to describe and problems of **transversal depression** type of damaged

**Problem:** Roughness

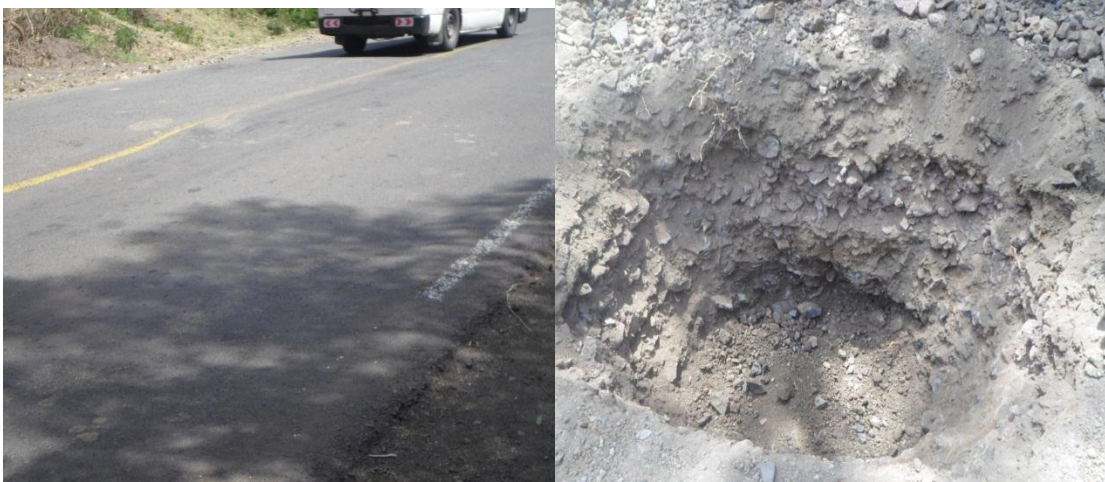
**Figure 3.7 Representative Shoved/ Corrugation damaged and their samples (28/09/2008)**

- ✓ In **sample five** to describe and problems of **shoving/ corrugation** type of damaged

**Problem:** Roughness

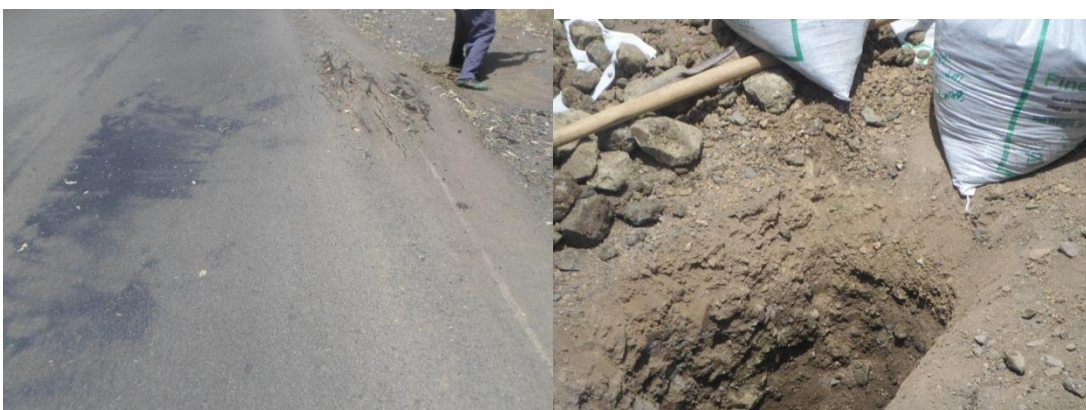
**Figure 3.8 Representative Rutting damaged and their samples (28/09/2008)**

✓ In **sample six** to describe and problems of **rutting** type of damaged

**Problem:** Ruts filled with water, can be hazardous because ruts tend to pull a vehicle towards the rut path as it is steered across the rut.

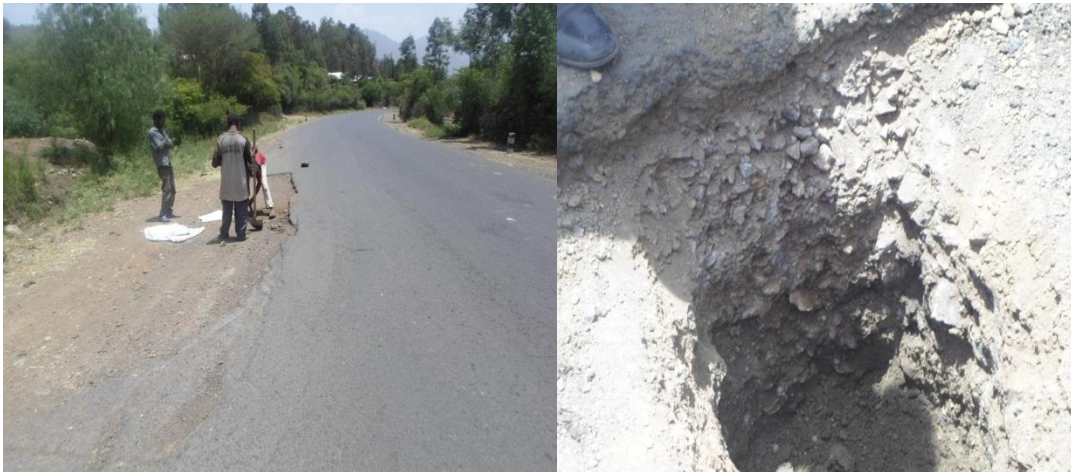
**Figure 3.9 Representative Potholes/debonding damages and their samples  
(29/09/2008)**

- ✓ In **sample seven** to describe and problems of **potholes/ debonding** type of damaged

**Problem:** Roughness (serious vehicular damage can result from driving across potholes at higher speeds), moisture infiltration.

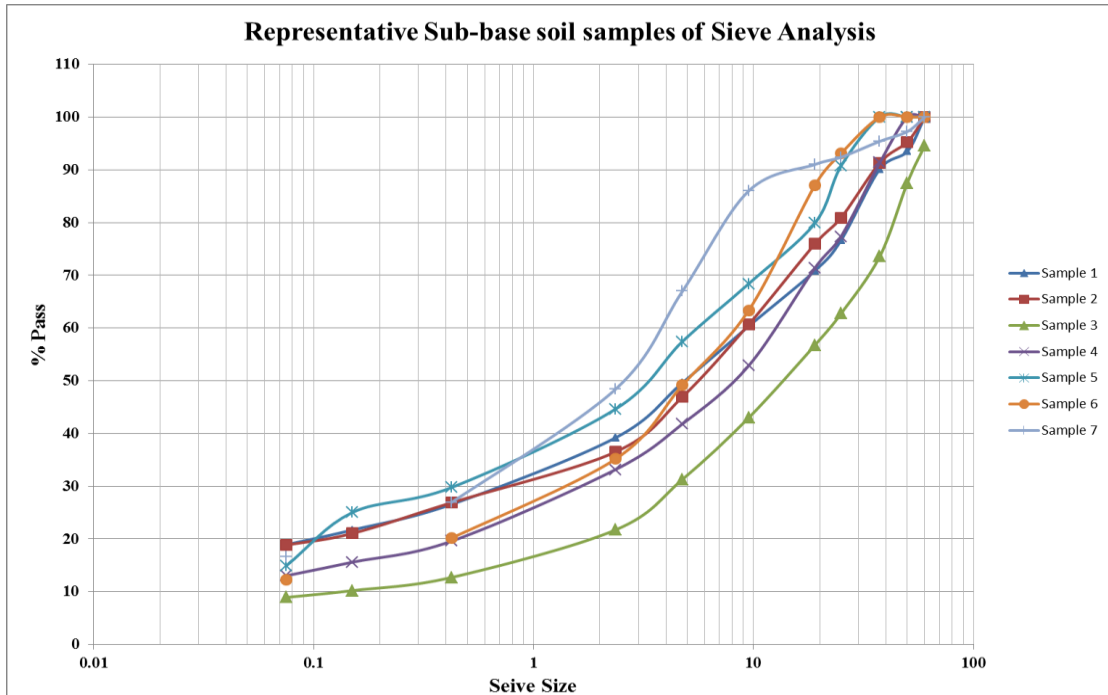
**Figure 4.4: Sieve Analysis graph of sub-base soil sample**

The result of the particle size analysis contained in Table 4.2 indicates that the soil's clay content for all sub-base samples ranged from 8.9% to 18.9%. According to the Federal Ministry of Works and Housing (1997) specification, the clay content for sub-base materials must not exceed 35%. The high clay content could be responsible for instability of road pavement in the area. so from test results for all sub-base materials are fulfilling the FMWH specification.

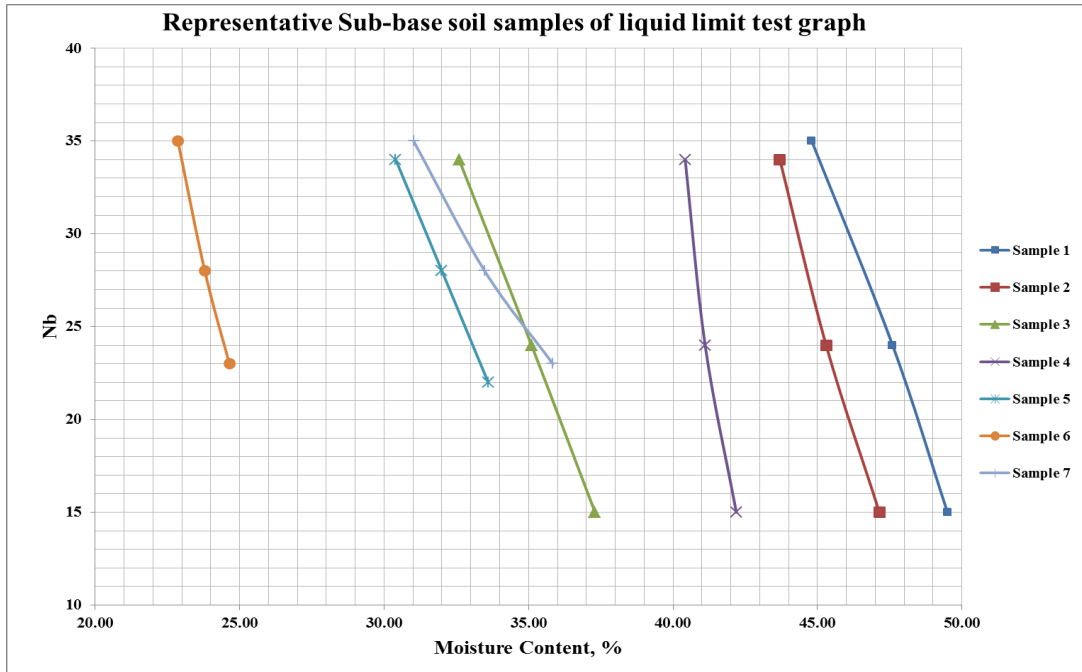
**Figure 4.5: Liquid limits test graphs of sub-base soil samples**

- According to Ethiopian Road Authority (ERA), Addis Ababa – Dessie rehabilitation project material specification requirements. For sub-base material  $PI \leq 15$ . All sub-base soil samples met these required specification except sample 1 and 2 sub-base materials.
- The Federal Ministry of Works and Housing (1997) specifications are liquid limits of 30% maximum, plastic limit of 30% maximum and plasticity index of 13% maximum for sub-base materials. From Table 4.3 shows that the liquid limit of the sub-base soils ranged from 23.6% to 47.3% while the plastic limit ranged from 16.9% to 30.45% and the plasticity index ranged from 6.7 to 18.05. None of the sub-base soil samples met these required specification except sample 6.

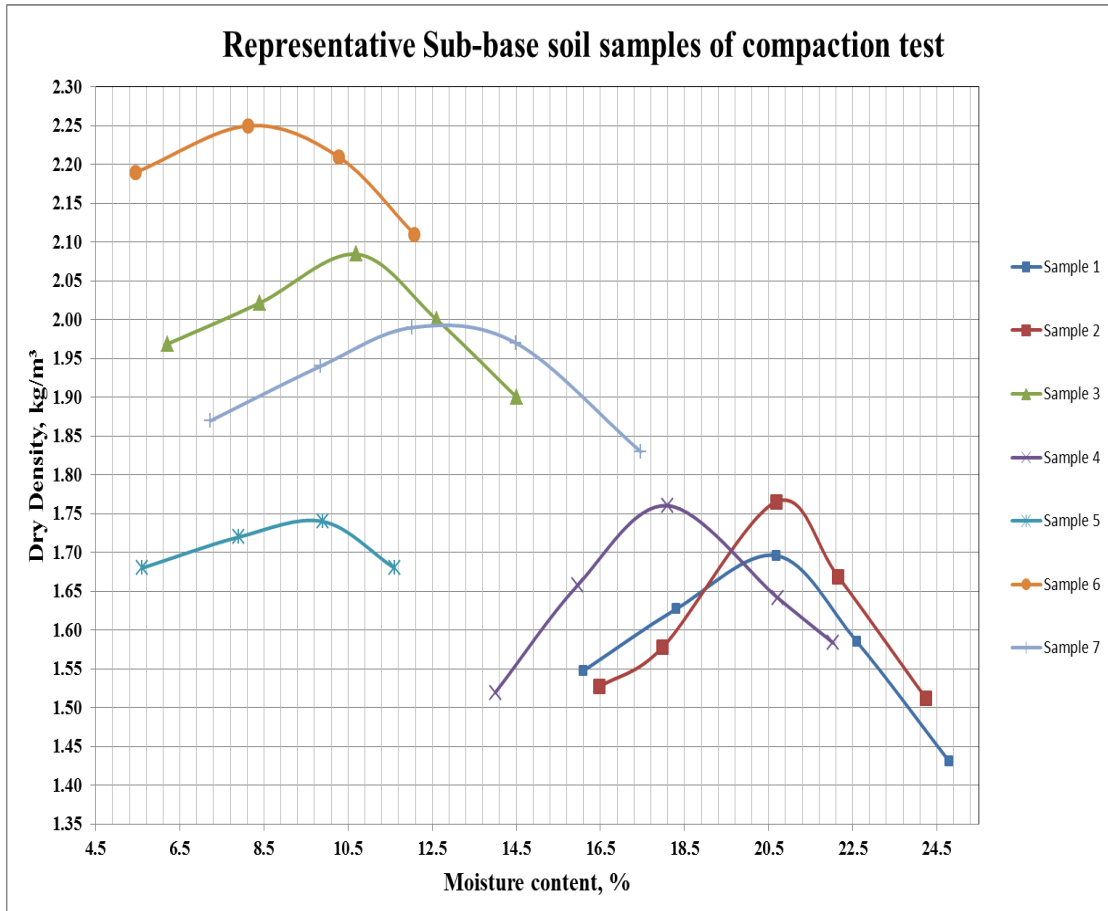
Figure 4.6: Compaction test graphs of sub-base soil samples

From Table 4.6, shows that the maximum dry density (MDD) of the sub-base soil materials ranged between 1.74 and 2.25 kg/m<sup>3</sup>, while the optimum moisture content (OMC) ranged from 8.5% to 20.71 %. The Federal Ministry of Works and Housing, (1997) specified OMC less than 18% for sub-base soil materials. Based on these specifications, sub-base soil samples 1 and 2 are not suitable as sub-base material. Sub-base Sample 4 could be suitable with a minimal soil modification.

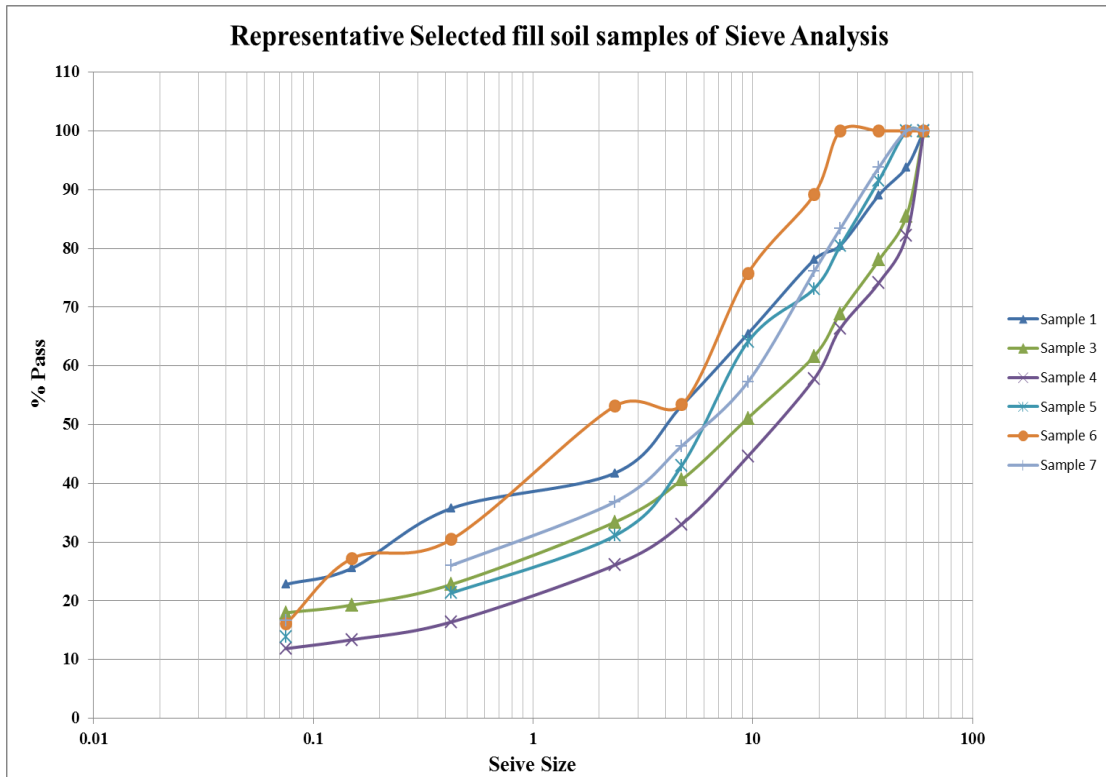
Figure 4.8: Sieve Analysis graphs of selected fill soil samples

responsible for instability of road pavement in the area. so from test results for all selected fill materials are fulfilling the FMWH specification.

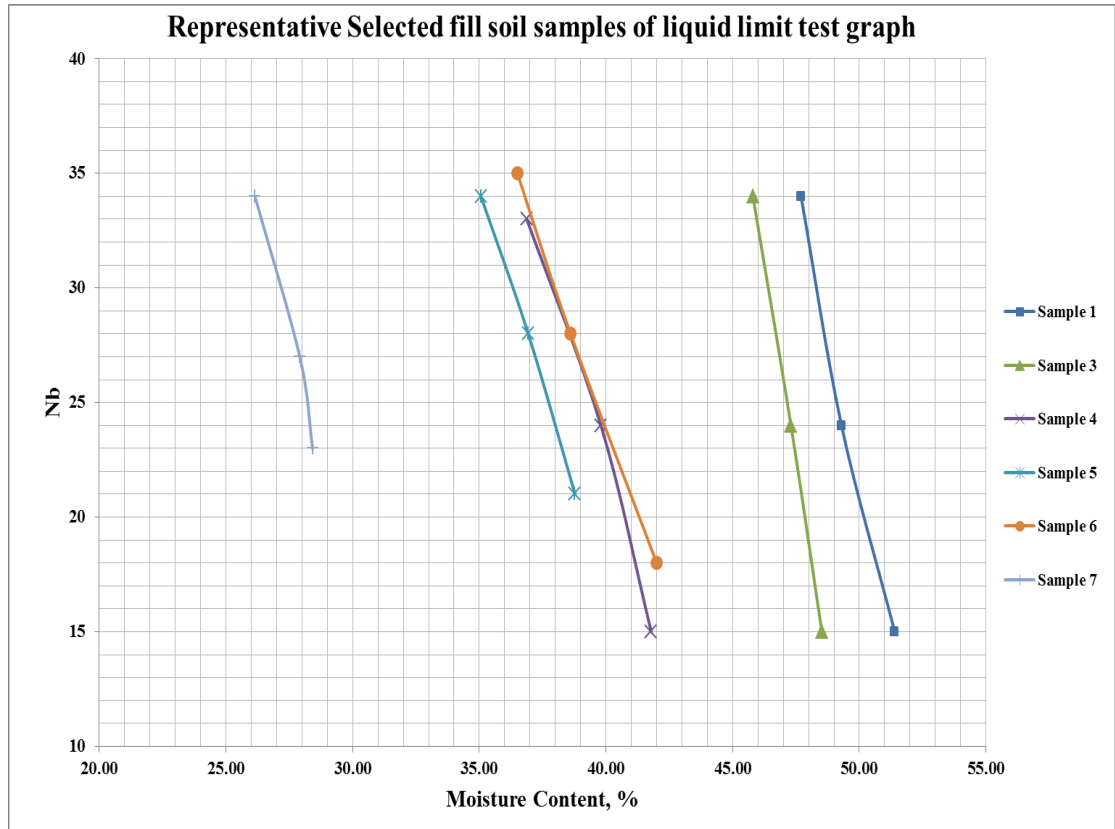
**Figure 4.9: Liquid limits test graphs of selected fill soil samples**

- ✓ According to Ethiopian Road Authority (ERA), Addis Ababa – Dessie rehabilitation project material specification requirements. For selected fill material  $PI \leq 25$ . All selected fill soil samples met these required specification.
- ✓ The Federal Ministry of Works and Housing (1997) specifications are liquid limits of 30% maximum, plastic limit of 30% maximum and plasticity index of 13% maximum for selected fill materials. From Table 4.3 shows that the liquid limit of the selected fill soils ranged from 27.6 % to 48.95 % while the plastic limit ranged from 15.8 % to 29.55 % and the plasticity index ranged from 11.2 to 20.5. None of the selected fill soil samples met these required specification except sample 7.

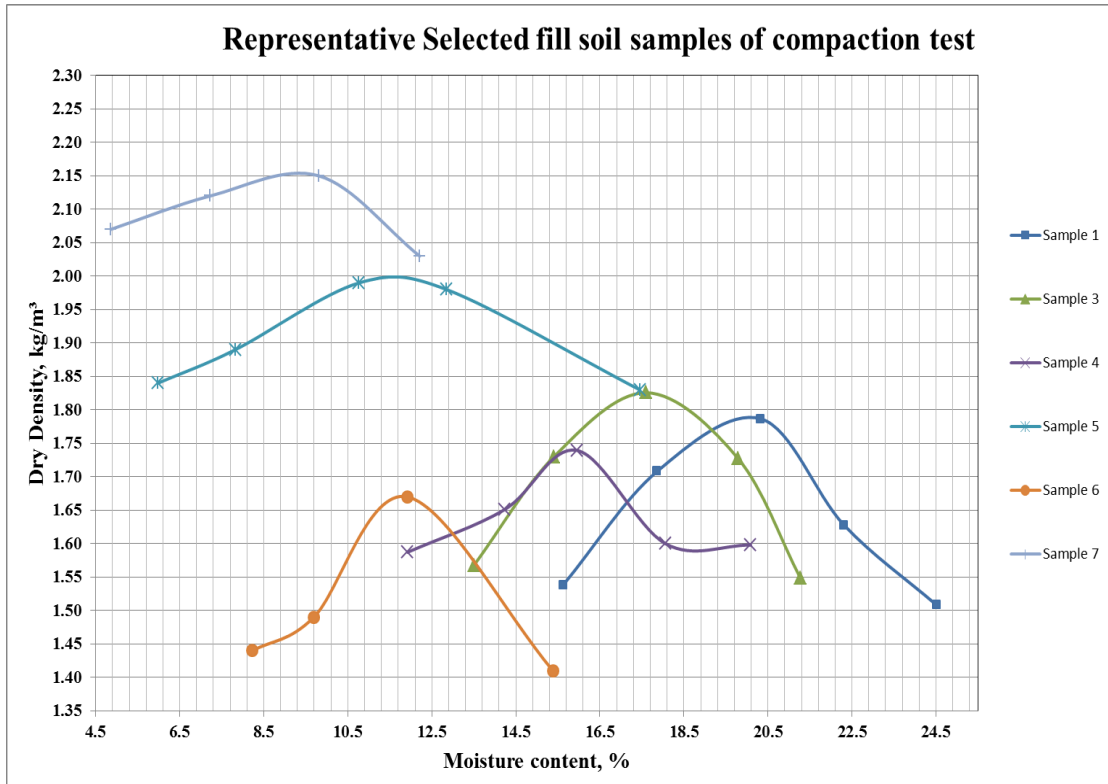
Figure 4.10: Compaction test graphs of selected fill soil samples

From Table 4.6, shows that the maximum dry density (MDD) of the selected fill soil materials ranged between 1.65 kg/m<sup>3</sup> and 2.16 kg/m<sup>3</sup>, while the optimum moisture content (OMC) ranged from 9.4 % to 20.33 %. The Federal Ministry of Works and Housing, (1997) specified OMC less than 18% for selected fill soil materials. Based on these specifications, selected fill soil sample 1 are not suitable as selected fill material.

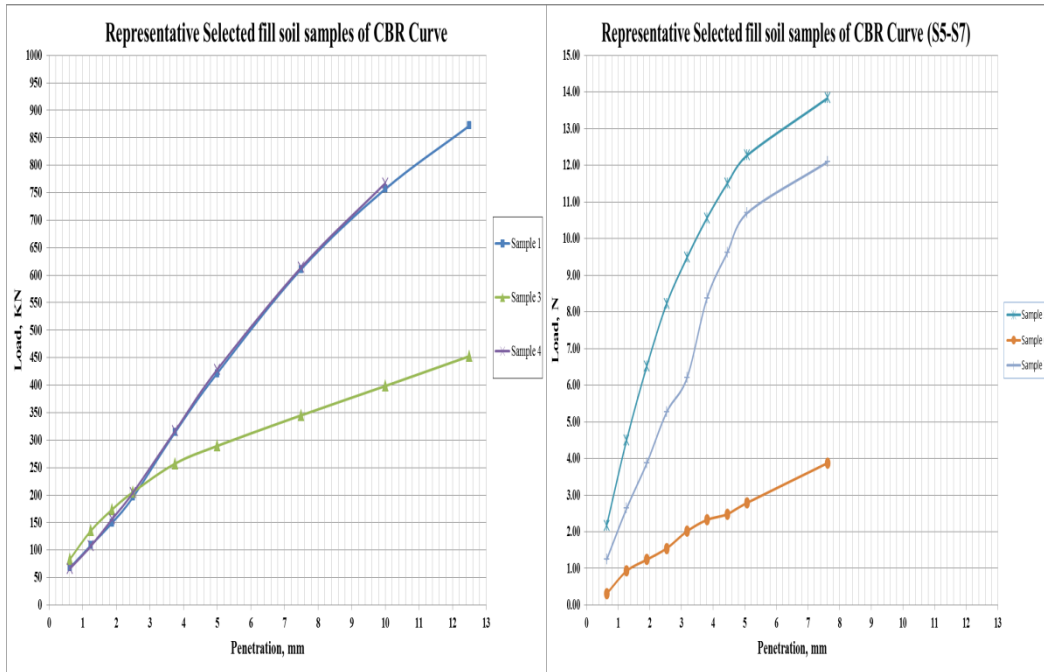
Figure 4.11: California Bearing Ratio test graphs of selected fill soil samples

From Table 4.7, shows that the four days soaked CBR values of selected fill soil materials ranged from 13.9 % to 62 %. The Ethiopian Road Authority (ERA), Addis Ababa – Dessie rehabilitation project material specified CBR greater than or equal to 15 % for selected fill materials. Based on these specifications, selected fill soil sample 6 are not suitable as selected fill material.

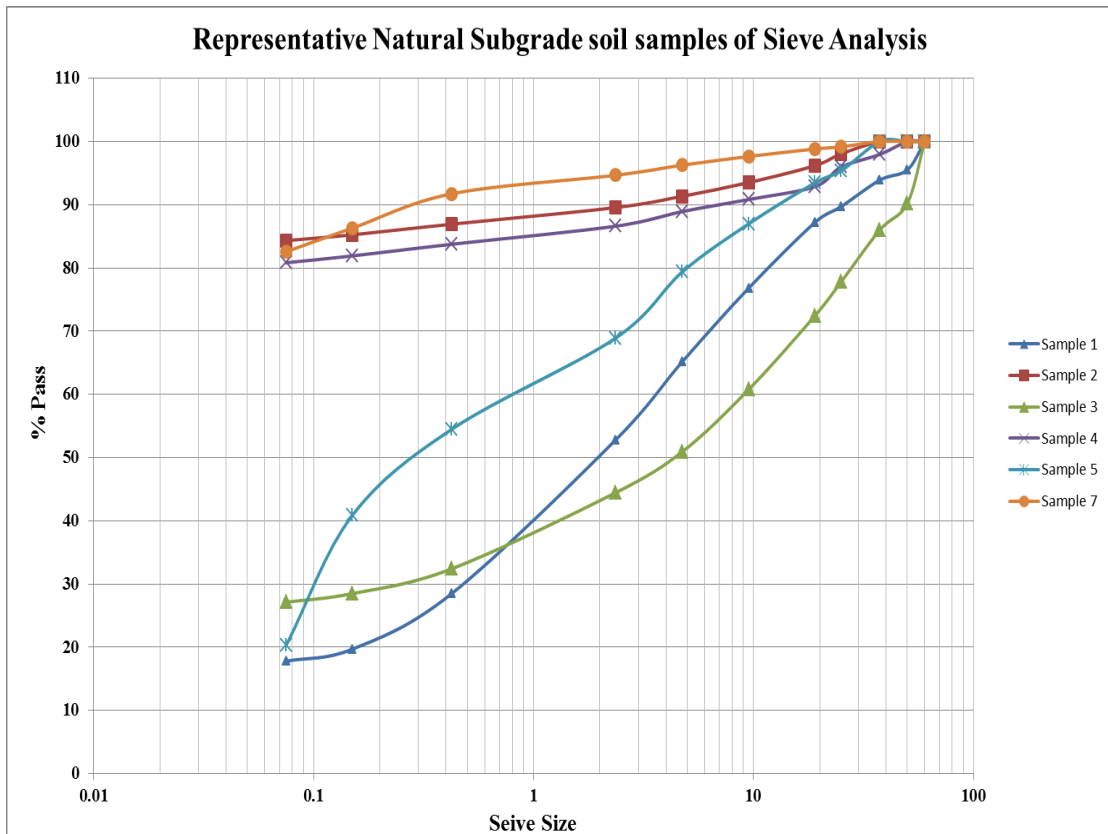
**Figure 4.12: Sieve Analysis test graphs of natural subgrade soil samples**

these specifications, natural subgrade soil sample 2, 4 and 7 are not suitable as embankment. Also, general rating as sub-grade (in accordance with AASHTO (1986)) is fair to poor materials. They have significant constituent materials of mainly clayey soils while few are silty or clayey gravel and sand whereby the % passing No 200 sieve is <35%.

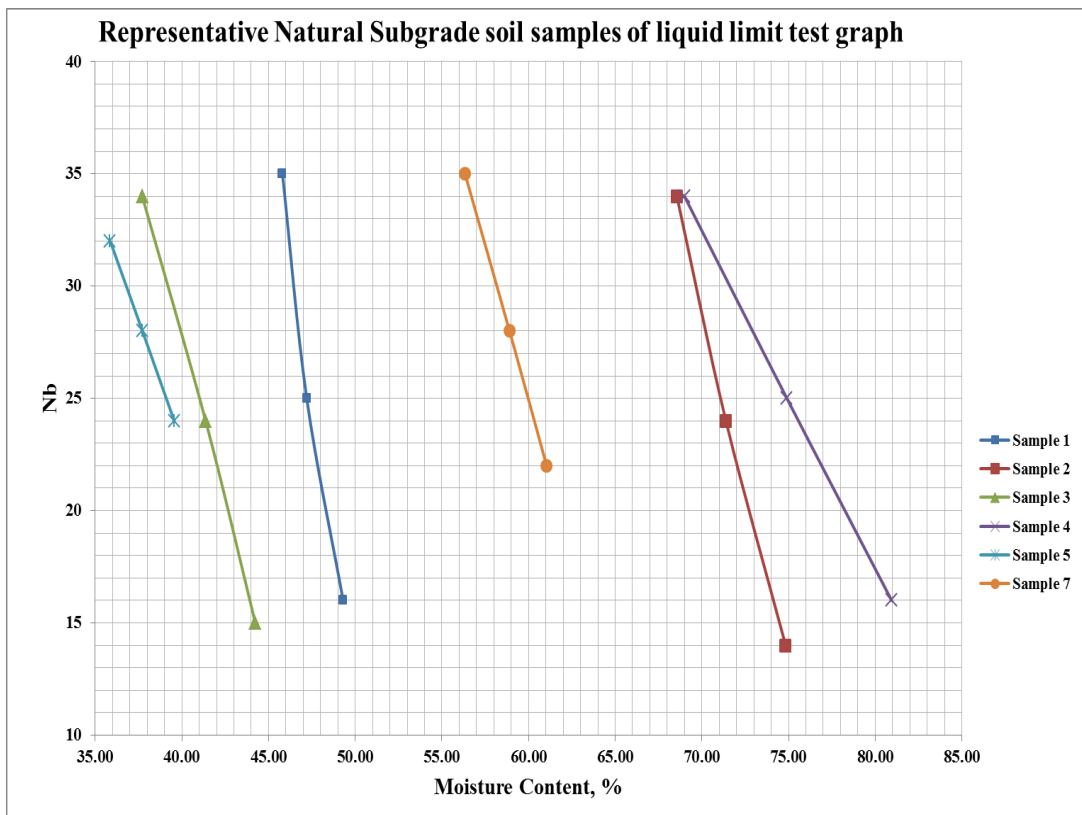
**Figure 4.13: Liquid limits test graphs of natural subgrade soil samples**

- ❖ From the AASHTO soil classification of soil samples for highway, A-1, A-3, and A-2 soils are excellent to good soils for highway with percentage passing Sieve No. 200 not more than 35% while A-4 to A-7 soils are fair to poor soils with percentage passing Sieve No. 200 greater than 35%. Based on this, natural subgrade soil Samples 1, 3, and 5 may be classified as excellent to good sub-grade soils while the sample 2, 4, and 7 are fair to poor soils for sub-grade.

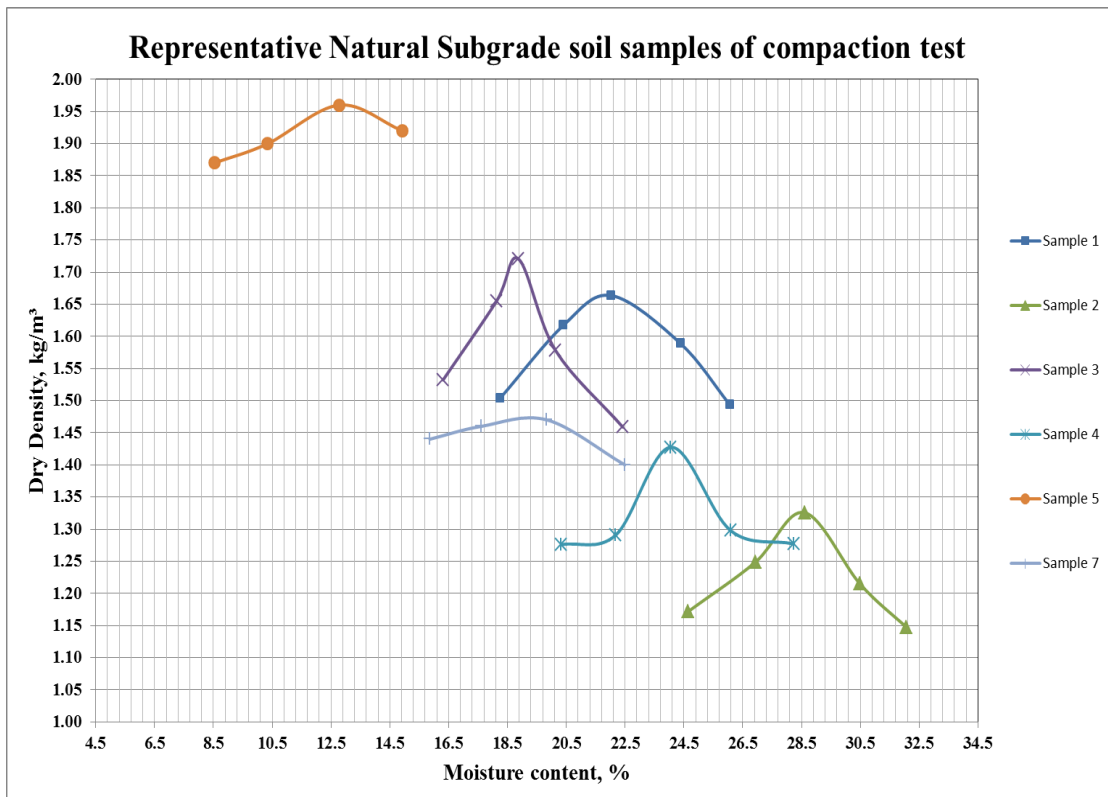
Figure 4.14: Compaction test graphs of natural subgrade soil samples

are not suitable as subgrade (embankment) material. Natural subgrade Sample 3 could be suitable with a minimal soil modification.

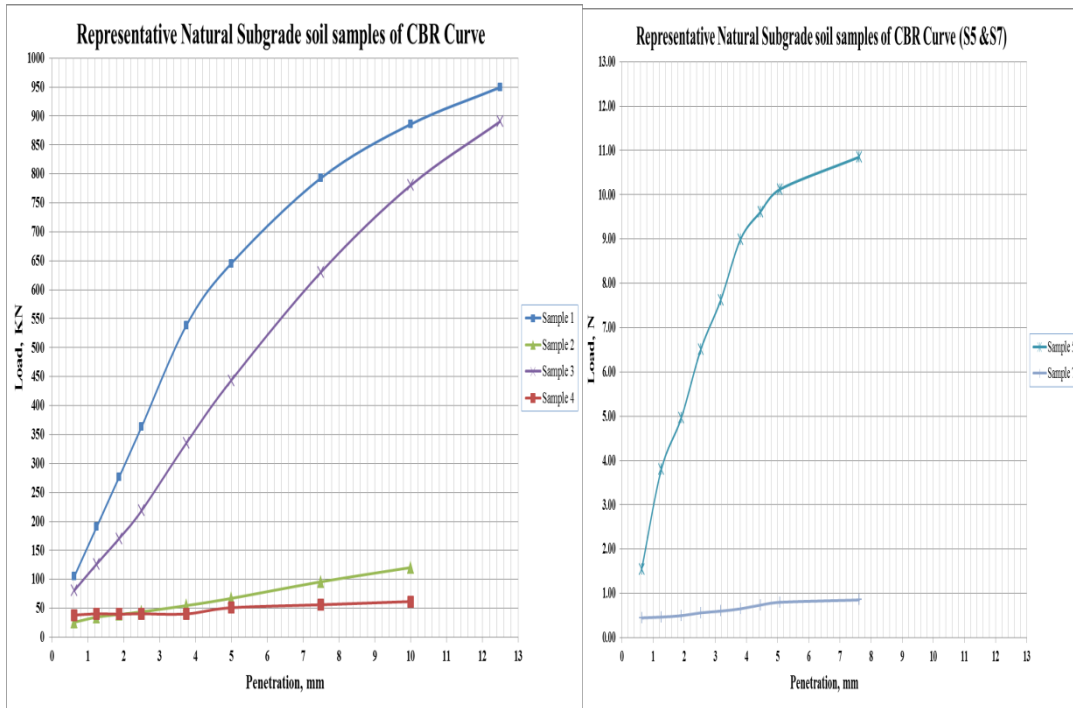
**Figure 4.15: California Bearing Ratio test graphs of natural subgrade soil samples**

From Table 4.7, shows that the four days soaked CBR values of natural subgrade soil materials ranged from 3 % to 50.58 %. The Ethiopian Road Authority (ERA), Addis Ababa – Dessie rehabilitation project material specified CBR greater than or equal to 5 % for natural subgrade materials. Based on these specifications, natural subgrade soil samples 2, 4, and 7 are not suitable as subgrade material.

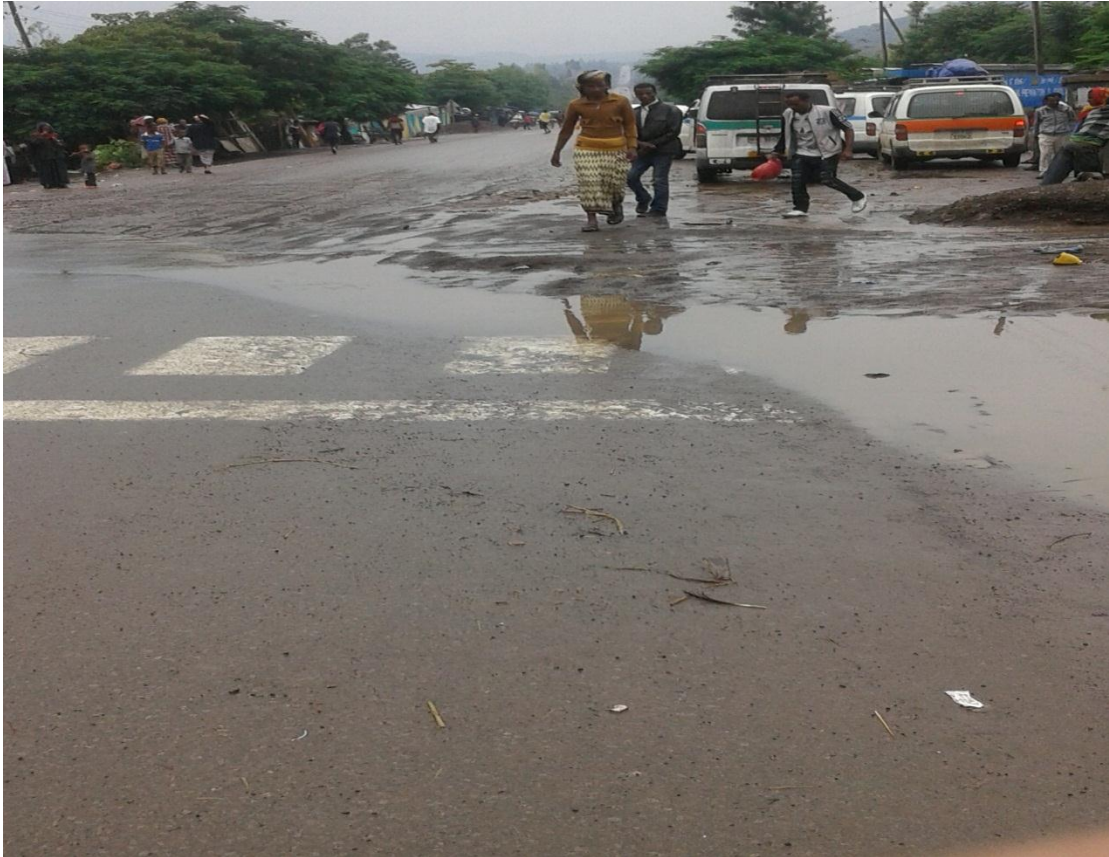
**Figure4.16: Drainage problem in Harbu town**

The pavement design and construction practice must be modified in such a way to have structural pavement layers capable of draining free water rapidly after its entry. Such rapid drainage can be achieved by providing highly permeable layers of open graded material with collector pipes to ensure constant gravity drainage. Surface and sub-surface drainages not only protect pavements from large surface inflow, but also from inflows of high ground water in wet periods or any unexpected inflows.
