*Investigation on the Causes of Pedestrian Accidents at Roadside Walkways and its Possible Interventions, Case Study in Jimma Town.*

A Thesis submitted to the School of Graduate Studies of Jimma University in Partial fulfillment of the requirements for the Degree of Masters of Science in Civil Engineering (Highway Engineering)

By  
Melkamu Gizaw Gobena

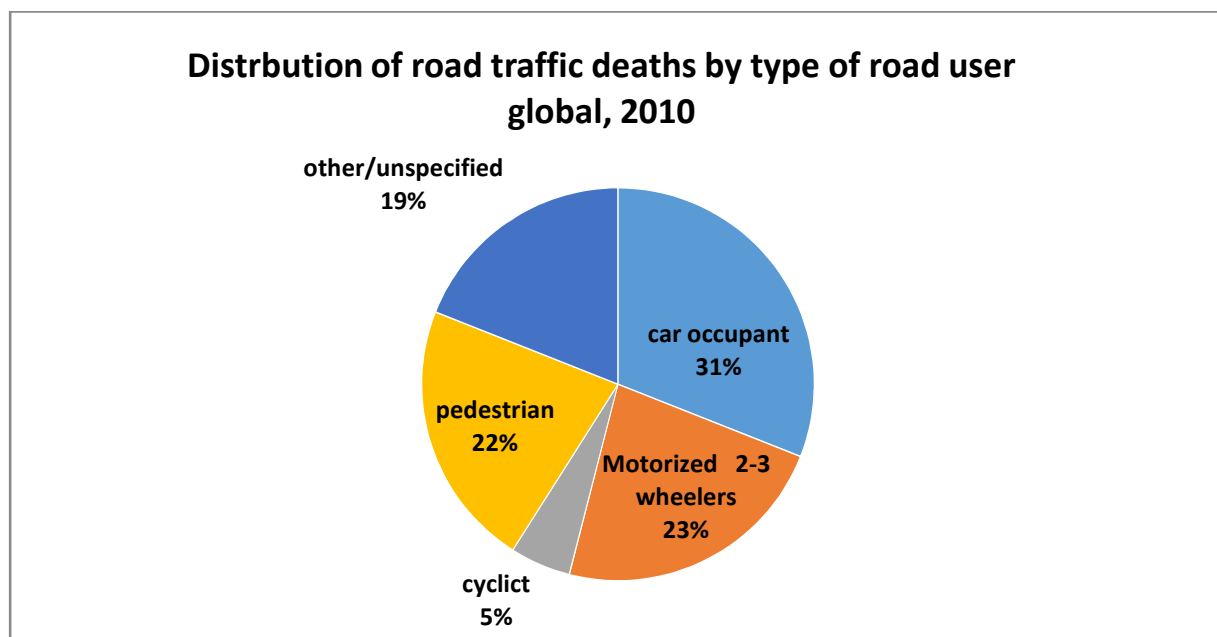
Figure 1.1 Distribution of road traffic deaths by type of road user, global, 2010

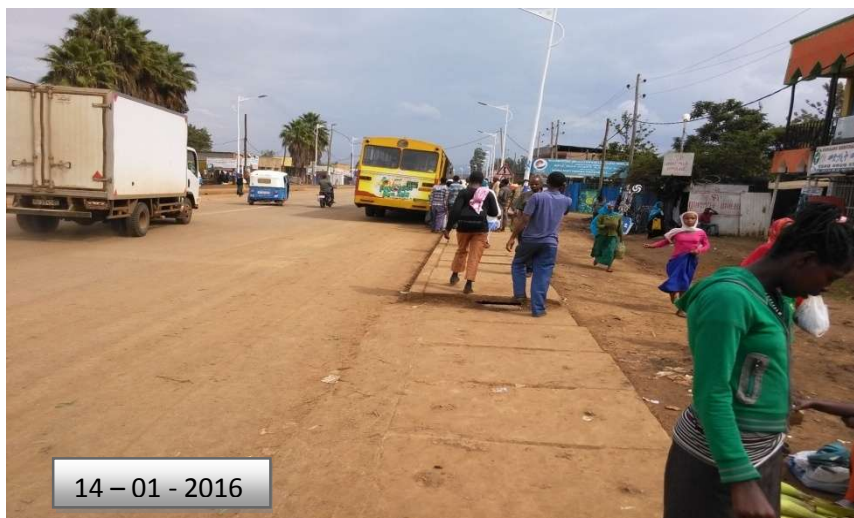
Figure 4.1 No Walkway No Buffer around Menaheria (Bus station)

Walking along the road way is another type of accident that can be seen almost everywhere in Jimma city. Often people faced accident while waiting for the buses or taxi on the walkways or just beside the walkway. Some buses, taxi or other human haulers collide with the pedestrians for not having the control of the speed in the places where they are supposed to stop. Walkers in the Cenentral Hotel – Feidi RA – Shenen Gibe Hospital are facing a crash so often while waiting for the taxi or bus. From Hermata Bank – Tsehay Abebe RA most of the cases pedestrians are not using the sidewalks due to some sort of problems are getting collided with some vehicles. In the route from Tsehay Abebe RA – Farmid RA- Awetu River area is somewhat good.

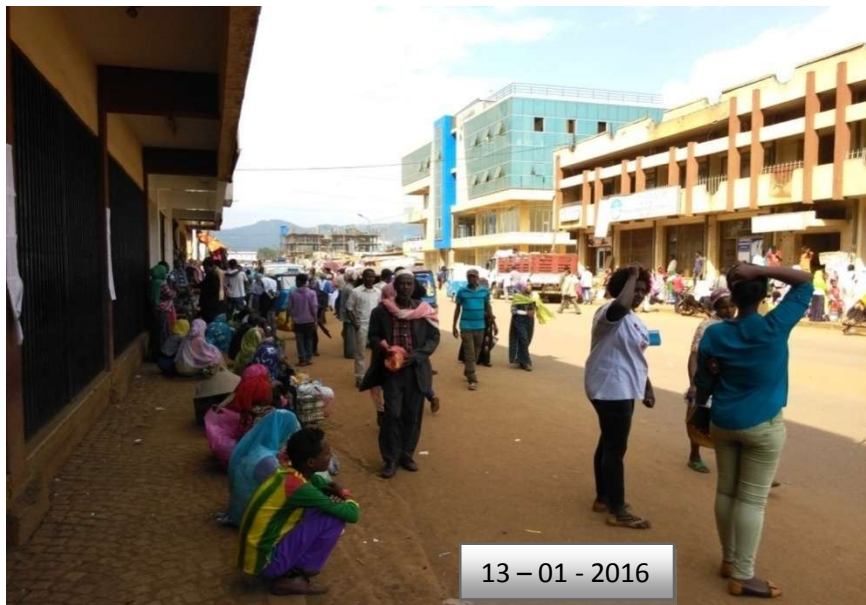
Figure 4.2 Walkway without Buffer (Around Merkato)

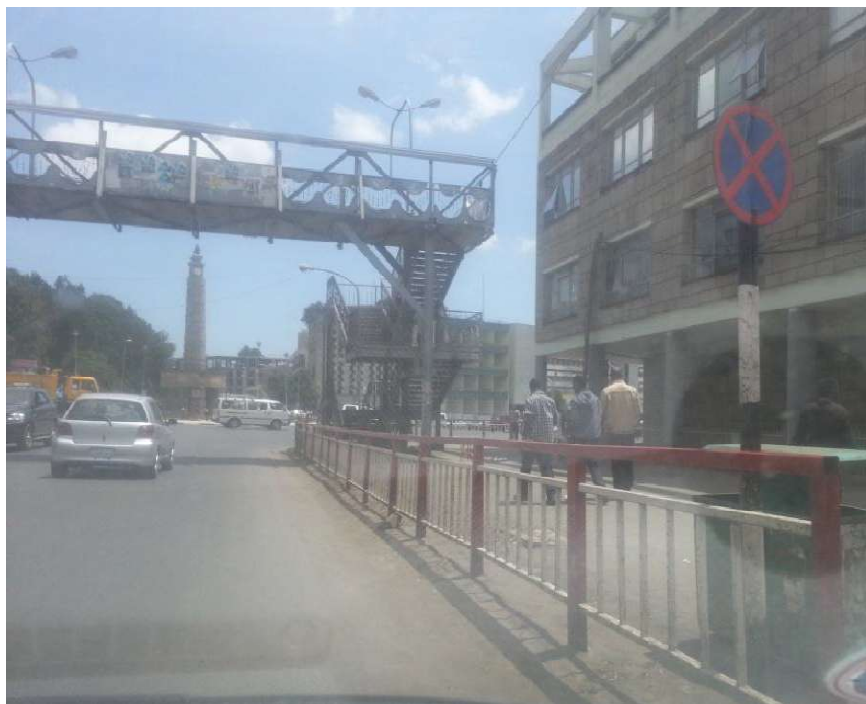
Figure 4-3 Sample Walkway with buffer (Not in Jimma)

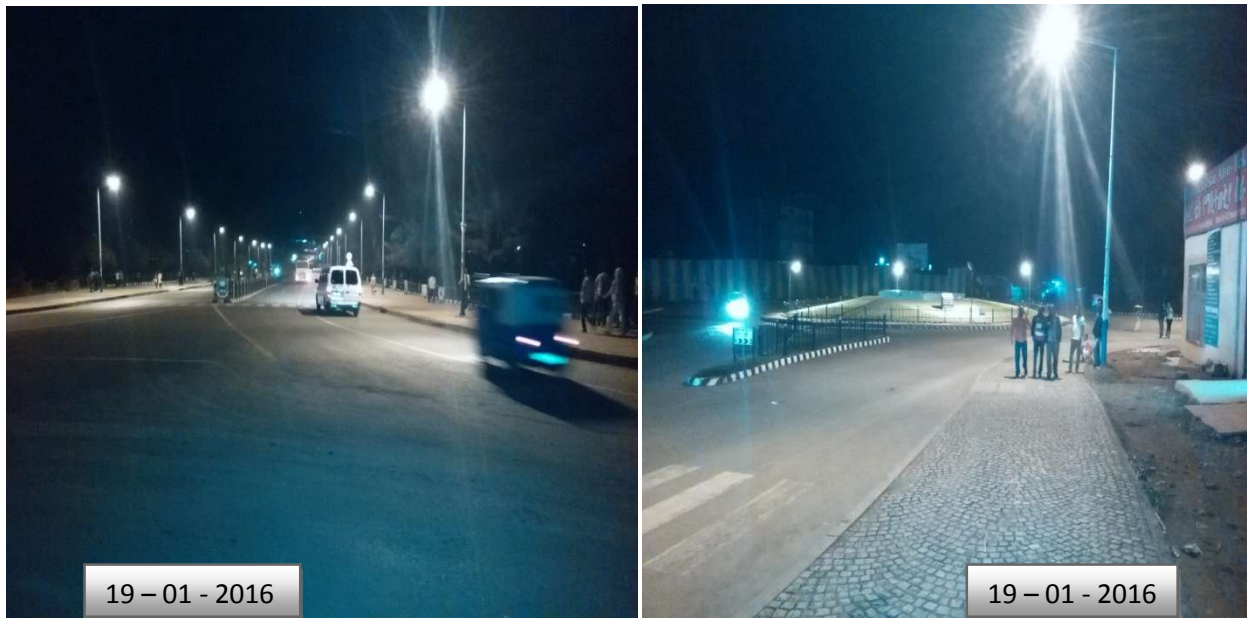
Figure 4-4 the above picture shows with good light (Around Ferenj Arada and Mercato )

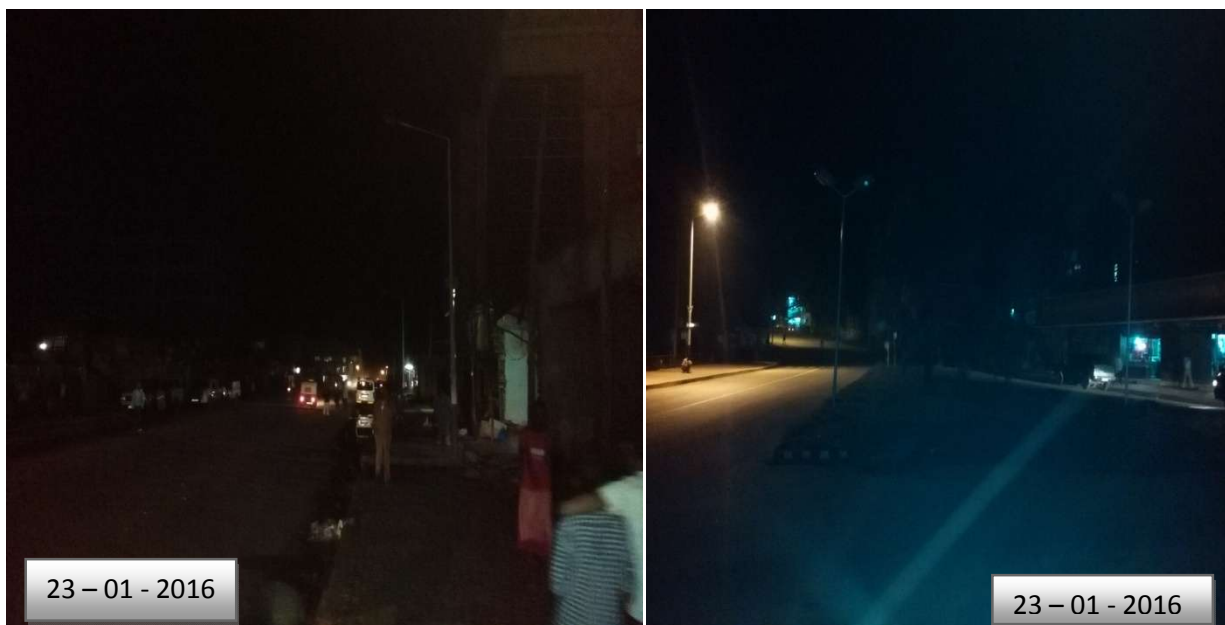
Figure 4-5. The above picture shows with bad light( Around Bus station and Leghar )

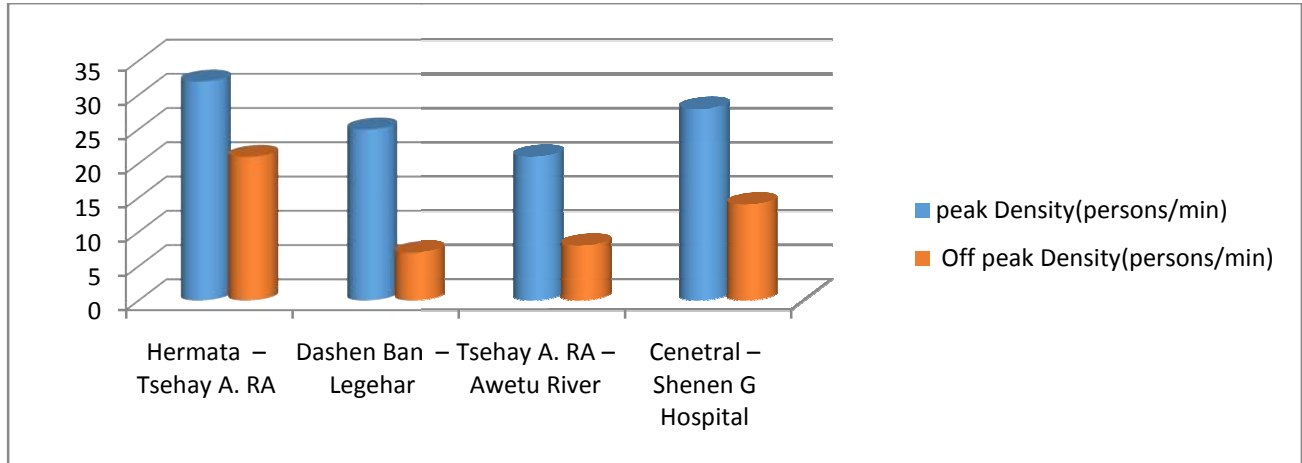
Figure 4.6 shows peak and off peak density of the selected blocks

Study Routes	Density(persons/mi n)		Sitting Benches	Illegal occupancy
	Peak	Off peak		
Hermata Bank – Tsehay Abebe RA	32	21	None	Illegal vendors, structures and parking car
Dashen Bank(Merkato) – Legehar	25	7	None	Illegal vendors, structures and parking car
Tsehay Abebe RA – Farmid RA- Awetu River	21	8	None	To some extent
Cenentral Hotel – Feidi RA – Shenen Gibe Hospital	28	14	None	Illegal vendors, structures and parking car

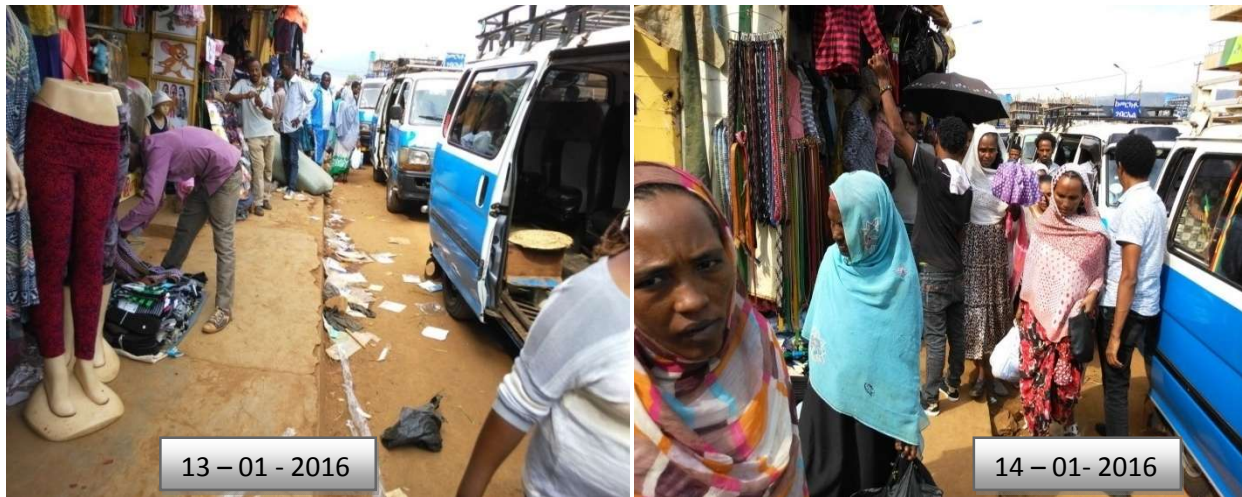
Figure 4.6 the above figure shows illegal vendors (Around Merkato)

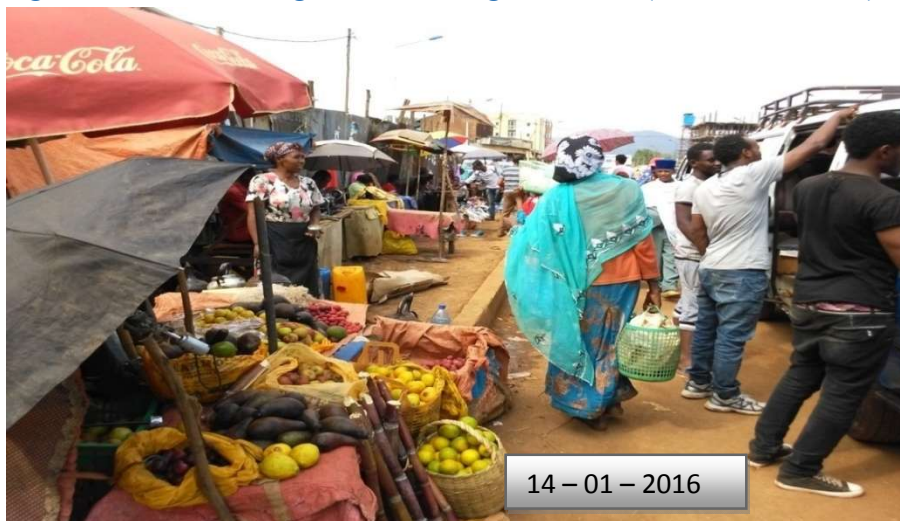
Figure 4.7 the above figure shows Obstacles (Around Merkato)

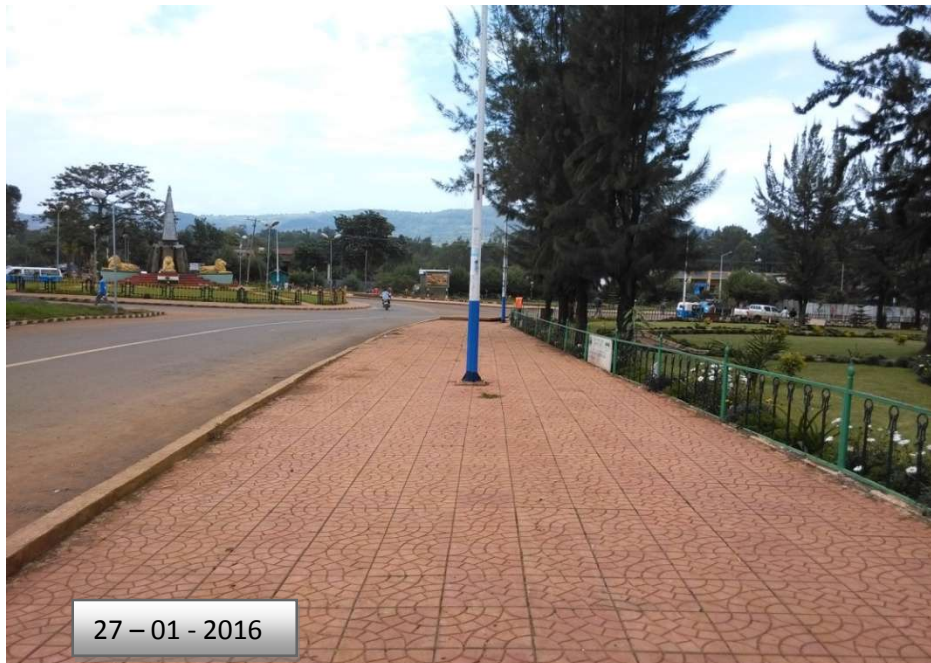
Figure 4.10 walkway with good continuity (Around Farmid )

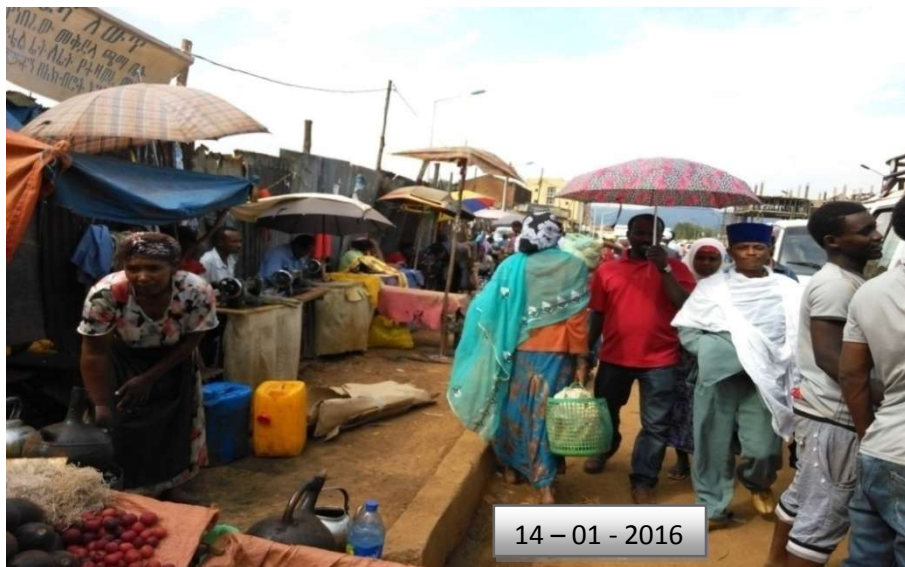
Figure 4.11 walkway with bad continuity (Around Legehar)

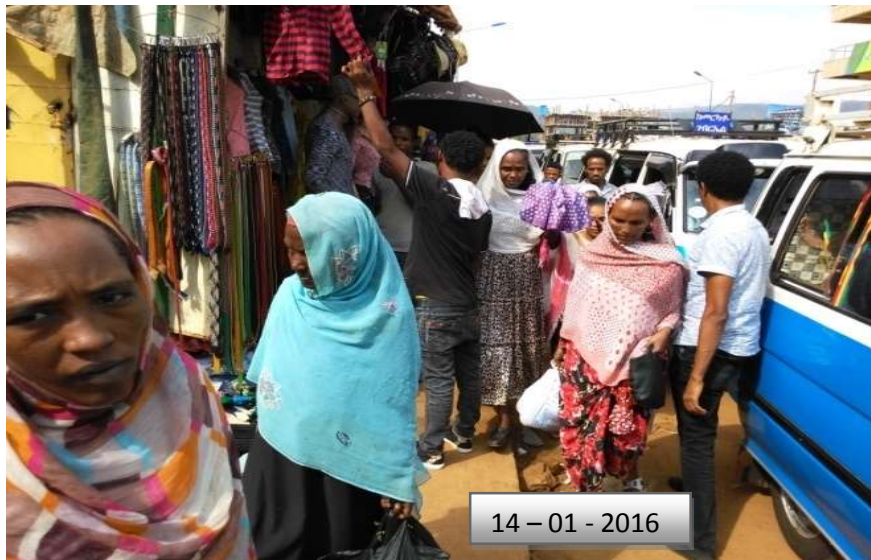
Figure 4.12 Walkway with bad visibility ( Around Mercato)

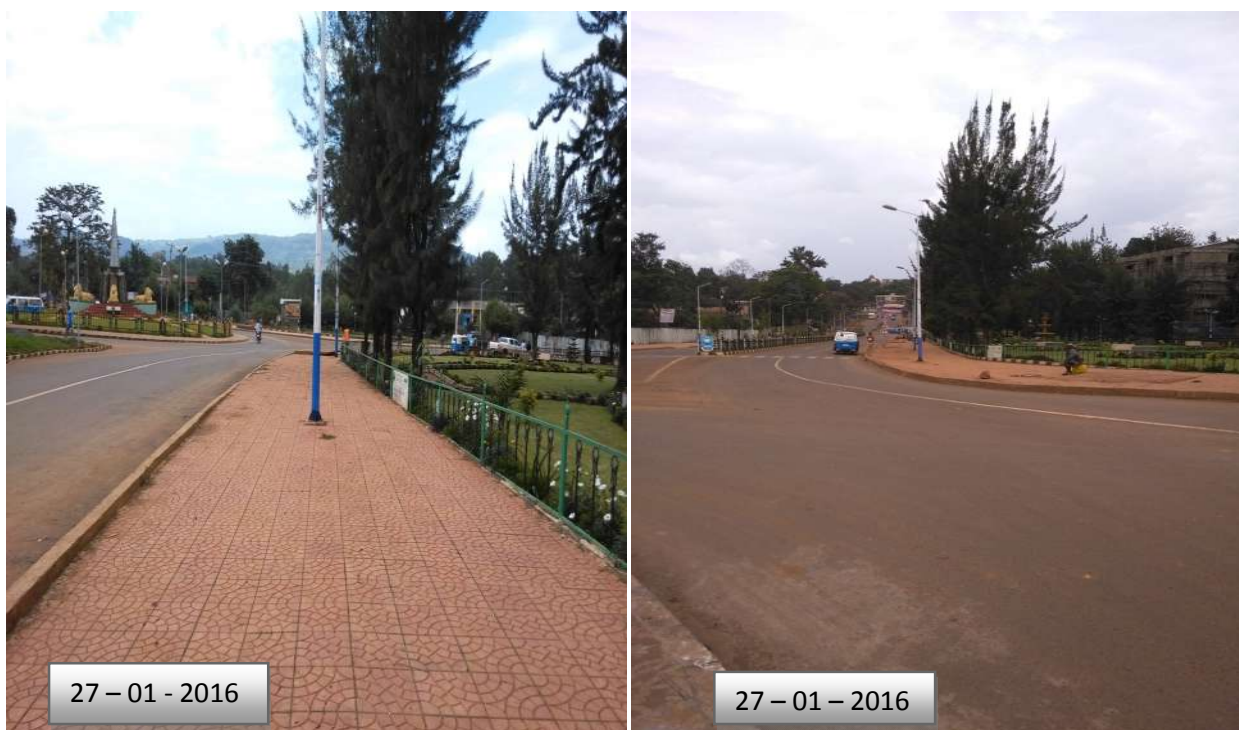
Figure 4.13 Walkway with good visibility ( Around Hermata)

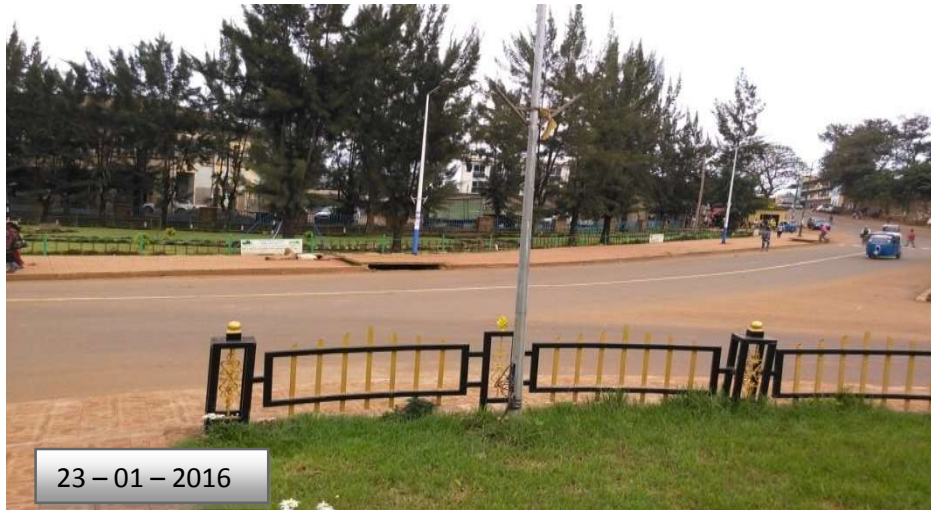
Figure 4.15 Walkway with high scale attractiveness (Around Hermata)

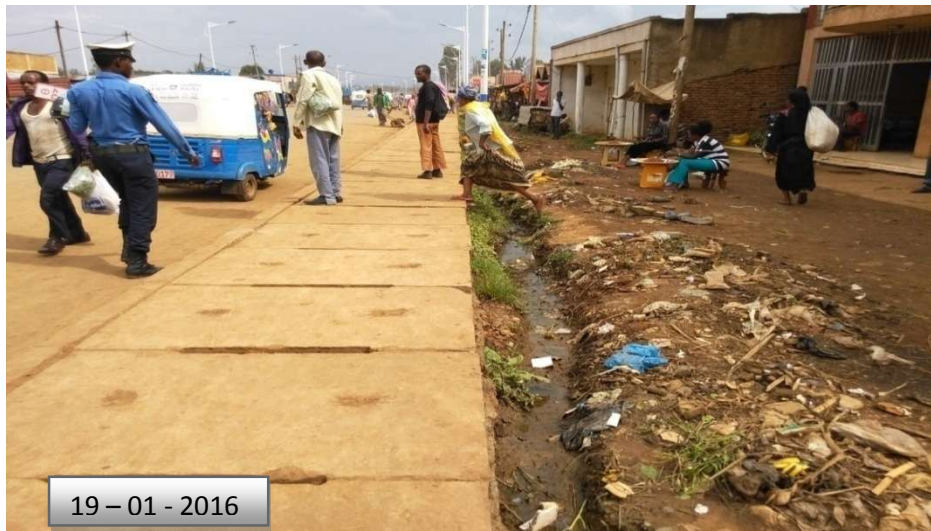
Figure 4.16 No Walkway with bad attractiveness (Around Menaheria/Bus station)

In the above picture and Figure 4.16 No walkway and bad road side approaches covered by mud and unlined ditch around Dashen Bank (Merkato) – Legehar and Cenetral Hotel – Feidi RA – Shenen Gibe Hospital that makes very difficult situation for the vulnerable walkers like the baby and disabilities. For instance, walkers do not want to use the footpaths for walking rather than using the carriage way which allow more pedestrians face for accidents as well. In the case of Farmid RA- Awetu River the walkway is attractive to the pedestrian.

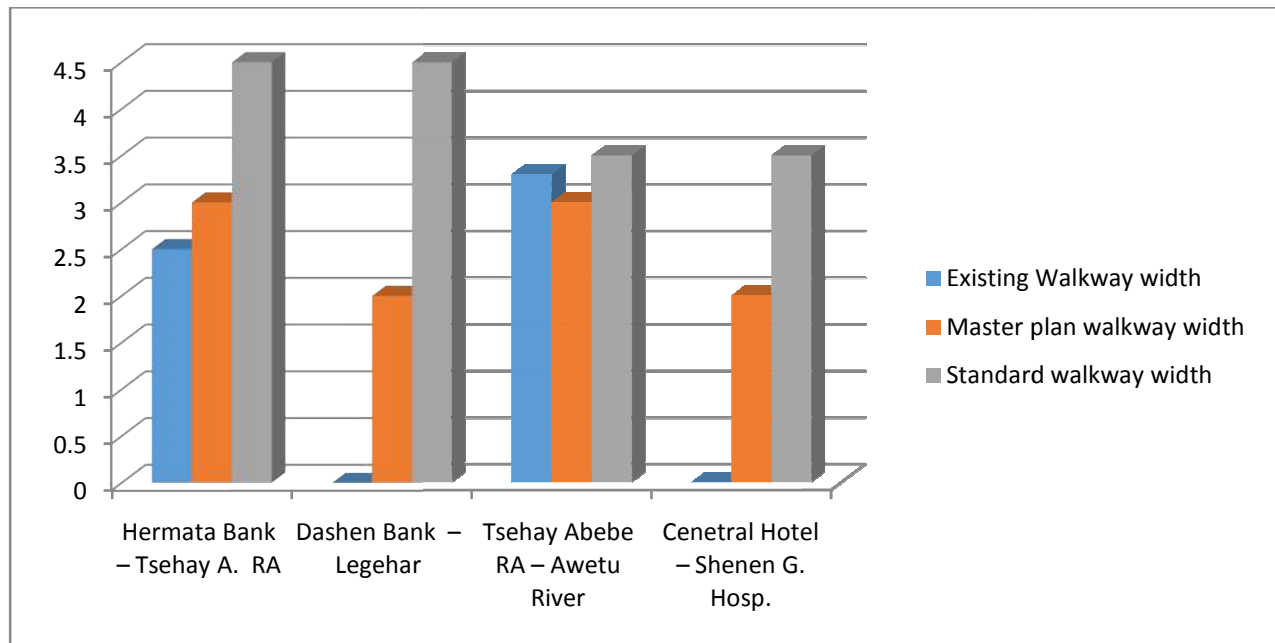
Figure 4.18 shows Existing, Master plan and Standard walkway width description

elevated walkways, and crosswalks. Walking characteristics play a major part in the design geometric features and some of controls devices. Generally as we compare the walk way roadsides with the standard highway capacity manual they are not satisfy the criteria except Farmid RA- Awetu River route.

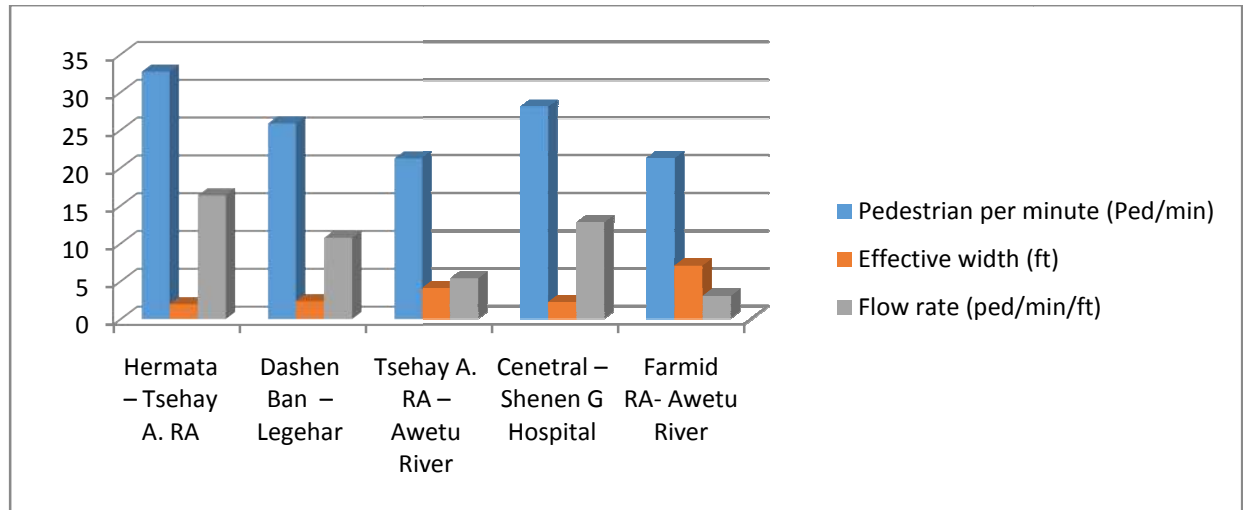
Figure 4.9 shows pedestrian per minute, Effective width and Flow rate

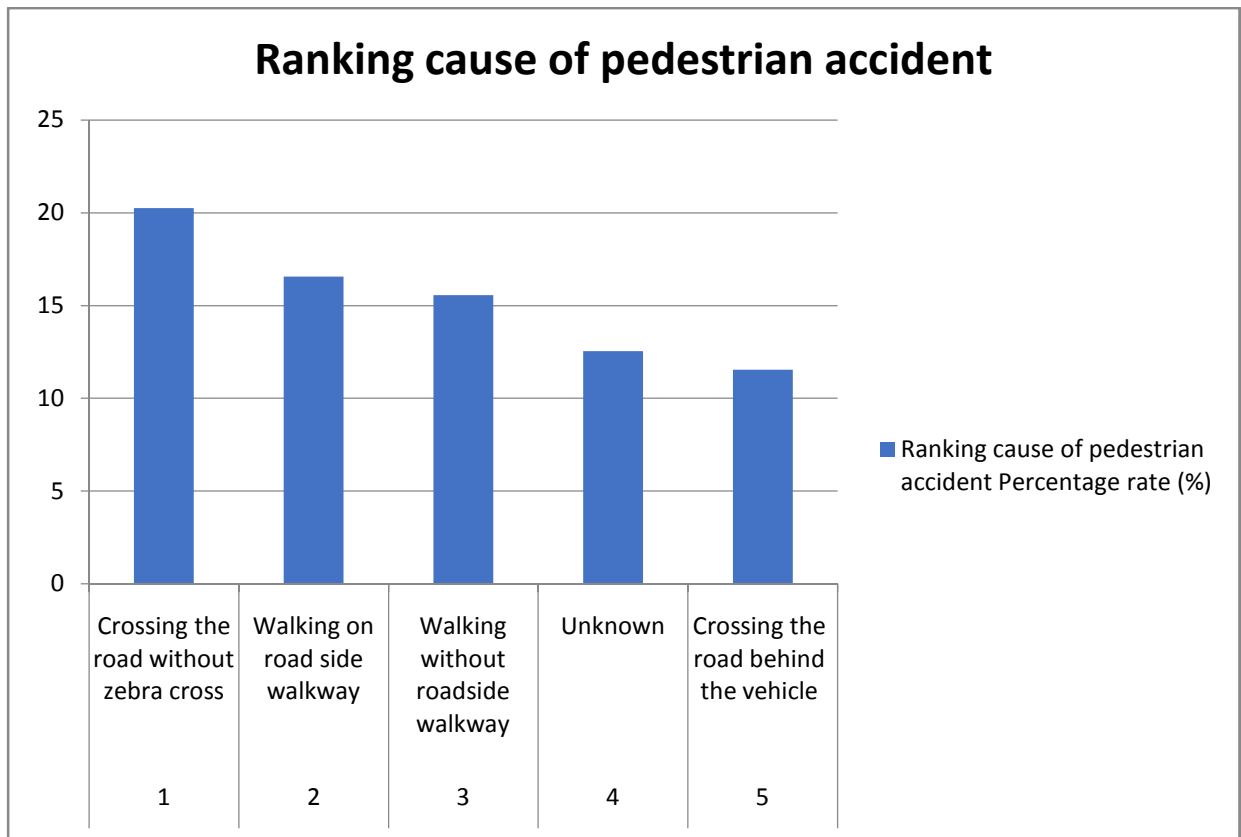
Figure 4.19 Ranking cause of pedestrian accident based on pedestrian behavior

The above table stipulates that, 104 RTAs were recorded from the last three years. This indicates that an average of 34.67 RTAs have occurred at every year. The highest numbers of RTA as well as the largest frequency of RTA incidents were recorded accident due to pedestrian crossing the road without zebra cross. crossing the road without zebra cross exhibits 21 (20.26) of RTAs the lowest frequency of RTA incidents were recorded accident due to pedestrian, Crossing the road on zebra cross exhibits 1 (0.99%) respectively. Ranking cause of pedestrian accident due to pedestrian behavior or pedestrian movement for the last three years is shown in Figure 4.19.

Crossing the road without zebra cross, walking on roadside walkway, walking without roadside walkway and crossing the road behind the vehicle these are the main identified cause of pedestrian accidents. The above problem indicates properly constructed roadside walkway is minimizing the accident which is happening big problem in the town.

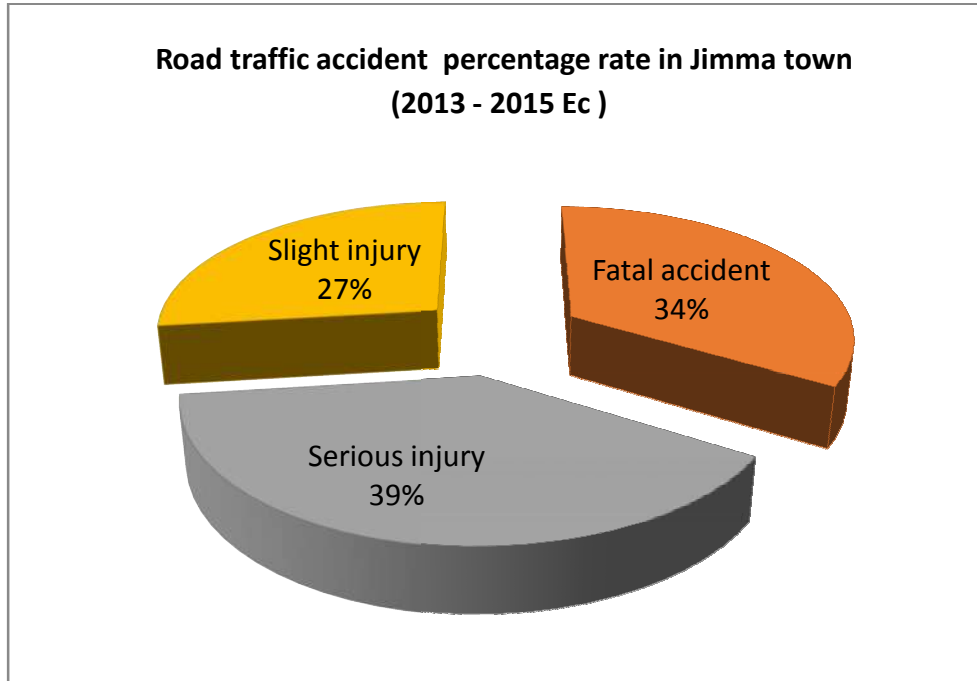
Figure 4.20 road traffic accident percentage rate in jimma town (2013 – 2015)
