PERFORMANCE EVALUATION OF GRAVEL ROAD: CASE STUDY ALONG
SHAMBU TO AMURU ROAD SEGMENT, HORO GUDURU WOLLEGA

A Research Thesis Submitted to the School of Graduate Studies of Jimma University in
Partial Fulfillment of the Requirements for the Degree of Master of Science in Civil
Engineering (Highway Engineering)

Bona Ayele

FEBRUARY, 2018
JIMMA, ETHIOPIA

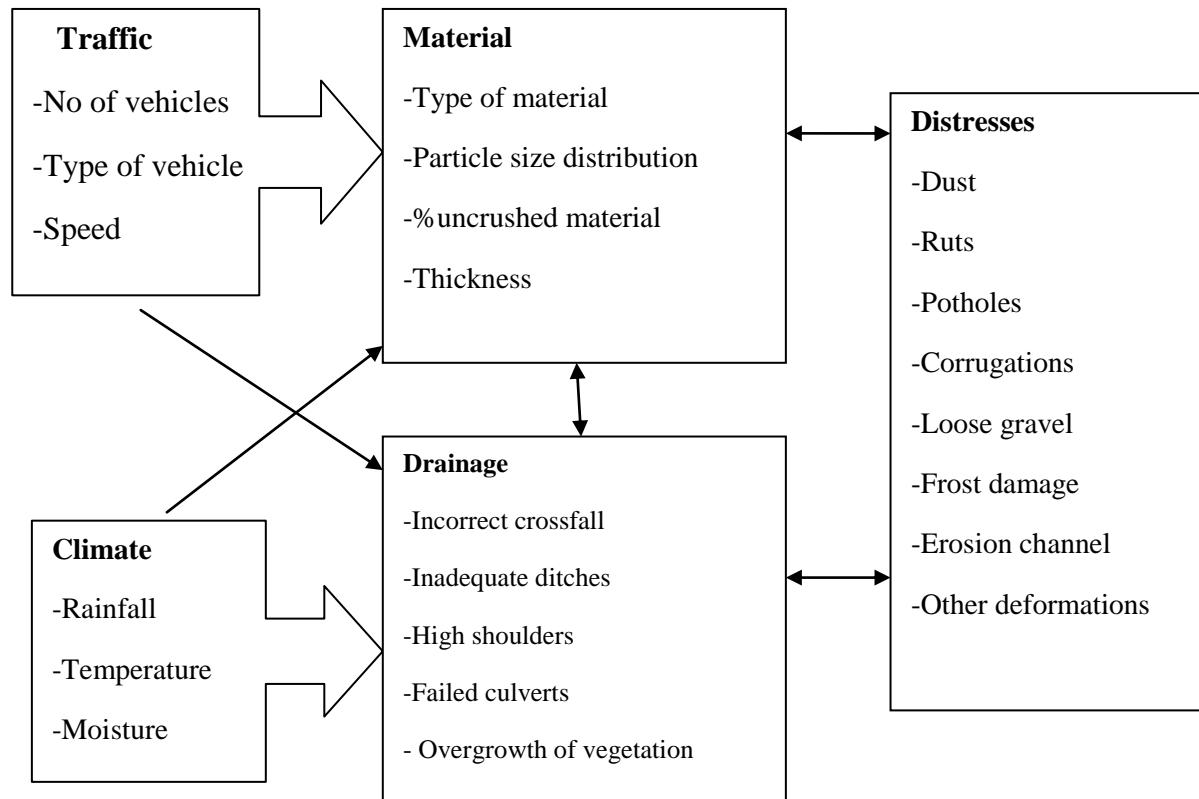
Figure 2.3: Schematic of deterioration process on gravel roads

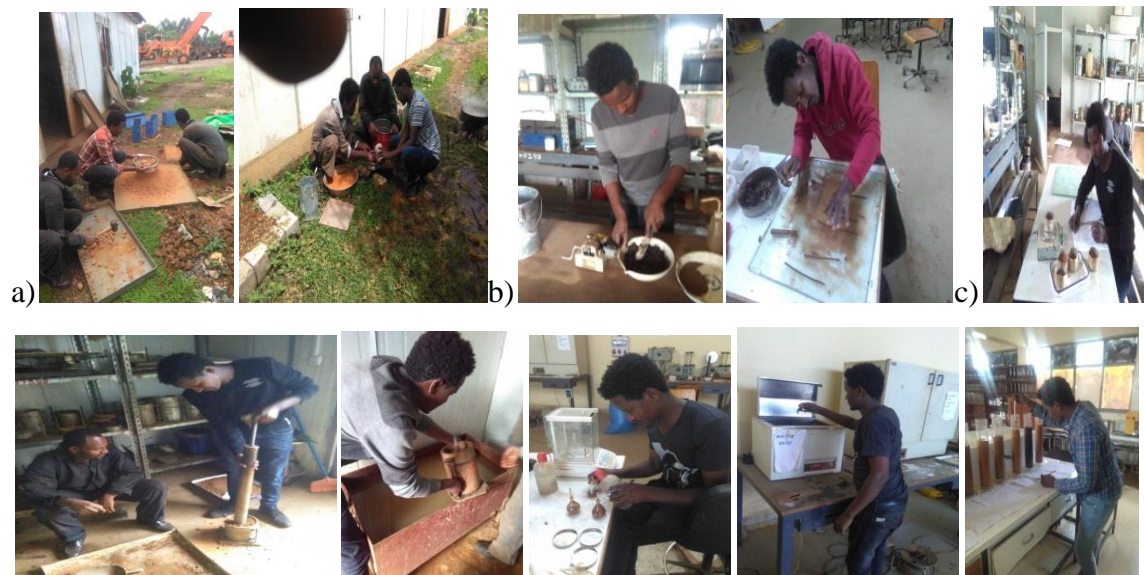
Figure 3.3: a) sieve analysis b) LL and PL test, c) compaction and CBR soaking d) specific gravity test and hydrometer test pictures of laboratory test activities

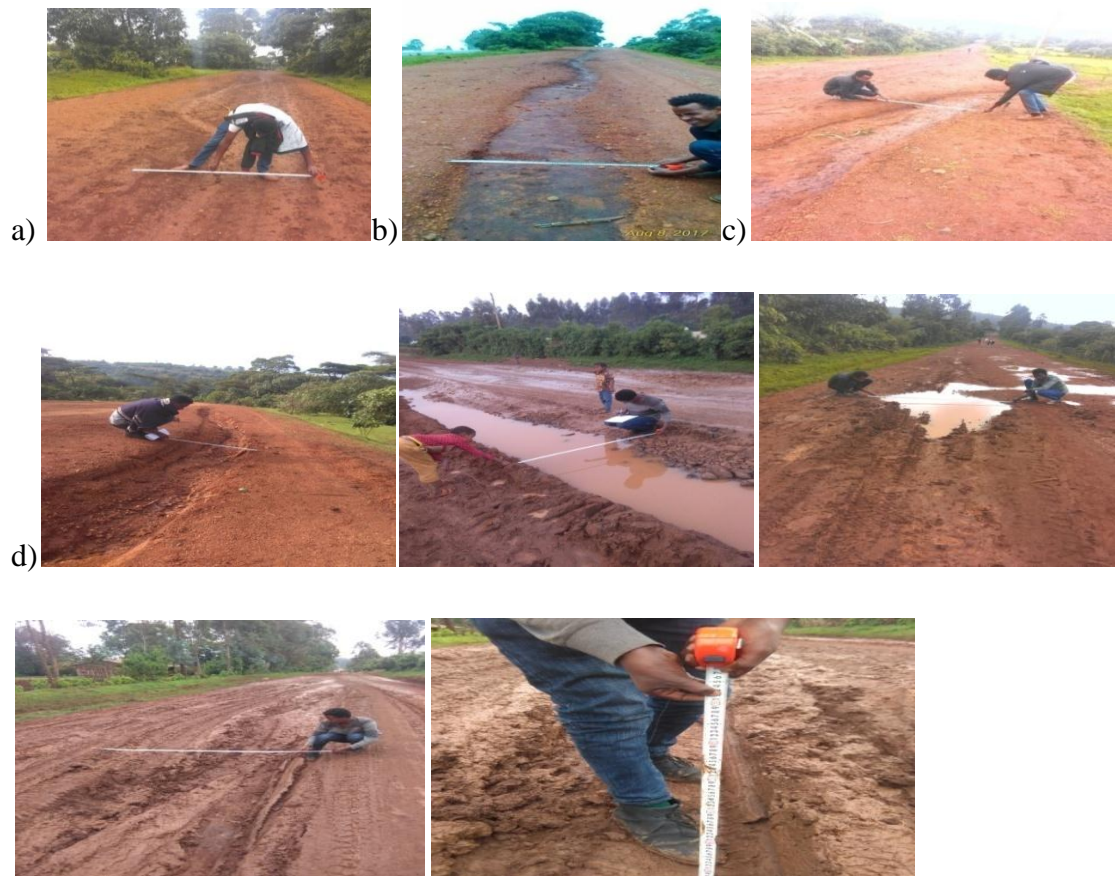
The surface gravel thickness was measured at right side, left side and center of each section of the road, by carefully digging using hand tools and measured with meter tape. Then it was used to describe which material is suitable or not, at what portion of the road is more loose (at center or at sides) and make description for the materials with result of laboratory results. For all sections, measurements were done for rutting, potholes, erosions both (longitudinal and transverse). Dustiness, Corrugations, loose materials, slipperiness, sub grade exposure, landslide of the road at embankment places, trafficability and the like, isolated problems were assessed in detail by visual observation and supported by photograph taken at each section of the study segment.

Figure 3.4:A) rutting B) longitudinal erosion, C) and transverse erosion) potholes, distress measurement at different section of the study segment.

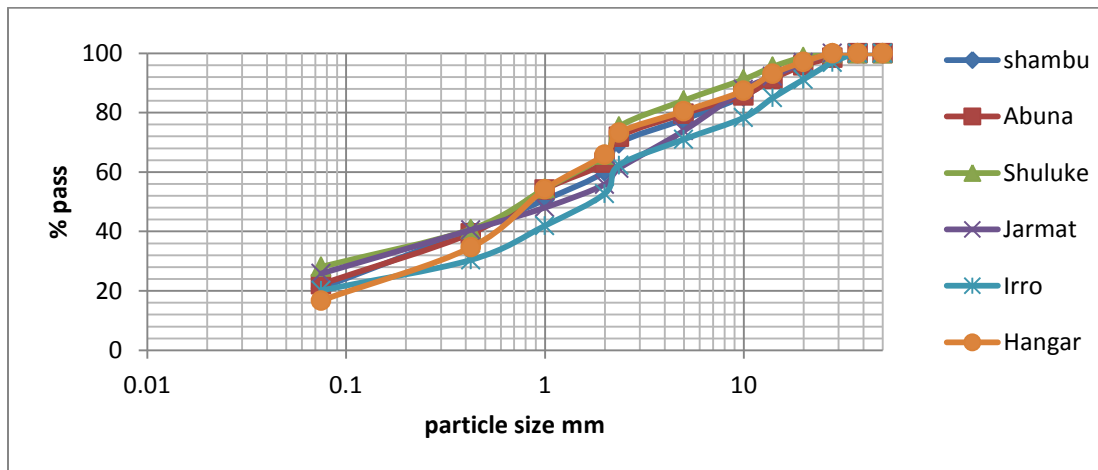
Figure 4.1: graph of sieve analysis of summary of percent pass by mass of SW

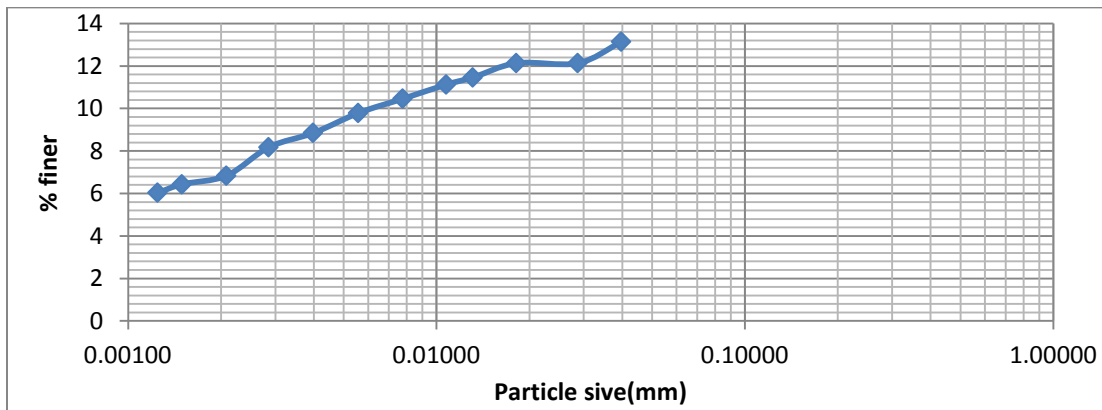
Figure 4.3: Typical graph of Hydrometer Test Results for Surface wearing at Hangar

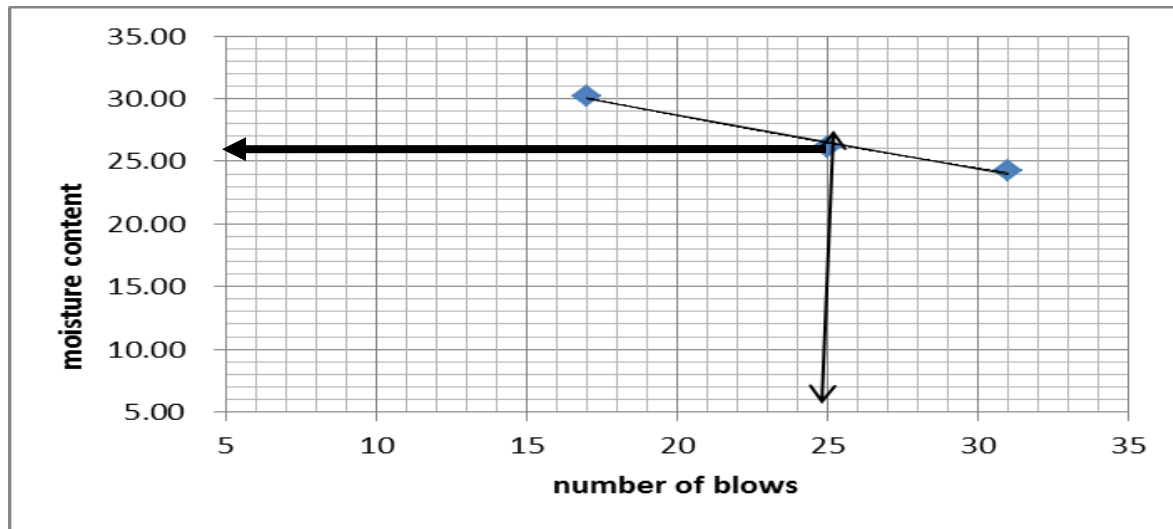
Figure 4.4: Typical Results of LL and PL graph of Subgrade Soils at Hangar

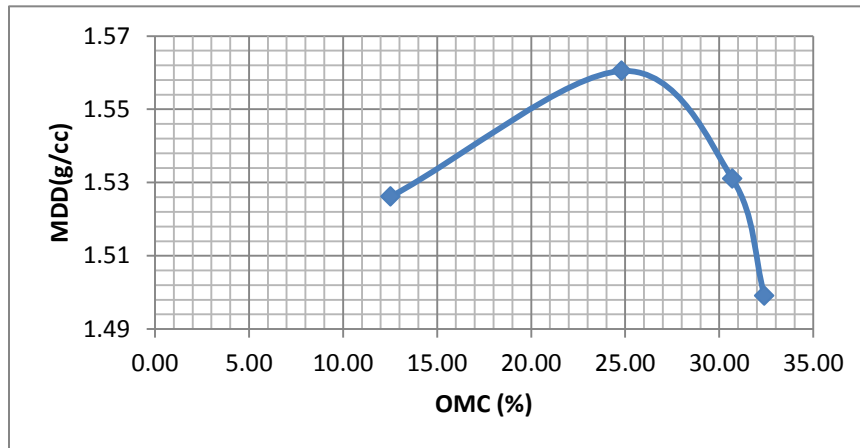
Figure 4.5: Typical Moisture Density Relationship of SG Soil at Hangar Station

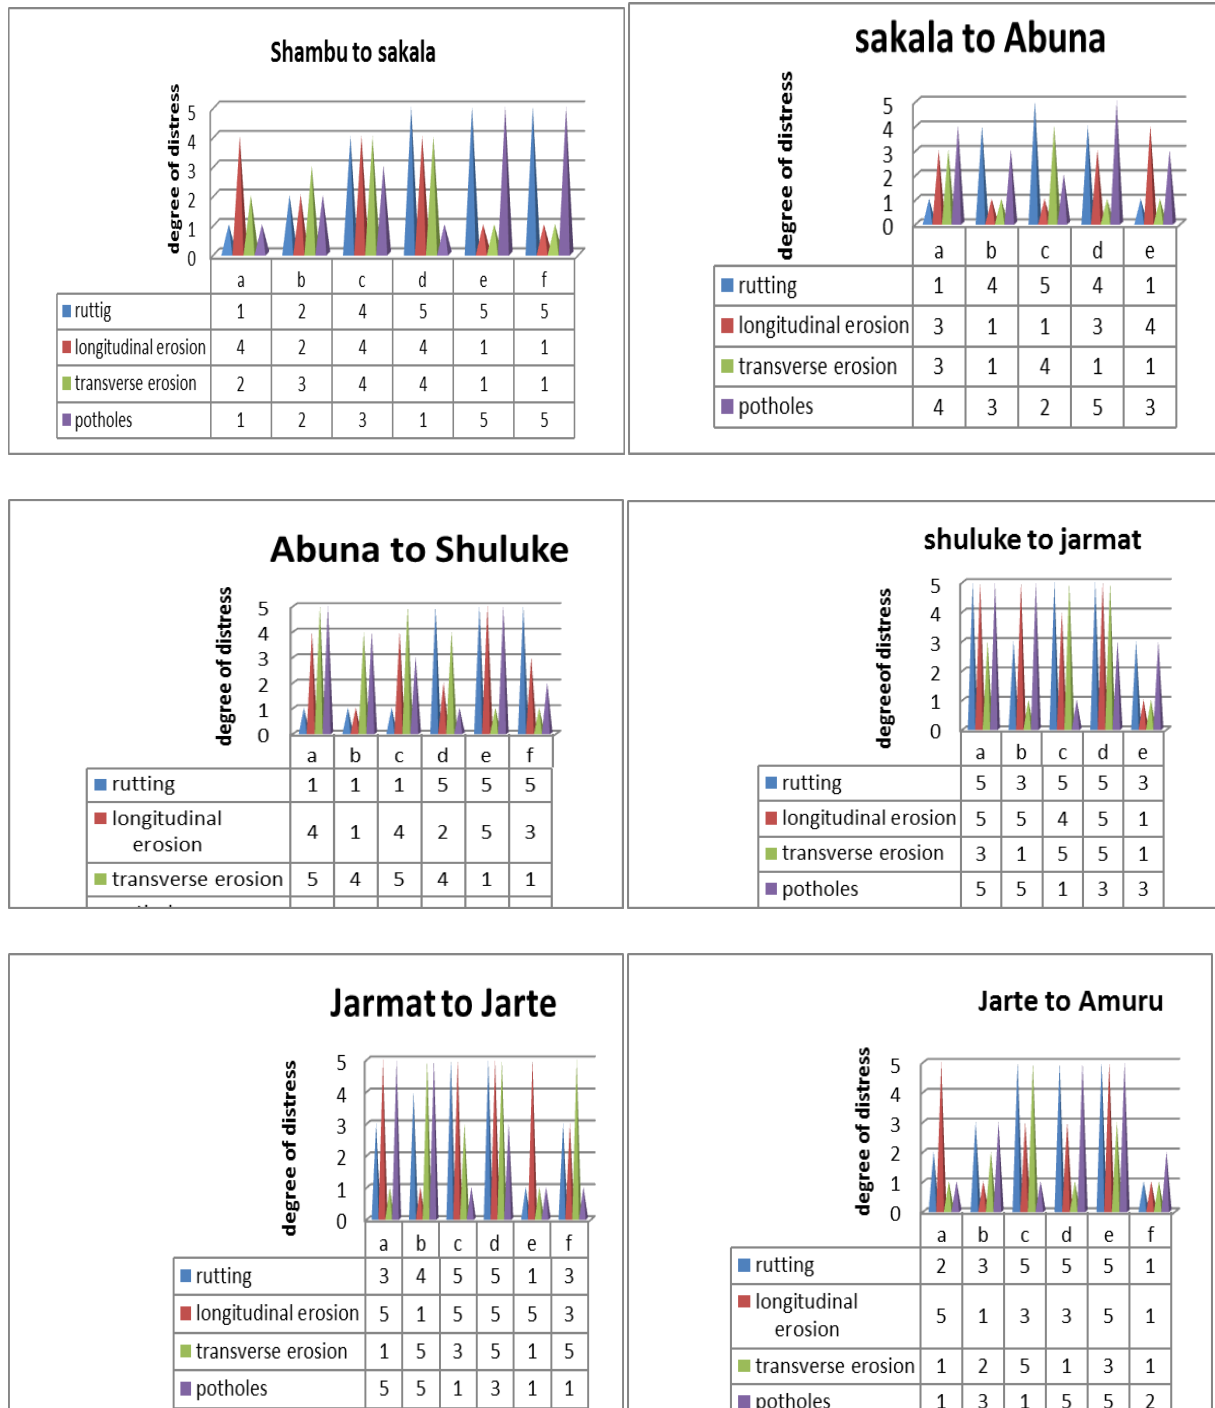
Figure 4.8: degree of distress along the study sections

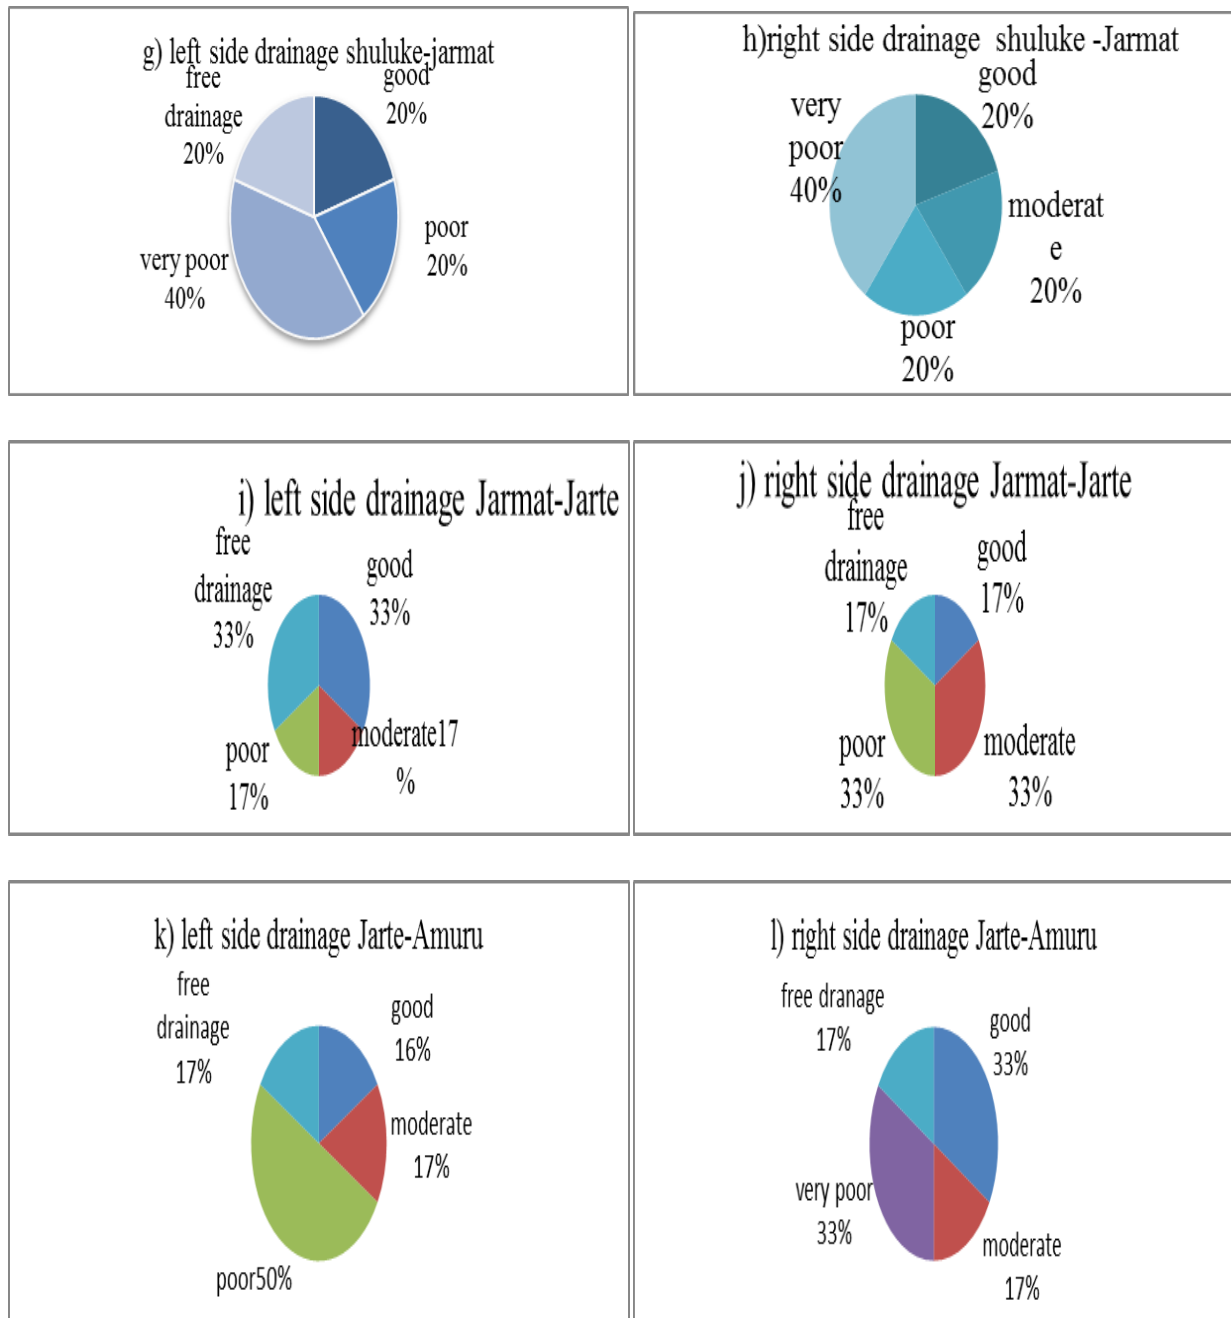
Figure 4.9: Side drainage factor classification in the pie char

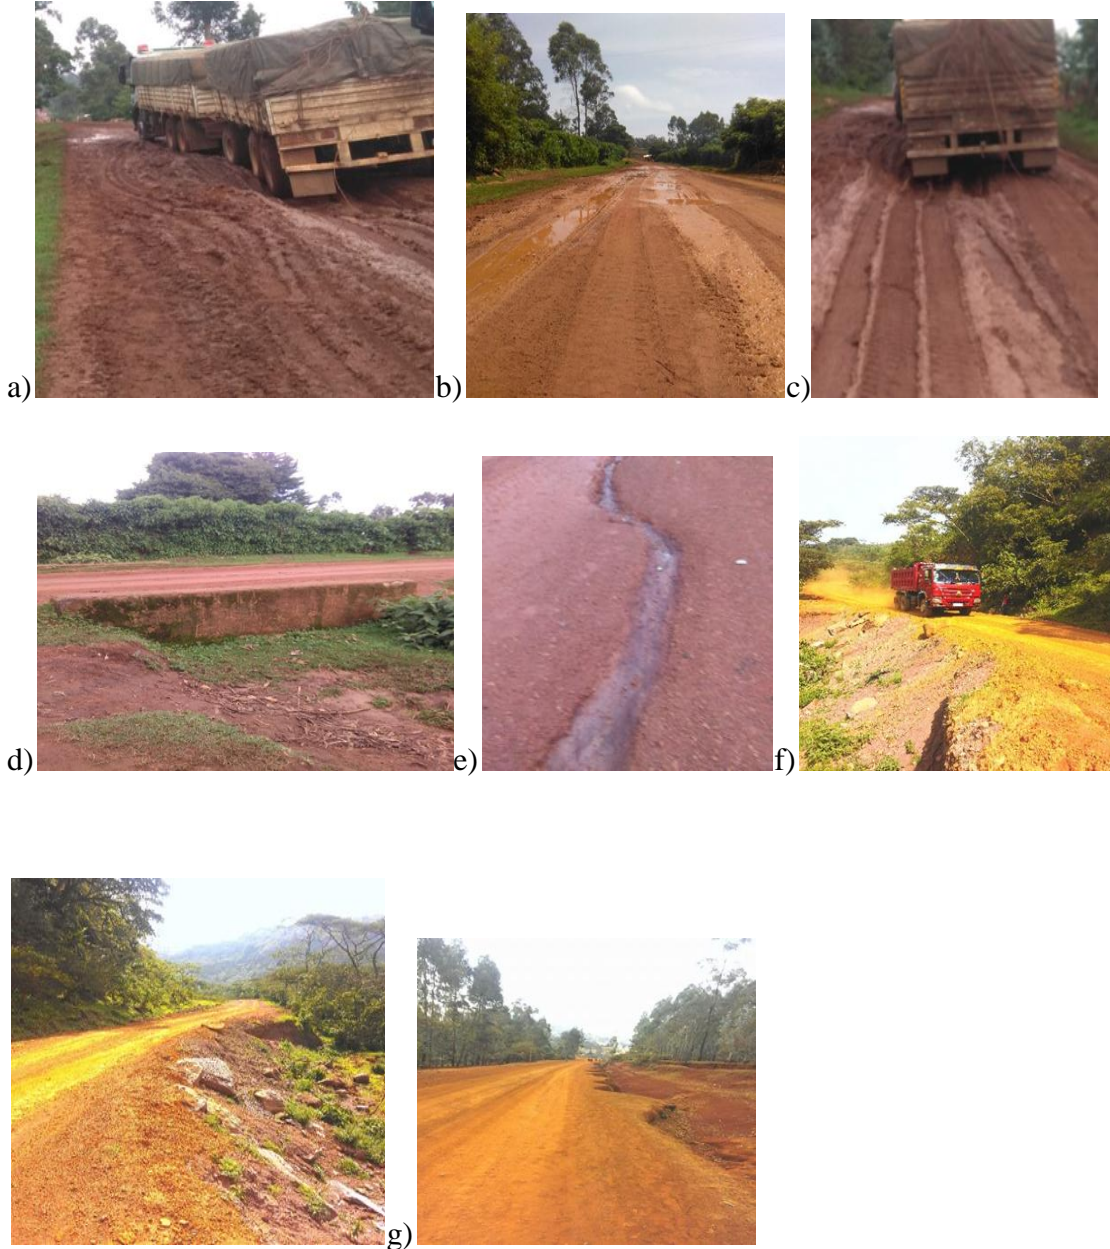
a)subgrade exposure, b) severely damaged due to lack of good crown, c)lack of surface wearing course, d) closed cross pipe drainage due to luck of maintenance, e) longitudinal erosion damaged surface, f) partial failure of road way due land slide, g) poor side drainage damaged by scouring and erosion.
