Road Safety Audit In Relation To Road Geometric Design Parameters: Case
Study on Shashemene-Wendogenet-Gemeto Road

A Thesis Submitted to the School of Graduate Studies of Jimma University in Partial
Fulfillment of the Requirements for the Degree of Masters of Science in Highway
Engineering.

Rena Dedefo

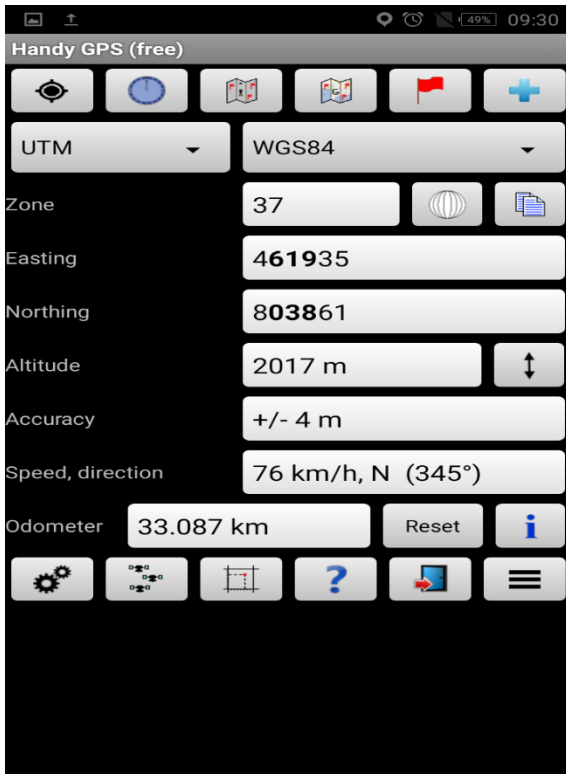
Fig.3.4 Handy GPS used during site survey

Visibility; Sight Distance: During field visits, data /information was collected through observation. The sight distance along the road was obtained by calculating the values gained from as built data and sight line have been checked by using GPS to obtain the point of tangency and point of curve corresponding with the as built data by compensating the accuracy. The GPS also used to obtain the location of sight obstruction with respect to curve point. The accuracy of the GPS is then compensated to decrease the error.

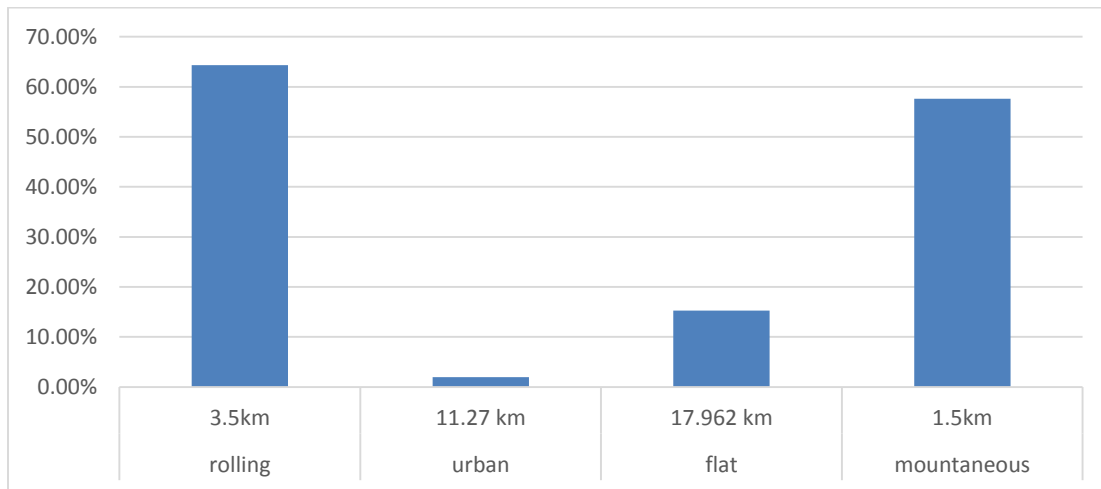
Fig.4.1 percentage of obstruction less than 1.5m from the edge of the lane

The sight distance along the road is inadequate or restricted when plantation on the edges of embankments; especially at the inner edge of horizontal curves obstruct the sightlines to stationary objects or oncoming vehicles. At the straight sections, visibility and sight distance is restricted at built-up areas / bus-stands due to parked vehicles and road side developments and activities. Inadequate sight distance results in a shorter reaction and response time available to the driver when the change is sighted which results in a higher crash risk. Road side obstructions restricting visibility occur greatly on rolling and mountainous area having 64.3 percent and 57.6 percent from the given terrain class road length. Obstruction cover which restrict sight distance in urban area appeared to be 2 percent of the length 11.27 as shown on figure 4.1.

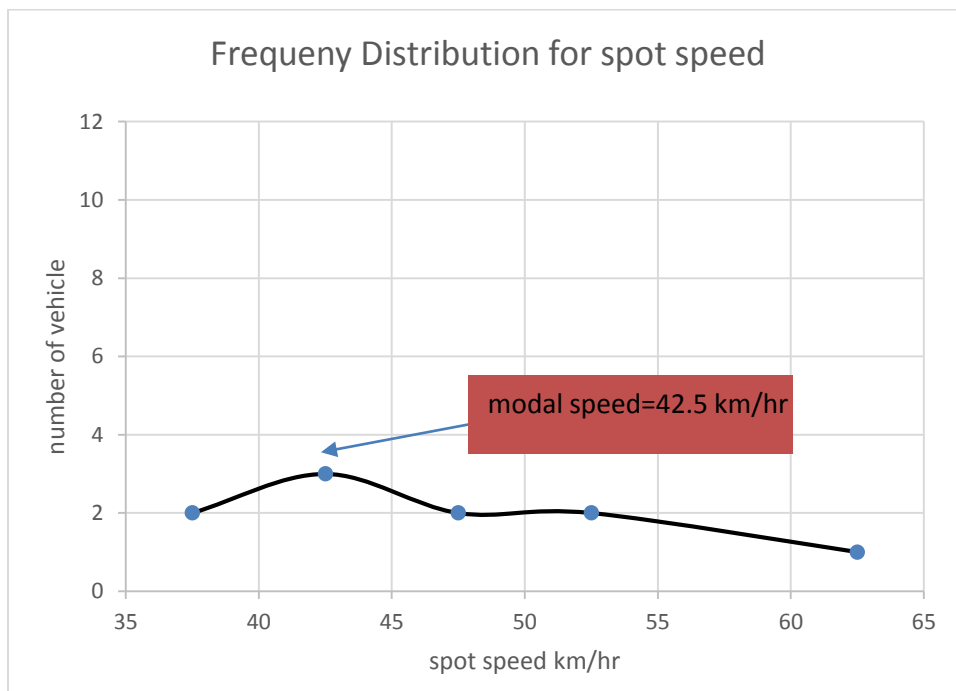
Figure 4.2 Frequency Distribution for Spot Speed at Curve Section

At station 10+560-10+720 from sample of 10 vehicles 30 percent falls under the speed range 40-45 as stated on figure 4.2 and 98 percent of the vehicles travel below 64km/hr as shown on figure 4.3

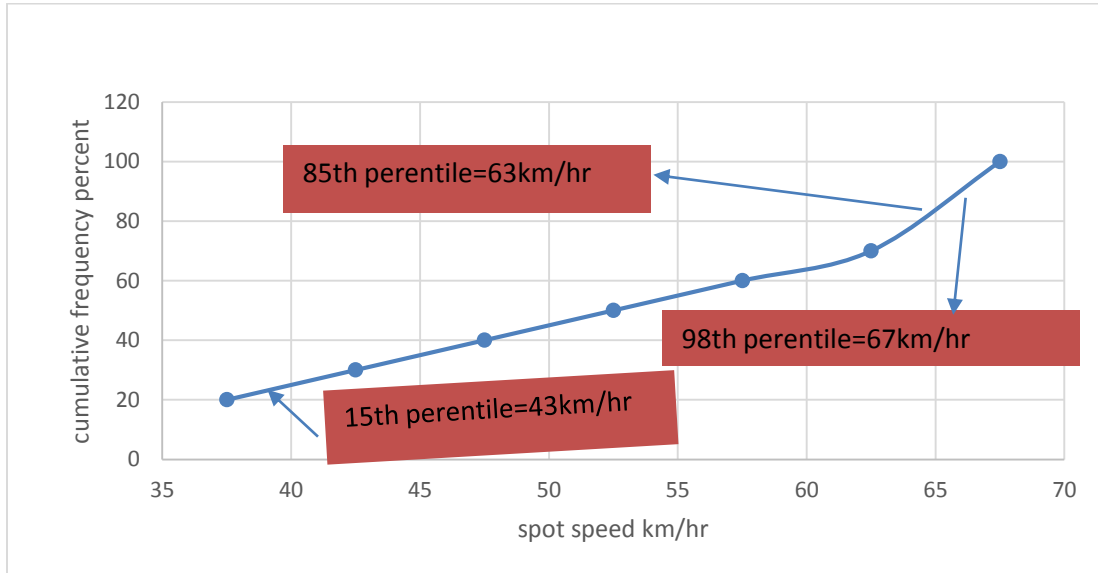
Figure 4.7 Cumulative Frequency Distribution of Spot Speed at Curve (6+880-6+990)

From the speed study, it is found that along this highway, 98th percentile speed varies between 64 to 69 km/h and 85th percentile speed varies between 63 to 67 km/h. This implies that the highway is not capable of maintaining its intended design speed. At present condition, segment-specific speed limit/zoning needs to be applied for safety reasons.

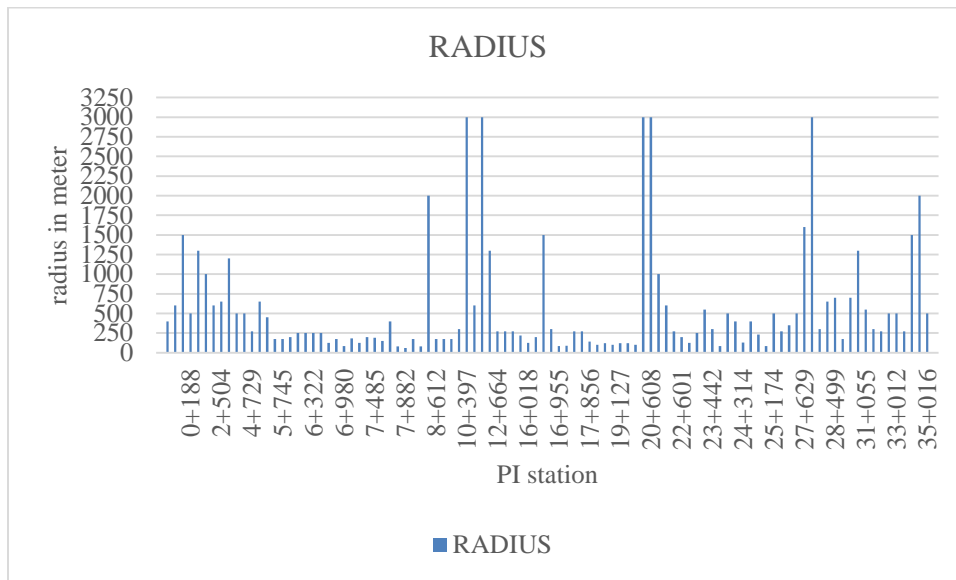
Fig 4.8 Radius of horizontal curve

attention while negotiating these geometric constraints. 43% of radius of horizontal curves are less than 250 m as shown on figure 4.8

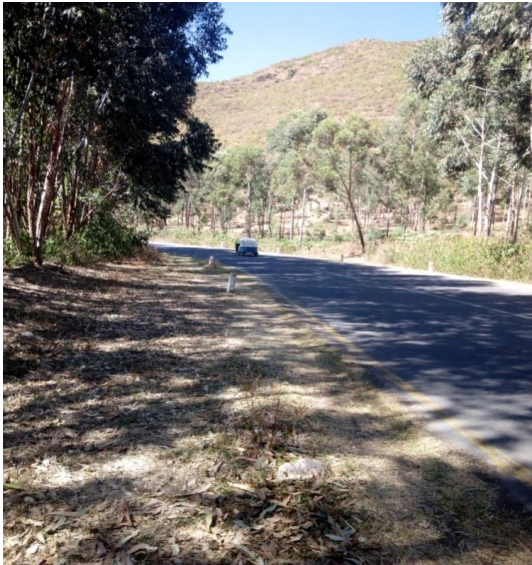
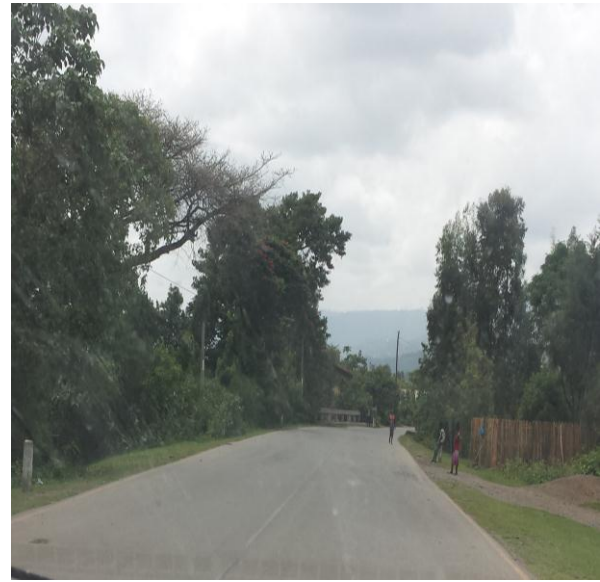
Fig 4.9 (a)Goto Anoma restricted sight due to road side obstruction Fig 4.9 (b)Lomicha bridge ; restricted site to obstruction

$M_s = 5.6341$ should be provided for adequate stopping sight distance but due to vegetation obstruction 3.5 meter from the edge of the inner lane should be removed

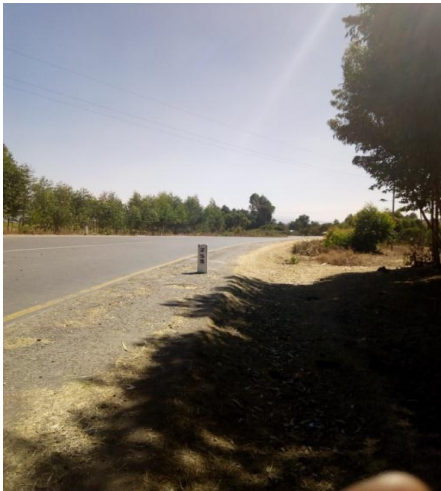
At some places, due to roadside vegetation and obstructions, effective shoulder width is reduced and as a result, Non-Motorized Vehicles (NMVs) using shoulder comes to the carriageway.

Figure 4.11 Inadequate shoulder width

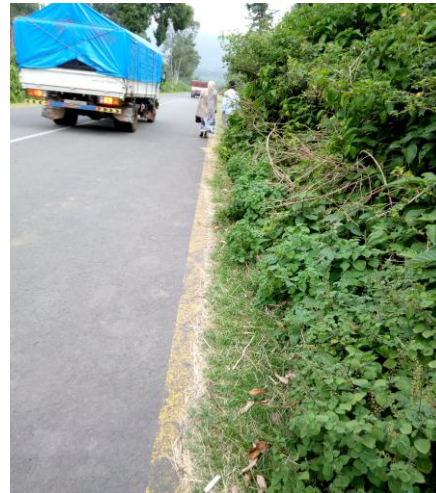
Figure 4.12 shoulder absent due to vegetation

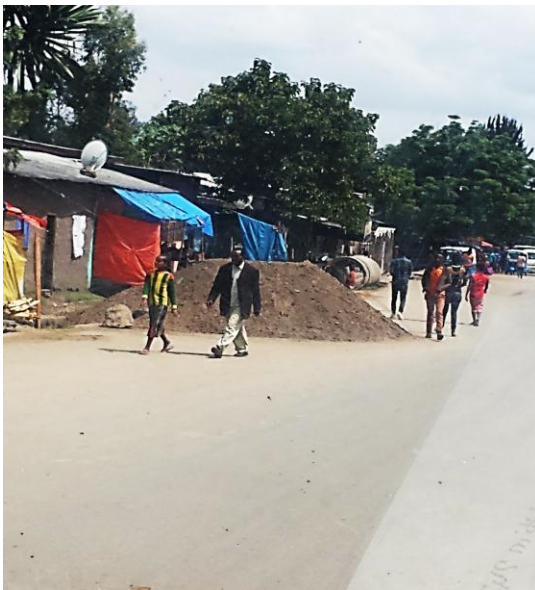
Fig 4.13 obstructions dumped on the carriage way

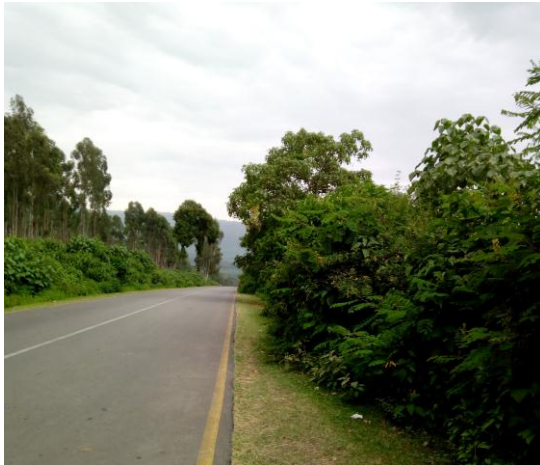
This highway required 1.5 m wide walkway on each side. Except very rare occasions, walkway is either not available or existing walkway is covered with roadside vegetation or damaged due to soil erosion thus not useable almost throughout the length of the

Figure 4.14 shoulder is not walk-able or absent due to vegetation

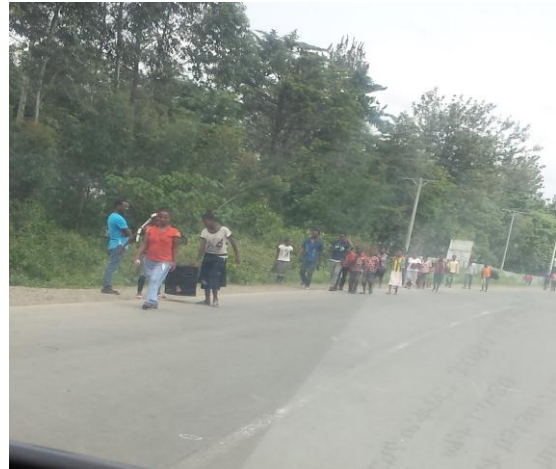
Fig 4.15 No enough space for pedestrians

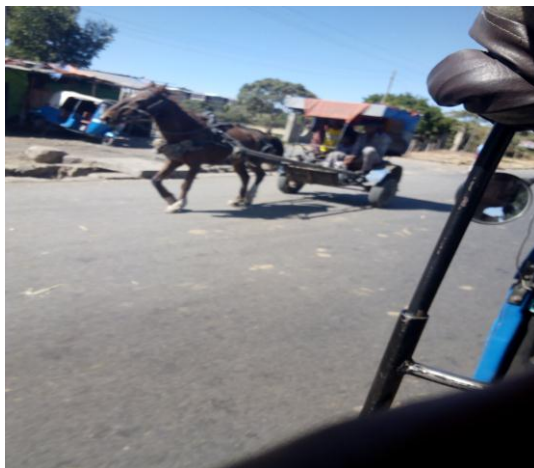
Fig 4.16 No enough space for Non-motorized vehicle

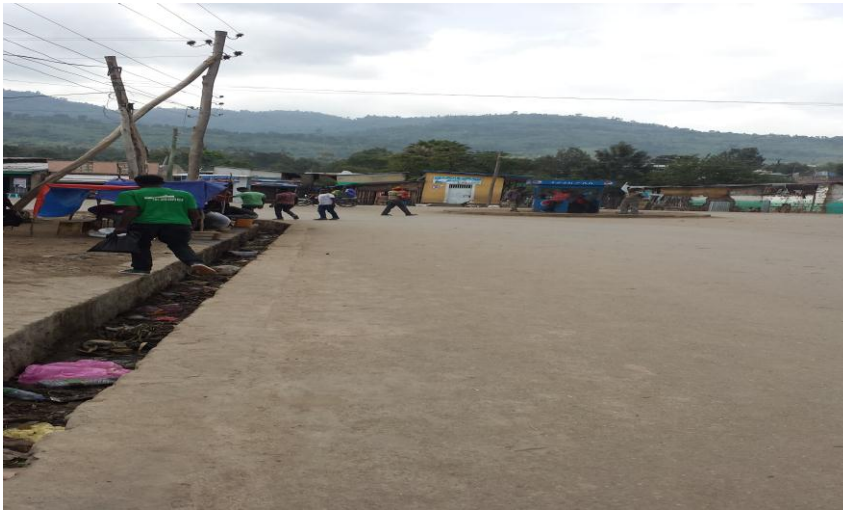
Lack of delineating edge line, centerline and zebra crossing at 47.3 percent of the route excluding the 2.7km access road towards Shebele.

Fig 4.17 No center and edge line and zebra crossing near round about

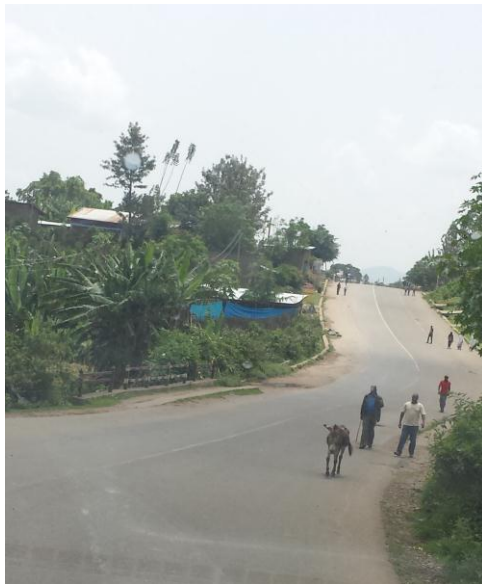
Fig 4.18 no guide post for culvert

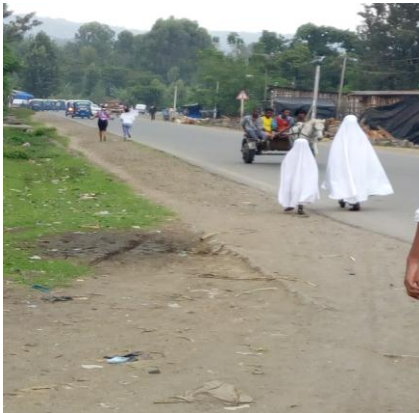
At Wesha town there is a bajaj station at a curve and the road have become very narrow for the passage of huge traffic between Kella and Wesha town.

Fig 4.20 wesha bajaj station at curve

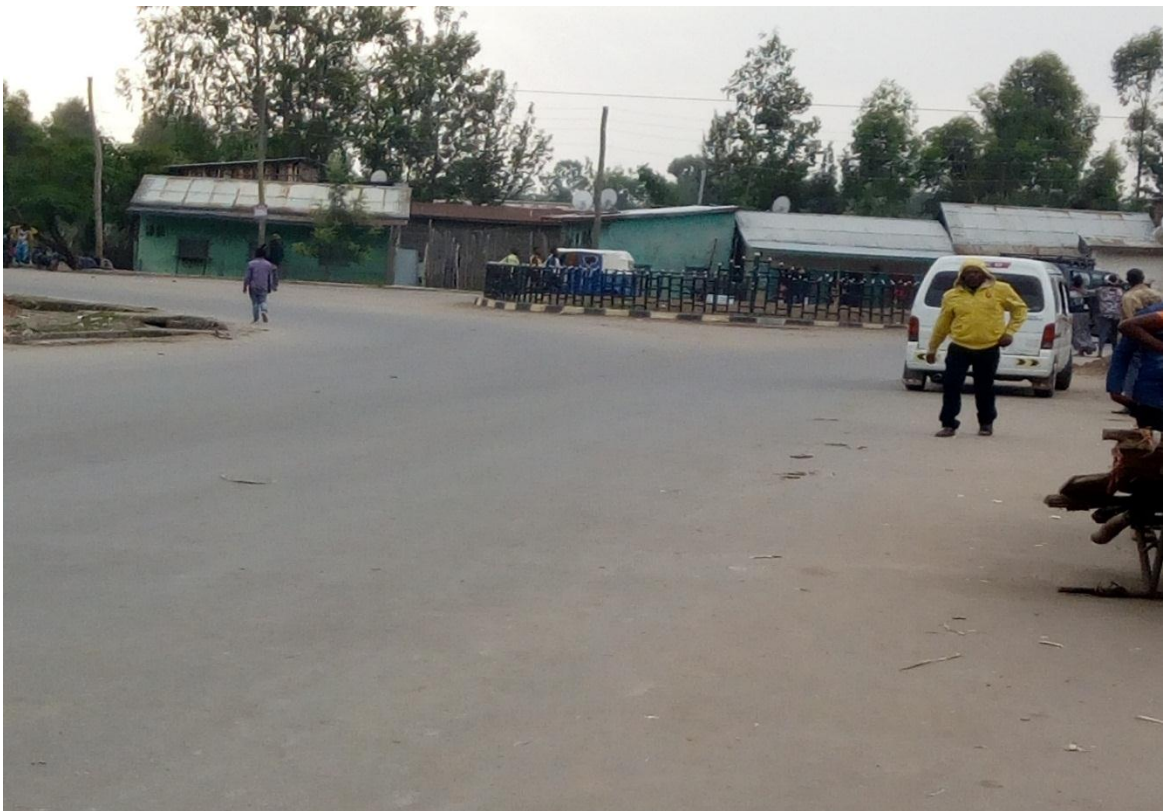
There is round about when going from basha town towards meribu and gemeto which doesn't have any approaching sign, zebra crossing, center line and edge line delineation and at the edge of the round about there is road side development (tire repairing station)

Fig 4.21 round about with no delineation

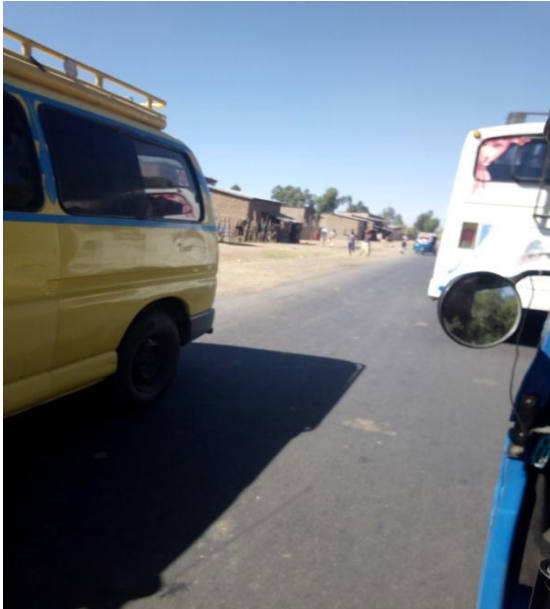
- Vehicle paths and splitter nose at junctions are not marked or delineated and pedestrian crossing sites (zebra) are not well marked (figure 4.22 and figure 4.23).
- Edge line markings are faded out or invisible due to dust, mud and weather effects.
- Along the highway, painted “Edge line” and “Center line” markings are not observed.

Figure 4.22 No center line between the two directions

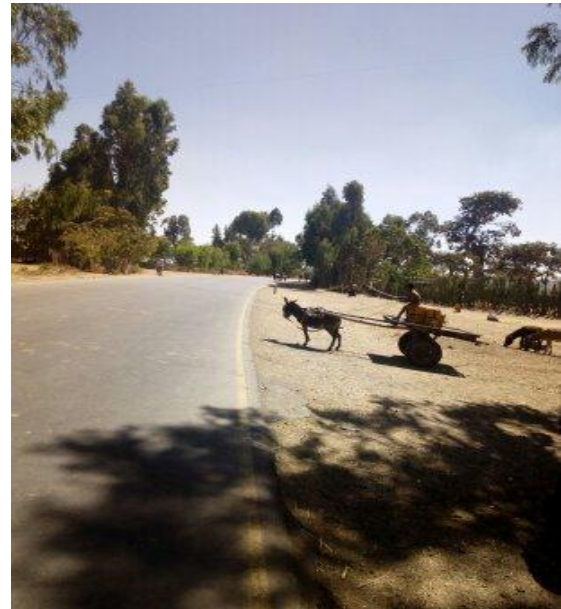
Figure 4.23 No zebra crossing

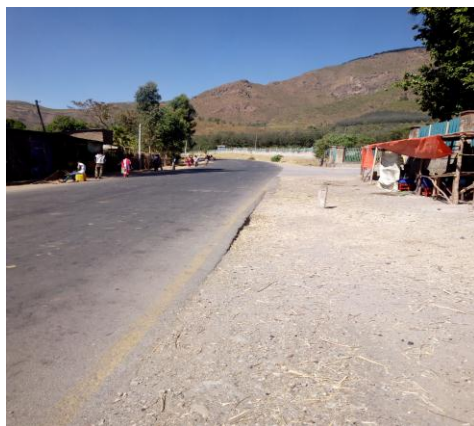
Fig 4.24 zebra crossing not visible

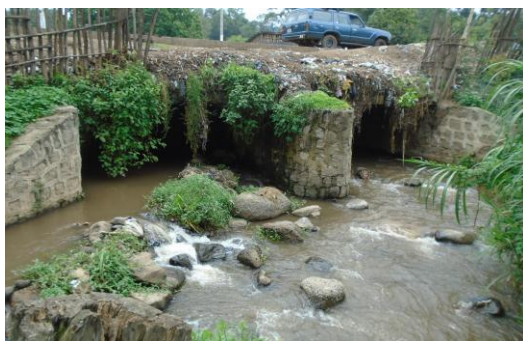
There are two bridges without guardrail namely wesha bridge 264.1km away from Addis Ababa and werka bridge 265.4 km from Addis Abeba. Wesha Bridge was used previously by the localities to wash clothes and throw garbage in the river. It is constructed as the situation is and no measures have been done before the construction of the bridge

Fig 4.25 Werka Bridge needs maintenance and guardrail should be provided

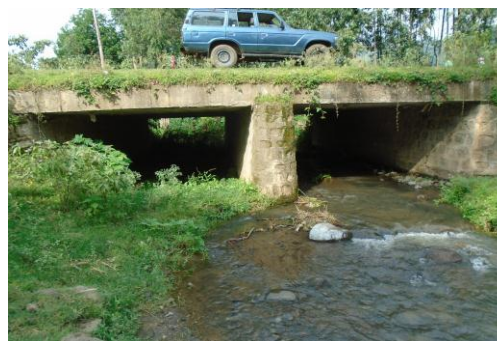
Fig 4.26 Wesha bridge guardrail should be provided

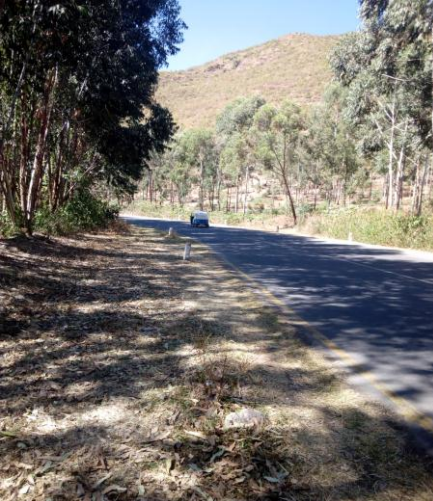
<p>Result :lane width 3.5 and distance of obstruction is 1m</p> <p>Problem: obstruction restricts driver sight of</p>

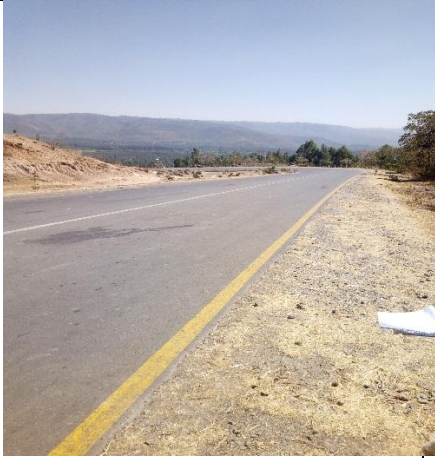
#3	Area around Bele

No sign for curve approaching
#4	In front of wendogenet forestry collage

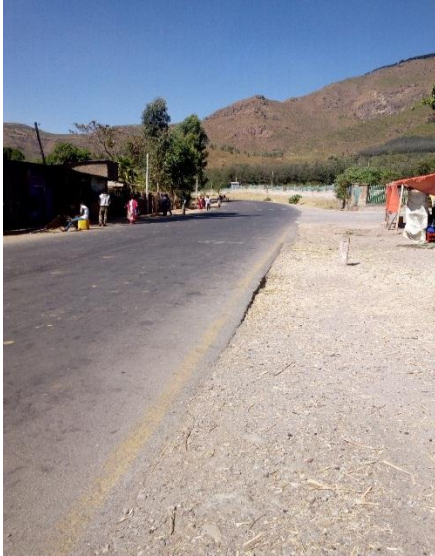
Un paved shoulder, absence of delineation and zebra crossing is not clearly visible

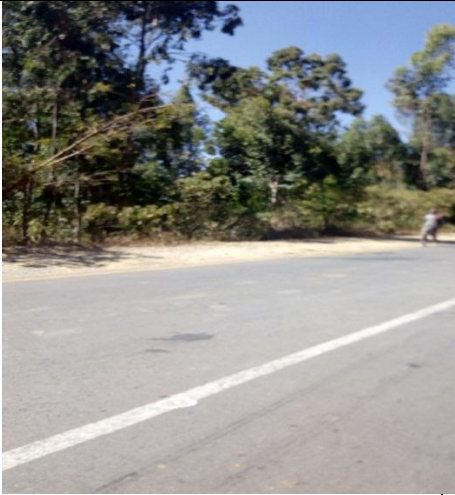
<p>#5</p>	<p>Shesha wereda area (shasha qaqasi)</p>

<p>Vegetation near the carriageway(1m-0.5m away from the edge of the lane)</p>
<p>#6</p>	<p>10+480 km from the start</p>

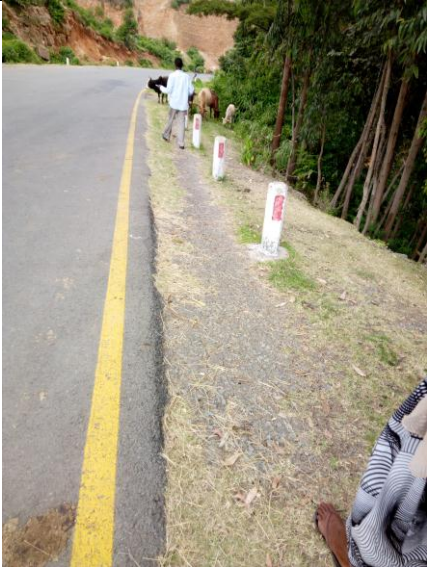
<p>High drop-off at shoulder, inadequate shoulder and road side obstruction restricting sight of driver</p>

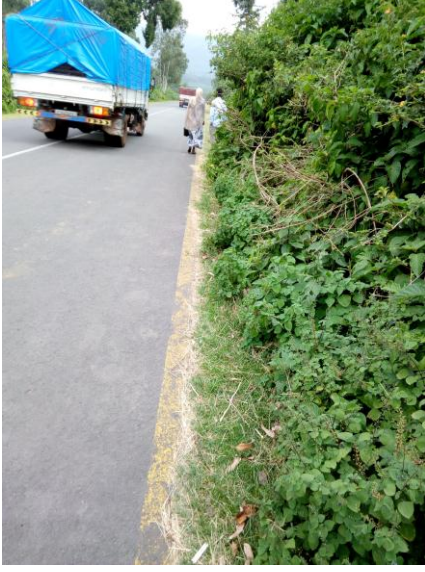
<p>#7</p>	<p>10+500-10+790</p>

<p>Absence of shoulder, obstruction near carriageway, narrow carriageway with sharp curves</p>
<p>#8</p>	<p>Wesha town</p>

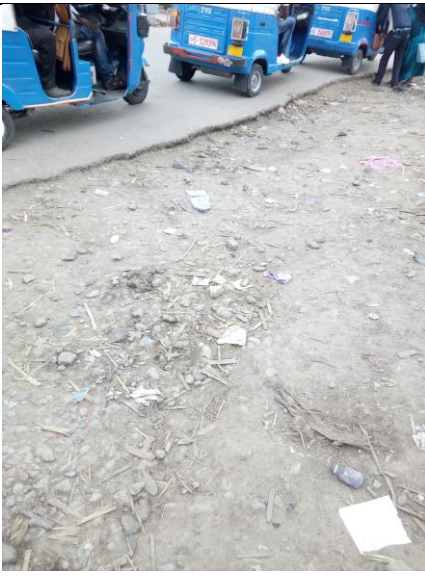
<p>Damaged shoulder, random usage of carriageway as Bajaj and taxi station</p>

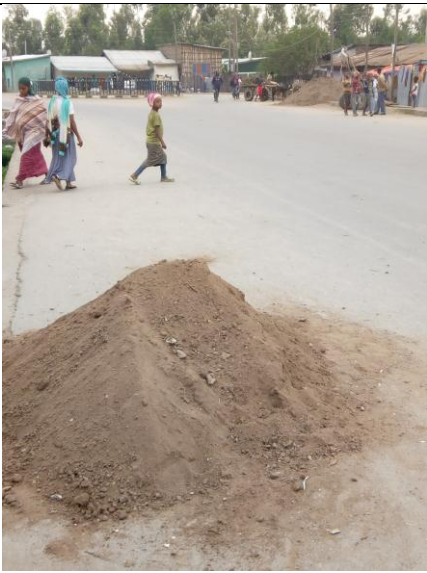
<p>No center and edge line marking of road, dumped construction materials on carriageway, commercial activities near the roundabout edge</p>

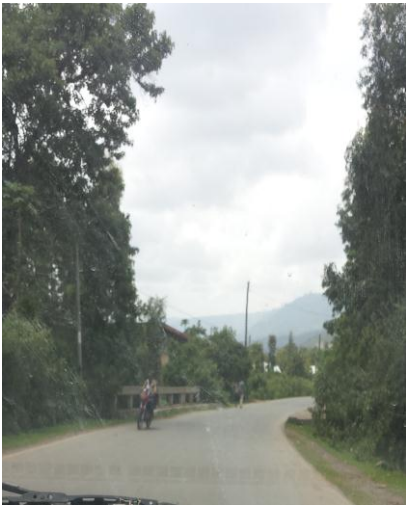
#11	Hailu bridge after Meribu town approaching to Gemeto

Bridge on sharp curve , roadside obstruction, no guide post for culvert
------------	---	--	--
