**Slope Stability Analysis and Mitigation Measures of the Agoro –
Shahgubi Section of the Agulae - Berhale Road, Northern Ethiopia.**

**A Final thesis submitted to the School of Graduate Studies of Jimma University in
partial fulfillment of the requirements for the Degree of Master of Science in Civil
Engineering (Geotechnical Engineering)**

By: Mengesha shiferaw Berhie

December, 2017

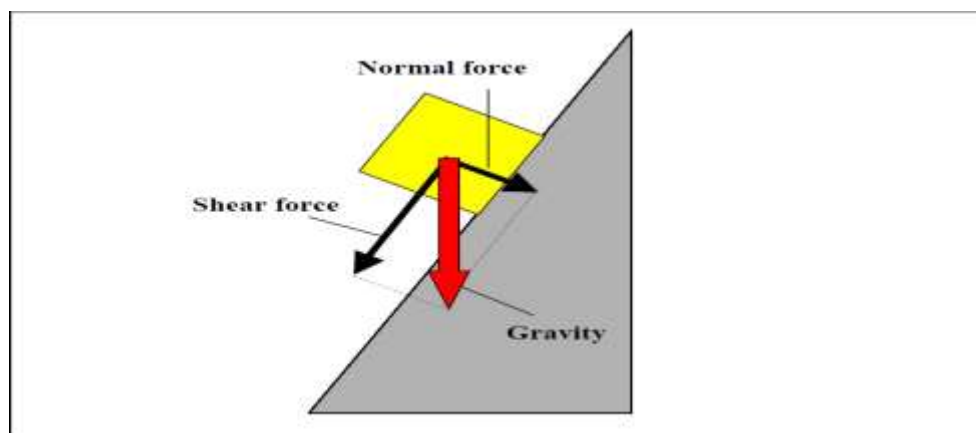
Figure 2.1 Shear force and normal force to gravity on a steep slope (UNESCO,1988).

greater the height, steepness and convexity of slopes, the greater the volumes of the landslides. On a steeper slope, the shear stress or tangential component of gravity increases and the perpendicular component of gravity decreases. The forces resisting movement down the slope are grouped under the term shear strength which includes frictional resistance and cohesion among the particles that make up the object as shown in figure 2.1 below. When the shear stress becomes greater than the shear strength then the slope fails (UNESCO/UNE, 1988).

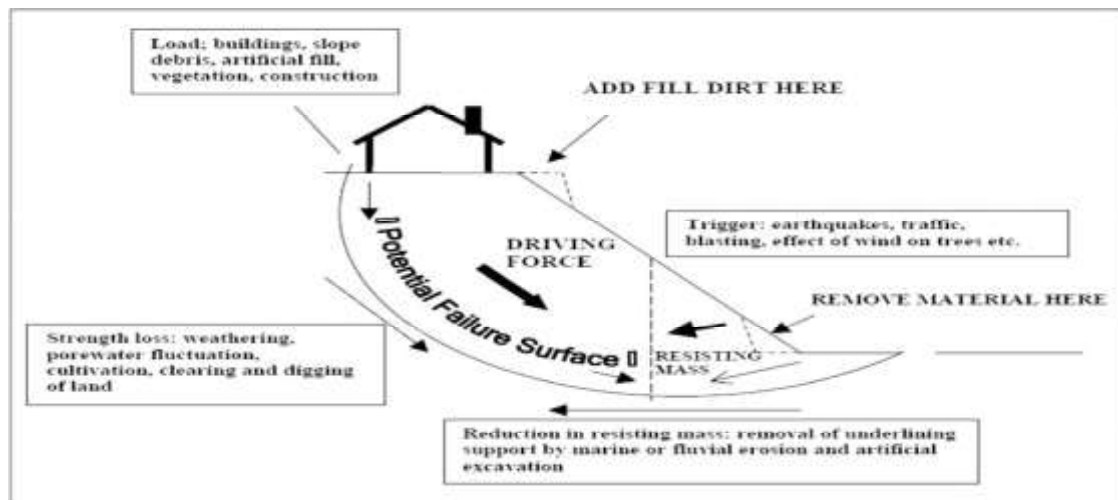
Figure 2.2 Landslide mechanics(after Alexander, 1993)

Slope instability is the condition which gives rise to slope movements. In every slope there are forces (stresses) which tend to promote movement (shear stress), and opposing forces which tend to resist movement (shear strength). Sliding occurs when the forces tending to cause movements are greater than those resisting it. In normal circumstances, the shear stress is balanced by shear strength and a state of equilibrium is maintained. However, this equilibrium can be disturbed by stress increments or the weakening of frictional force (Alexander, 1993).

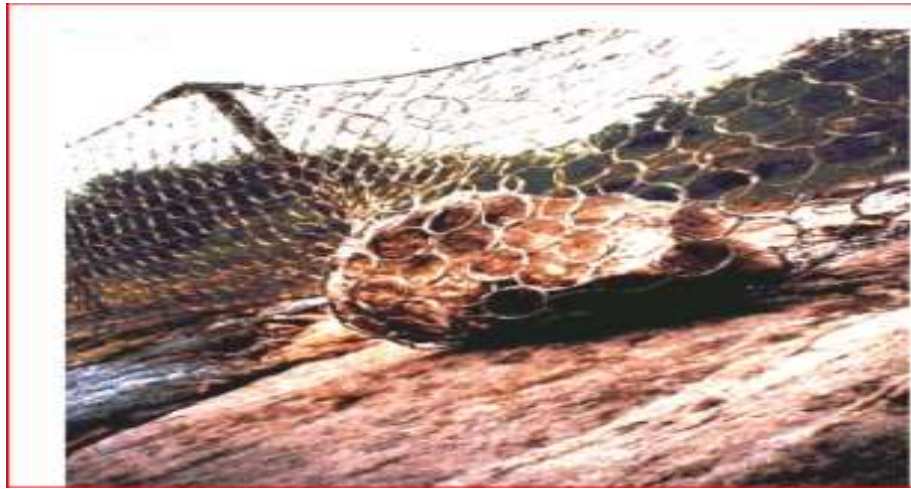
Figure 2.4 Geo-brugg ring net restraining after (Spang, R.M., Soñner, T., 1995)

Rock traps work well in catching rockfalls provided that there is sufficient room at the toe of the slope to accommodate these rock traps. In the case of very narrow roadways at the toe of steep slopes, there may not be sufficient room to accommodate rock traps. This restriction also applies to earth or rock fills and to gabion walls or massive concrete walls. Catch fences or barrier fences in common use are estimated to have an energy absorption capacity of 100 KN/m^2 . The mesh is draped over the rock face and attached at several locations along the slope. The purpose of the mesh is not to stop rockfalls but to trap the falling rock between the mesh and the rock face and so to reduce the horizontal velocity component which causes the rock to bounce out onto the road way (Badger, and Lowell, 1992)

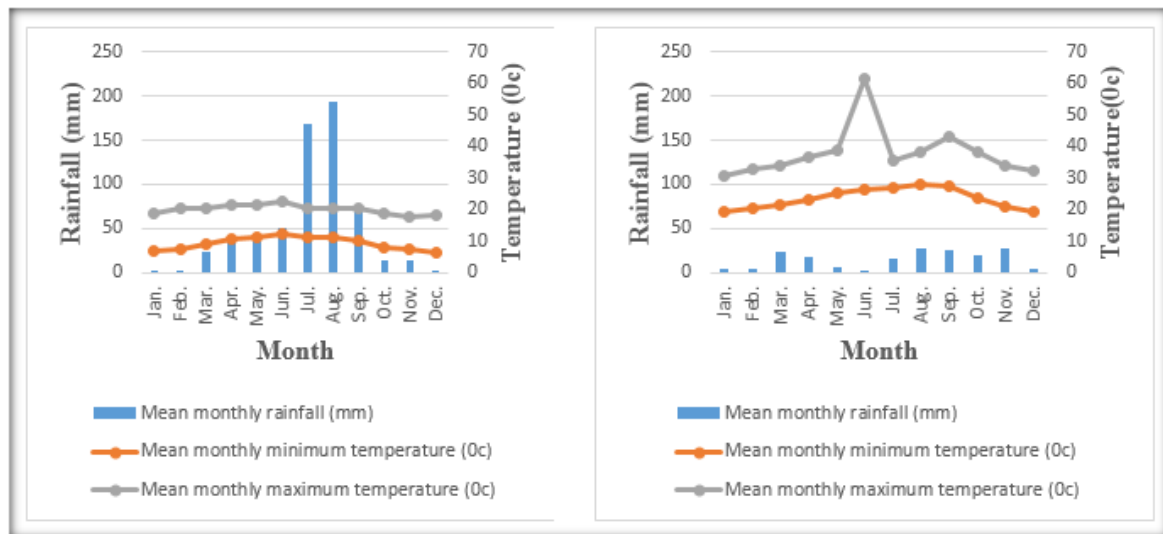
Figure 3.3 Mean monthly rainfall, and mean monthly minimum and maximum temperature data of Atsbi (left) and Berhale (right) (after EMNSA, 2016)

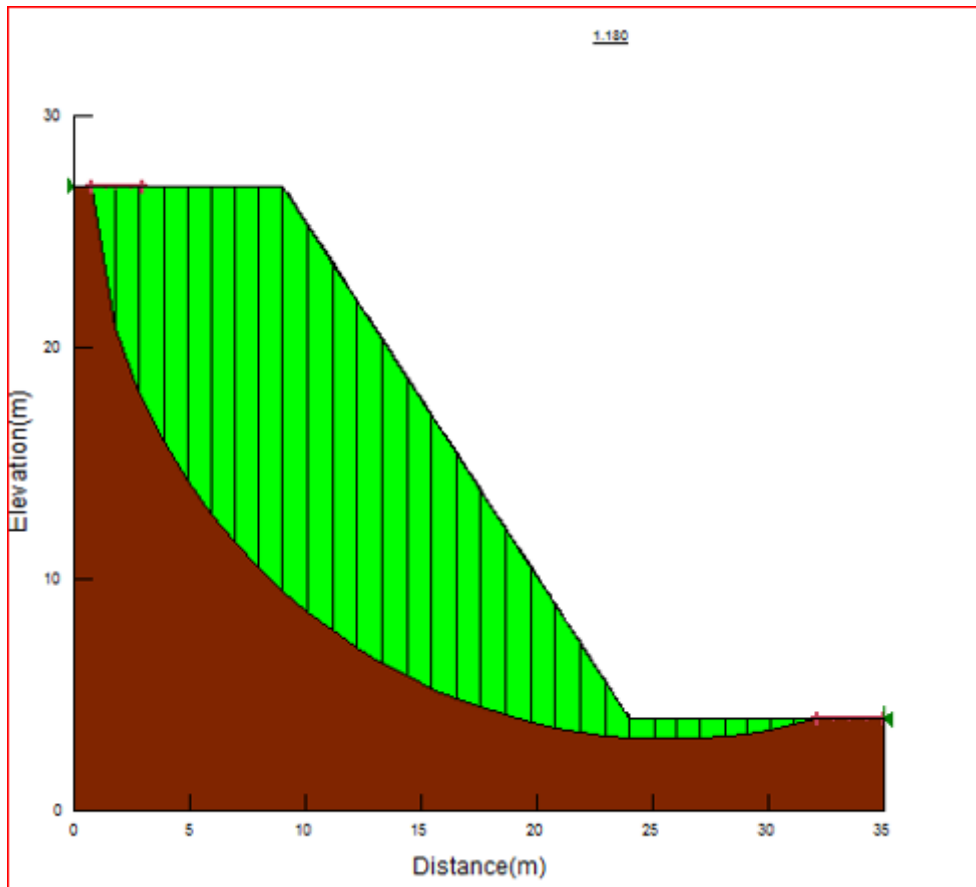
Figure 4.1 Most critical failure circle for homogenous failed slope A-1-01

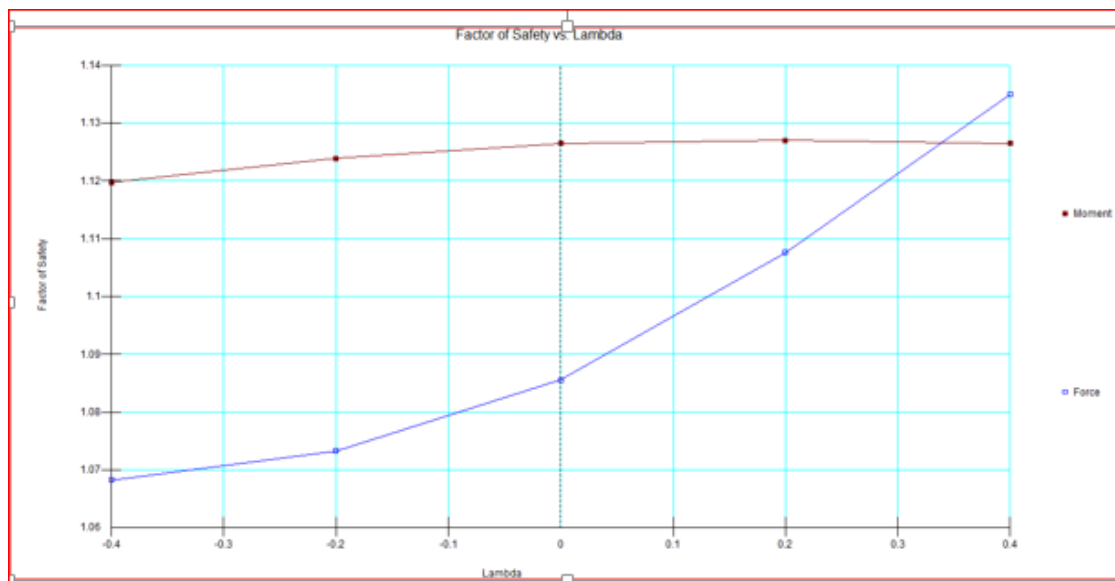
Figure 4.2 lambda vs. factor of safety

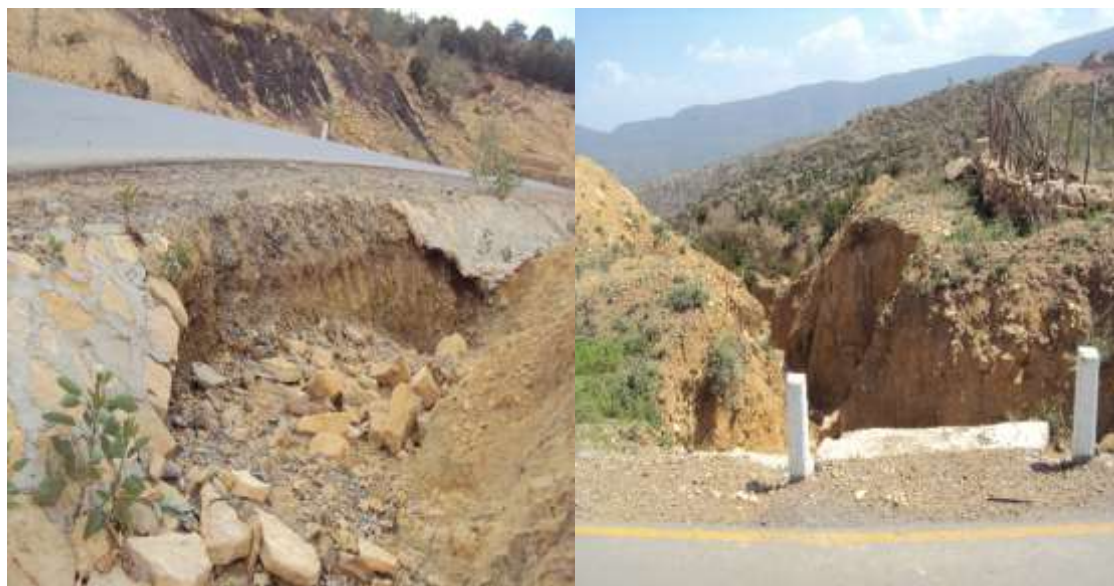
4.4 Figure road side ditches and culverts scouring problems at the study area.

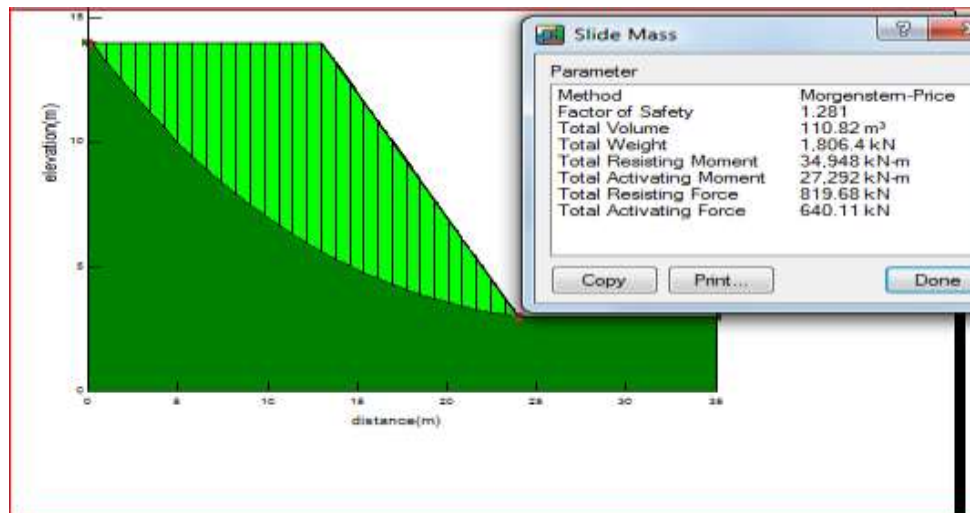
Figure 4.7 Most critical failure circle for Homogenous slide mass failed slope after flattering (Slope changed from (IV: 1H to 1V:2H))

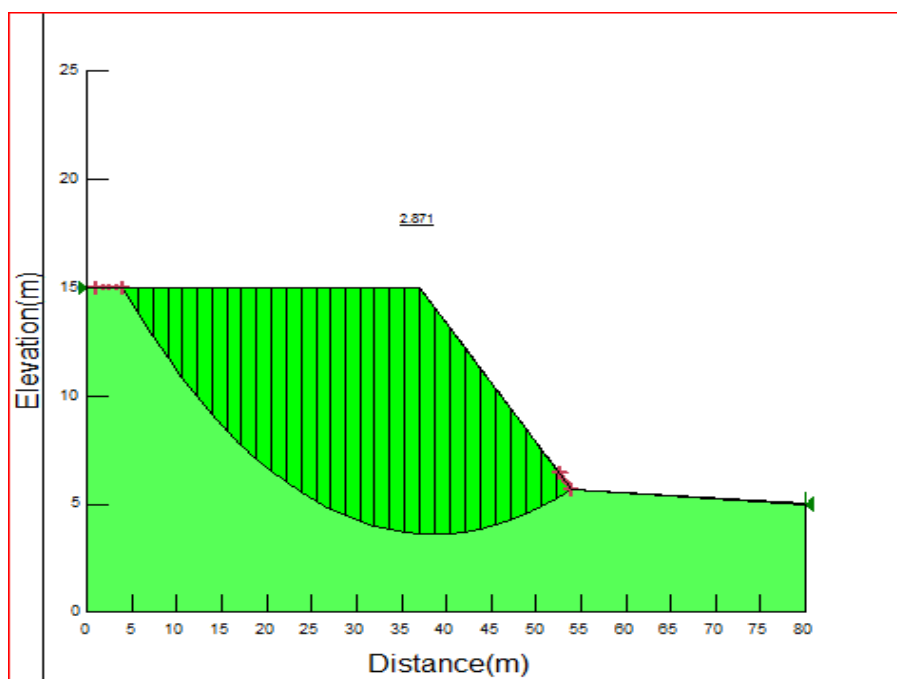
Figure 4.8 Most critical failure circle for Homogenous slide mass failed slope (after flattering slope angle changed from IV: 1H to 1V:3H)

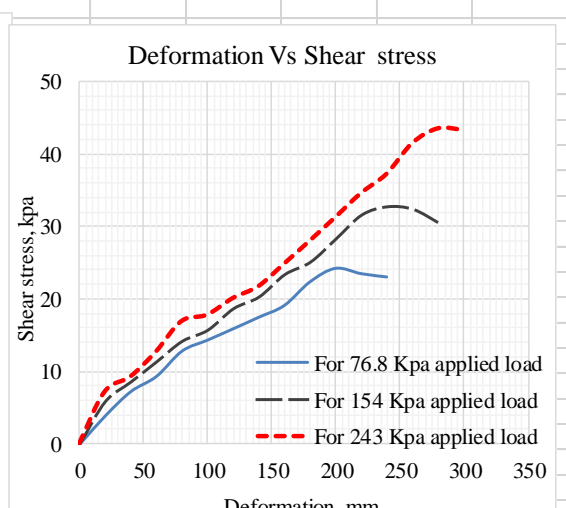
Angle of internal friction, ϕ =	12.24	Cohesion, C (kN/m ²) =	31.18
--------------------------------------	-------	------------------------------------	-------

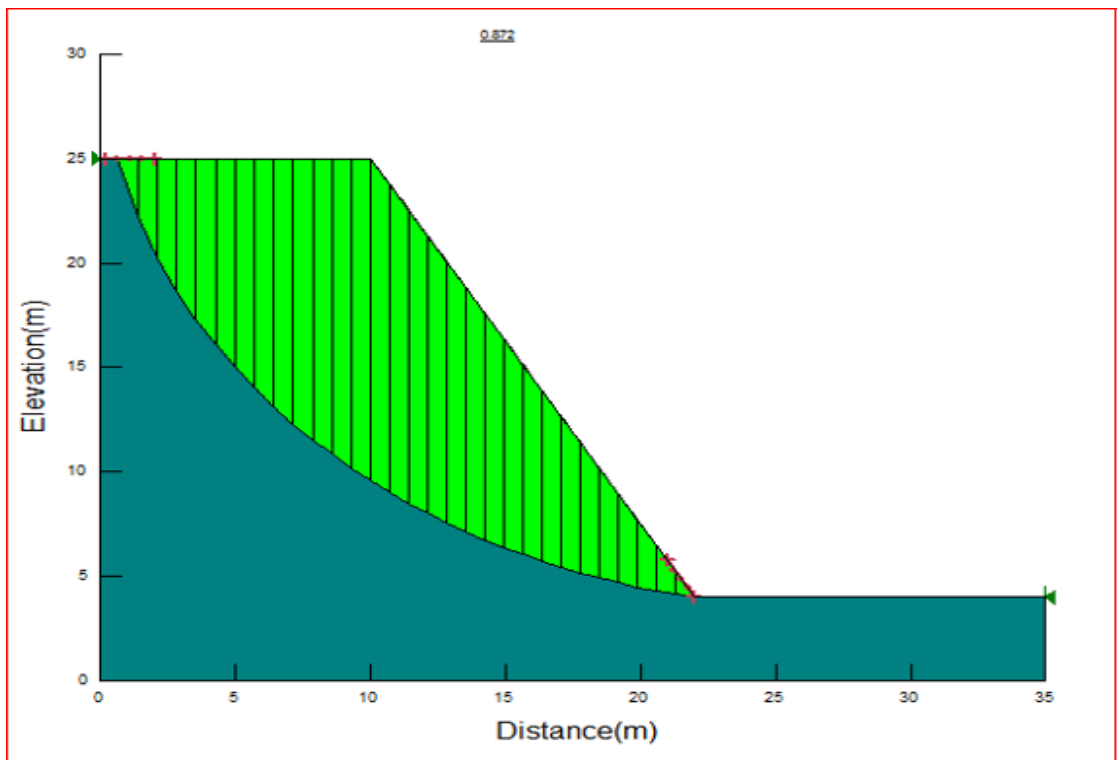
Figure B1.11 Most Critical Failure Circle for Homogenous failed slope AS-1-01

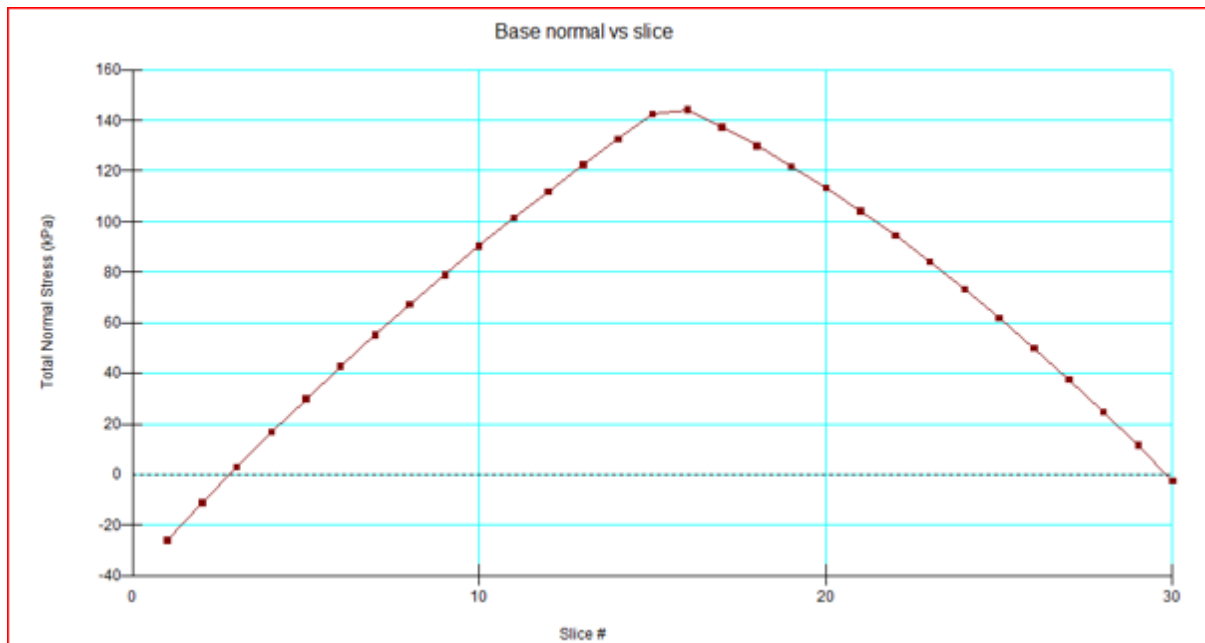
B1.20 Figure slice vs. total normal stress

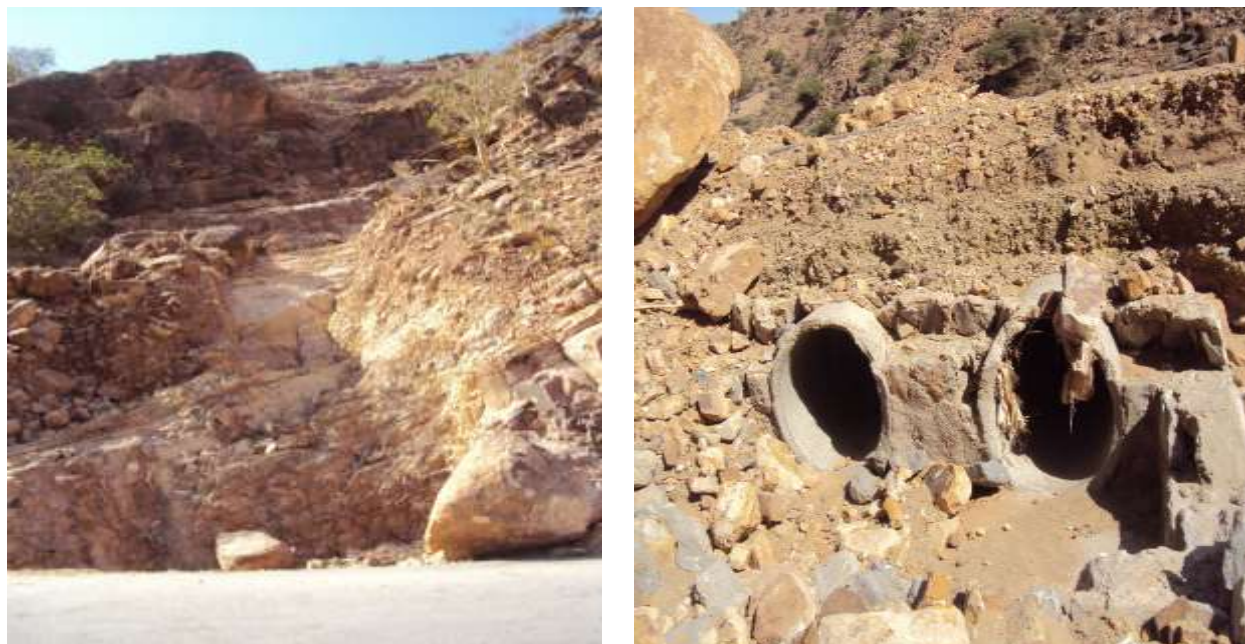
Figure C1.1 Blocked culverts

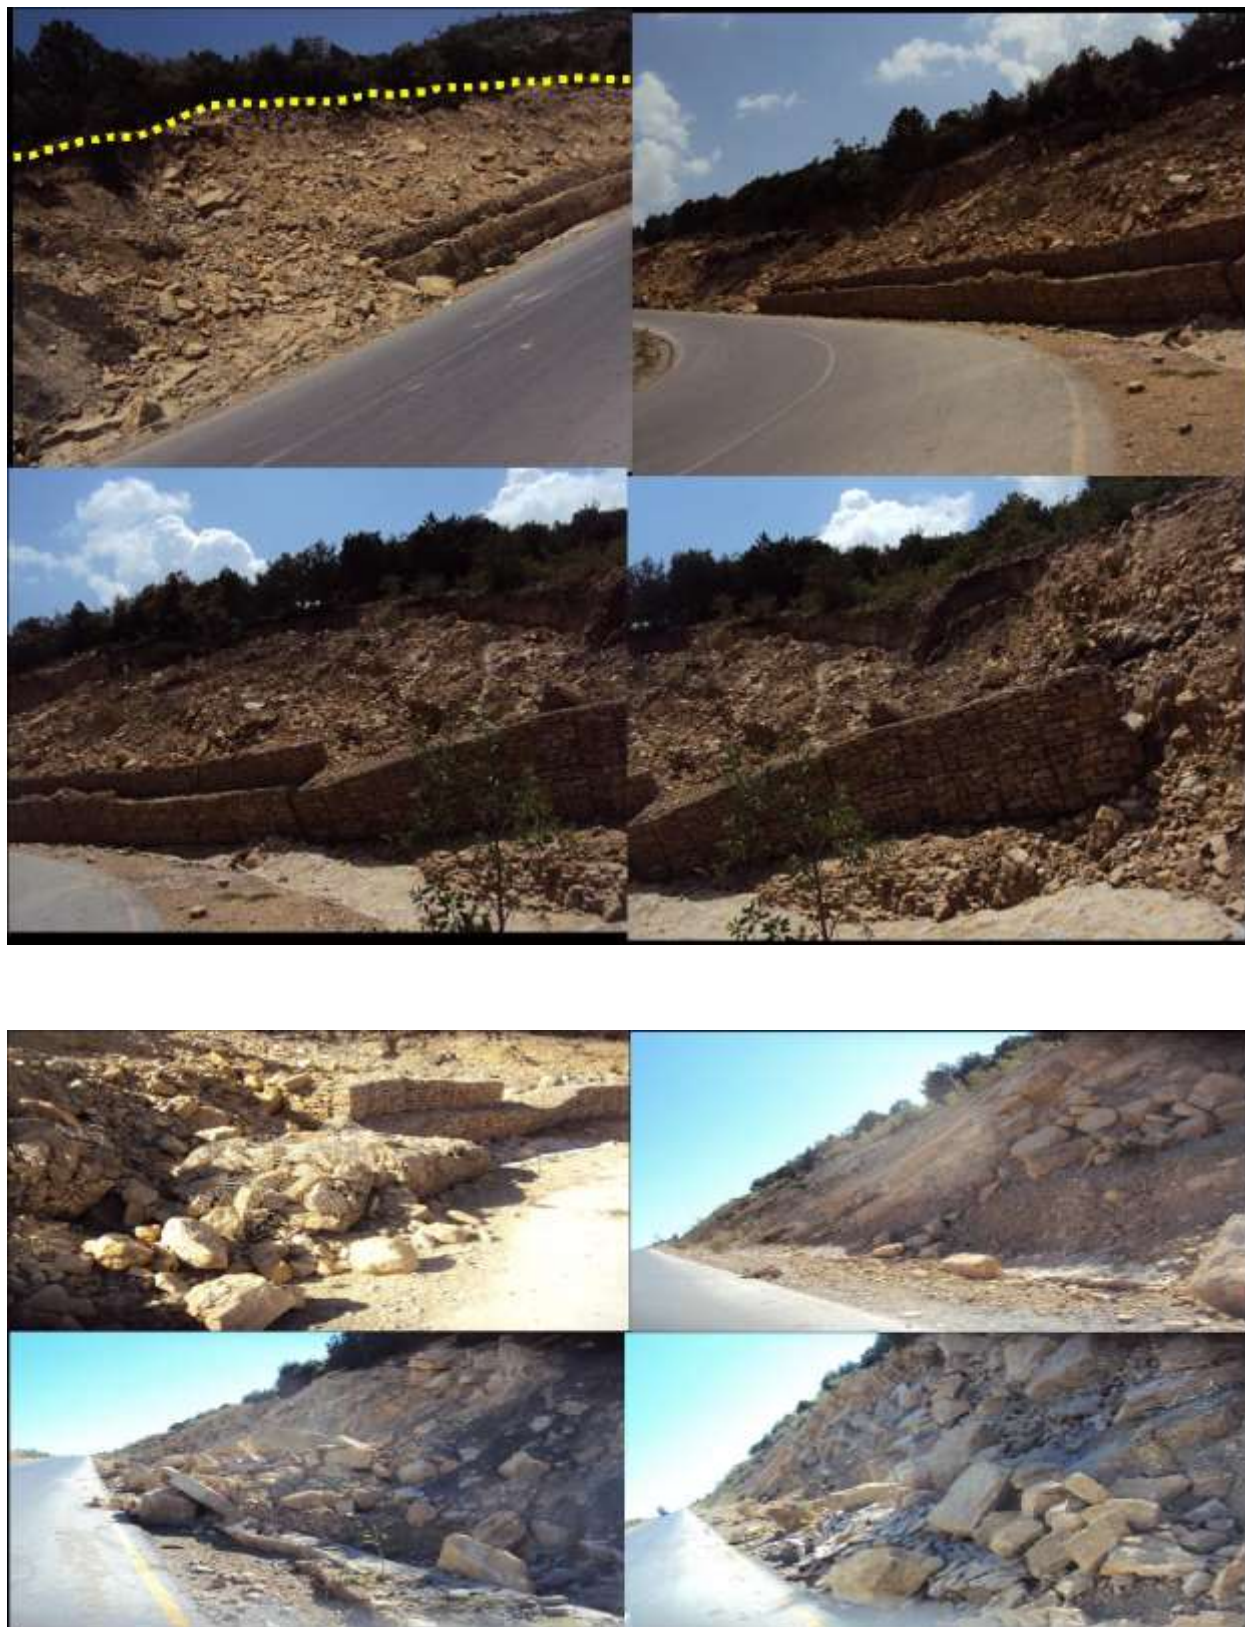
Figure C1.3: Damaged retaining wall and failed slopes

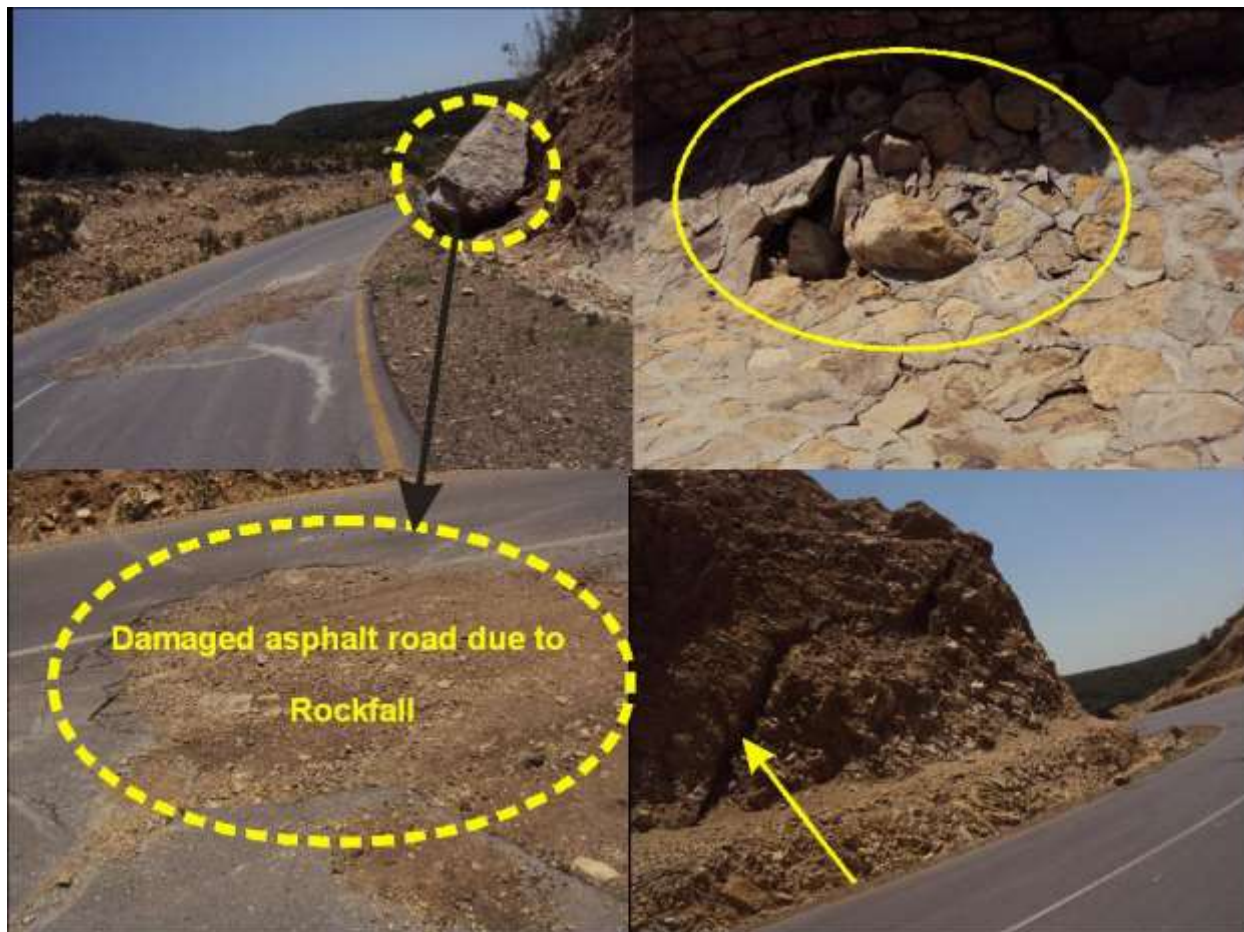
Figure D1.4 Cracked slope
