Jimma University

**Causes of Flexible Pavement Deterioration and Its Remedial Measures: A
Case Study Bako to Nekemte Road section.**

A Thesis Submitted to School of Graduate Studies of Jimma University, in Partial Fulfillment of the Requirements for Degree of Masters of Science in Civil Engineering (Highway Engineering Stream).

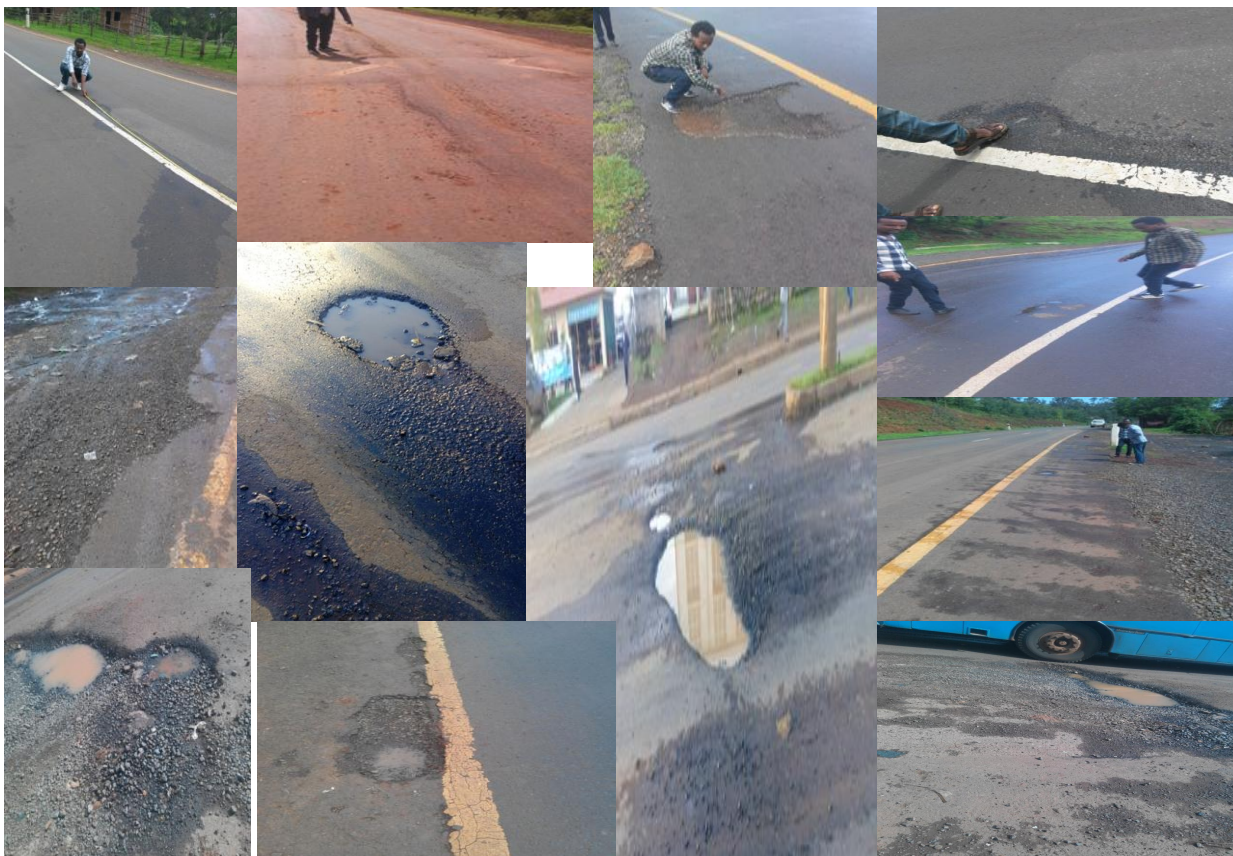
Figure 1.1 different deteriorations types which are exist along Bako-Nekemte currently

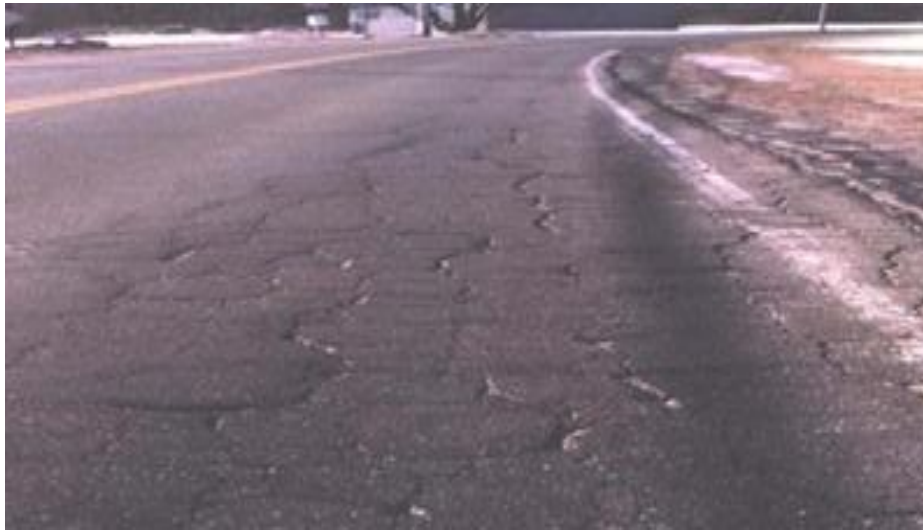
Fatigue cracking is commonly called alligator cracking. This is a series of interconnected cracks creating small, irregular shaped pieces of pavement. It is caused by failure of the surface layer or base due to repeated Traffic loading (fatigue). Eventually the cracks lead to disintegration of the surface, as shown in Figure. The final result is potholes. Alligator cracking is usually associated with base or drainage problems. Small areas may be fixed with a patch or area repair. Larger areas require reclamation or reconstruction. Drainage must be carefully examined in all cases.

Figure 2.1 alligator crack

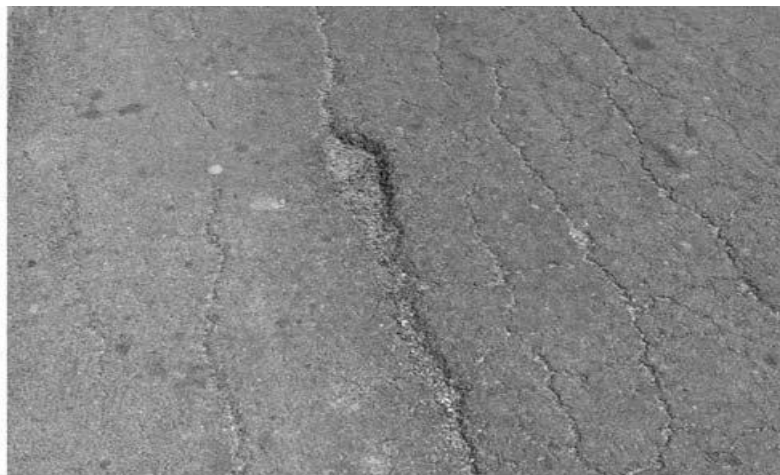
Longitudinal cracking are long cracks that run parallel to the center line of the roadway. These may be caused by frost heaving or joint failures or they may be load induced. Understanding the cause is critical to selecting the proper repair. Multiple parallel cracks may eventually form from the initial crack. This phenomenon, known as deterioration, is usually a sign that crack repairs are not the proper solution

Figure 2.2 Longitudinal Cracking

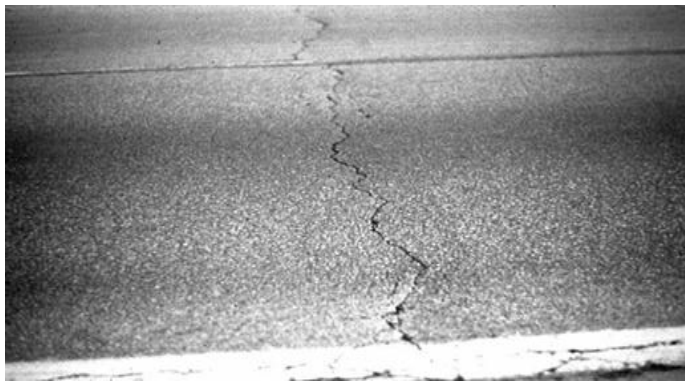
Transverse cracking form at approximately right angles to the centerline of the roadway. They are regularly spaced and have some of the same causes as longitudinal cracks. Transverse cracks will initially be widely spaced (over 20 feet apart). They usually begin as hairline or very narrow cracks and widen with age. If not properly sealed and maintained, secondary or multiple cracks develop, parallel to the initial crack. The reasons for transverse cracking, and the repairs, are similar to those for longitudinal cracking. In addition, thermal issues can lead to low-temperature cracking if the asphalt cement is hard [28].

Figure 2.3 Low severity transverse cracking

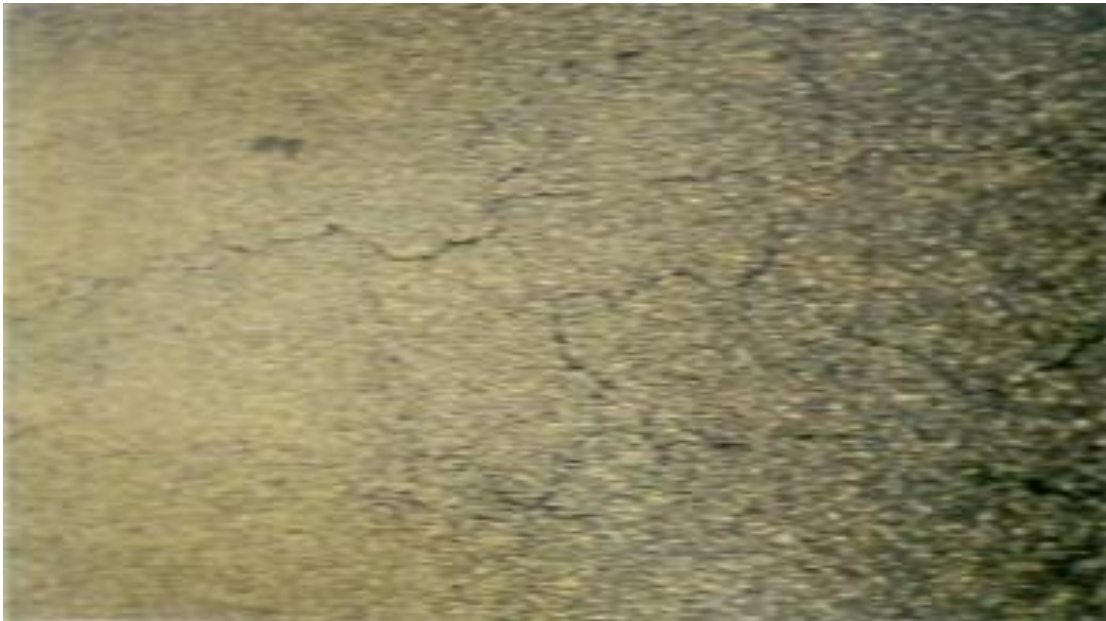
Block cracking is an interconnected series of cracks that divides the pavement into irregular pieces. This is sometimes the result of transverse and longitudinal cracks intersecting. They can also be due to lack of compaction during construction. Low severity block cracking may be repaired by a thin wearing course. As the cracking gets more severe, overlays and recycling may be needed. If base problems are found, reclamation or reconstruction may be needed. Figure shows medium to high severity block cracking.

Figure 2.4 Block cracking

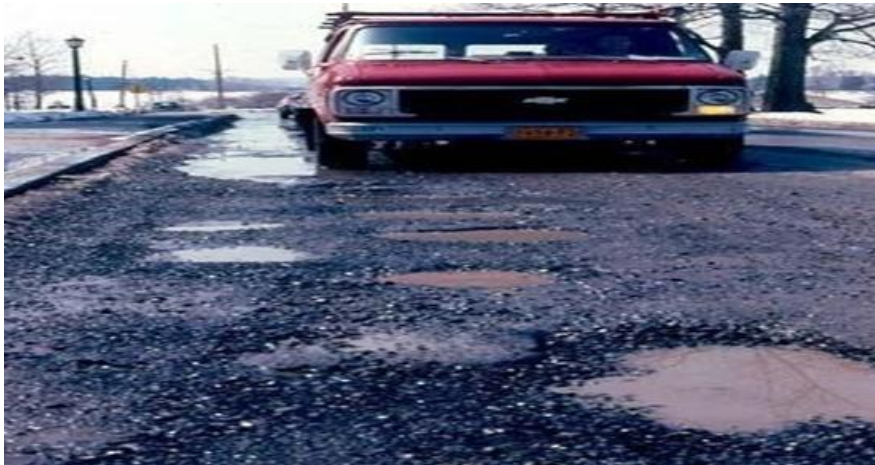
into the lower layers of the pavement. Potholes are often located in areas of poor drainage, as seen in Figure. Potholes are formed when the pavement disintegrates under traffic loading, due to inadequate strength in one or more layers of the pavement, usually accompanied by the presence of water. Most potholes would not occur if the root cause was repaired before development of the pothole. Repair by excavating and rebuilding. Area repairs or reconstruction may be required for extensive potholes.

Figure 2.6 Potholes caused by poor drainage

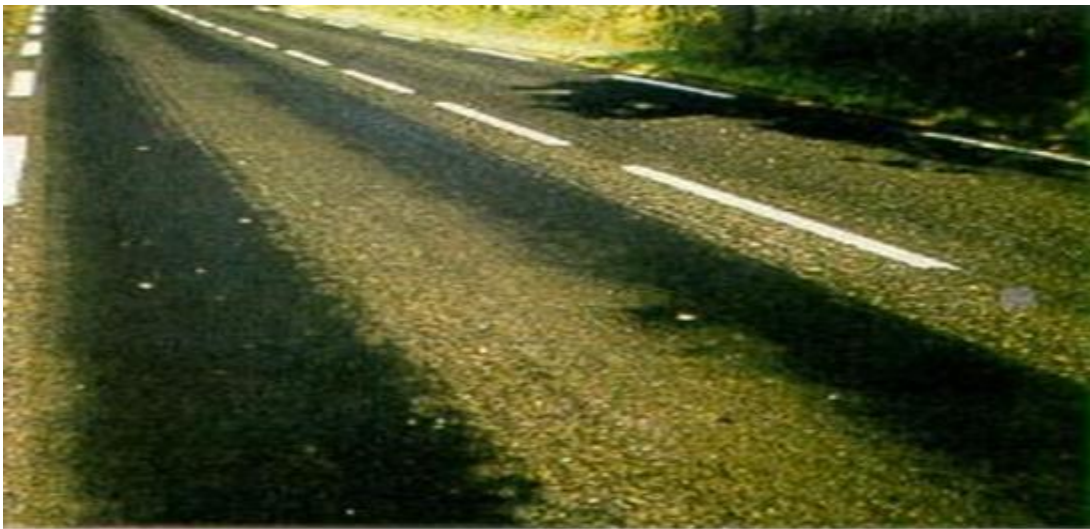
Raveling is the loss of material from the pavement surface. It is a result of insufficient adhesion between the asphalt cement and the aggregate. Initially, fine aggregate breaks loose and leave small, rough patches in the surface of the pavement. As the disintegration continues, larger aggregate breaks loose, leaving rougher surfaces. Raveling can be accelerated by traffic and freezing weather. Some raveling in chip seals is due to improper construction technique. This can also lead to bleeding. Repair the problem with a wearing course or an overlay.

Figure 2.7 High severities raveling of asphalt surface

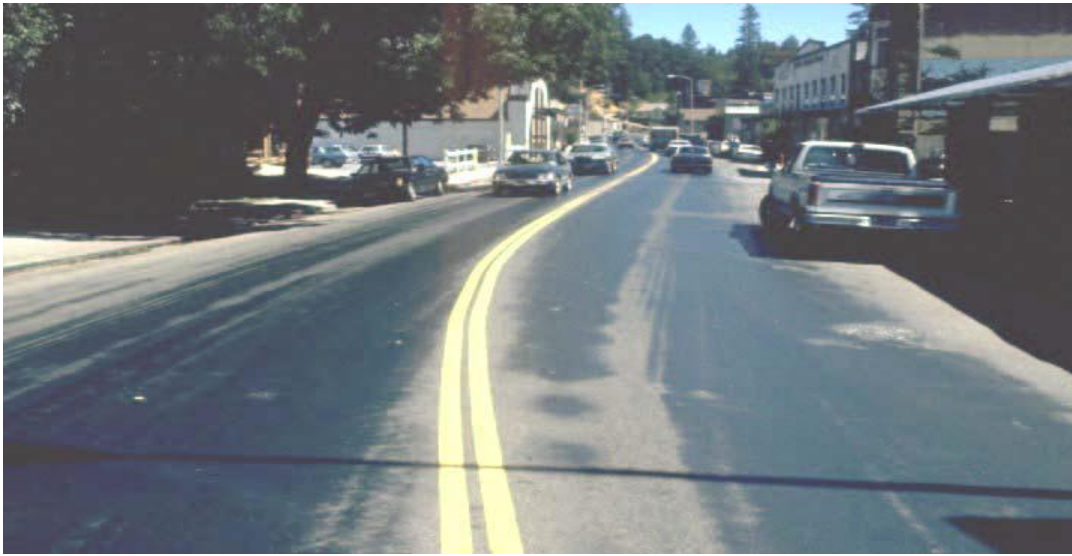
Bleeding is defined as the presence of excess asphalt on the road surface which creates patches of asphalt cement. Excessive asphalt cement reduces the skid-resistance of a pavement, and it can become very slippery when wet, creating a safety hazard. This is caused by an excessively high asphalt cement content in the mix, using an asphalt cement with too low a viscosity (too flow able), too heavy a prime or tack coat, or an improperly applied seal coat. Bleeding occurs more often in hot weather when the asphalt cement is less viscous (more flow able) and the traffic forces the asphalt to the surface. Figure 13 shows an example of bleeding during hot weather

Figure 2.8 Bleeding

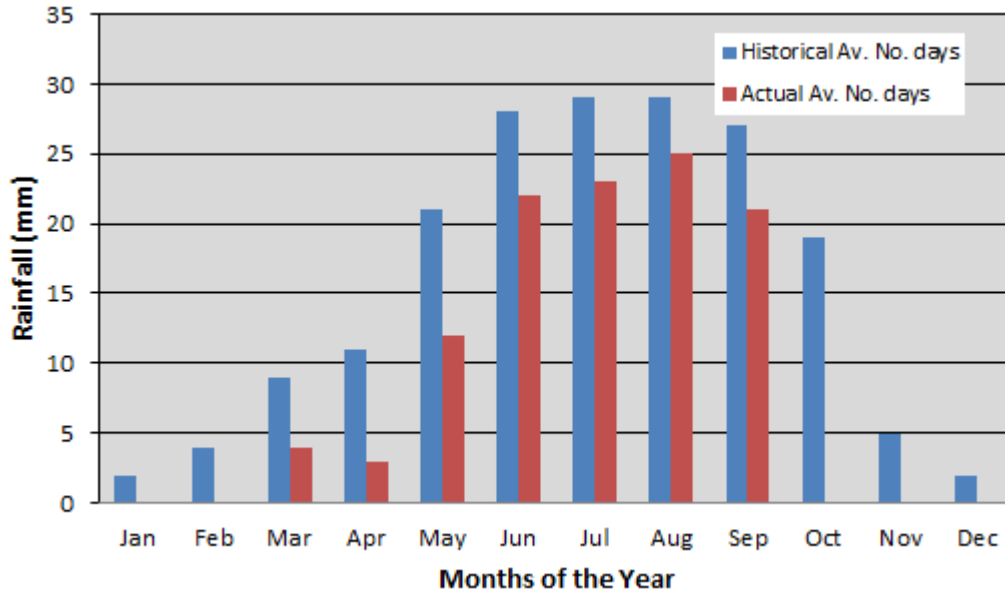
Figure 3.1 Annual rainfall of the road section.

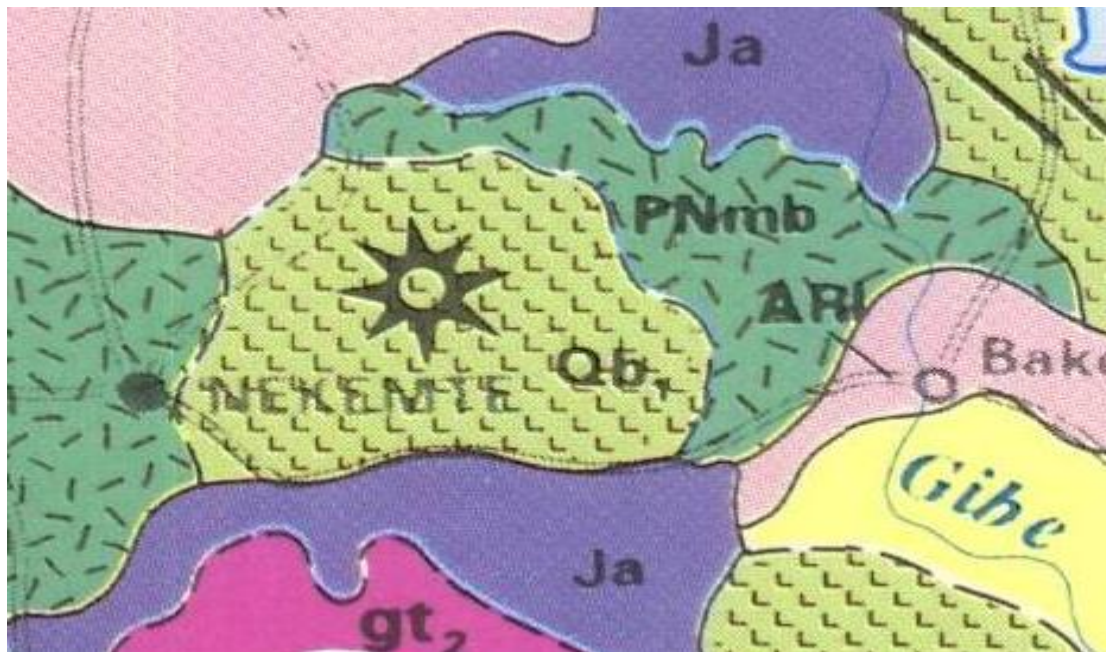
E. Mekonen Basalts (PNmb): The group consists of Tertiary Flood Basalts overlying the crystalline basement and is mainly found from around km 70 to around km 85 and from around km 130 to around km 140.5. Nekemte is covered with the Mekonen Basalts.

Figure 3.3 Geological Map of Ethiopia in the corridor of Bako - Nekemte Road

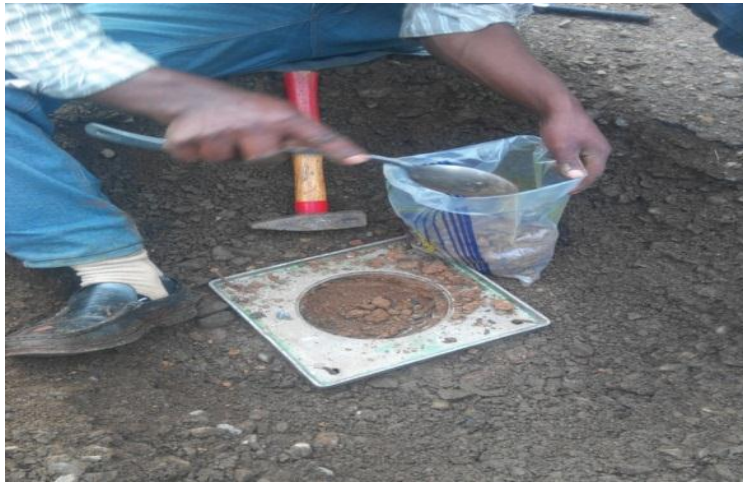
Field tests were conducted on the selected sections of Bako-Nekemte road rehabilitation project. The field tests performed by checking thickness of the pavement layers, field moisture content and field density for each pavement layer. In each location, the surface of the material layer that had been tested was trimmed and smoothed to form platform for the measuring apparatus. Then a pit was excavated through the guide of the pavement material cross section of the road prism. The material from the pit, to a depth of t h e actual pavement material thickness, was carefully collected and put inside of polyethene bag, then, tightly sealed, and labeled for subsequent natural moisture content determination. The bulk density had been computed after completion of each test. The field dry densities of all samples were later computed based on the results of the natural moisture content at determined in the laboratory.

Figure 3.4 field density tests (photo 9, 7, 2016)

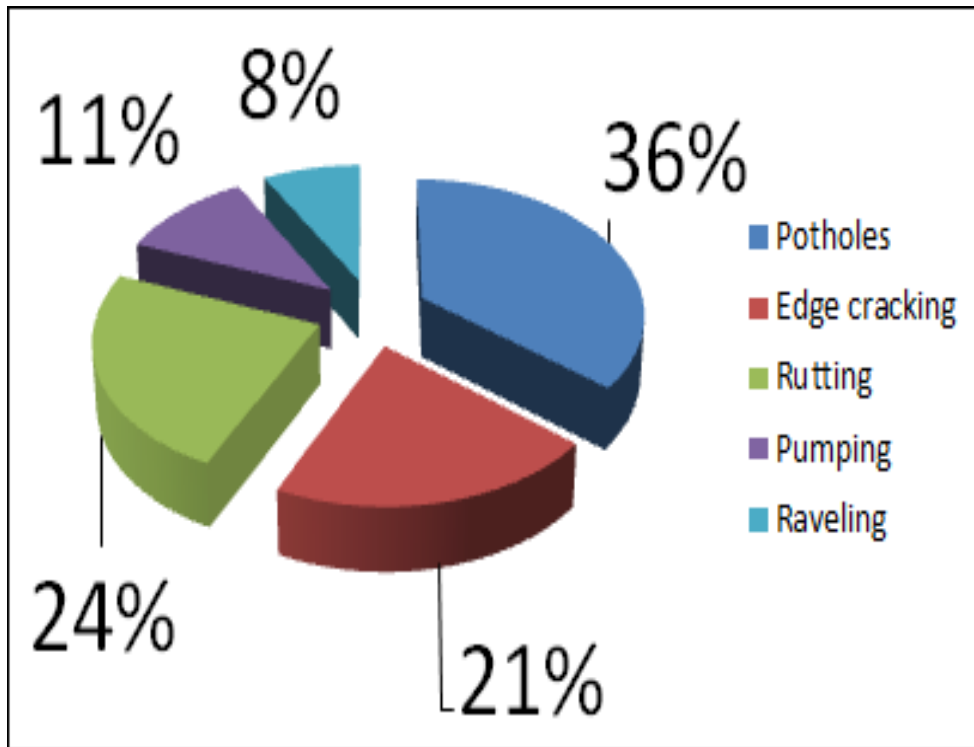
Figure 4.1 the percentage of common deterioration types and their severity.

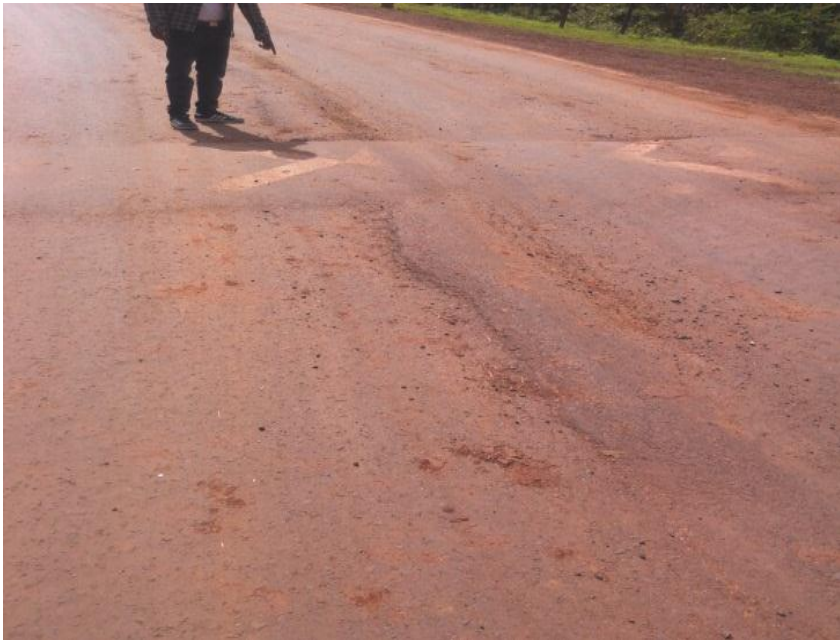
Rutting at wheel path at section 2 (photo10, 6,2016)

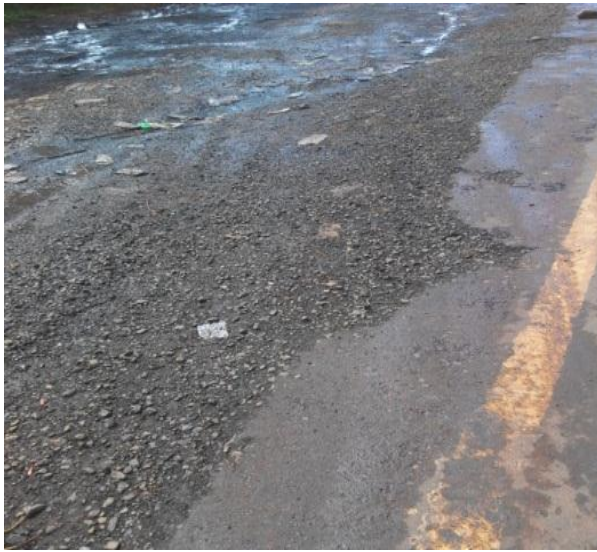
Edge cracking at section 3 (photo 15, 6, 2016)

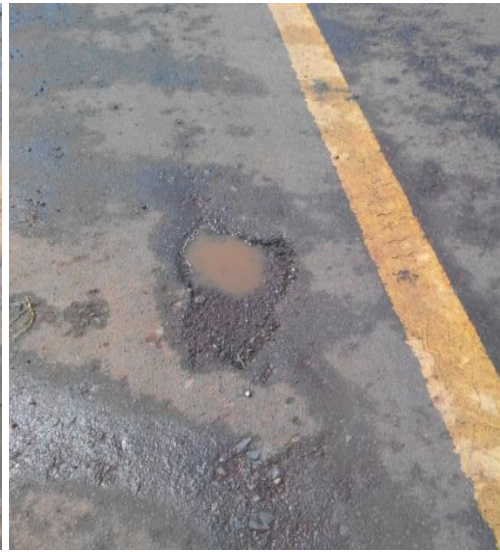
Potholes at section 2(photo10, 6, 2016)

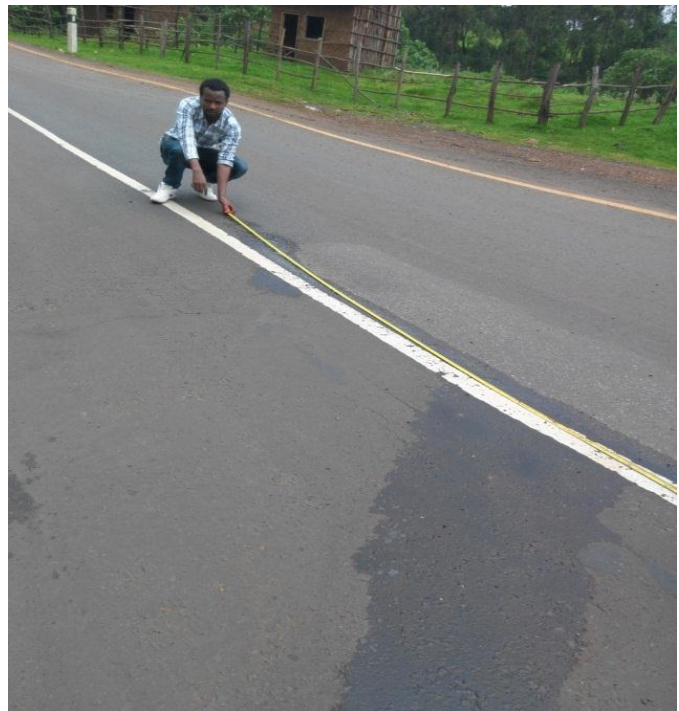
pumping type at section 1(photo 12, 6, 2016)

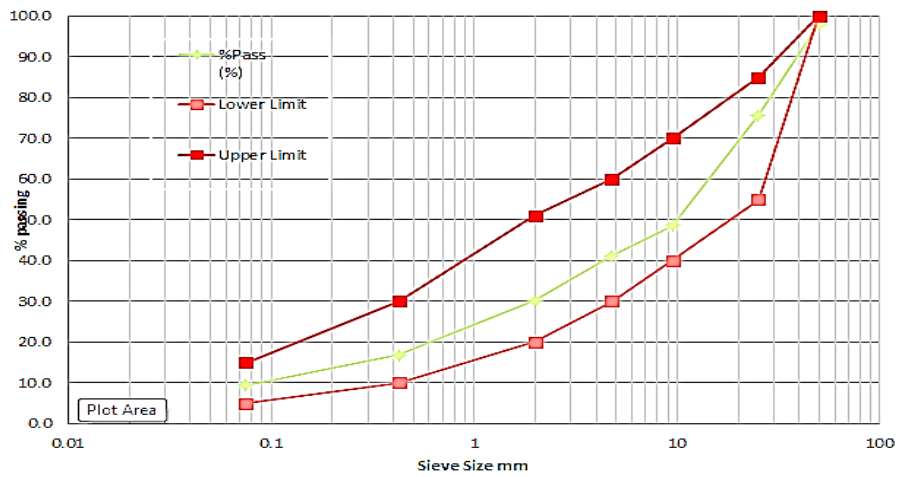
Figure 4.8 Base course material particle size distributions at section 2

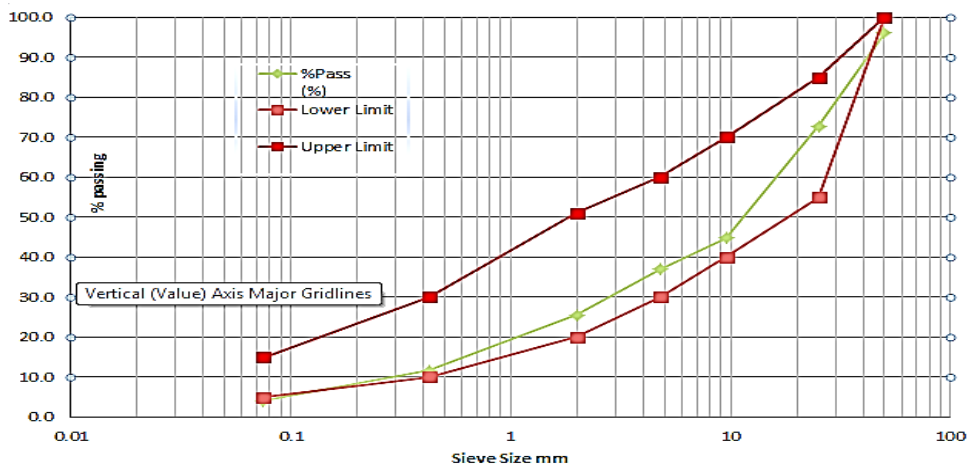
Figure 4.9 Base course material particle size distribution at section 3

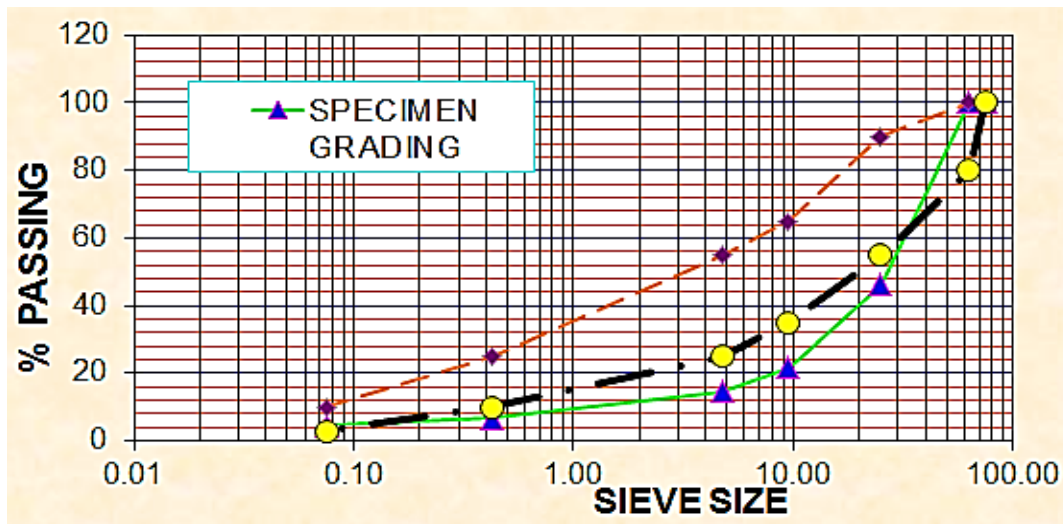
Figure 4.12 Natural Sub base material particle size of section 3

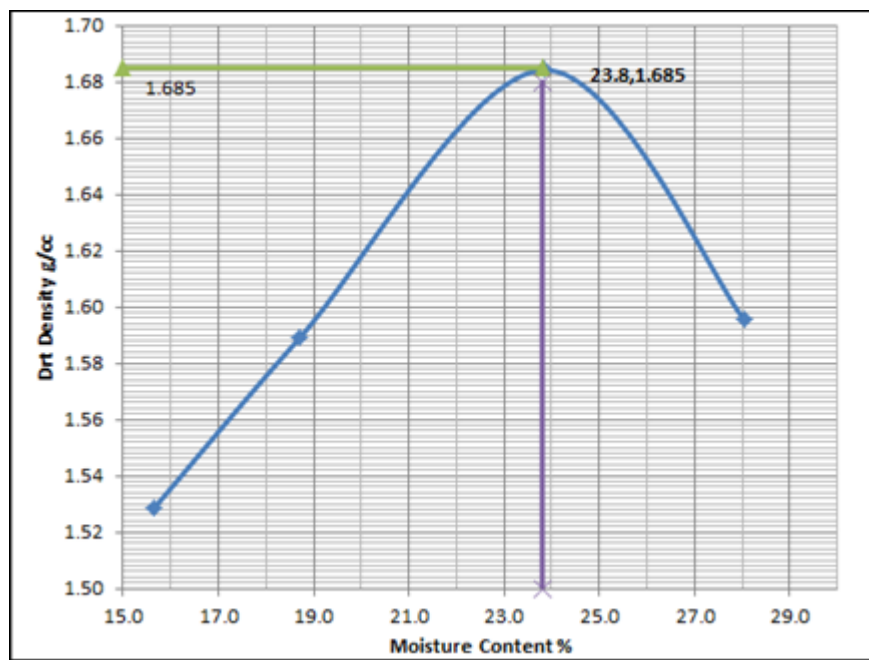
The dry density values on the y-axis and the moisture contents on the x-axis were plotted. And a smooth curve connecting the plotted points was drawn

Figure 4.13 Moisture content against dry density

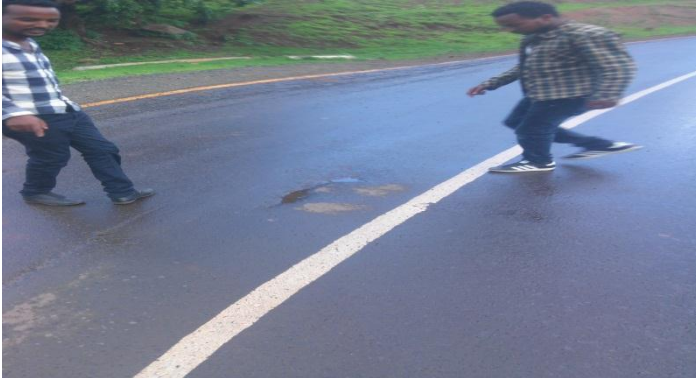
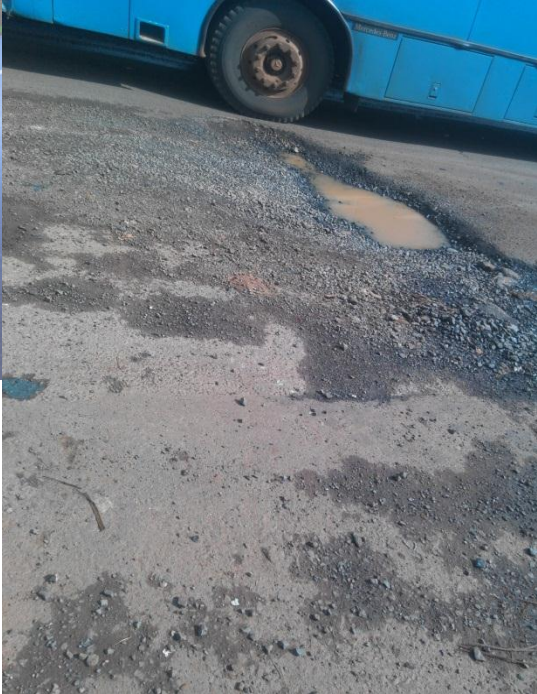
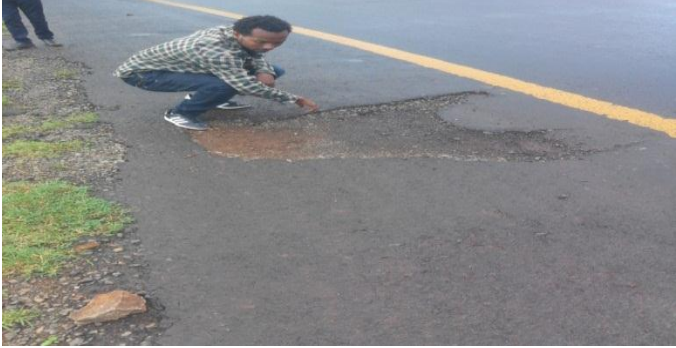
Raveling type of deterioration

Potholes type of deterioration

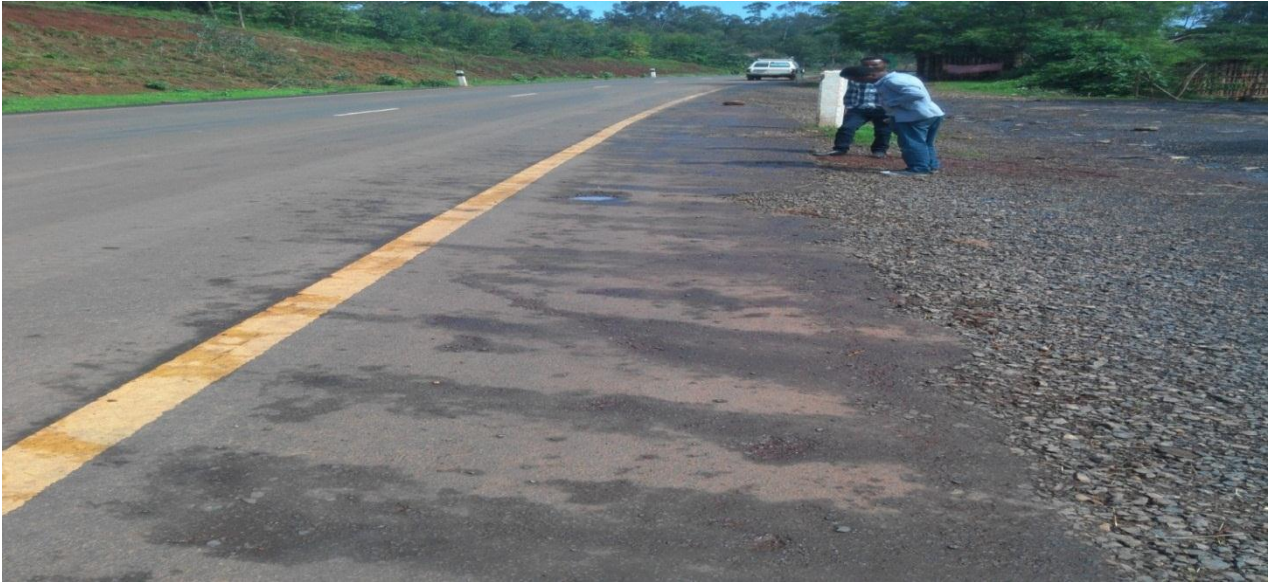
Edge crack type of deterioration

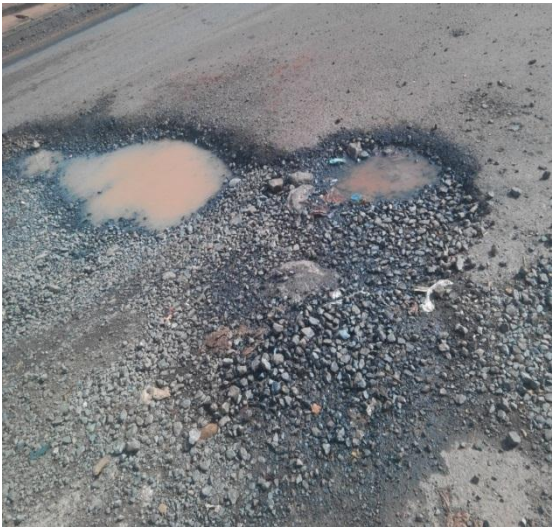
Pot hole type

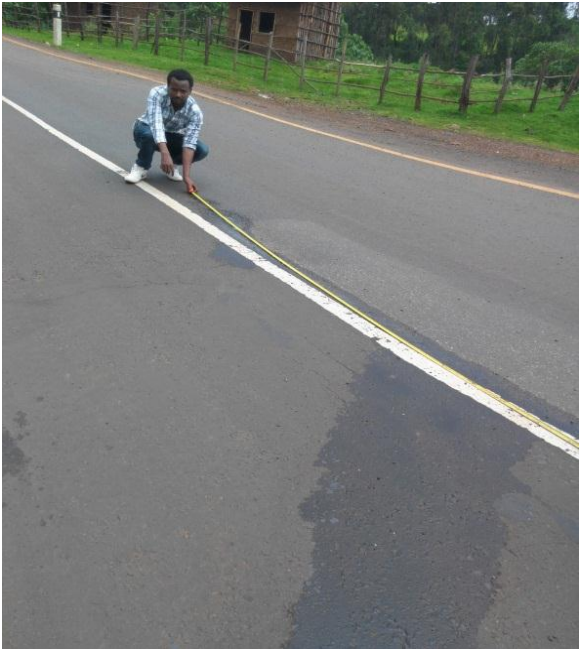
Pumping types of deterioration

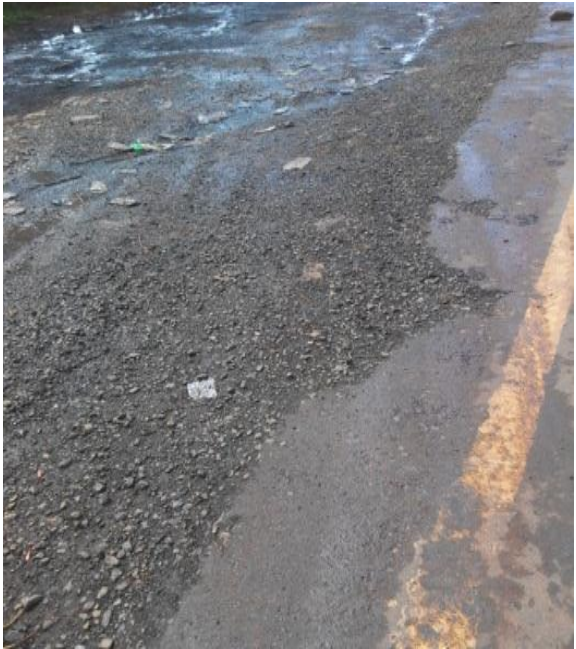
Edge cracking type of deterioration

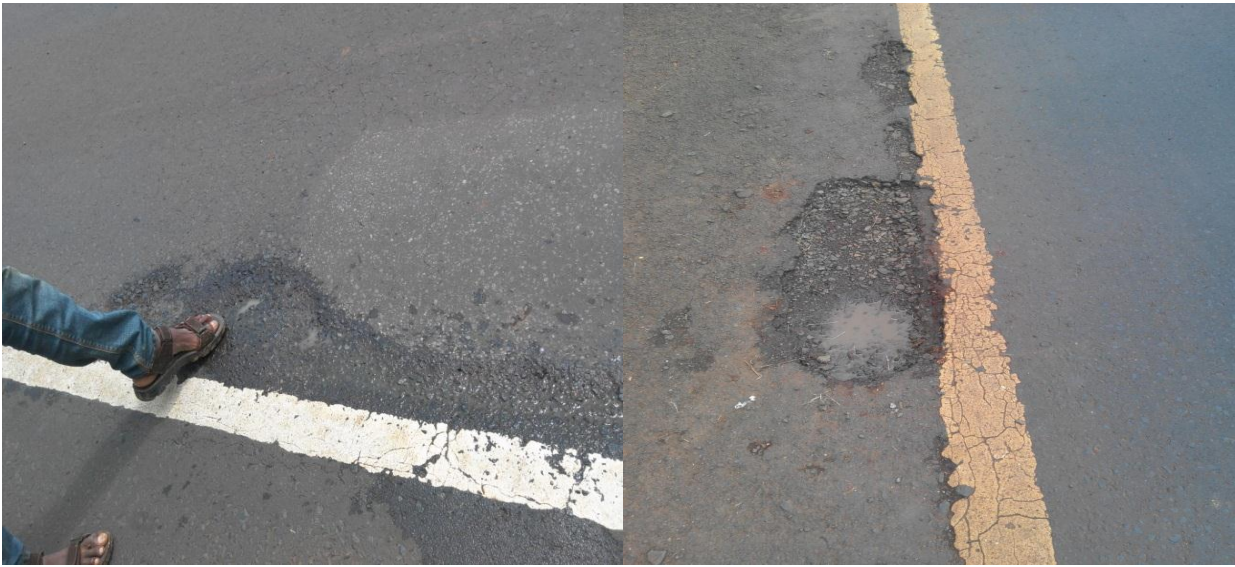
Pumping types of deterioration

pothole at edge damage type

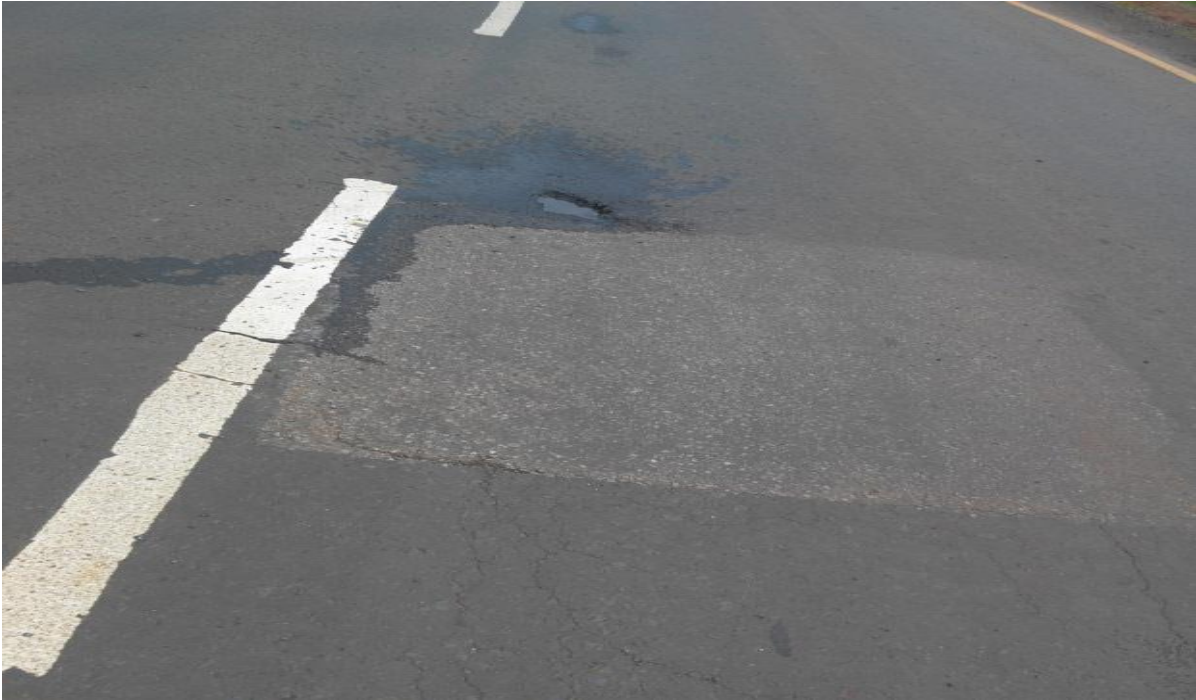
Pot hole and patch

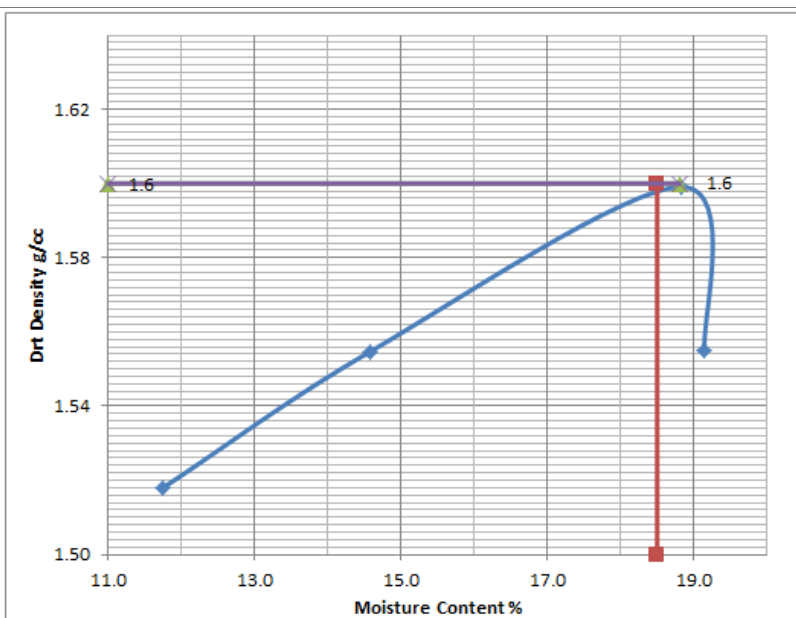
Appendix F: Compaction curve of Natural sub base at section 3

REPRESENT SECTION : SECTION 3					Date Sampeld 24/06/16		
description: Ntural sub baase material					Date Tested:- 29/06/2016		
PURPOSE MOISTURE CONTENT DETERMINATION							
Trial No.	1	2	3	4			
Weight of Mould + Wet soil (g)	11932	12102	12348	12318			
Weight of Mould (g)	7304	7304	7304	7304			
Weight of Wet soil (g)	4628	4798	5044	5014			
Volume of Mould (cc)	2123	2123	2123	2123			
Wet density (g / cm3)	2.18	2.26	2.38	2.36			
Moisture Content Determination							NMC
Moisture can	A-7	A-3	A-6	A-8			A-1
Weight of Wet soil + cont. (g)	328.0	383.0	352.0	322.0			419.0
Weight of Dry soil + cont. (g)	310.0	356.0	321.0	290.0			405.0
Weight of Container (g)	38.0	36.0	45.0	38.0			40.0
Weight of water (moisture) (g)	18.0	27.0	31.0	32.0			23.0
Weight of Dry soil (g)	272.0	320.0	276.0	252.0			272.0
Moisture content (%)	6.62	8.44	11.23	12.70			8.50
Dry Density (g / cm3)	2.04	2.08	2.14	2.10			
MDD 2.14 g/cc				OMC 11.23 %
