**JIMMA UNIVERSITY
SCHOOL OF GRADUATE STUDIES
JIMMA INSTITUTE OF TECHNOLOGY
SCHOOL OF CIVIL AND ENVIRONMENTAL ENGINEERING
HIGHWAY ENGINEERING STREAM**

**EFFECTS OF ROUTE AND GEOMETRIC DESIGN DEFICIENCIES
ON THE ROAD USERS: A CASE STUDY ON ADDIS ABABA - JIMMA
HIGHWAY**

A Thesis Proposal Submitted to School of Graduate Studies in Partial
Fulfillment of the Requirement for Degree of Masters of Science in
Highway Engineering

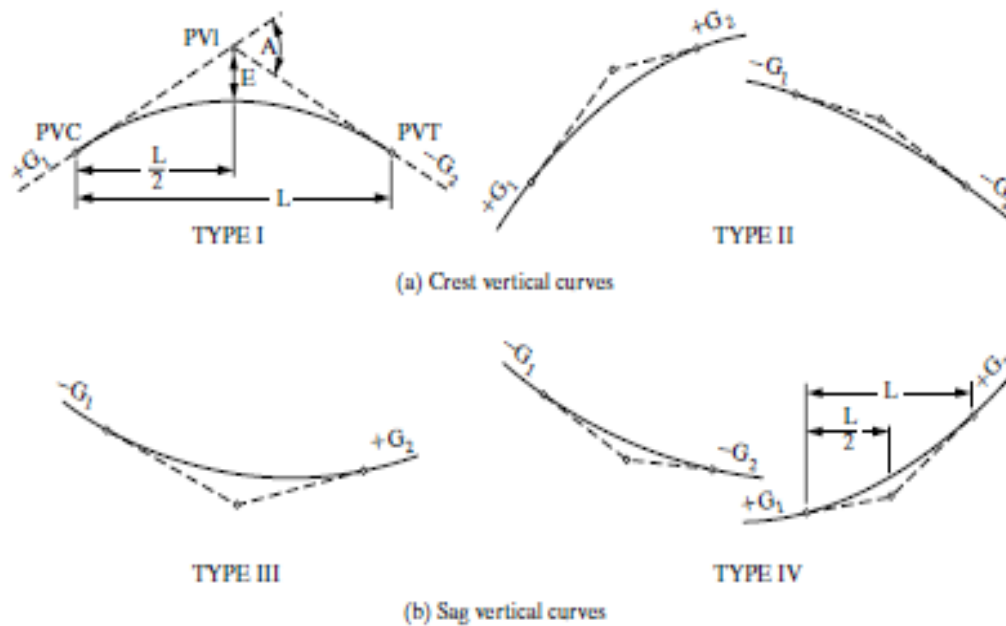
Figure 2.8: Types of Vertical Curves

Vertical curves are used to provide a gradual change from one tangent grade to another so that vehicles may run smoothly as they traverse the highway. These curves are usually parabolic in shape. The expressions developed for minimum lengths of vertical curves are therefore based on the properties of a parabola. Figure 2.8 illustrates vertical curves that are classified as crest or sag (*Traffic and Highway Engineering*, Nicholas J. Garber and Lester A. Hoel, 2010).

G_1, G_2 = grades of tangents (%)

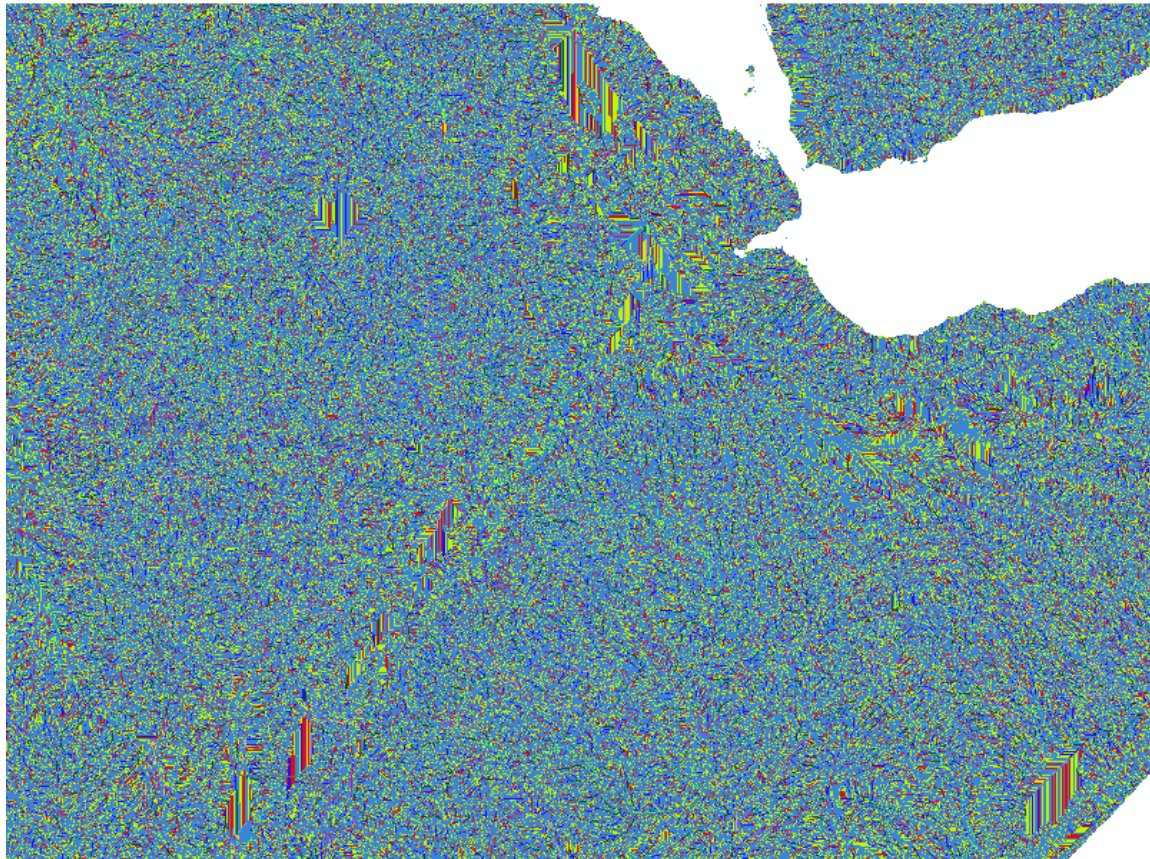
Figure 3.4: Stream-Order Output Map Derived from DEM

direction, Flow accumulation, Con, Stream order and Raster to Polyline tools were used in the stream order analysis. As the result of software analysis based on ArcGIS 10 done by Strahler method, stream order raster having a Grid-code of 9 was derived.

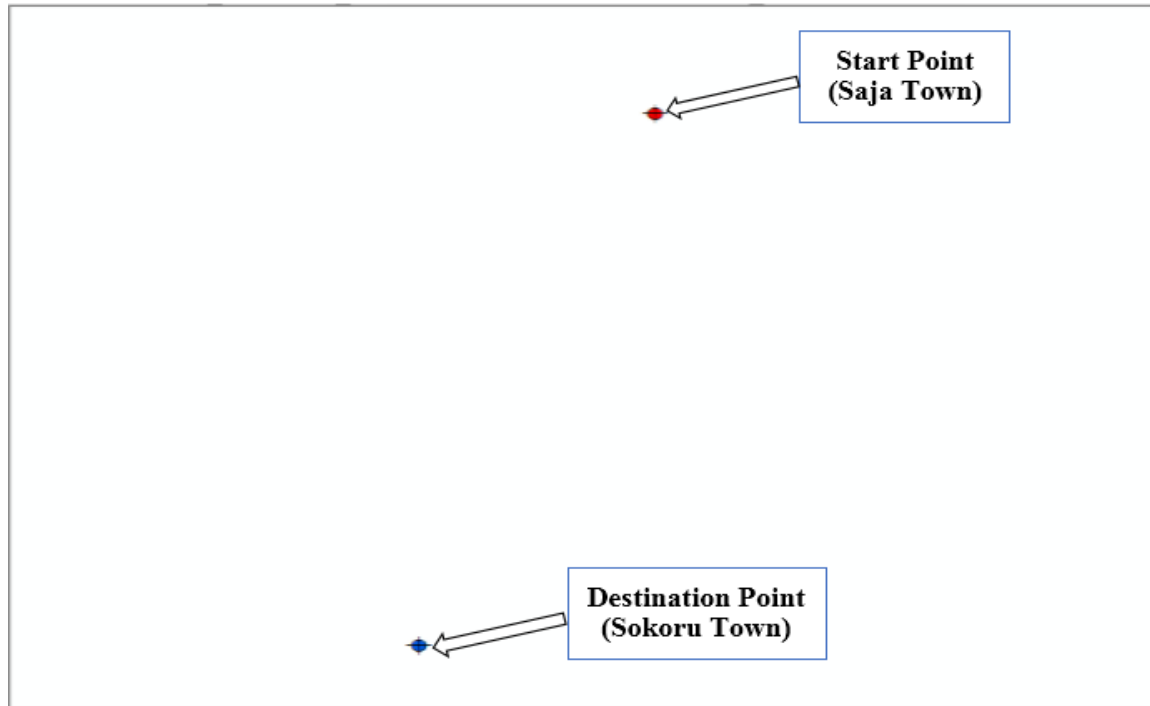
Figure 3.5: Map Showing Start and End Points for the Road Path

To compute a distance over a rough or friction surface, there is a need to specify the start and destination points in which the path is to follow. The source feature is the image that indicates the cells from which cost should be determined, which is an integer with cells indicated by a zero value. Two new shape files, the start and destination points for the road path were simply created by inserting their geographic coordinates (latitude and longitude) in new shape file dialog box using ArcCatalog 10 and the cost path in the distance menu in the cost dialogue box was used in the calculation. This start and destination points were not created as stand-alone points. This was to ensure that the route points created was within the coordinates of the area under study. The blue and red spots in Figure 3.5 show the start point and destination points of the road path in the Ethiopian boundary.

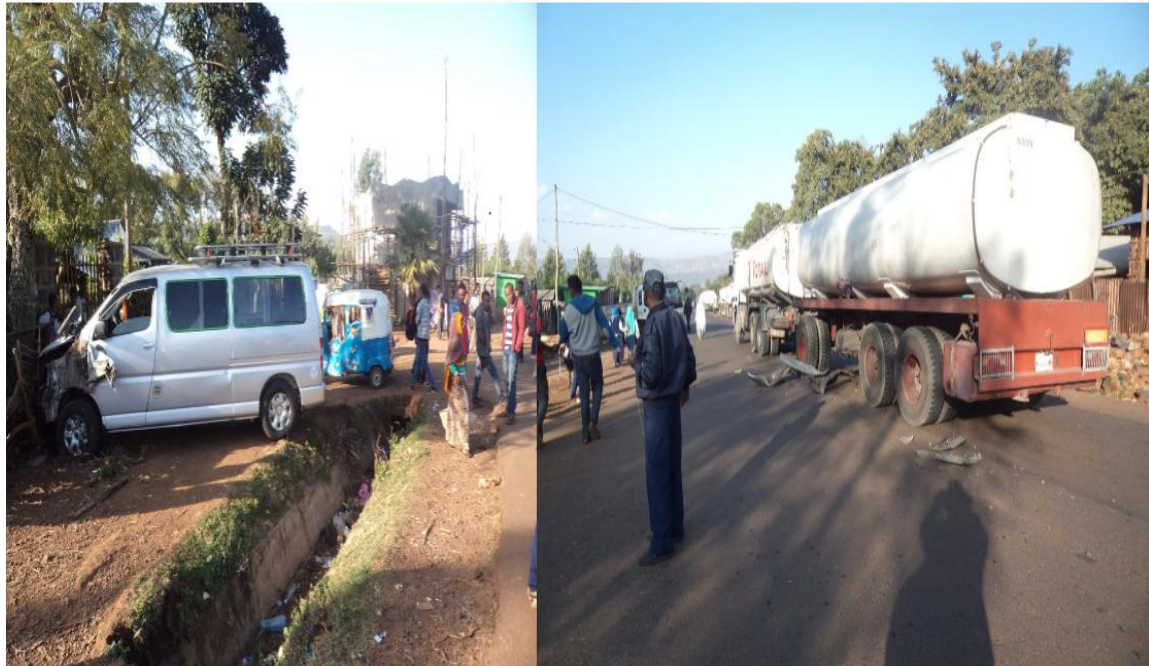
Photo: Vehicle-vehicle Collision Occurred between Oil Truck-trailer, Mini-bus and Bajaj in Sokoru Town (Nov. 2015)

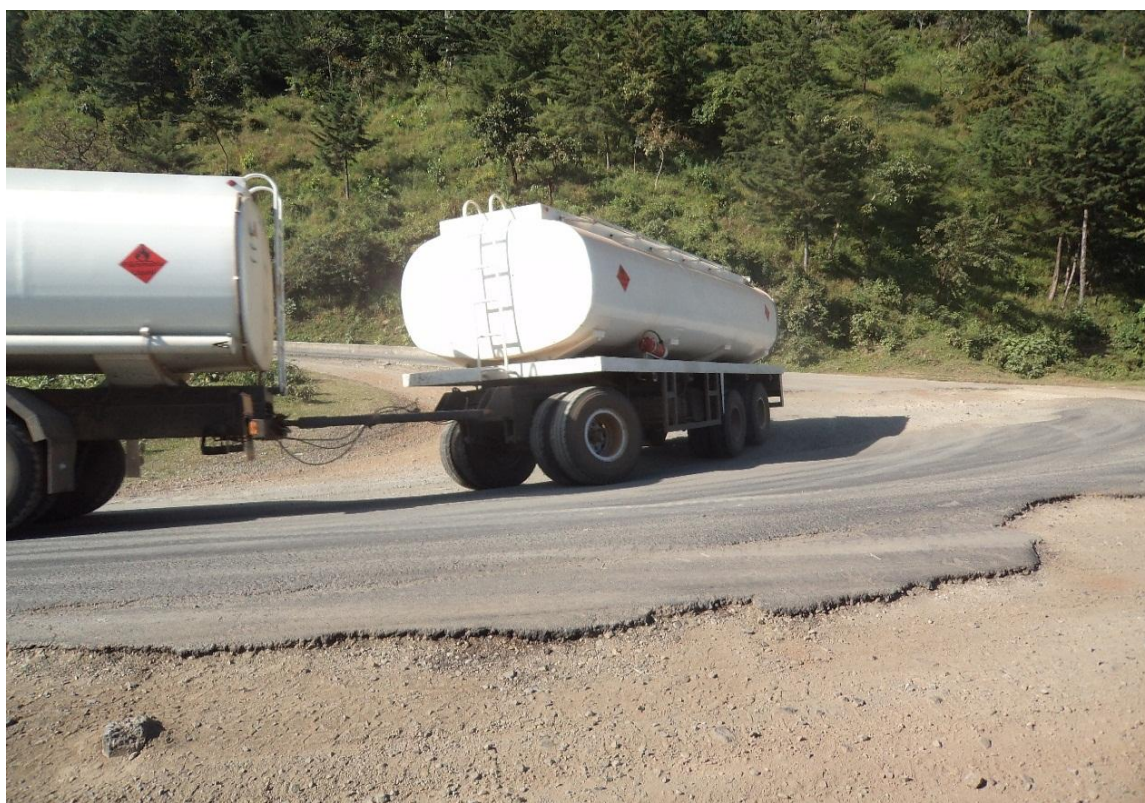
Photo: Switch-back Curve Having Radii of 13.75m in Correspondence with 5.83% grade Found in Sokoru Woreda (Shoshe) At Station Km 247+820.

- ☞ In the long term interventions Re-alignment of the road should be required for the road sections Gibe Bridge to Abelti town and Saja town to Sokoru town.
- ☞ For particular black-spot areas short term and long term engineering interventions has recommended and summarized in the Table from 4.24 to 4.28 listed below.

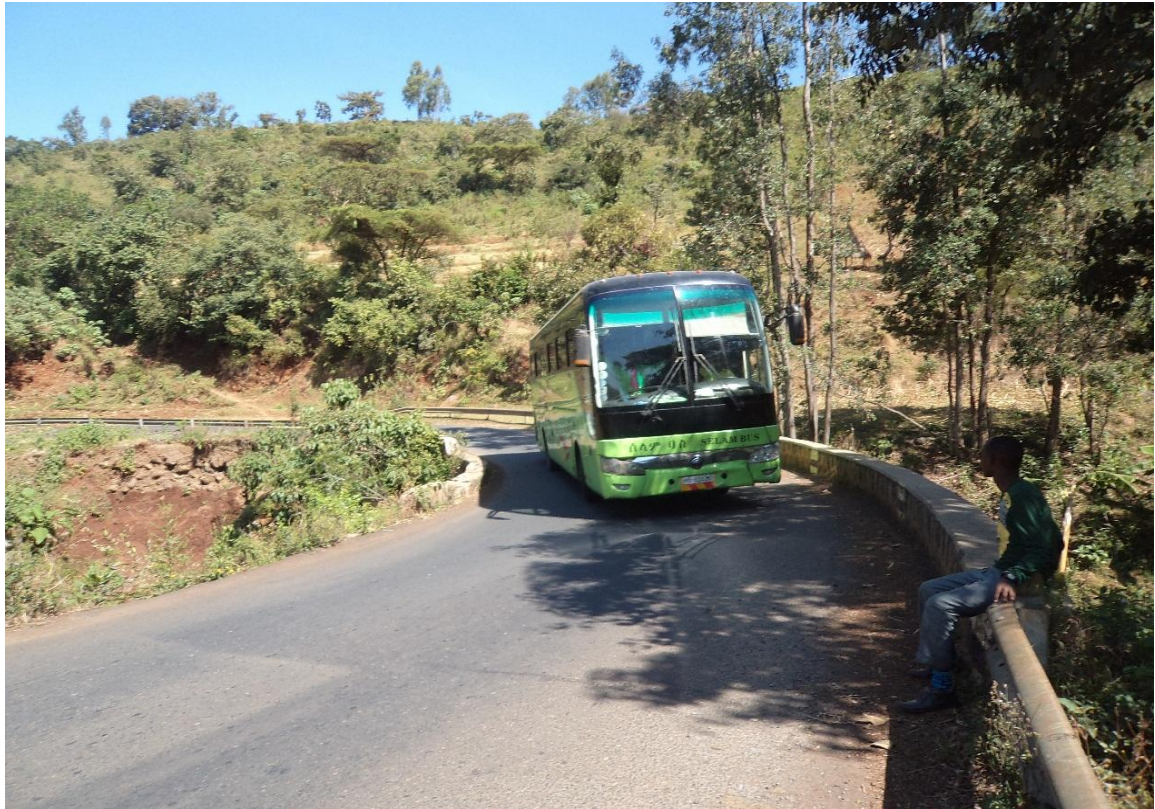
Photo: Narrow (6m) Bekere River Bridge Found in Sharp Horizontal Curve (Curve Radii 26m) in Sokoru Woreda at Station Km 247+216

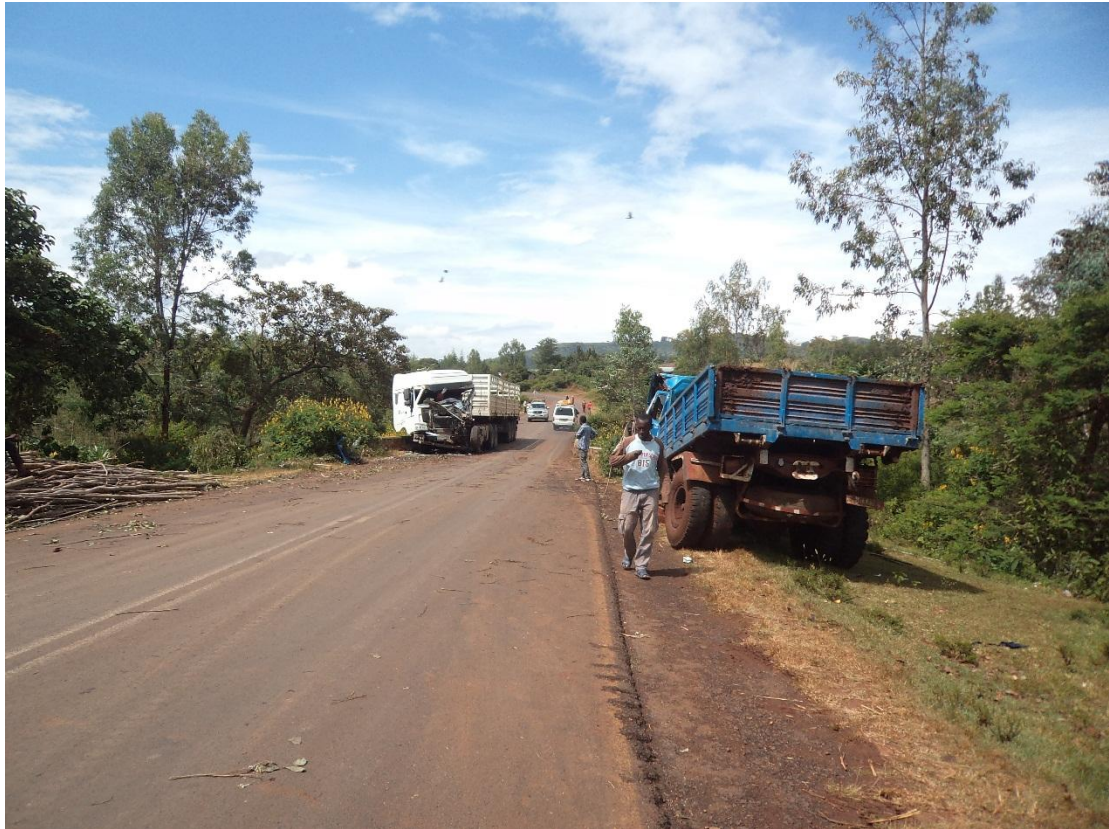
Photo: Traffic Crash Occurred between Sino-Truck High-bed and N₃ Truck on Narrow Mendio River Bridge (Oct. 19/2015 G.C.)

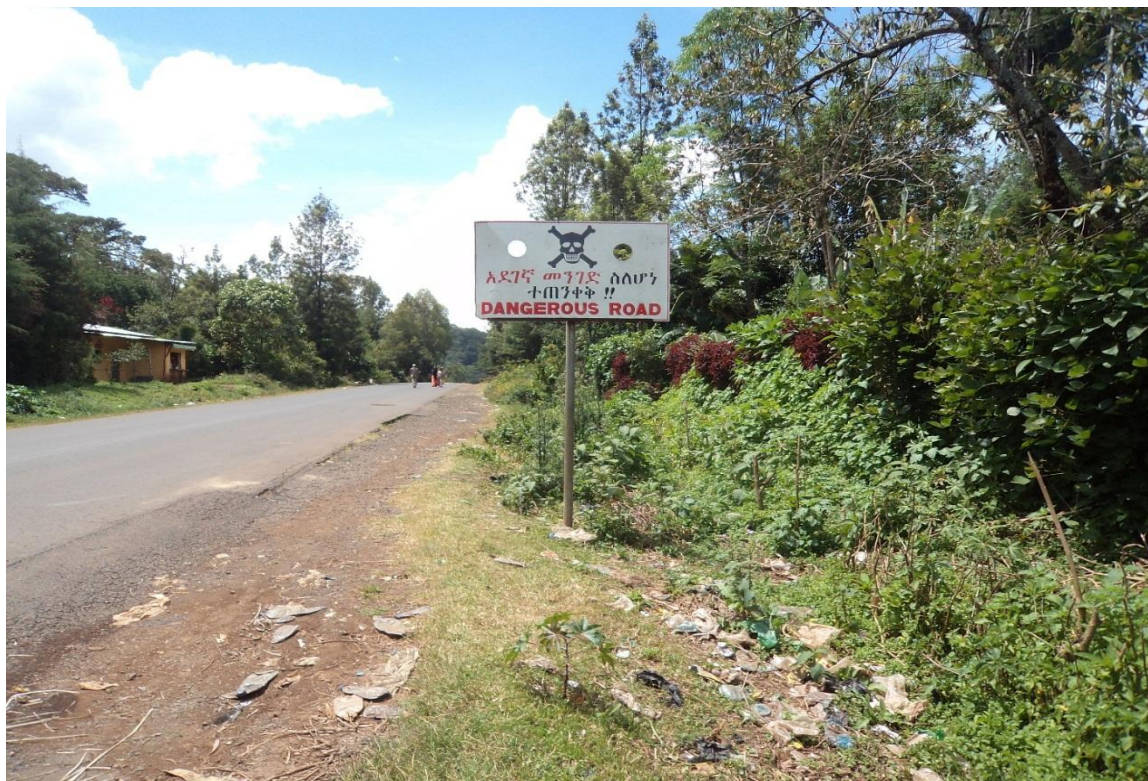
Photo: Warning Message of the Forthcoming Road at Station 347+300 (Beda Buna) on Wide Steel Board

Hence, to alleviate the traffic crash associated with horizontal alignment deficiencies of this black-spot area between station km 347+216 to km 348+716:

- ☞ In the long-term intervention re-alignment of the road should be required.
- ☞ Short-term engineering interventions are listed in the Table 4.21-4.28.

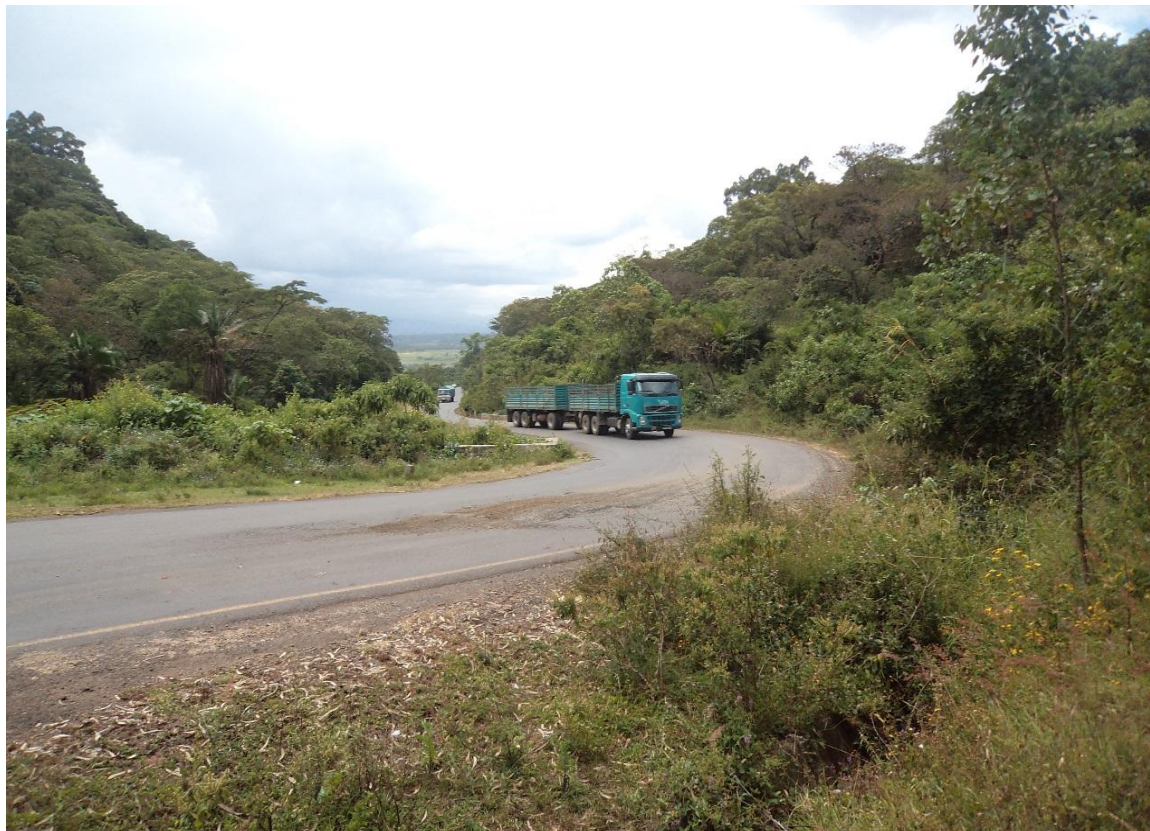
Photo: Steep Downgrade of 7.865% in Correspondence with Successive Sharp to Reverse Curves (Consisted of Radii 31m) at Beda-Buna Approach Jimma Town.

☞ **In the long-term intervention re-alignment of the road should be required.**

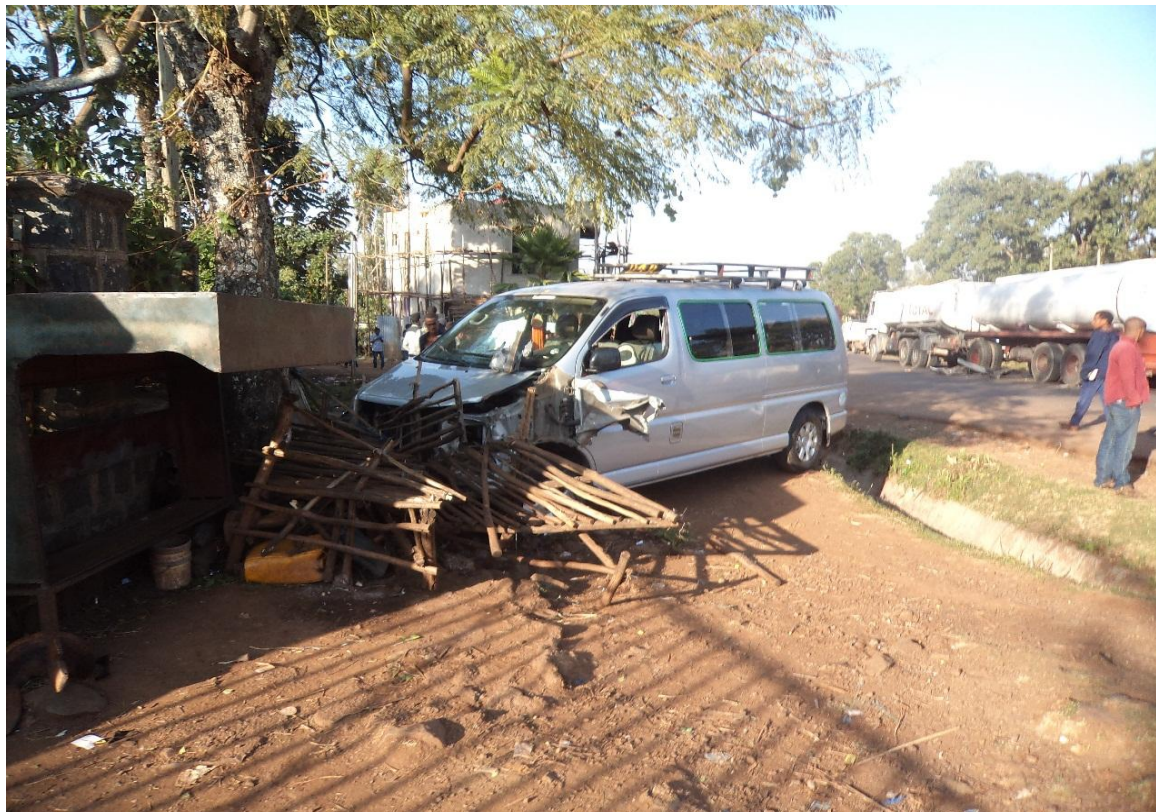
Photo: Vehicles Collisions Occurred Between Oil Truck-Trailer, Mini-bus & Bajaj in Sokoru Town (Nov, 2015).

Based on five years, 2003 to 2007 E.F.Y traffic crash data collected from 11 Woredas and 3 City Administrations Police Offices, another reason for the conclusion of the road stretch Gibe Bridge to Deneba town as a major black spot road segment in relative to geometric design deficiencies is based on comparative study of estimated cost of property damages occurred by road traffic crash on the road segment length of 80.3km which accounts 23.5% (from the total road length of 337.241km, Welete Suk-Jimma) comprised about **Birr 14,401,282.00** (179,343.49 ETB/Km) as summarized in Table 4.12, from the total property damages of **Birr 41,589,772.38** occurred in total road length of 337.241km of Welete Suk-Jimma road in contrast to frequency of traffic crash involved property damages only (PDO) on the road segment Welete-Woliso 4.18, Woliso-Gibe Bridge 0.73, Gibe Bridge-Deneba and Deneba Jimma 0.98. This huge amount of property damages is mostly resulting from Over-Turning/Run-off-the-road (including Falling) and Head-On collision of Heavy-Trucks, Truck-Trailers and large Buses, causing due to deficiencies of geometric design alignment and narrower cross section of the roadway and bridges located in sharp simple circular curves, reverse curves and broken-back curves in addition to poor driving behavior of the drivers.

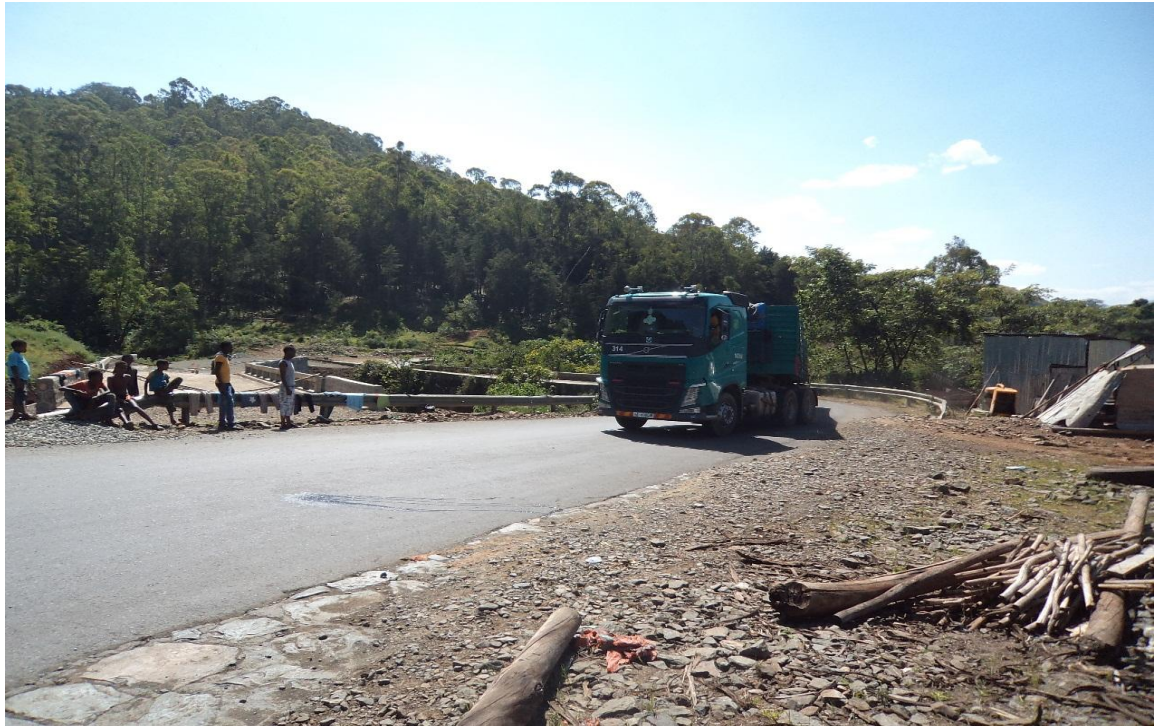
Photo: Kosho Bridge both Existing and Re-located Bridge

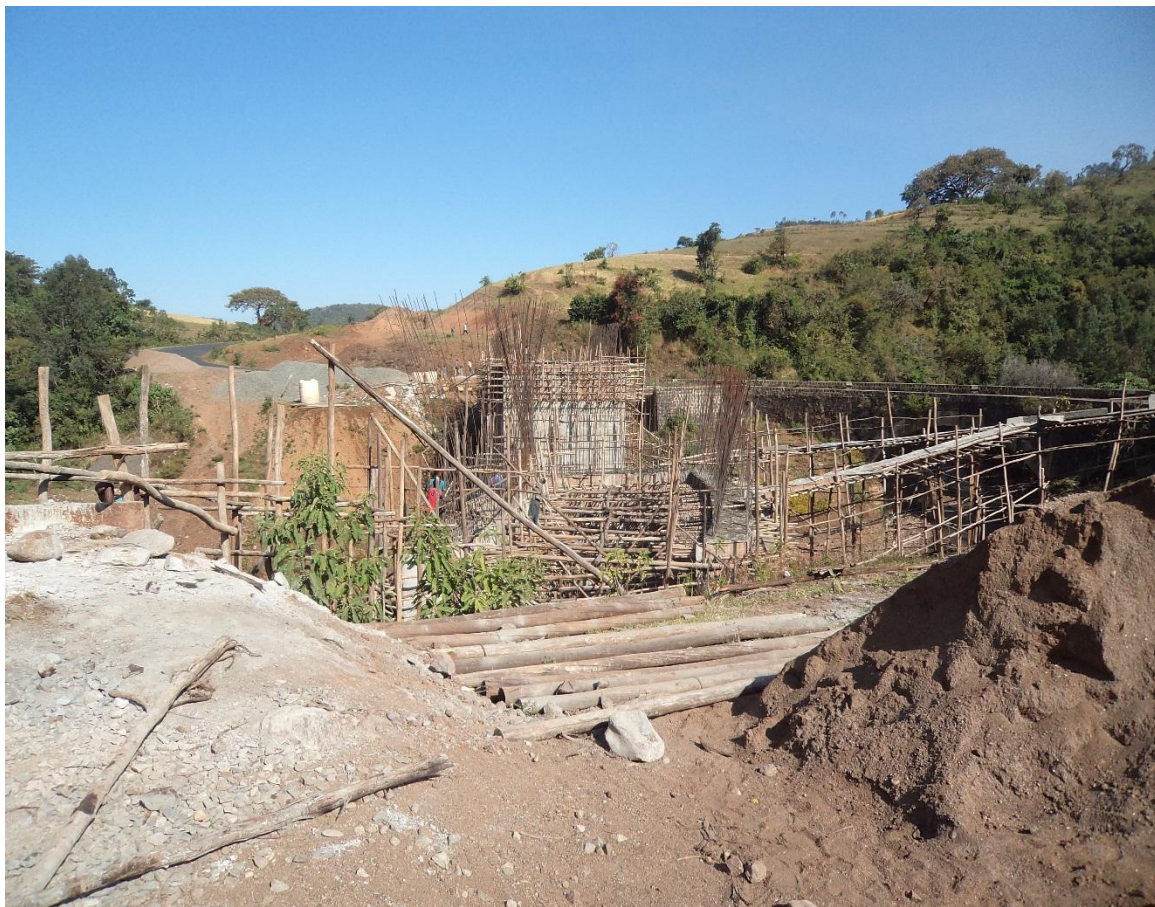
Photo: Simini Bridge both Existing and Re-located Bridge

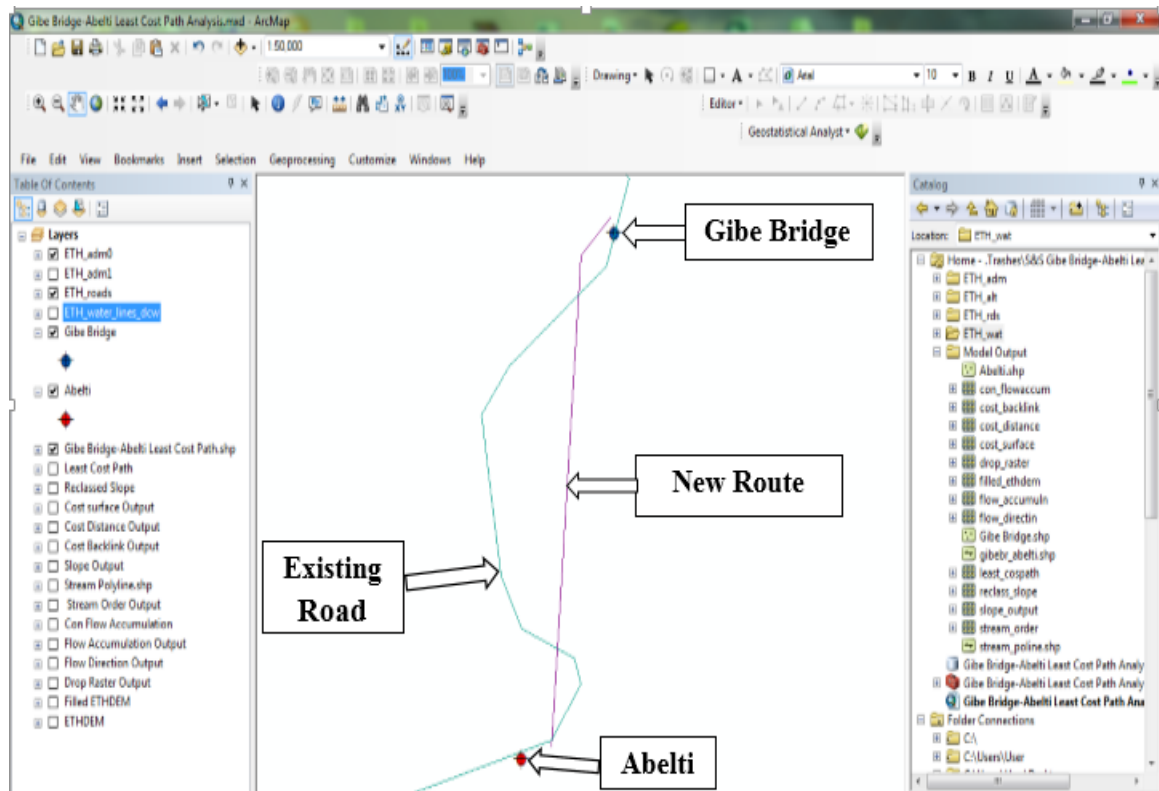
Figure 4.1: Gibe Bridge-Abelti Town Least Cost Path

62	37.571	8.17	903370.7189	342575.5168	
63	37.571	8.169	903260.1332	342575.1248	
64	37.571	8.168	903149.5475	342574.7329

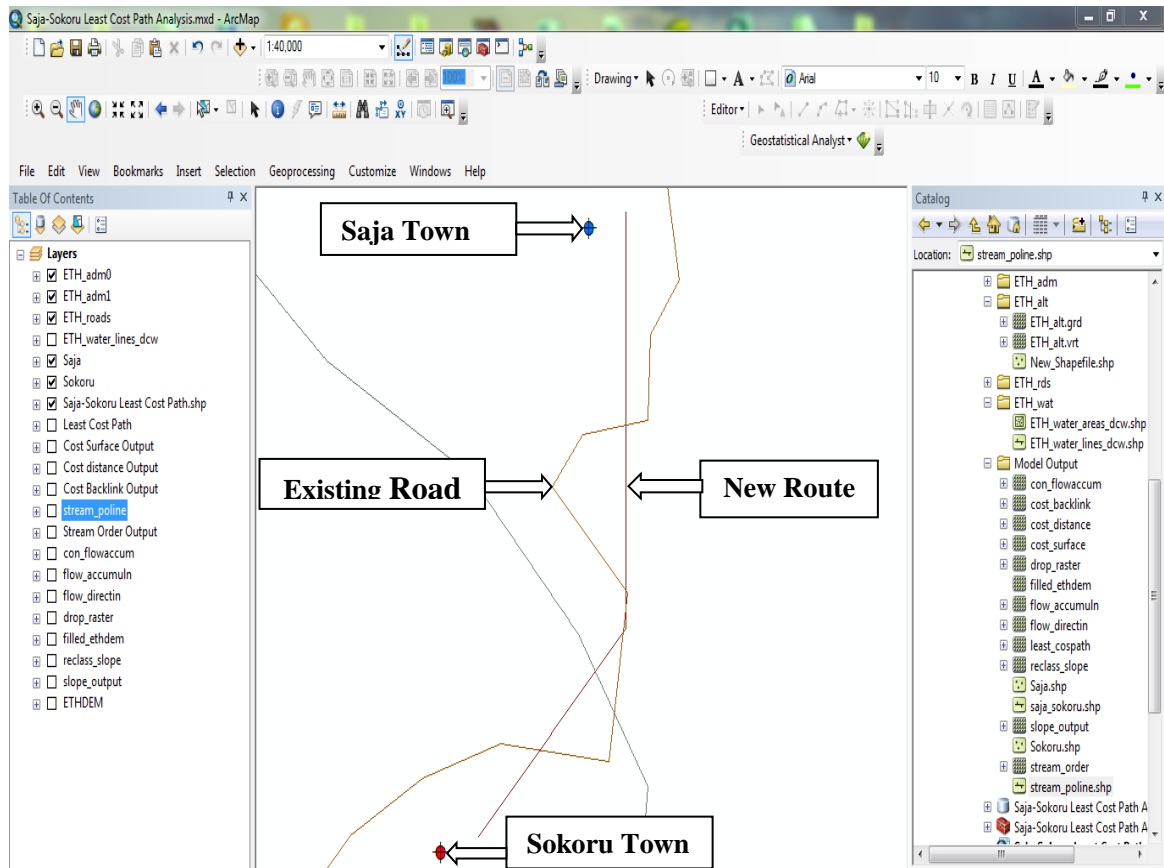
Figure 4.2: Saja-Sokoru Town Least Cost Path

Serial No.	Decimal Degrees (DD)		UTM Coordinates in Meters		Remark
	Longitude	Latitude	Northing (Y)	Easting (X)	
42	37.433	7.93	876885.1935	327267.6915	
43	37.432	7.929	876775.0185	327157.016	
44	37.431	7.929	876775.435	327046.7578	
45	37.431	7.928	876664.8436	327046.34	
46	37.43	7.928	876665.2603	326936.0815	
47	37.43	7.927	876554.669	326935.6634	
48	37.429	7.926	876444.4945	326824.9863	
49	37.428	7.926	876444.9116	326714.7272	
50	37.428	7.925	876334.3201	326714.3087	
51	37.427	7.925	876334.7375	326604.0493	
52	37.427	7.924	876224.1459	326603.6306	
53	37.426	7.923	876113.9719	326492.9519	
54	37.425	7.923	876114.3897	326382.6918	
55	37.425	7.922	876003.7981	326382.2727	
56	37.424	7.921	875893.6244	326271.5929	
57	37.423	7.921	875894.0426	326161.3322	
58	37.423	7.92	875783.4509	326160.9127	
59	37.422	7.919	875673.2776	326050.2318	
60	37.421	7.919	875673.6962	325939.9705	
61	37.421	7.918	875563.1044	325939.5505
