The Influence of Road Geometric Design Elements on Road Traffic Accident from Bedele City to Dedesa River.

A Thesis Submitted to School of Graduate Studies of Jimma University, Jimma Institute of Technology in Partial Fulfillment of Requirements for Degree of Masters of Science in Civil Engineering (Highway Engineering Stream)

Berhan Ganta

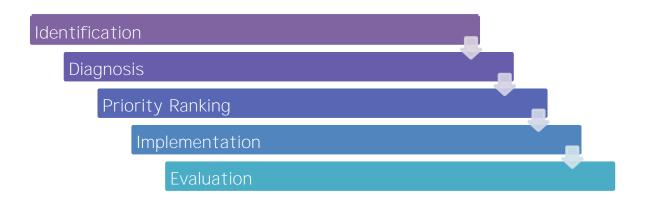
Figure 5 Black spot identification systematic process and procedure [15] To determine the most dangerous accident sites, the Flemish government analyses the road traffic accident data that are obtained from the Analysis form for Traffic Accidents, this form should be filled out by a police officer for each road traffic accident that occurs with injured or deadly wounded casualties on a public road.

On this portion we try to give a better understanding for investigation of black spot location and improvement ways. Now the most commonly used steps of black spot improvement process are the following.

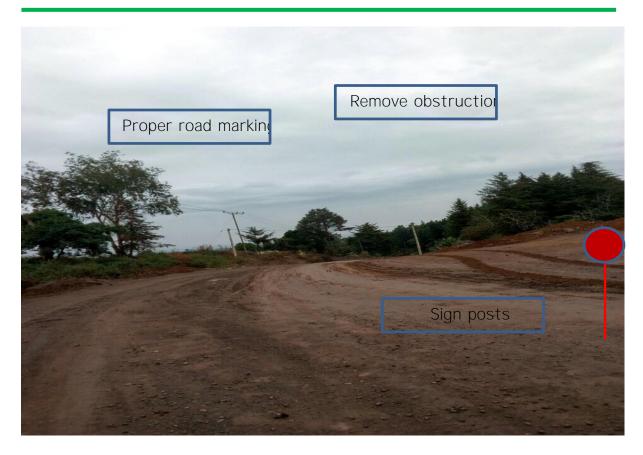
Figure 16 Saxa (P value-32)

Actually, the presence of very sharp curve on this road. Existence of these sharp horizontal curves made every travel risky and dangerous. Furthermore, there occur curve obstruction. Therefore it needs measures to decrease the road user from any accident.

- a) Sign posts with speed limit 40km/hr.
- b) Vegetation obstruction should be removed
- c) It is recommendable to place guard rail

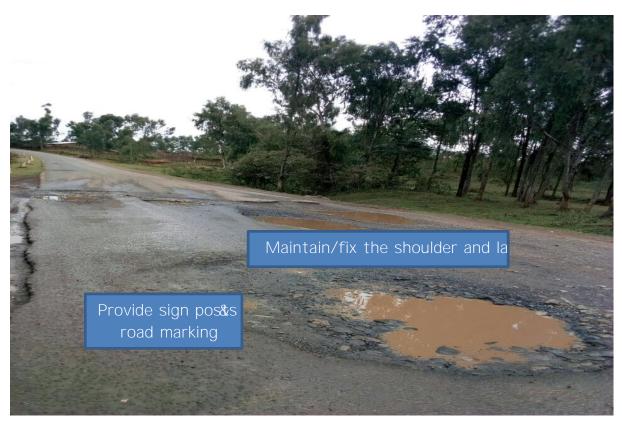
Figure 17 Sidan (P value-18)

The road segment lack traffic sign posts and curve widening where it is necessary. The counter measure:

- a) Proper traffic sign should be installed and speed limit of 70Km/hr. on curve area
- b) Avoiding curve obstruction and blockage.
- c) Maintain the shoulder and road section
- d) Provide road marking

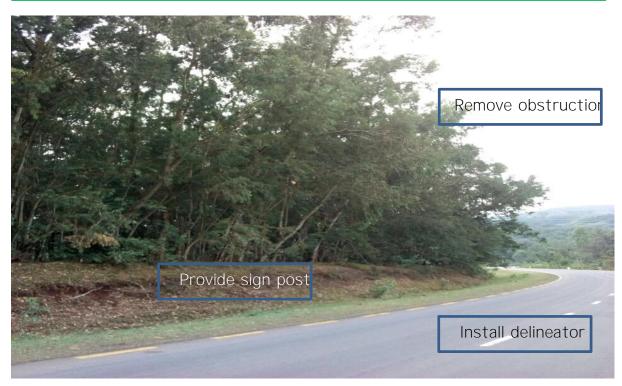
Figure 18 Adebi (P value-20)

Perhaps, the lack of curve widening, road markings had already faded and curve obstruction is also visible. In addition, the road section has sharp curve.

- a) Removal of vegetation obstruction
- b) Providing sign posts and speed limit of 50Km/hr.
- c) Construct road side delineators

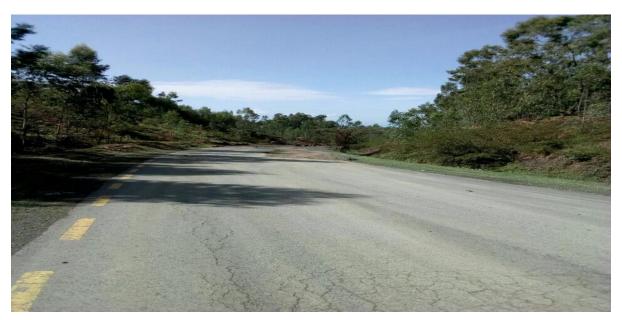
Figure 19 Demo (P value-21)

The main reason of traffic accident at this black spot is obstruction, vertical curve at horizontal curve and existence of an intersection at the curve. To decrease occurrence of road traffic accident at this identified black spot location;

- a) Provide standard curve widening, sign posts and speed limit of 50Km/hr.
- b) Removing vegetation
- c) Reflective guide posts and studs should be placed
