**DEFECTS ON LOW COST HOUSES A CASE IN 20/80 CONDOMINIUM**

**BUILDINGS IN MEKELLE**

**A Thesis Submitted to the School of Graduate Studies of Jimma University in Partial  
Fulfillment of the Requirements for the Degree of Master of Science in Civil Engineering  
(Construction Engineering and Management)**

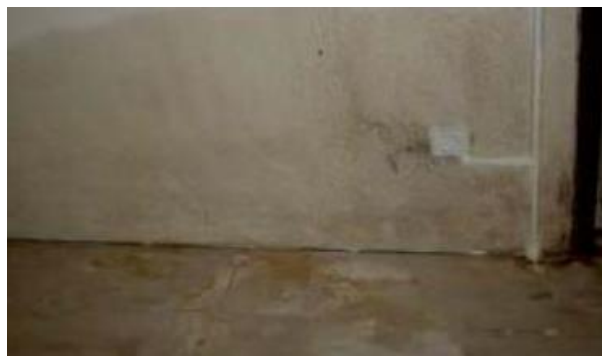
Figure 2.1 Rising damp

3. Condensation: This is moisture generated in the internal. Many activities such as washing or drying of clothes, even breathing, are major sources of moisture generation. Other causes of moisture can be from bottle gas heaters, and un-vented tumble dryers. Condensation related problems such as mould growth generally occur during the winter months when the outside temperatures are colder than those inside a building. As shown in figure 2.1 Kam S.C. (2016) pointed out that rising dampness were happened due to weak damp proof course.

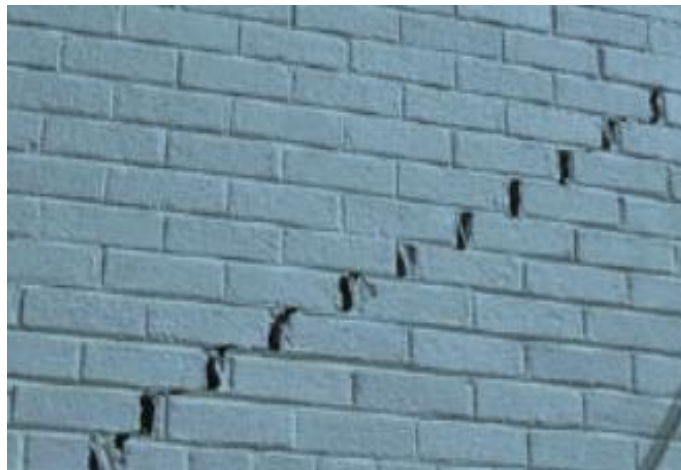
Figure 2.2 Wall crack

Crack defect have classified of visible damage to walls. According to the construction, the occurrence of wall crack was due to overloaded or because of the structure had settled or heaved. Vertical and angled crack are usually caused by settlement or heaving. Nevertheless, for horizontal crack are more likely to be caused by lateral pressure. Cracks are usually the widest at the top of the building diminishing to a hairline crack at or near the foundation level. Figure 2.2 were taken from study conducted by Azree, O. M. and Nadia O. B. (2014) described that cracks are usually the widest at the top of the building diminishing to a hairline crack at or near the foundation level

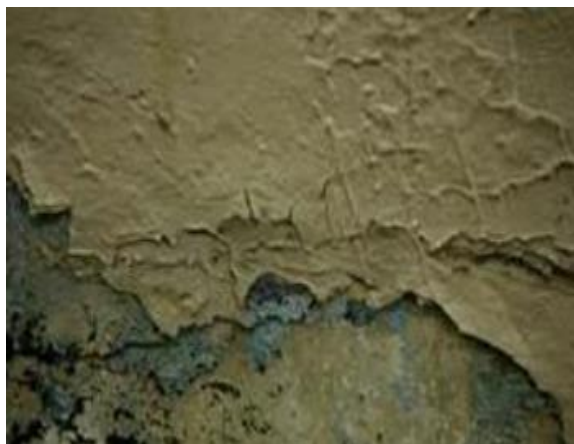
Figure 2.2 Peeling paint

Peeling paint is always the result of poor surface preparation of the element to be painted. The majority of peeling paint problems occurs on surfaces exposed to the rain, sun, and the variation degree of temperature. When paint peels from an interior wall, the reason for the peeling paint is mostly often due to an improper preparation of the surface before painting. Buildings that are located near the sea may face a much higher risk once the signs of peeling paint are visible on the exterior walls.

Kam, S.C. (2016) describes that the main causes of peeling paint and plaster crack are that the moisture gets inside the paint surface through the crack or gap that are made by human or furniture. The moisture makes the plaster damp and dry, it will decrease the bonding strength between the plaster and concrete surface that may cause the plaster crack. And the plaster crack allows more moisture to seep inside between the plaster and paint and which can cause peeling of paint. Figure 2.3 were taken from Azree, O. M. and Nadia, O. B. (2014) which concludes that Peeling usually occurs on building facades, mainly on plastered walls, columns and other areas which are exposed to excessive rain and great dampness.

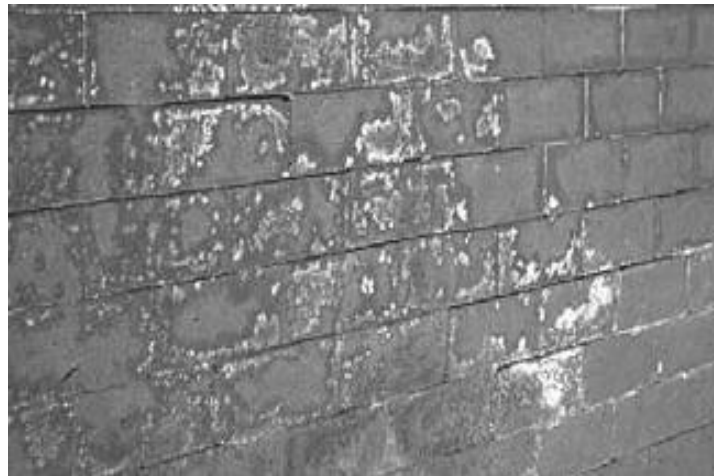
Figure 2.3 Efflorescence

Efflorescence is a white powdery deposit on exposed masonry surfaces caused by the leaching of soluble salts. Efflorescence occurs when soluble salts in the units or mortar are taken into solution by prolonged wetting. As the wall begins to dry, the salt solution migrates toward the surface through capillary pores. When the water evaporates, the salts are deposited on the face of the wall.

As shown in Figure 2.4 study conducted by Ahmad, S. (2013) stated that efflorescent (whitish bleeding) spotted on the external wall surface of social security organization office in Malaysian building were occurred due to chemical reaction of the wall materials and high moisture content on the wall prior to painting process.

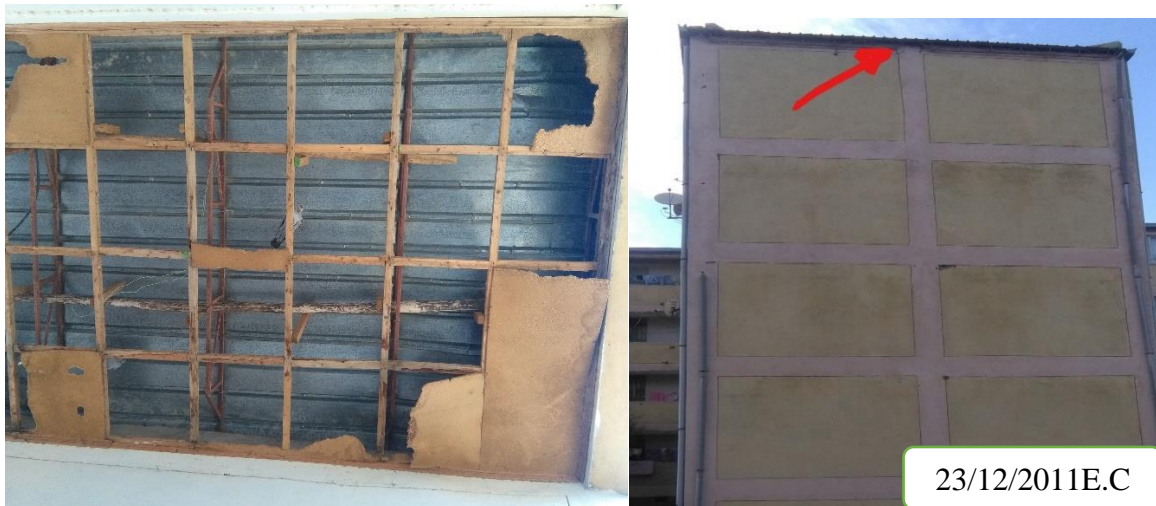
Figure 4.4 Roof defect in Edaga Bieray condominium

The main problem of roof defects in the condominium buildings was that it allow the water to go inside the building through the roof connection. A drop of rain water enters to the building through the hole provided to fix the sheet metal with the purlin. Roof washer used to protect leakage through the connection were drilled manually fit with the J-bolt and it had larger diameter than the bolt.

The gutter used to collect the water from the roof and transmitted to the down pipe were not properly fixed by steel strap with the facial board. This becomes a reason to disconnect from the roof and fall down to the ground. As shown in figure 4.4 the researcher also observed that roof defect was most common condominium defects in Mekelle.

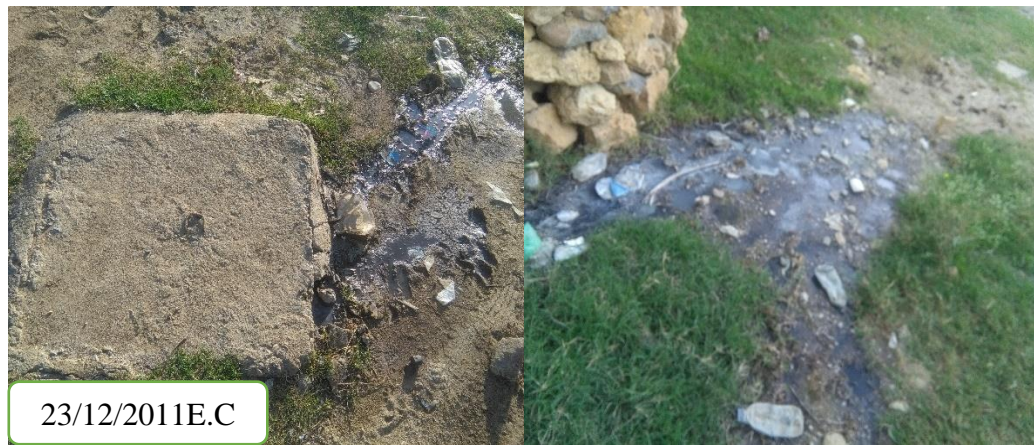
Figure 4.5 Septic tank leakage in Senet condominium

The Ethiopian public health proclamation 200/2000 article 12 states that no person shall dispose solid, liquid, or and other wastes in a manner which contaminates the environment or affects the health of the society. But as shown from the figure 4.5 most of the septic tanks in Mekelle condominium sites couldn't serve the community and liquid waste leaks through the manhole.

The capacity of septic tank constructed in the condominium projects was 98 M<sup>3</sup> for 25 householders and 50.4 up to 67.73 M<sup>3</sup> for 20 households but it didn't serve the occupants sufficiently. Occupants were required to pump 2-3 times per a year, but still leakage of the septic tank had not stopped. Figure 4.5 explains that waste water leakage from septic tank and manhole in most condominium building demands quick attention unless it becomes the sever defect on the condominium occupant than the current condition.

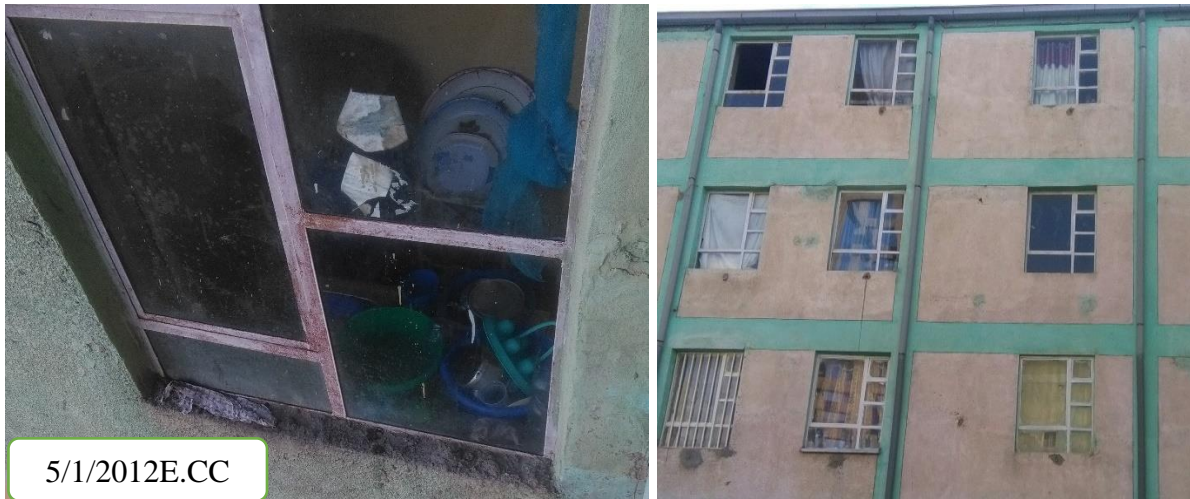
Figure 4.6 Window defect

In most of the windows there was no window sill and the hole were poured with insufficient mortar this becomes easy to enter the water to the wall or inside the building. In some houses the external doors were not easily accessible since Hinge used to connect the frame with the plane were not properly welded. As shown in figure 4.6 most windows in Mekelle condominium

factory produced window sill or rich cement mortar were not provided before window had been assembled. Corroded LTZ window and door frame were also found in the condominium.

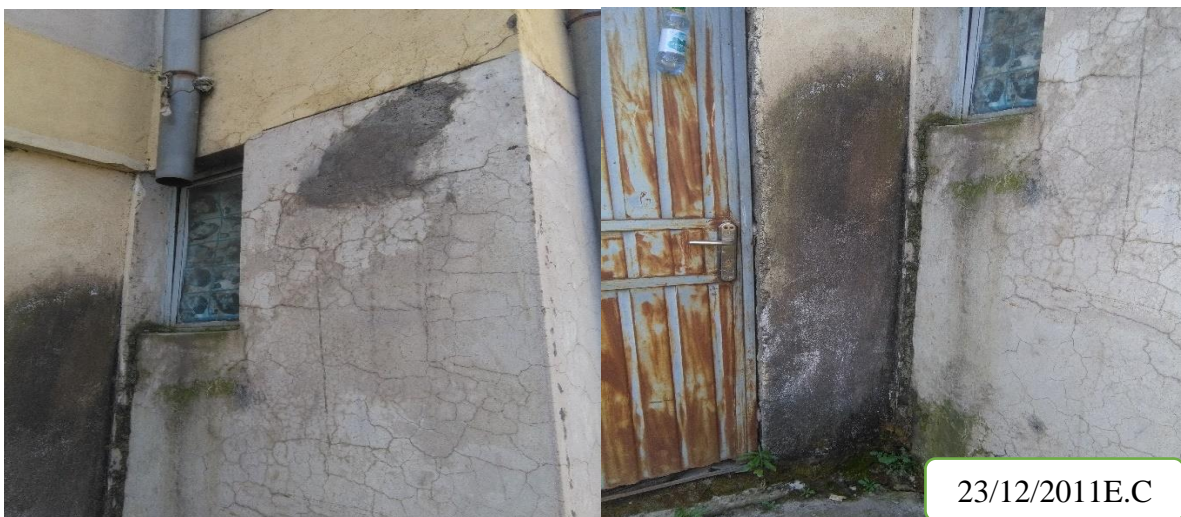
Figure 4.7 Condominium dampness in Edaga Bieray

Dampness in building is one of the important aspects to consider during building design. The existing of dampness in the condominium building was one of the most damaging factor that really must be taken care of. It causes damage in decaying and loosing up of plaster and paint, rotting in the timber structures, corrosion metals in door and window and also destroying the equipment in the building.

As a wall affected by dampness, the water enters to the surface and trapped by the paint or cement-mortar. The evaporating of water from the surface lifts the film in bubbles that eventually break to leave the blisters. Even if dampness was the fifth most common condominium defect, the value of the building were highly affected. As shown in the figure the defected down pipe crossed the toilet window and the water laid on the bottom part of the window which cause dampness to the wall surface. Figure 4.7 describes that the defect in down pipe and roof gutter were the main source for building dampness. Down pipe crossing the toilet window indicated that there was a problem in fixing the drainage.

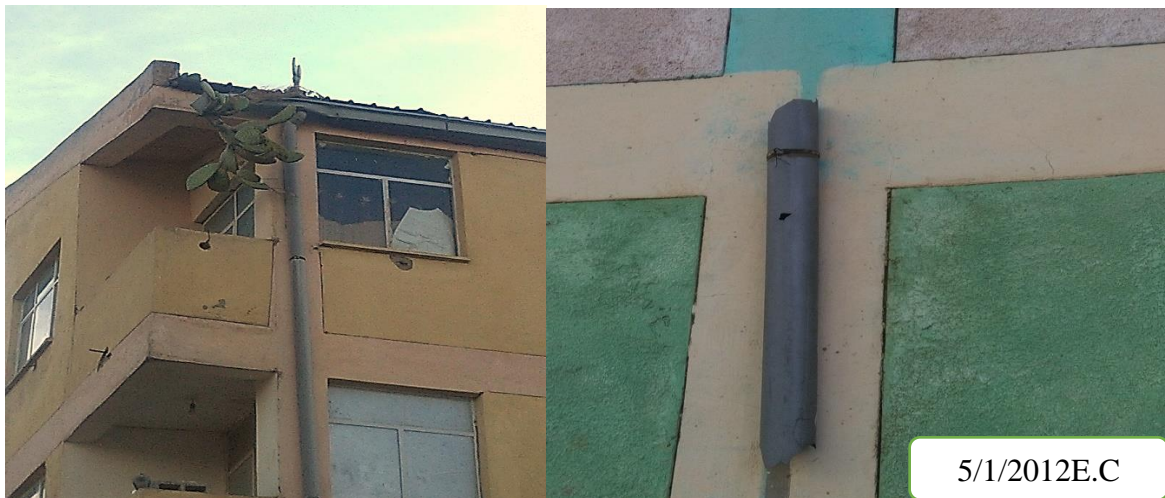
Figure 4.10 Maintenance problem

the condominium sites affects the proper serviceability of the building and requires higher maintenance cost.

Occupants had not establish strong association which helps them to resolve their problem cooperatively and complains were raised by affected or voluntary persons. There was no common deposit for common element maintenance purpose. Mekelle house development agency describes that the occupant lefts the maintenance of roof and external walls to the government and those who live in the top story were challenged financially to maintain the roof defect.

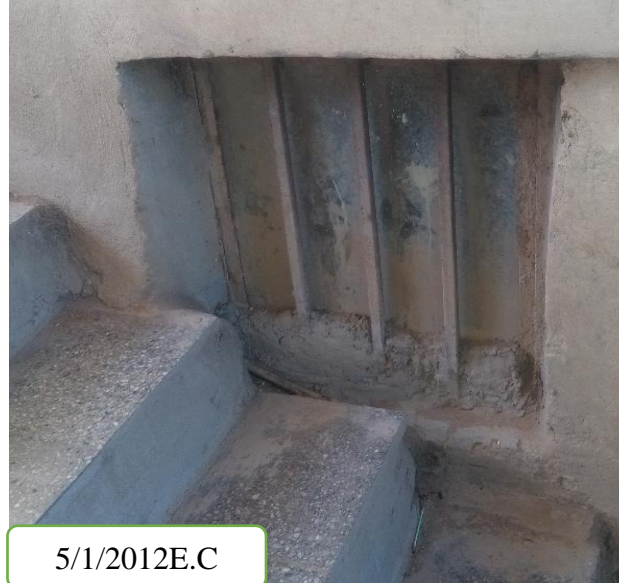
Figure 4.11 Design deficiency in toilet window

Miss match of structural plan with architectural plan, architectural with sanitary and electrical plan, small size septic tank design, exclusive of vertical access for roof and external wall maintenance, narrow corridor size in some condominium blocks, and provision of toilet window beside the stair were the critical problems shown in design of the condominium buildings. Ladder have been constructed for water tanker only but there was no vertical access used for roof maintenance of the building.

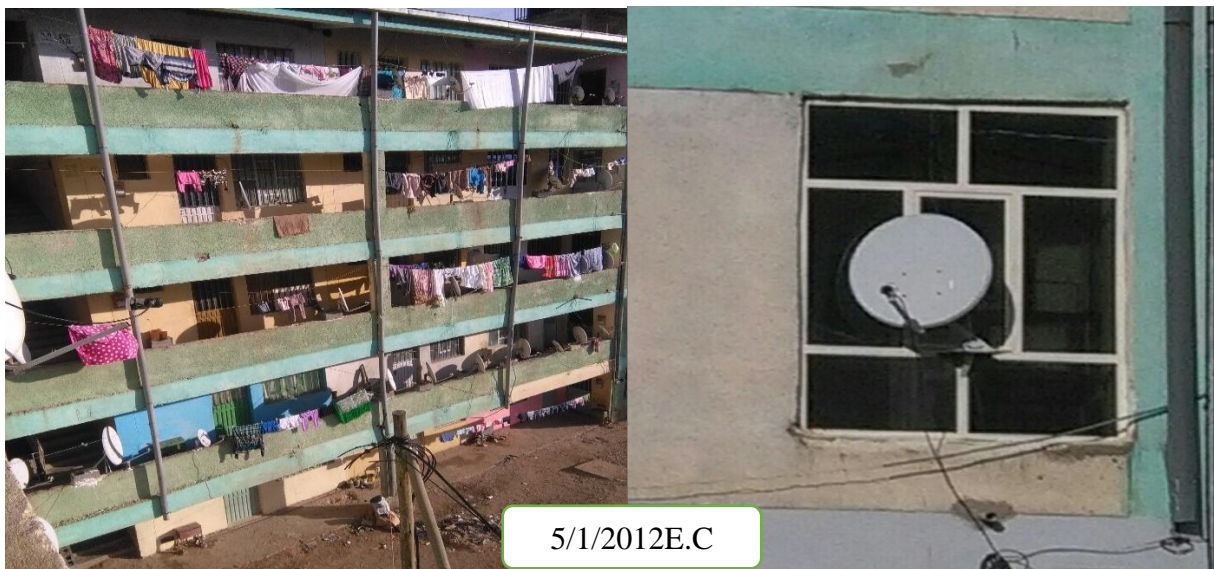
Figure 4.12 Occupational fault in condominium buildings

Using the building and its component for the desired and planned purpose plays a vital role in achieving the expected function of the building. Careless ness and miss use of the building component leads to a building defect and reduce the quality of service. Occupants fix the TV signal dish on the window frame and providing holes on the wall in different places, miss use of corridor draying cloths were the most occupational faults in the condominium buildings. As shown in the figure bellow Exclusion of communal building in the construction and non-consideration of the place for TV signal dish in design leads the occupant miss use the building component for other purpose. Figure 4.12 illustrated that absence of communal building and permanent fixing place for TV signal dish leads occupants to miss use the building component.

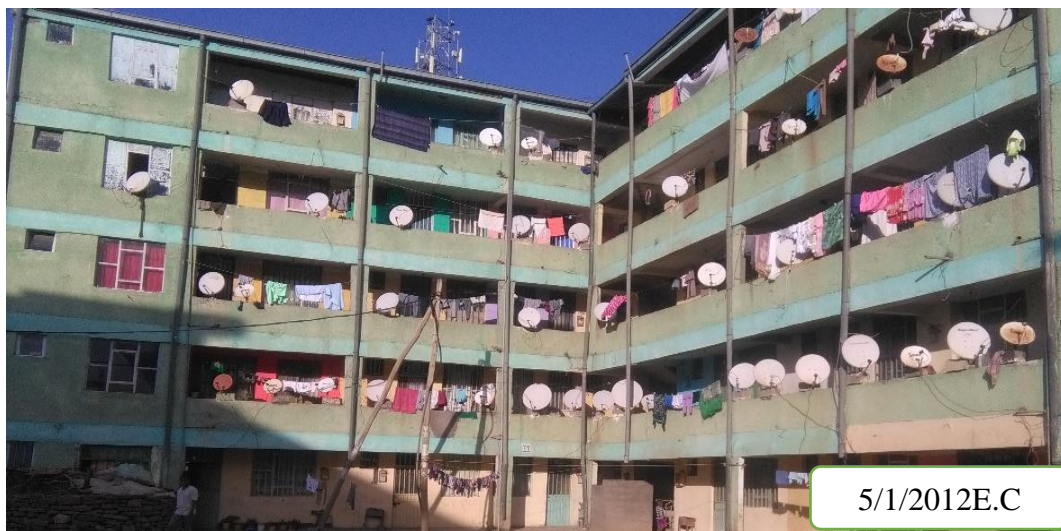
Figure 4.14 Quiha condominium building

As shown in figure 4.14 mistakes happened starting from design up to operation and absence of taking well organized solutions to the defect Mekelle condominium buildings looks like elder and nasty.
