**PERFORMANCE EVALUATION OF EXISTING ROAD
DRAINAGE STRUCTURE PROBLEMS: A CASE OF
SEBETA CITY, OROMIA, ETHIOPIA**

**A FINAL THESIS SUBMITTED TO FACULTY OF GRADUATE
STUDIES OF JIMMA UNIVERSITY, IN PARTIAL FULFILLMENT OF
THE REQUIREMENTS FOR DEGREE OF MASTER OF SCIENCE IN
HIGHWAY ENGINEERING**

August, 2020

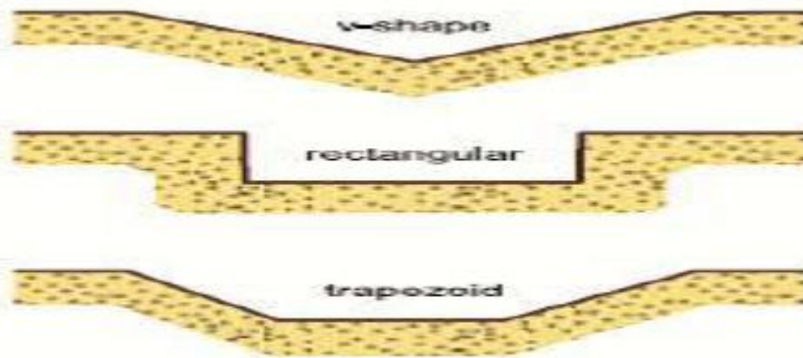
Figure 2.1 The common shapes of side drains.

Sides drains can be constructed in three common forms: V-shaped, rectangular or as a trapezoid. The V-shape is the standard shape for ditches constructed by a motor grader. However, it carries a lower capacity than other cross-section shapes. The rectangular shape requires less space but needs to be lined with rock or concrete to maintain its shape. This shape is often used in urban areas where there is limited space for the drainage.

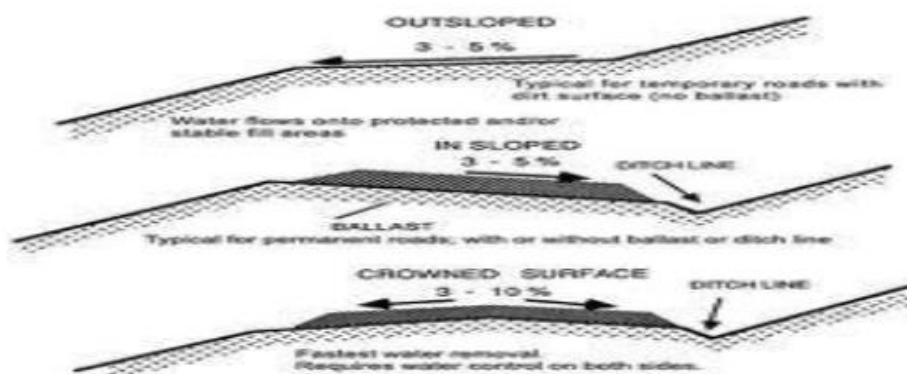
Cross-section Slope: Drainage of the road pavement is provided by shaping the road carriageway with a camber or cross slope. The camber is the slope from either side of the center line towards the road shoulders. For roads with asphalt surface, the camber is normally 2 to 3%, because water will easily flow off a hard, waterproof surface. On earth and gravel roads, the camber needs to be steeper because the water will flow more slowly and the surface is often uneven. Gravel and earth surfaces also absorb some of the surface water unless it is quickly drained away from the road. Thus, it is recommended that the camber is 5 to 7%. On sharp curves, the camber is often substituted with a super elevation which leads the water to the inside of the curve. The super elevation is installed with gradual change of the road cross-section from a camber shape to a road surface shaped with a cross slope.

Figure: 2.2: Cross sectional slope, (Source: [3])

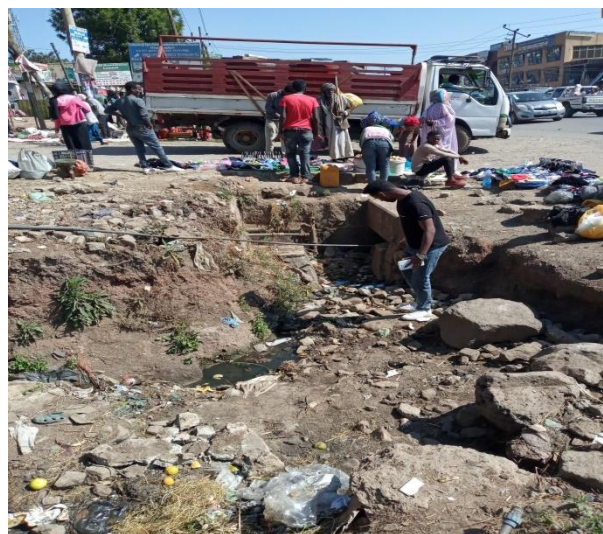
Fig: 2.3 scours of culvert at inlet discharge

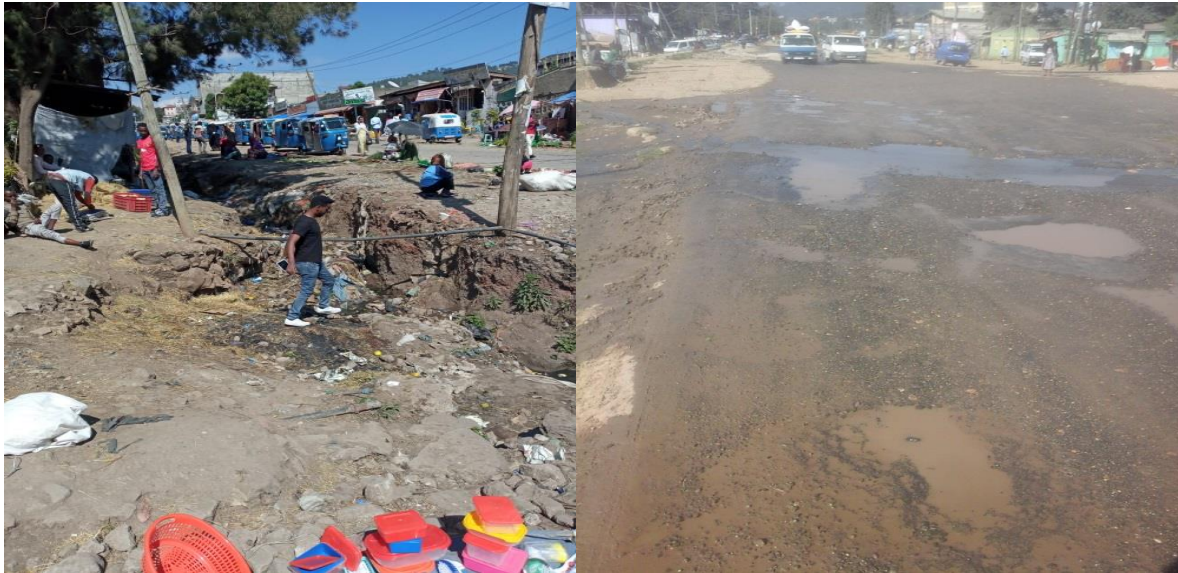
Fig 2.4 Road cracking due to failure of side ditch

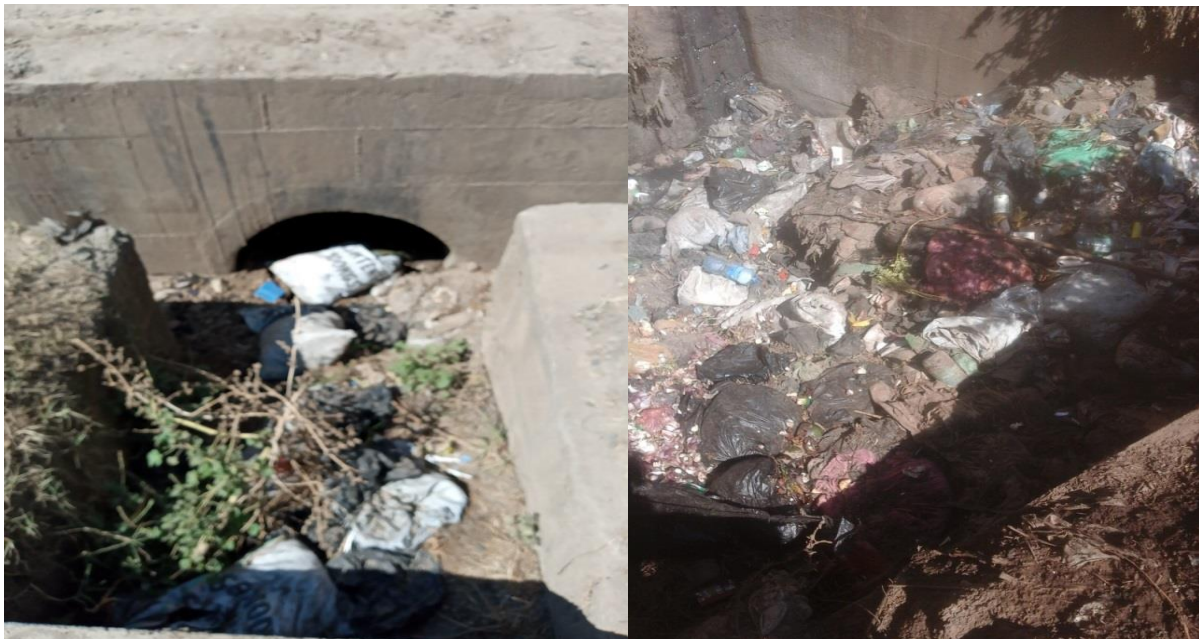
Fig 2.5 Solid wastes filling pipe culvert and reduce the flow capacity

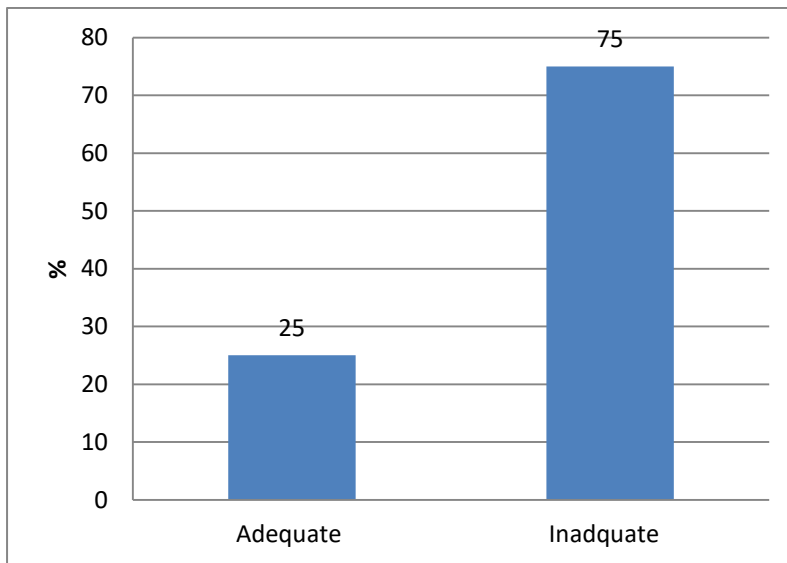
The engineers“ from Sebeta indicated that the drainage structure provided for Sebeta city road was inadequate and lack of serviceable. The magnitude of the water from the hills surrounding the area in which the road is situated was overlooked during design. They also indicated that studies that were carried out before designing the road were not sufficient to satisfactorily ascertain the amount of water that would cross the road at a point in time and therefore the design lacked capacity to adequately drain the runoffs during the rains. However, poor construction and totally no clearance of ditches and culverts which is fully by grass,solid waste andgarbage. As part of understanding the background of the poor drainage structure provisions in the Sebetacity roads, this study sought to find out from the engineers the percentage of roads that lacked adequate drainage structure.All Engineers are responses as about 75%-100% are inadequate drainage structure(see Figure 4.1).

Figure 4.1 Percentage of inadequate road drainage structure

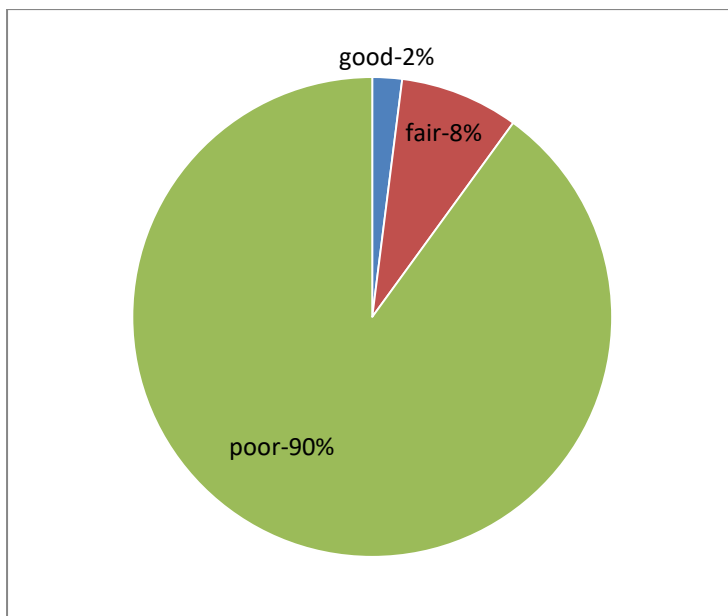
Most of the respondents are responses drainage structures are poor. Based on respondent survey data, maximum of responses (approximately (90%) had responded for poor condition of drain and about 8% of the respondents for fair category in the areas of flood occurred during rainy season in the town. Only 2% thinks the drainage system provided good in Sebeta city roads (see Figure 4.2).

Figure 4.2: State of the drainage structure in Sebeta city road

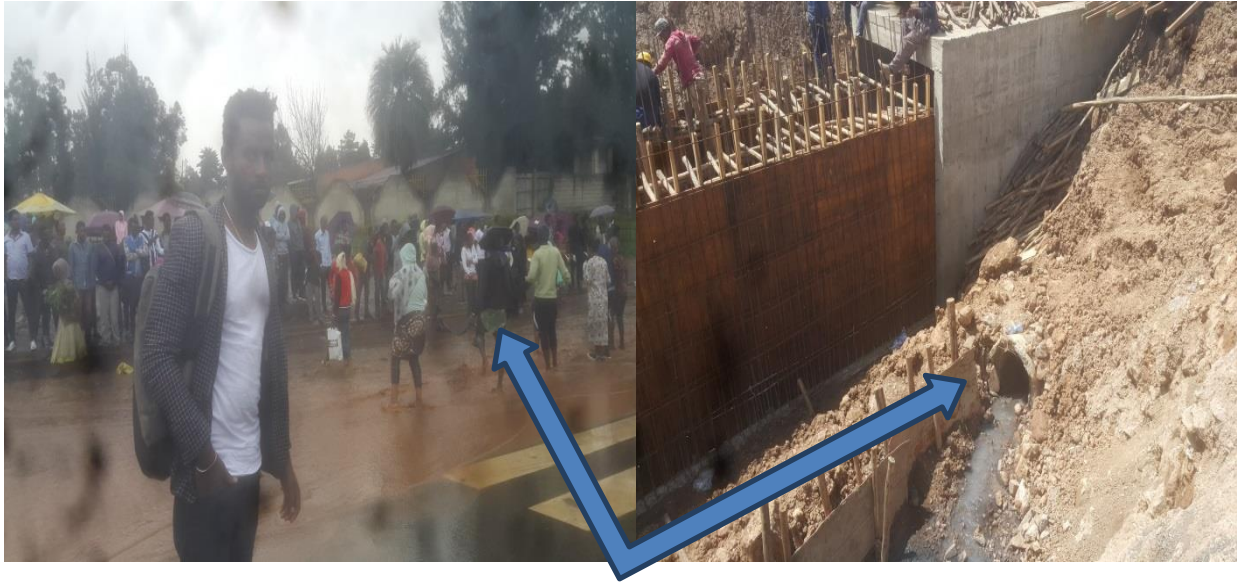
This research employed both observation and photography as tools for which data would be collected. This involved observation and taking of photographs to show the current state of the drainage system in Sebeta road. From observation also; a brief description of what was observed will be given with the help of photographs. From observation, the state of the drainage structure in city road is poor. The main challenges of the current drainage structures are: drainage structures are not well constructed, drainage systems are do not have the capacity to carry large amounts of water, hence resulting in overflowing, ponds or other spaces are not properly allocated to accommodate overflow of flooding; most ditches do not

have proper slope to let water pass through them, in some areas there are no drainage structure provided at all, some of existing drainage ditches have been silted by sand and other rubbish materials

Fig 4.5 Existing Road Drainage Structures Problem at Furi Area

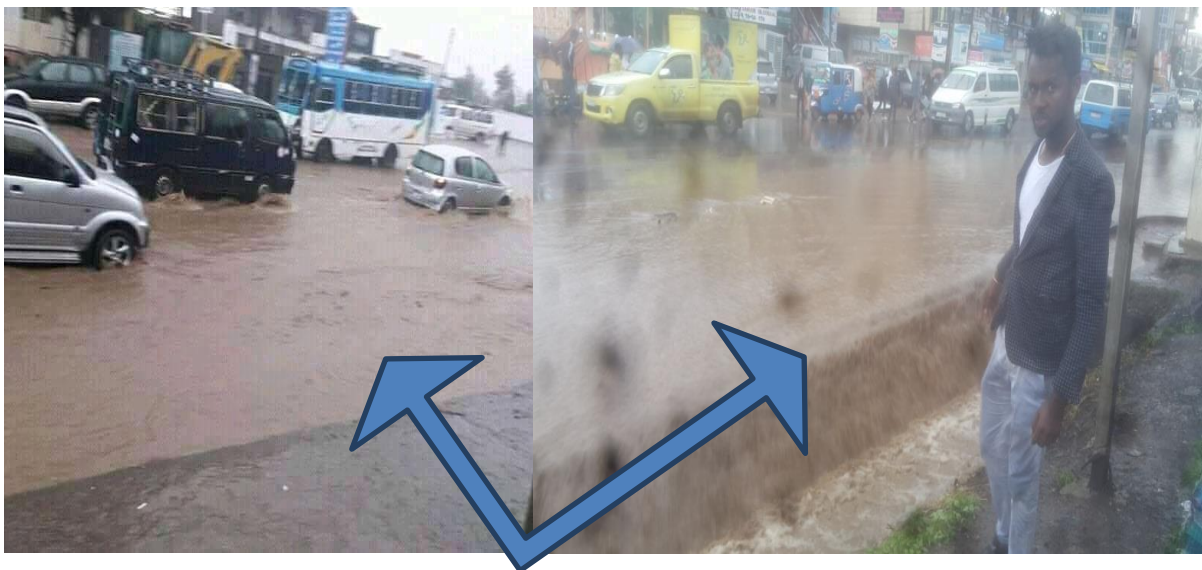
Figure 4.6 inadequate road drainage (over flow) around Kenteri/ Alemgane

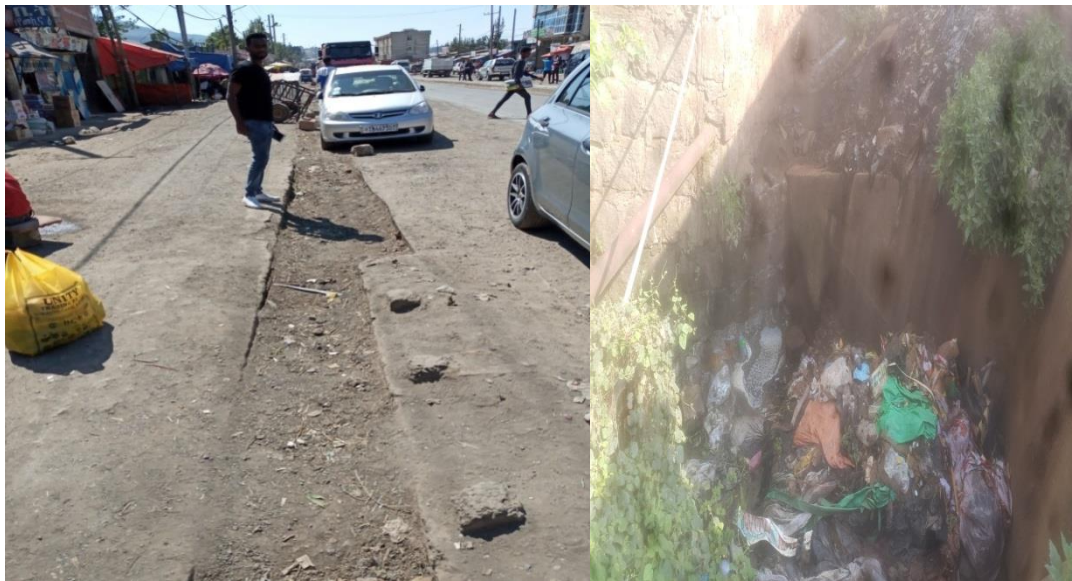
Figure 4.7 Solid waste dumped in to drainage ditches & culvert

Dumping of solid wastes in drainage facilities like demolished materials, soil, and house refuses plastic materials and others: This is to mean because of dumped solid waste in to the existing and urban drainage facilities the flood over flows and create a problem on residents and other urban infrastructure. The condition of the drain and its structures is very poor and getting deteriorated. The drain suffered from low capacity, natural siltation, absence of inlets, indefinite drainage outlets, lack of proper maintenance and over and above disposal of solid waste into the drain and the crossing culverts. The drain blocked with silt and sand accumulation, debris and vegetation as shown in above. It is clear that the drain and culverts being converted to dumpy place and subsequently obstructed the water flow.

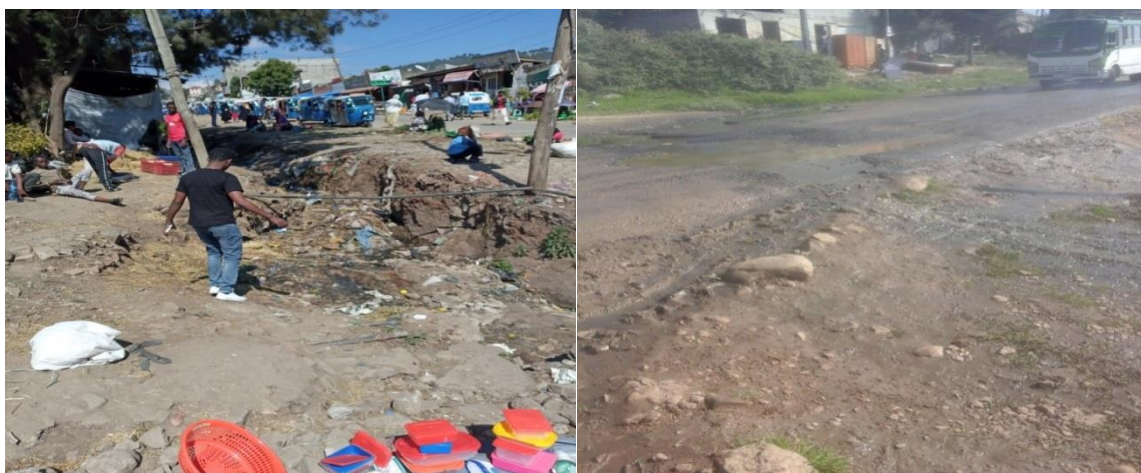
Figure 4.8 Failure of ditch and pavement distress.

Severe distresses were observed on the road surface. It was found that the surface runoff water over flow on surface as a result road material was eroded. Therefore, the major cause of pavement deterioration is inadequate drainage.

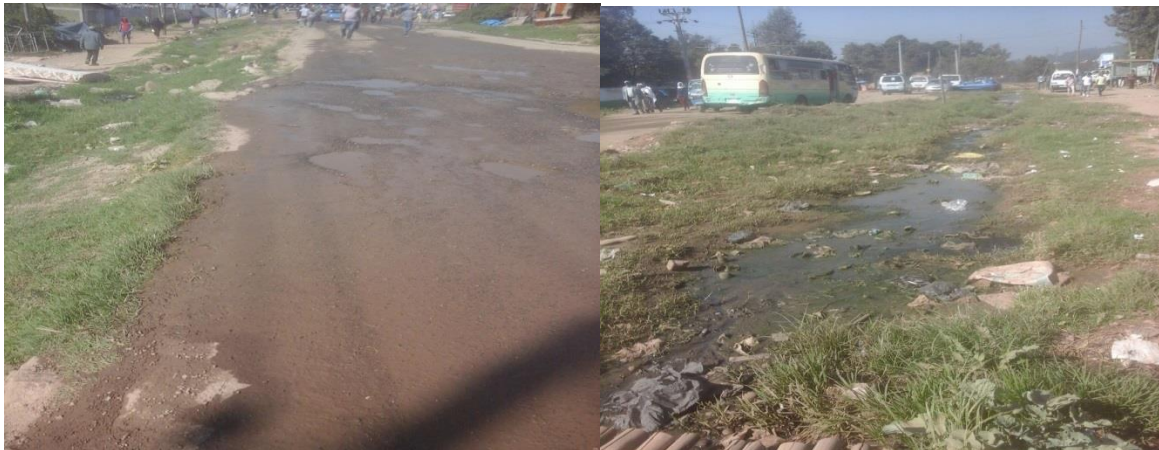
Figure 4.9 Drainage ditches blocked with grasses, silt, debris & sand accumulation

It is clear that the drain and culverts being converted to dumpy place and subsequently obstructed the water flow. This bad condition of the side drain and its structures remains the same throughout the year causing the runoff water to flow on the surface of the road and unable to run off through the path far from the failed drain. The resultant effect of this critical situation causes serious distresses and damages on pavement. The road edges suffered from detachment of asphalt layer due to continuous contact of water leading to stripping of asphalt from aggregates resulting in severe pavement distresses of cracking, potholes and failure of edges

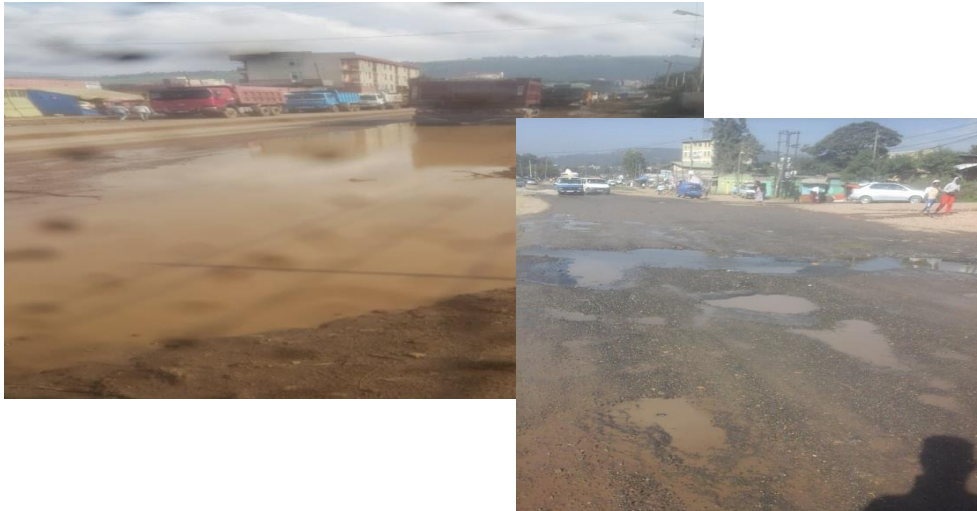
Maskeram Hotel

Figure 4.10 Severe failures of road due to water ponding on surface (Maskerem Hotel)

According to field observation made, some part of road have no drain ditches were constructed storm water collected at the edge of roads which reduce its capacity. It was found that the surface runoff water penetrated through the cracks and potholes cause a progressive inward penetration of the zone of soil movement leading to soil expansion and ultimately failure of the pavement. Therefore, the major cause of pavement deterioration is inadequate drainage. Significant cracking, potholes, heavy depression and edge failure

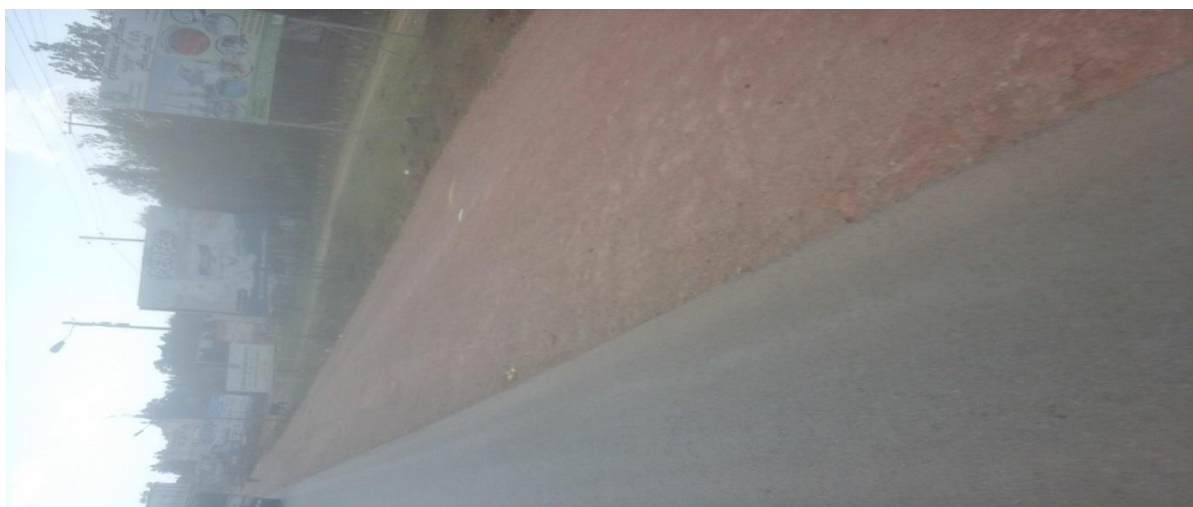
Figure 4.11 No side drainage ditch from Was fuel station to Nock fuel station

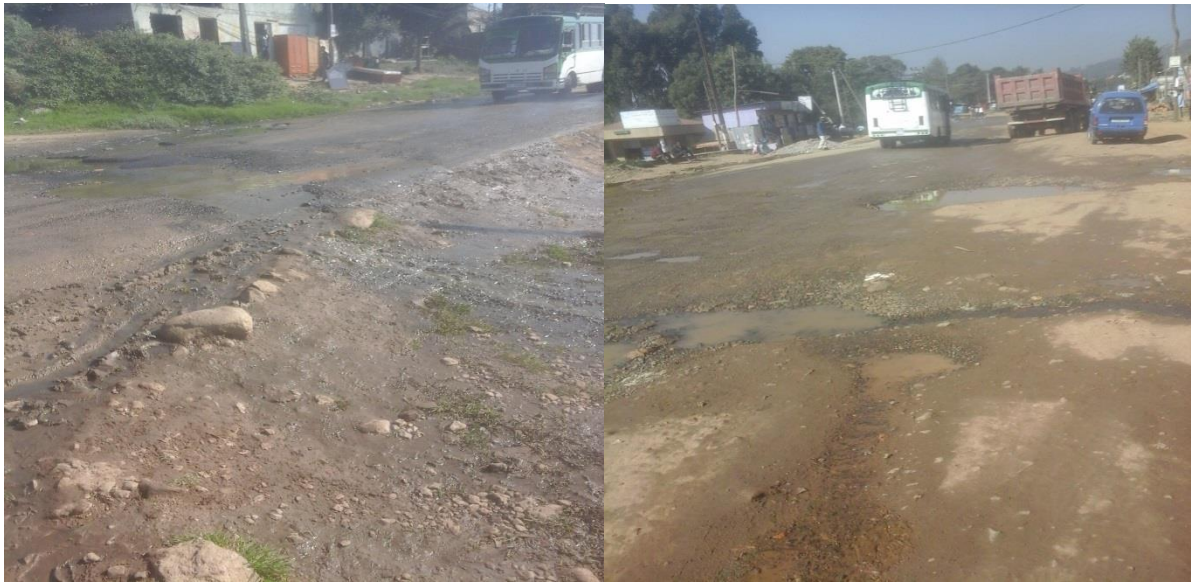
Figure 4.12 Road edge failure and pond of water

During the field survey, parts of the road that were washed away during the rains were observed and photographs taken. These parts of the road were washed away as a result of inadequate drainage facilities. The drain blocked with silt and sand accumulation, debris and vegetation as shown in Figure. It is clear that the drain and culverts being converted to dumpy place and subsequently obstructed the water flow.

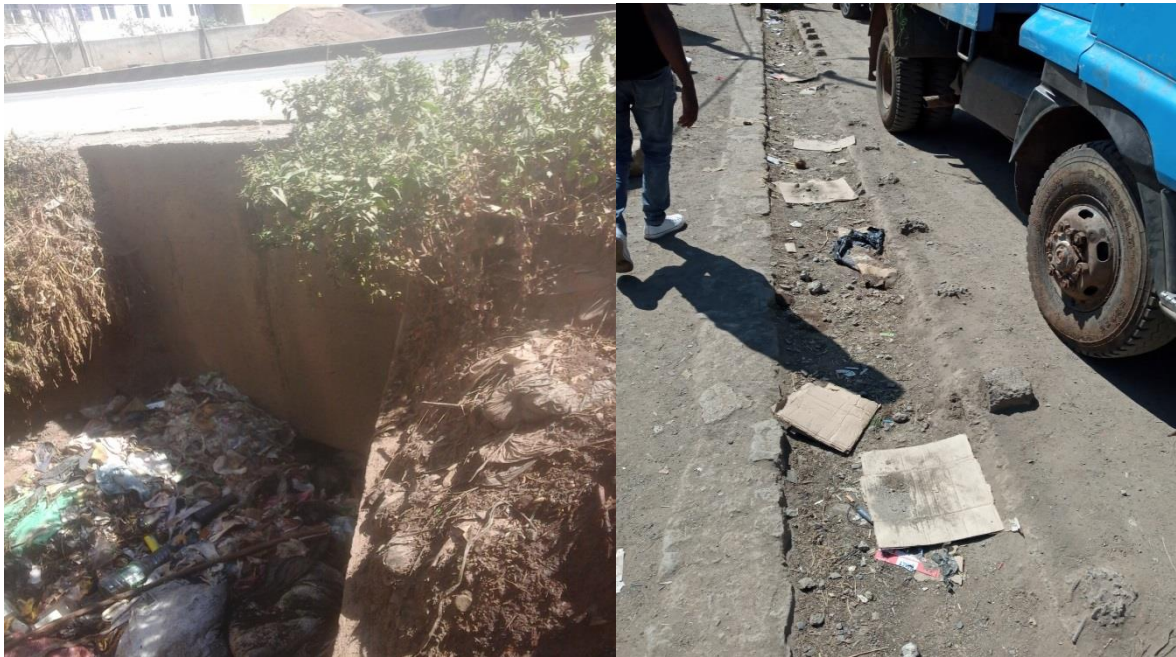
Figure 4.13 Culvert and roadside ditch discharge points totally blocked with refuse dumps

Dumping of solid wastes in to drainage culverts (Including demolished materials, soil, house refuses, plastic materials and others): This has been aggravated the problem of flooding. This is to mean because of dumped solid waste in to the existing urban drainage facilities the flood over flows and create a problem on residents and other urban infrastructure and utilities. The drain suffered from low capacity, natural siltation, absence of inlets, indefinite drainage outlets, lack of proper maintenance and over and above disposal of solid waste into the drain and the crossing culverts. The drain blocked with silt and sand accumulation, debris and vegetation as shown in Figure. During the field observation the following condition of existing drainage structure problems are observed, major dominant problems that could be encountered in the study area are: sedimentation, drainage structures fully covered by grasses and brushes, traffic disturbance, flood overtopping, deterioration of roads, erosion of surface of the road, swamp formation at lower reaches of the catchment's, deposition of refuse material in the drainage structures, and stagnation of water.

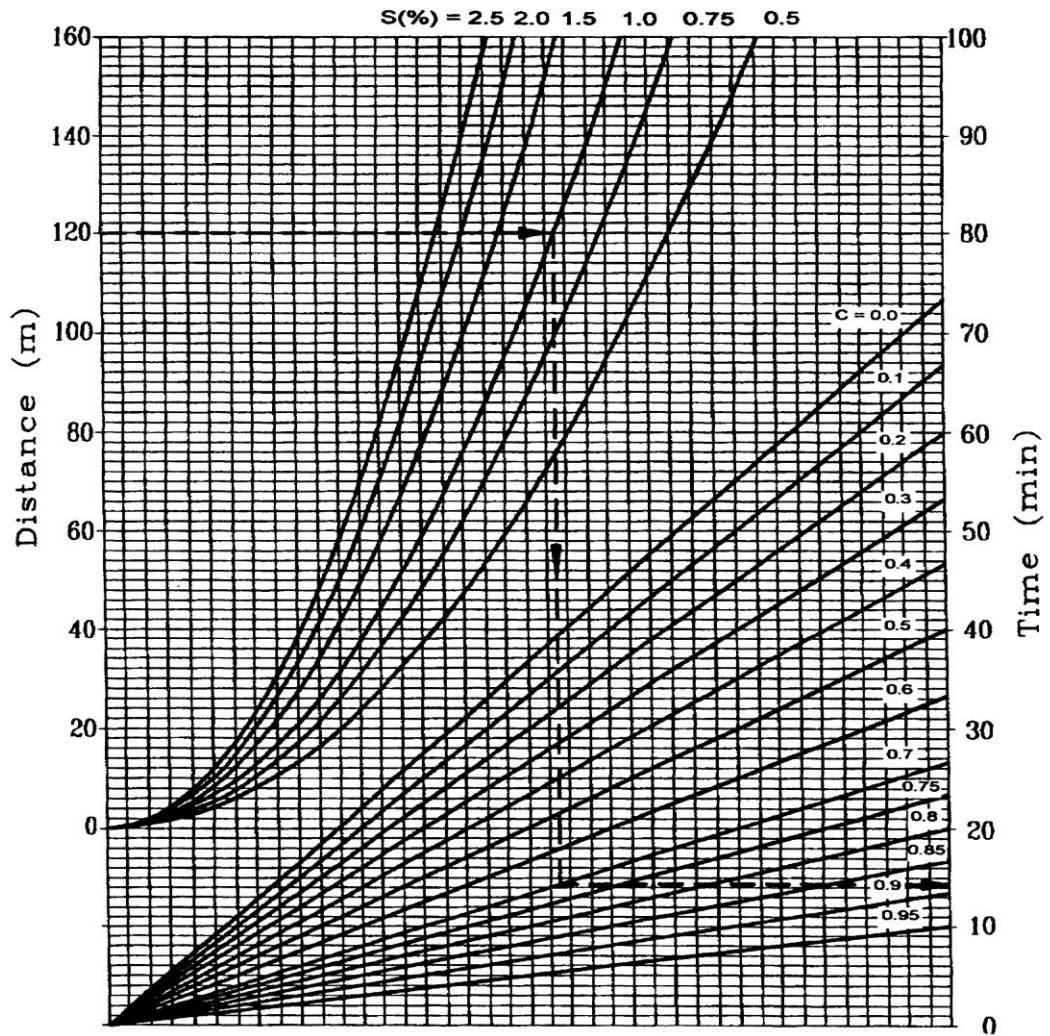
Figure 5-3 Overland Time Of Flow
