GEOTECHNICAL CHARACTERIZATIION AND SLOPE STABILITY ANALYSIS OF LANDSLIDE; THE CASE OF WERIE-MAYKINATAL ROAD, TIGRAY REGION, NORTHERN ETHIOPIA

A thesis submitted to the school of graduate Studies of Jimma University in Partial fulfillment of the requirements for the Degree of Master of Science in Civil Engineering (Geotechnical Engineering)

By: Terhas Abrha

January, 2020 Jimma, Ethiopia

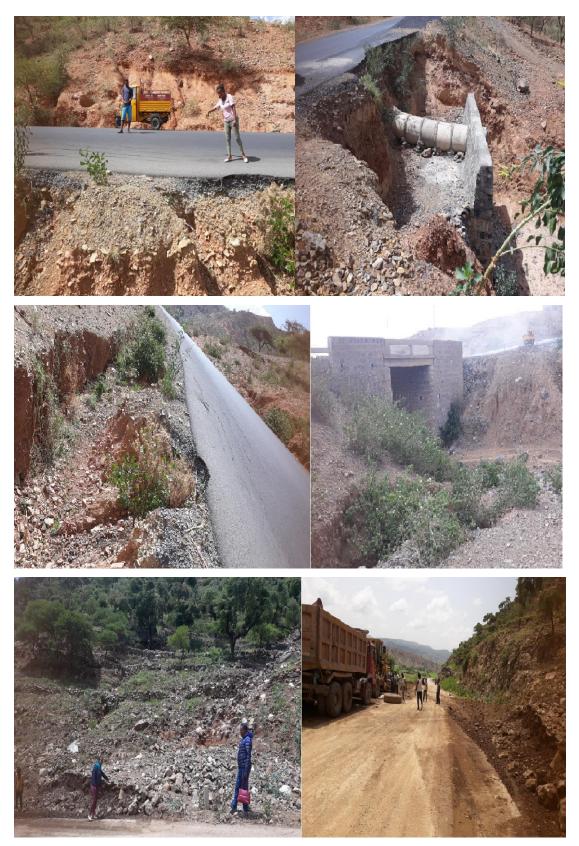
Figure3. 2 Many Cracks on road surface, ground subsidence and Slope instability

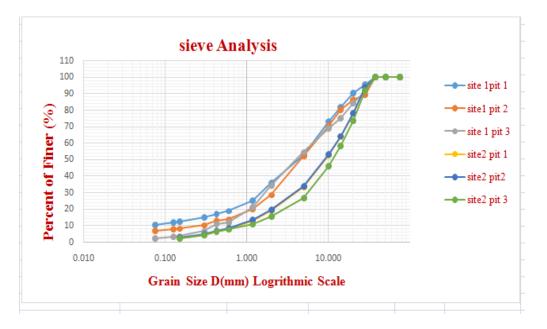
Figure 4.1 Size Distribution Curves for the Soil Samples

The combined grain size distribution curve for soil samples of the study area is shown on Figure 4.1. Most of the study area materials are coarse lessen than 50 percent are passed by sieve number 200(0.075mm). Results indicate generally the materials are categorized as GW and GP-GC and A-2-7 and A-2-6 from USCS and AASHTO respectively .The results and procedures are mentioned in the appendix A.

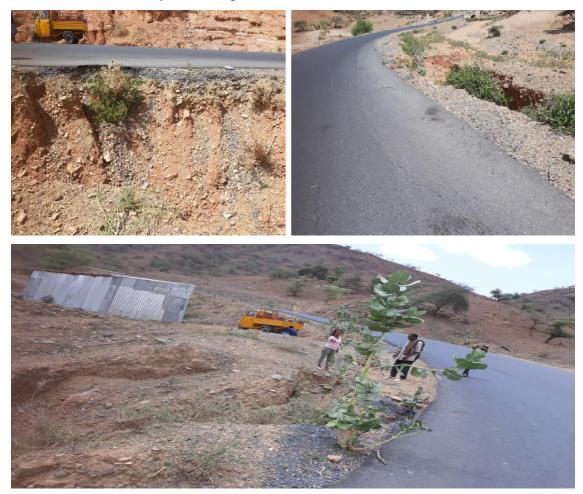
Figure 4. 12 Road Section General Side View

The presence of weak zone (highly to moderately weathered and fractured rock) and clay soil with small amount were the main causes for occurrence of landslide in the study area. The following figure mentioned the geological profile of the study area slope which indicates the existing material type and their thickness. The presence of erosion and gulleying at the bottom and top of the road are believed to have great influence on the stability of the slope.

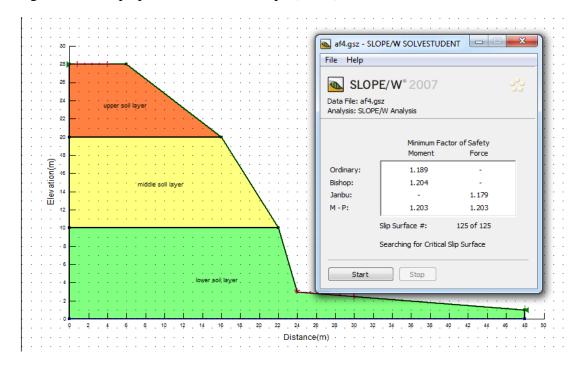
Figure B. 2 Resulting factor of safety for the SLOPE/W analysis (site 1)
