Assessment of small scale irrigation structure failures; case of Weira, Hadiya zone, SNNRP,  
Ethiopia

A thesis submitted to the School of Graduate Studies of Jimma University Institute Technology  
in Partial fulfillment of the requirements for the Degree of Masters of Science in Hydraulic  
Engineering

June, 2022  
Jimma, Ethiopia

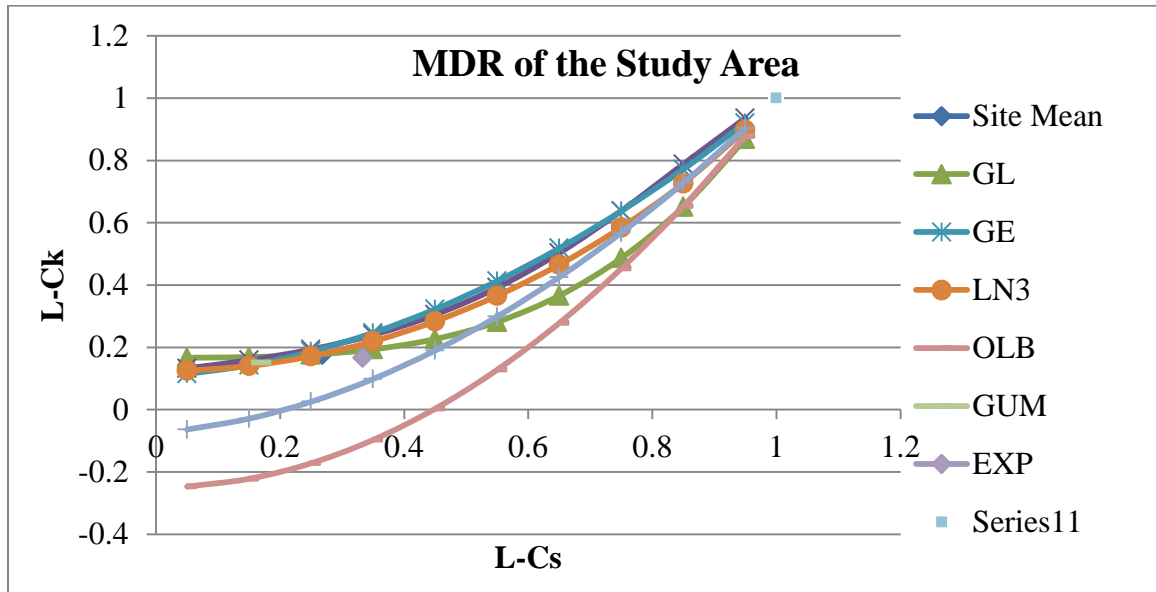
Figure 3.3 MDR of the study area

There are two methods to select best fitted statically methods. These are graphical and analytical methods. Here for this study graphically method was used. Using this method LN3 statically method was selected since the site mean falls on it more than other methods.

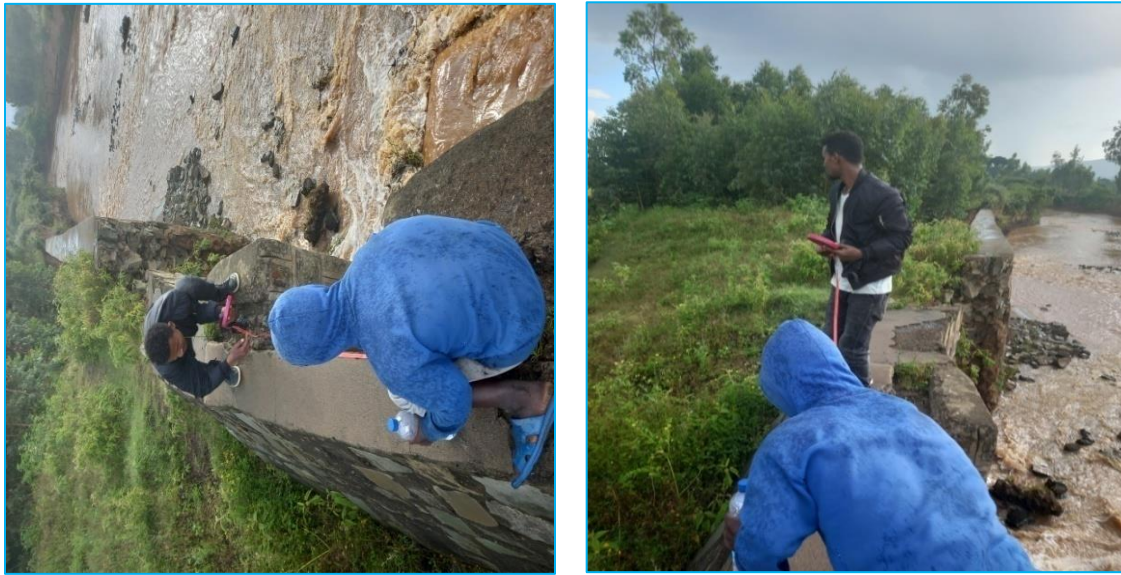
Figure 4.1 sluice gate

Damage on sluices gate table 4.1 and shows is observed during field visit fig 4.2 and questionnaires 26.7% of sluice gate damaged. The cause for the problem of gates can be mainly attributed to improper scheme operation, improper hydraulic and hydrological design. Improper operation and maintenance is the factor of absence of WUA and poor operation and maintenance skills of community, lack of training give for community irrigation scheme operation and maintenance.

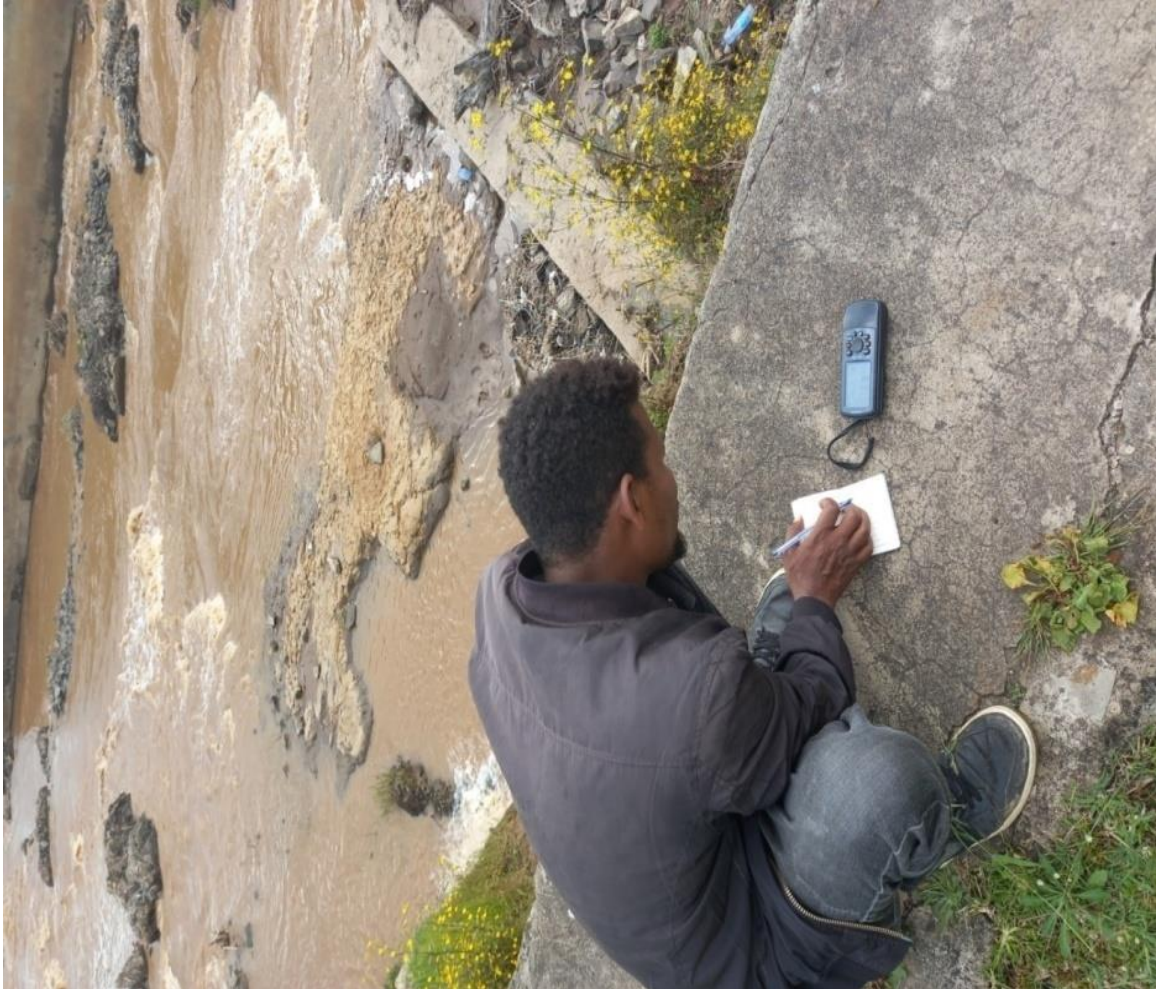
Figure 4.2 damage of downstream apron

In case of weira irrigation scheme the provision of quality construction material reduce its ability to withstand erosive power of the energetic water and these will result in eroded apron surface these is the impact of improper hydrologic and hydraulic analysis. Therefore from table 4.1 and field visit fig 4.3 and questionnaires 28.3% damage on downstream apron.

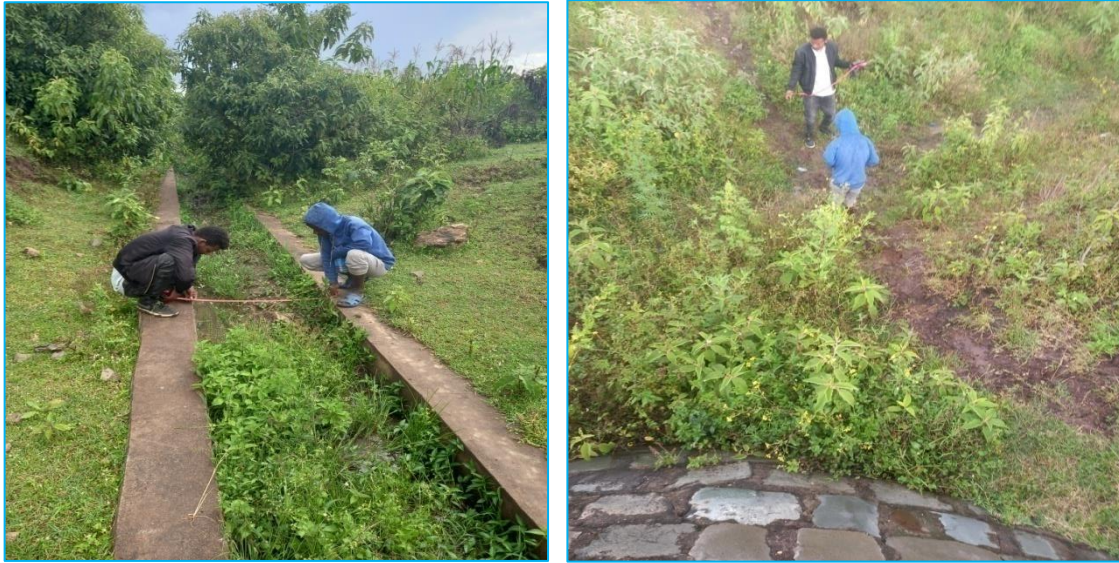
Figure 4.3 grass and silt accumulation

In canal it is observed table 4.2 and during field visit fig 4.4 and questionnaires 38.3% damaged the problem of Grass and silt accumulation in canal on farm lands, especially canals are caused due to uncontrolled runoff from the watershed along the canals that initiated the canals bank erosion and consequently the bank collapse and Accumulation of silt along the canal could usually causes weeds to grow along the canal and other major effect of silt deposition in an irrigation canal is the reduction in flow carrying capacity of the canal during field observation other animals dig holes in the canal this due to absence of WUA, lack of awareness of community and inadequate perform duties and responsibility and no formal handling of the project, have no sense of ownership of scheme and no formal management system for scheme.

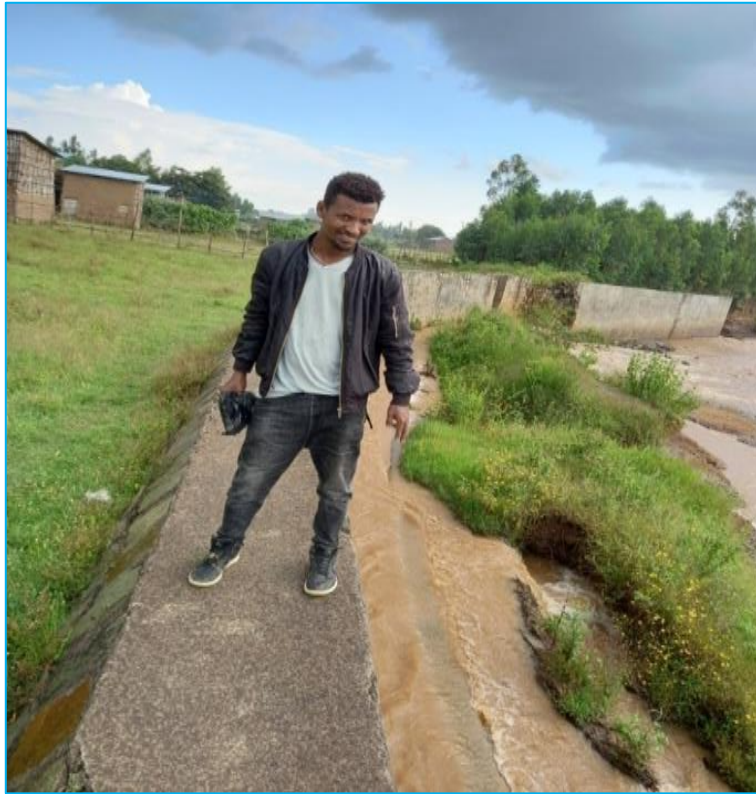
Figure 4.5 overtopping of canal

When we compare the estimated flood in the design document was by far less than the values of calculated design flood for cross drainages. This implies that the flood that came from catchment areas of the streams is above the capacity of the cross drainage structure of the irrigation scheme. Therefore, underestimation of the catchment area of streams caused serious flood around the scheme the magnitude of the damage of the irrigation structure due to flood.

The drop structure of the scheme and the culverts were seriously damaged by high flood that comes from the catchment area of the stream. Water is also following out of the designed root and it did not reach the command area it ought to be. Thus, it is possible to conclude that the major causes for the damage of the irrigation structures and overtopping of the canals were as the result of the flood that came from catchment areas of the streams. Therefore, the major cause for the hydrologic failure of the scheme is lack of appropriately estimated hydrological design of the irrigation project.
