Evaluation on the Integration of Road Network and Drainage System for the Occurrence of Flood: A Case of Bishoftu City

Thesis submitted to school of postgraduate studies of Jimma University Institute of Technology in partial fulfillment of the requirements for the degree of Master of Science in Civil Engineering (Highway Engineering)

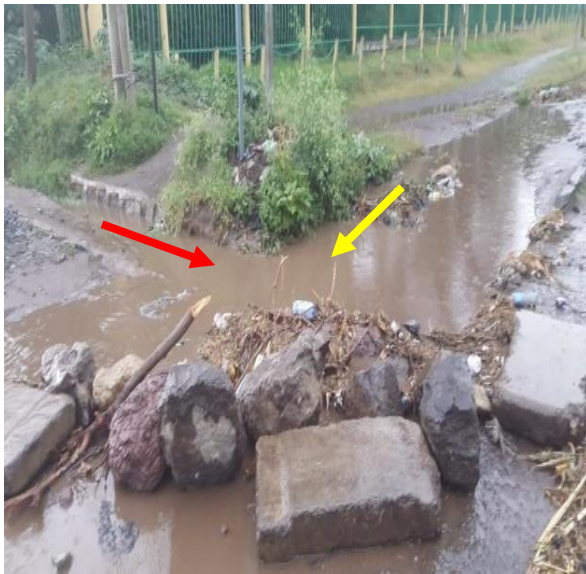
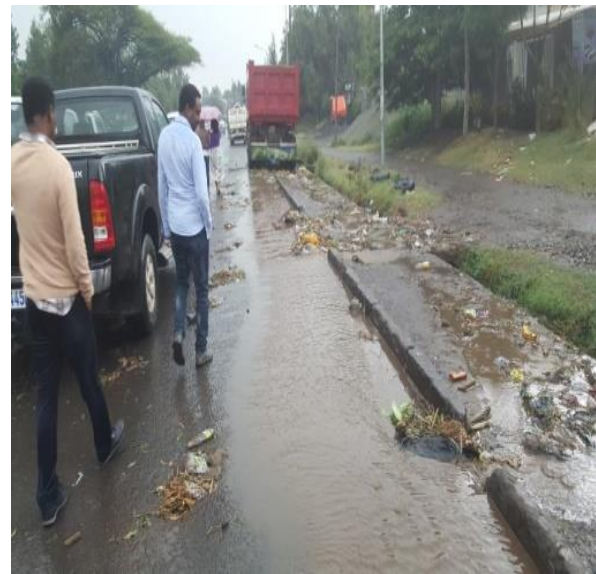
Figure 1. 1: Existing flood condition (Picture taken by Author on 23<sup>rd</sup> of August 2021).

Closed slab culvert condition

Surface flooding

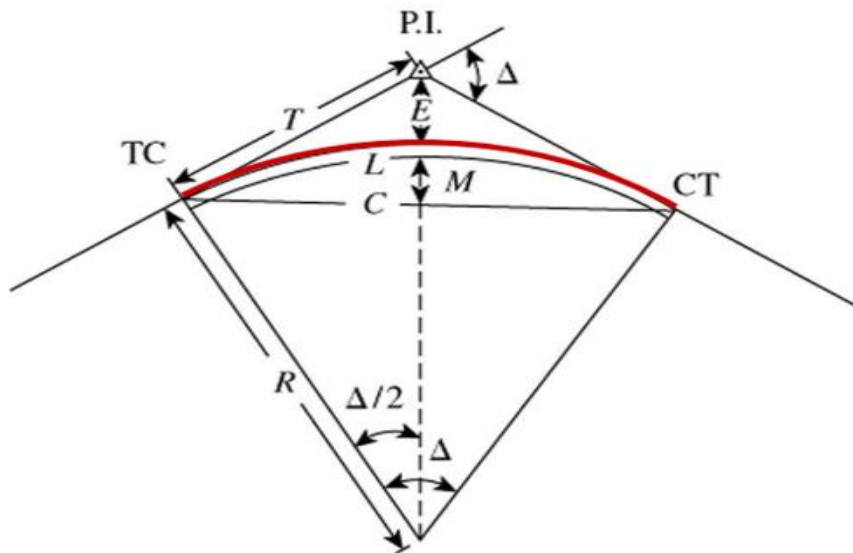
Figure 2. 1: Typical horizontal curve alignment

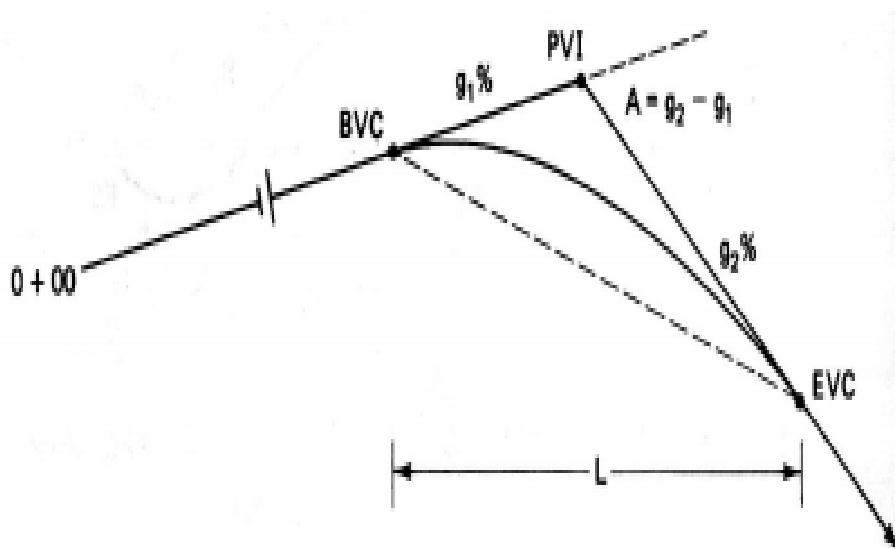
Figure 2. 2: Typical vertical curve (Source: ERA, 2013)

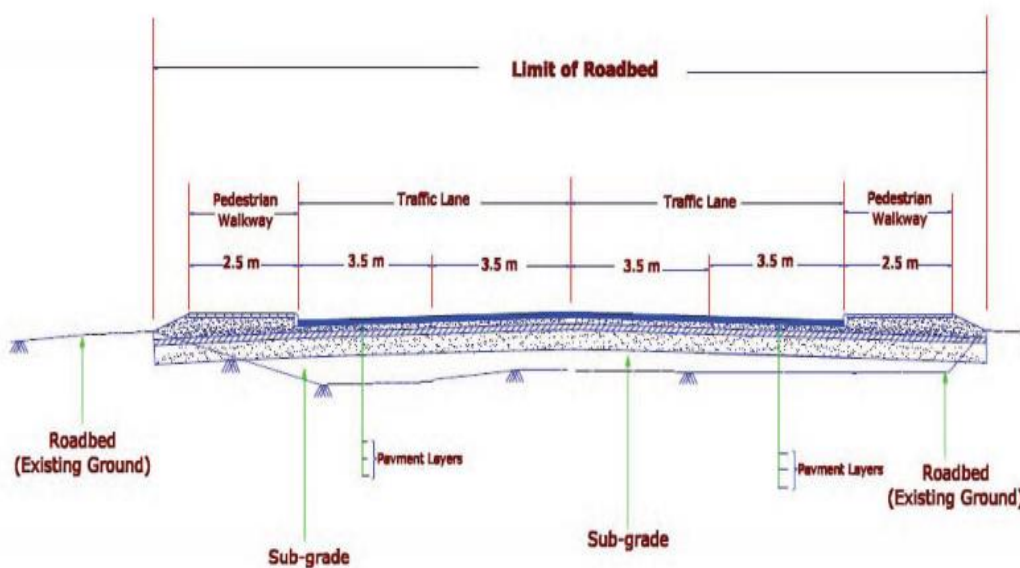
Figure 2. 3: Divided two lane typical town section (Source: ERA, 2013).

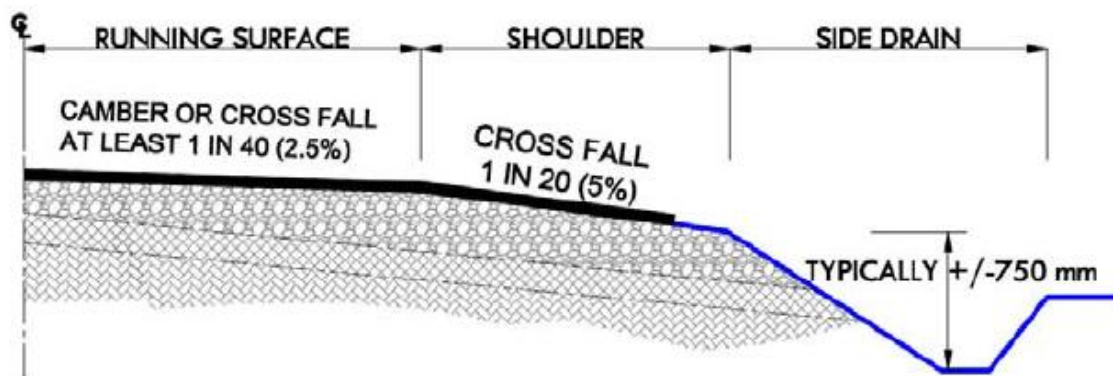
Figure 2. 4: Side drain ditch location in expansive soils (Source: ERA, 2013)

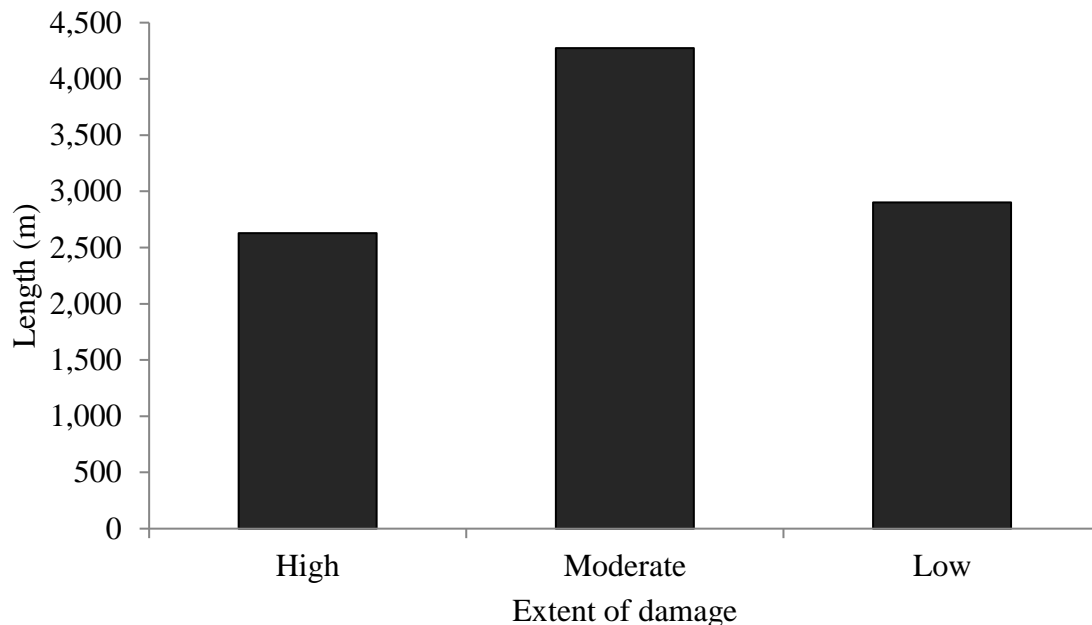
Figure 4.1 represents the extent of damage of flood prone area of Asphalt road. It clearly shows that road from Entry to Ziquala are highly damaged where as the road from Bus station to circle and Asphalt road at ziquala junction and segment from Bus station to Circle are with lower damage. From the assements made 26.82 % of the segment were highly damaged and 43.59 % were moderatly damaged while the remaining 29.59 % are with low severity.

Figure 4. 1: Asphalt Road severity level of damage for flood prone areas

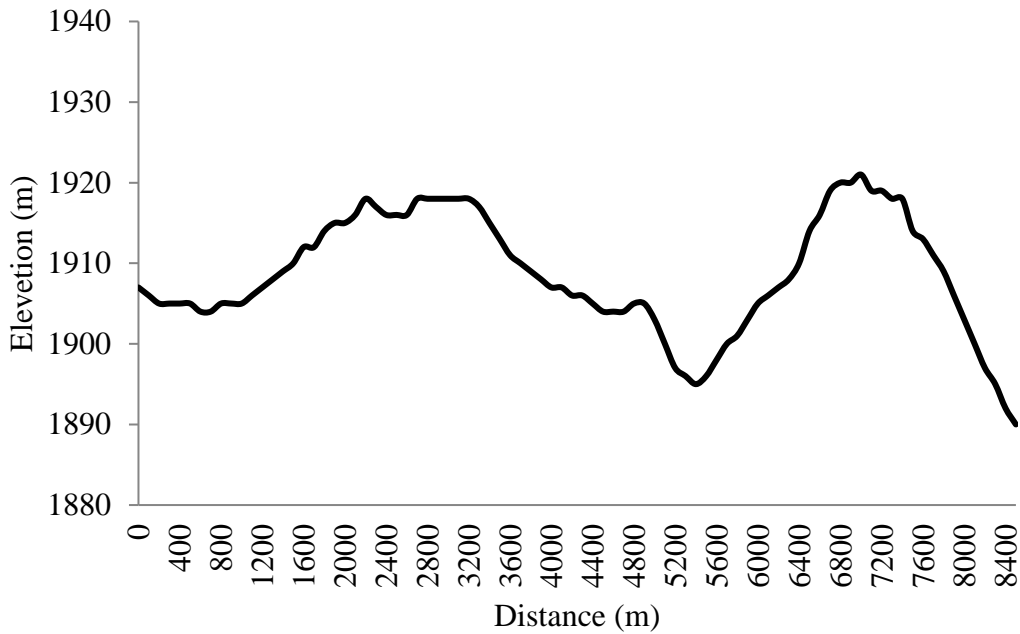
Profile of the main road clearly shows that the elevation difference of the minimum and maximum road section is 28 m. There are ups and downs in between this section as maximum elevation is between Getshet and Ziquala of 1918 m with minimum elevation at the gate of the Air Force 1890 m. Figure 4.2 shows longitudinal profile of the main road, the road needs crossing structures at six points as it was already provided on the existing road. It is remarkable that the longitudinal and cross-sectional slope of the road was not built in a uniform manner which will retard surface runoff to flow to the side drains. The longitudinal gradient of the main road is less deficient to move the surface runoff when compared to the mild cross-sectional slope of maximum 1.5 % and minimum 0.2 % which are below the standards of 2-3 %.

Figure 4. 2: Main Road profile.

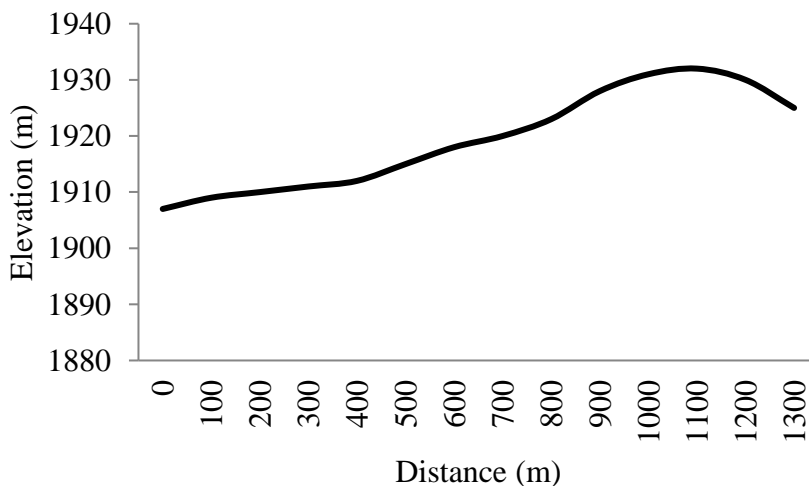
Asphalt road profile at joint of Ziquala shows Maximum elevation of 1931 m and minimum elevation of 1907 m. The road is inclined to main road with variable slope varying from 1-5 % from station 0+00 to 1+000 for 1 km. On the other hand, the remaining 300 m of the road is inclined to back ward with slope of (-3 %) and the side drain is also flowing to the other side of the road. There is no significant problem on this road and side ditches, even if the cross-sectional slope of this section is also mild (0.5 %) which is much less than the standard 2.5 %, the inlets and chamfers of the side ditches are properly provided and the longitudinal gradient helped to move surface flood to side drains.

Figure 4. 3: Asphalt Road profile at Ziquala joint.

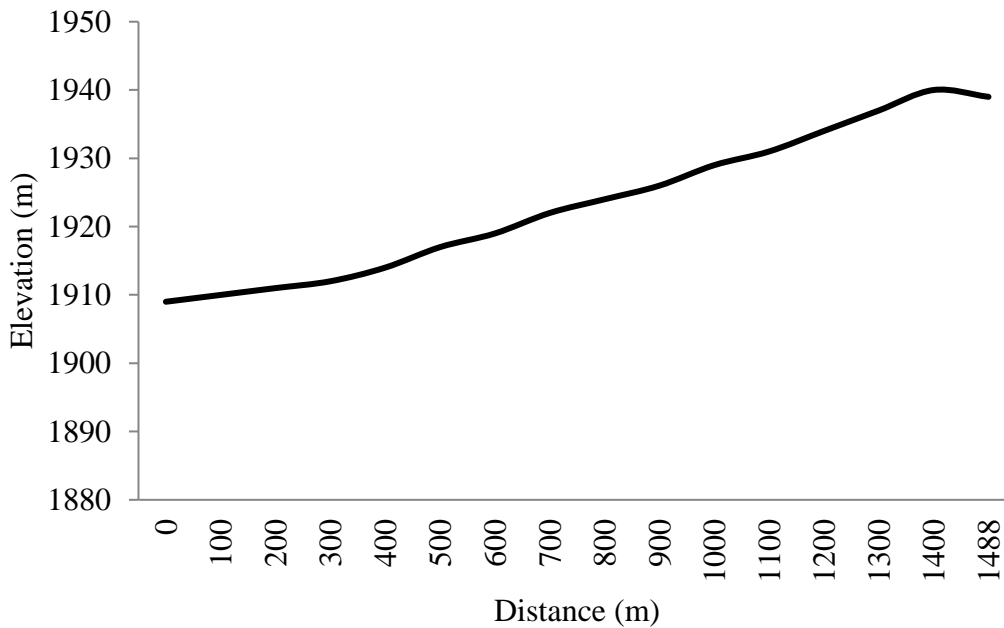
Cobble stone road profile at Innova shows Maximum elevation of 1939 m and minimum elevation of 1909 m. The road is inclined to main road with an average slope of 2.0 % varying from 1-3 % slope every 100 m. for this section as it was clearly seen during field survey, there is no cross-sectional slope provided to this section and the water was flowing over the whole section of the road and finally the road is subjected to distress with water detained over the distress areas.

Figure 4. 4: Cobblestone Road profile at Innova.

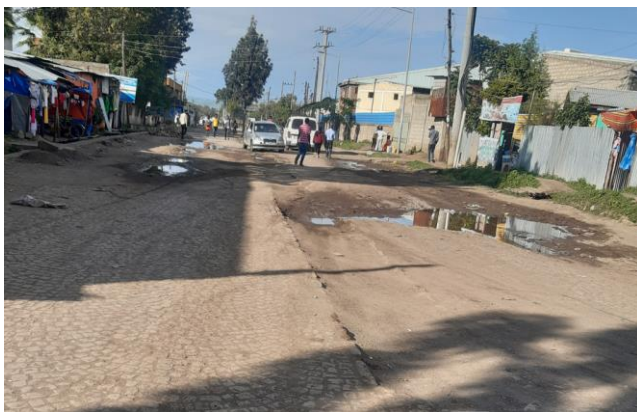
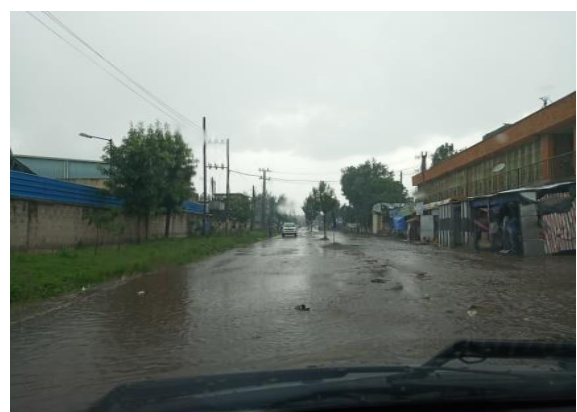
Figure 4. 5: Cobblestone Road with no cross-fall.

As shown in the Figure 4.5 cobblestone at Innova was deformed and the water is detained on the surface, even if there are side drains in both side, insufficient road profile and drainage structure provision results in damage to road surface pavements and flooding problem in the area of Innova and Getshet.

Road Profile condition during no rain

Road profile condition during rain

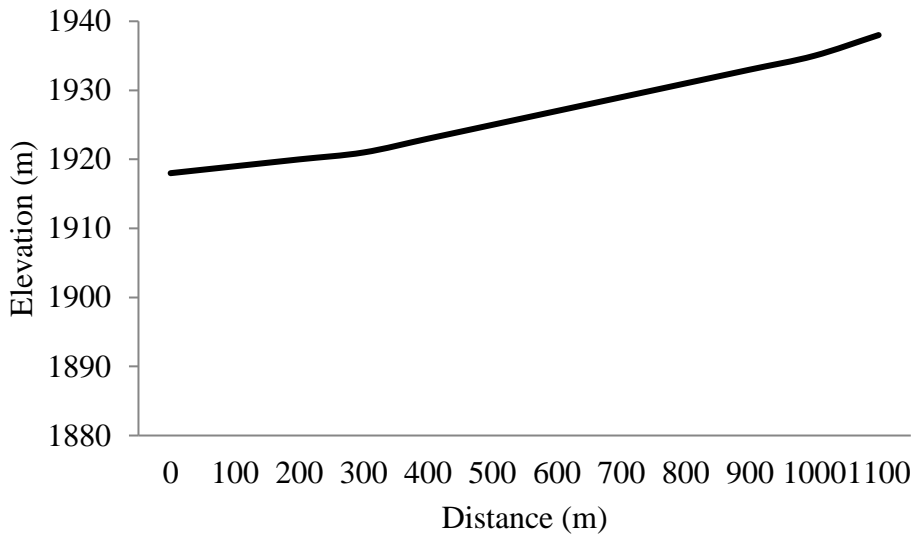
Cobble stone road profile at Getshet shows Maximum elevation of 1938 m and minimum elevation of 1918 m. The road is inclined to main road with almost constant slope of 1.8 % varying from 1-3 % slope every 100 m.

Figure 4. 6: Cobblestone Road profile at Getshet.

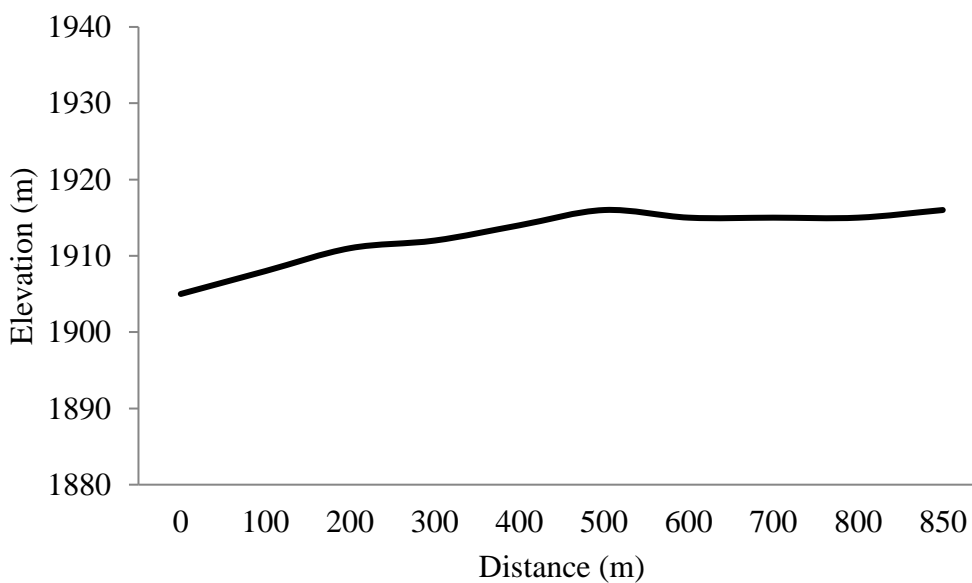
Cobble stone road profile at Eyasu Meda shows Maximum elevation of 1916 m and minimum elevation of 1905 m. The road is inclined to main road with variable slope varying from (-1.0 %) for 100 m (b/n station 0+500 and 0+600) to maximum slope of 3 % for 200 m at the joint on the main road, while the average slope is 1.3 % inclined to the main road.

Figure 4. 7: Cobblestone Road profile at Eyasu Meda.

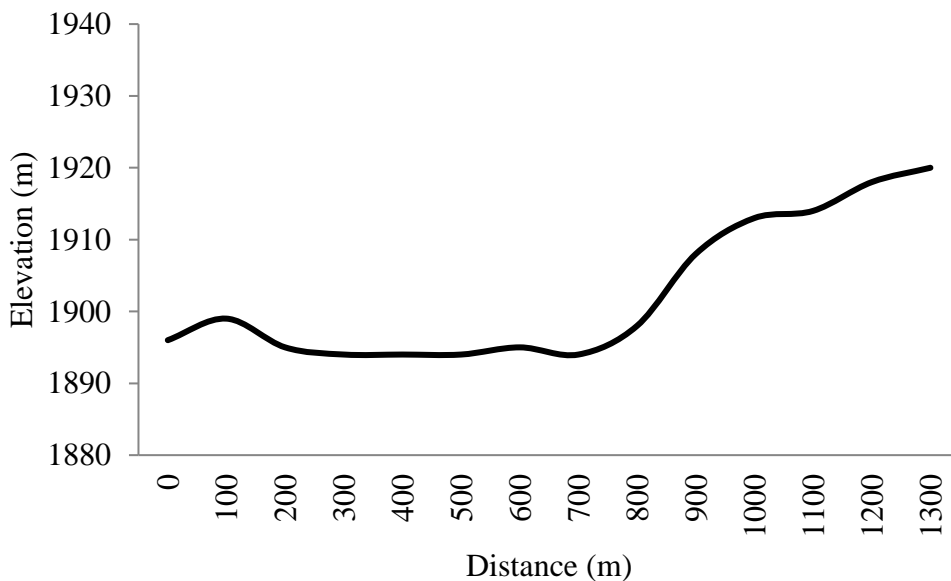
Providing the vertical alignment of the road with a gentle longitudinal gradient improves the road surface drainage. This slope facilitates the discharge of water from sections of the road surface with limited cross-slope. Steep road slope causes surface water to move rapidly and makes surface drainage difficult to control. This problem starts when the longitudinal gradient exceeds 8 % as it is seen for section b/n 0+800 and 0+900 which has slope of 10% for 100 m. Due to the steep grade; it becomes more difficult to evacuate water from the carriageway. This will result in accelerated wear of the road surface. If the steep slopes cannot be avoided by realigning the road, an alternative is to provide an erosion resistant surface to this section, such as stone pavement, asphalt or concrete. Equally, the side drains need to be protected in a similar way and here again after this steep slope of road profile there is a completely flat slope where there is no gradient and the surface runoff from upstream easily detained on the flat areas of section from 0+200 to 0+700. In addition to flatness of the area there are no side drains as well as no cross slopes in this area which will exaggerates the effects of flooding.

Figure 4. 8: Cobblestone Road profile at back of Bus station.

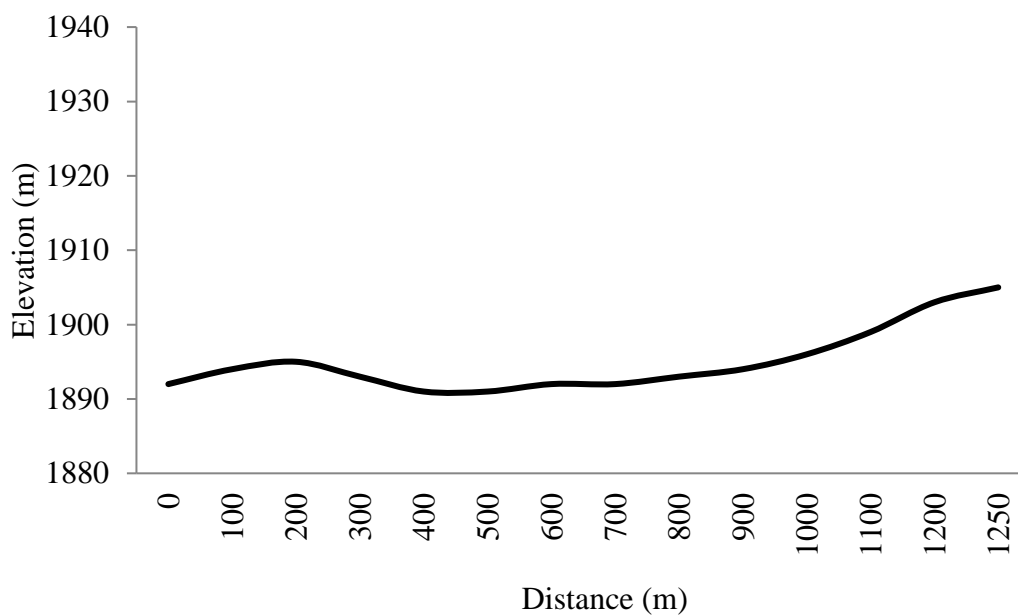
Gravel road profile shows maximum elevation of 1905 m and minimum elevation of 1891 m. The road is inclined to mid-way, between the road section of 0+400 up to 0+700 where there is constant elevation, with variable slope varying from (-2 %) for 200m (b/n station 0+200 and 0+400) to maximum slope of 3 % and 4 % for 100 m b/n 0+900 and 1+000 and 1+000 and 1+100 respectively, while the average slope is 2 % inclined to the mid-way between the roads. The area is highly affected by flood, and there are no side drains constructed for the whole section of the road, this section is just aside of the creator Cheleleka lake with no cross-fall slope.

Figure 4. 9: Gravel Road profile.

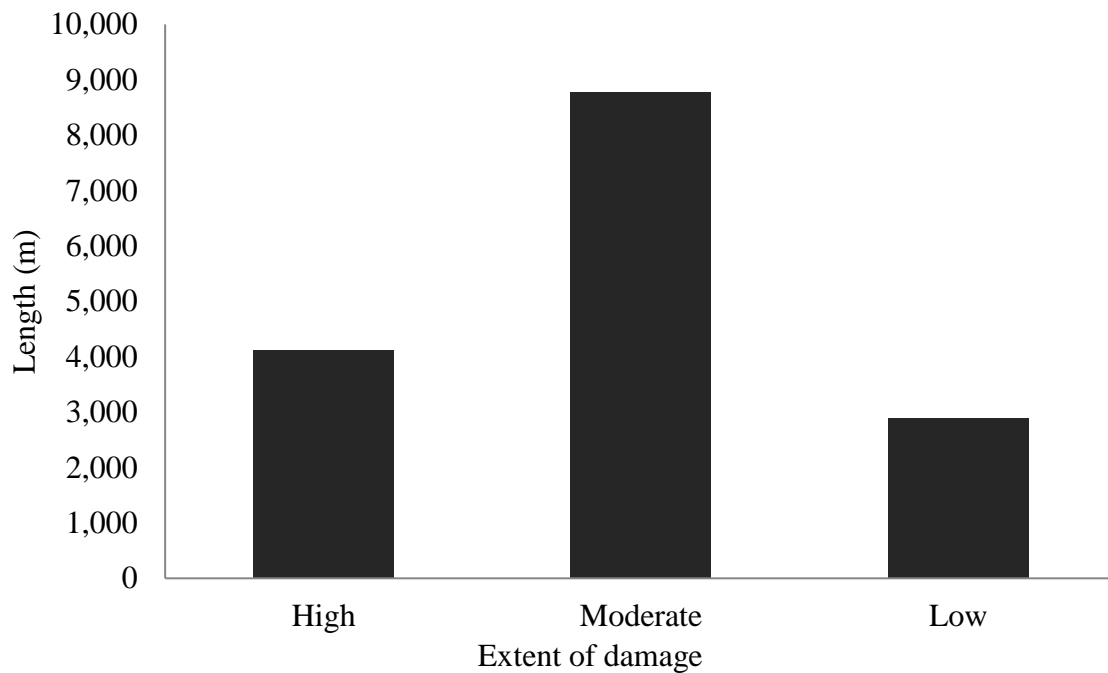
From Table 4.3 shows that for segment from Entry to Getshet, there is no side drains and the road is with major damage with high rate of potholes and block cracking, surface runoffs are detained over the surfaces of the road and actually minimum cross-sectional slopes are also the factors exaggerating surface flooding to this section. Evaluations of the survey indicates 26.07 % of the assessment area is highly damaged while 55.56 % of the area is with Moderate damage. But inspections of every route indicate 100 % of Innova to Getshet main road and Innova Cobble and 76.71 % of Entry to Innova main road are highly damaged.

Figure 4. 10: Total level of damage.

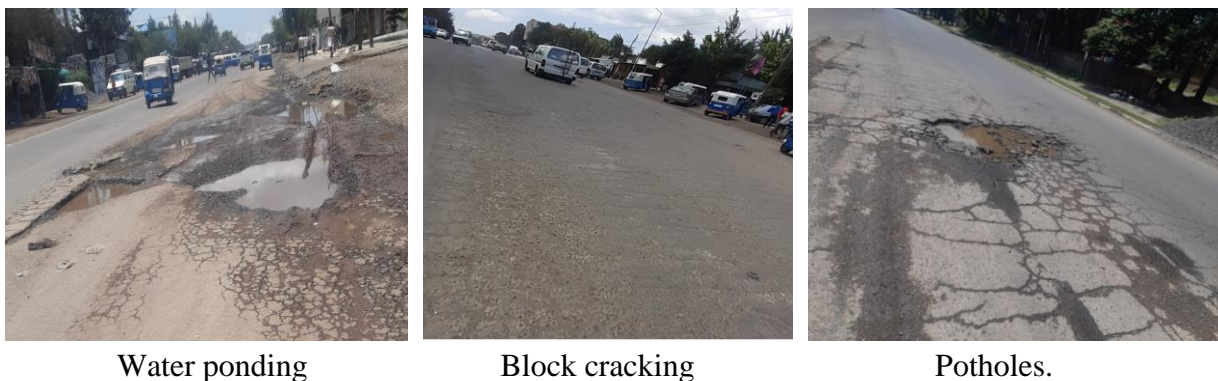
Figure 4.11 shows the road without side drains are highly affected by the flood and the area needs fundamental maintenance as the Potholes are with high severity damage. At this particular place the depth of pothole surpasses the pavement and base coarse thickness. Fatigue and Block cracking's are also changed to potholes as they didn't get maintained in timely manner, after some time of prolonged services without maintenance of the area, the pavement is totally demolished and changed to almost gravel road.

Figure 4. 11: Types of road failure

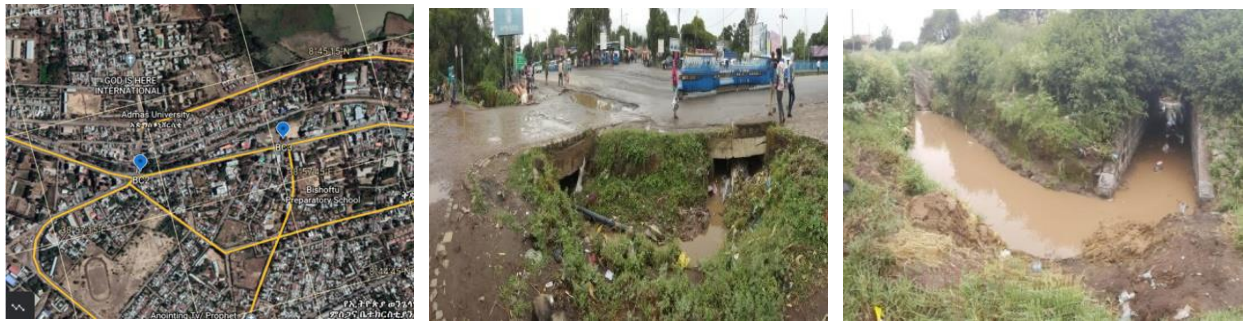
Location of structures      Drainage filled with solid waste      Drainage with L turn  
 Figure 4. 13: Zikuala catchment drainage structures condition.

The storm flow immediately changes direction after final culvert outlet, figure 4.13 b, and this is not recommendable as it leads to siltation and accumulation of waste that prevent smooth and unobstructed flow. Bridges and culverts shall be constructed perpendicular to the road as much as possible to avoid siltation and pressures to be created by the water.

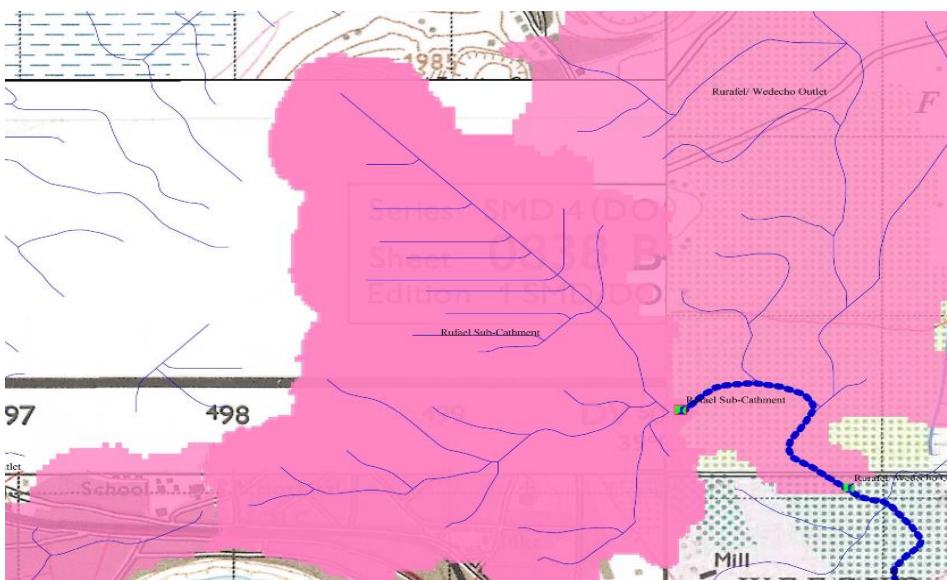
Figure 4. 14: Critical outlets condition of Wedecha catchment at downstream.

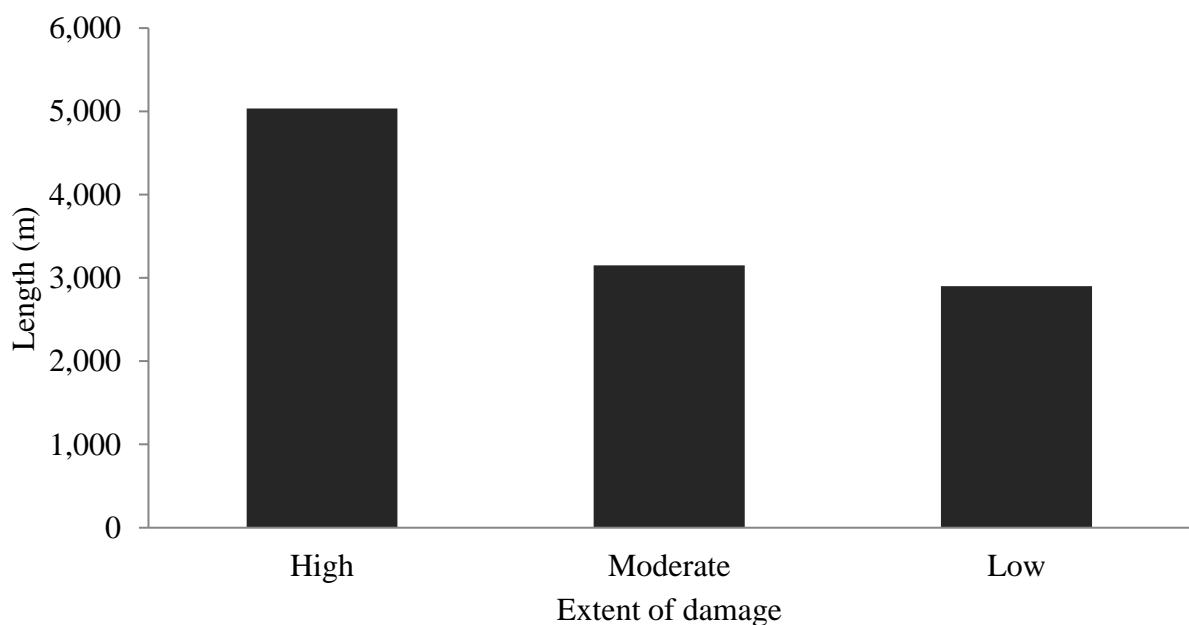
As shown in the Figure 4.15 the drainage lines which are highly damaged constitutes about 45.42 % of the totally assessed area, while 28.42 % are moderately damaged and only 26.16 % have low damage. This indicates that most of the drainages are functioning under design capacity as most are damaged and filled with solid wastes.

Figure 4. 15: Total level of damage for ditch.

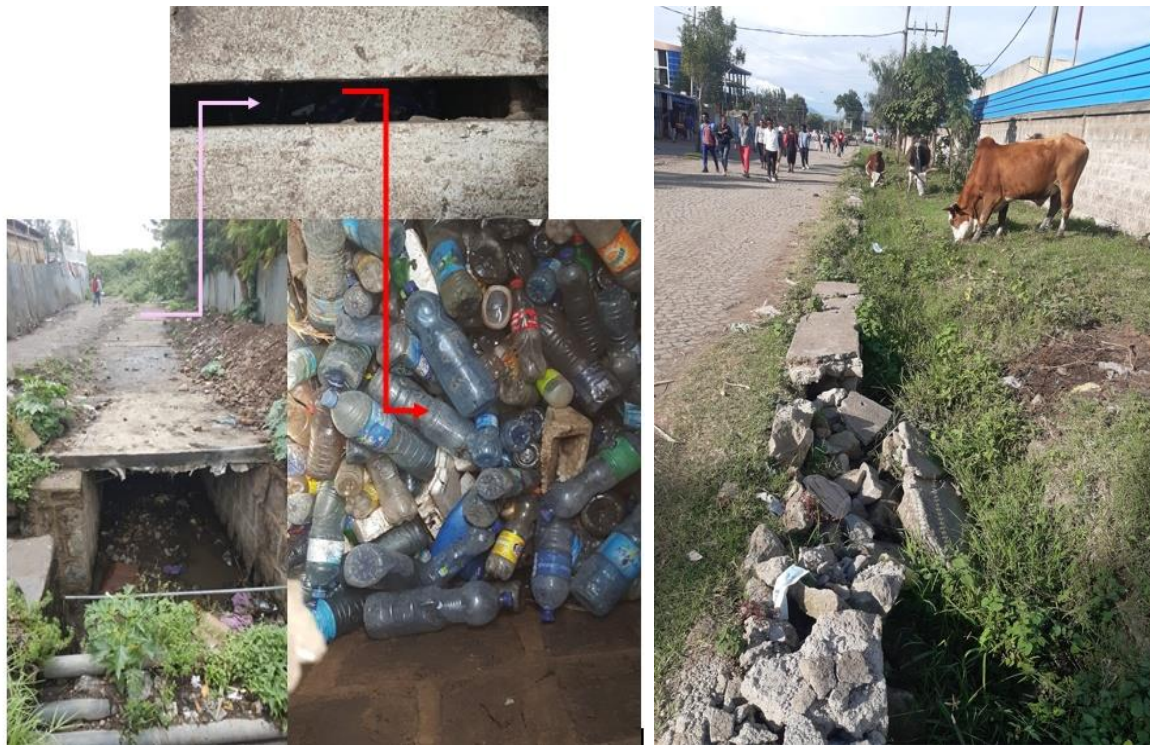
Accumulated plastic waste concealed by slab cover  
 Figure 4. 16: Conditions of drainage structures.

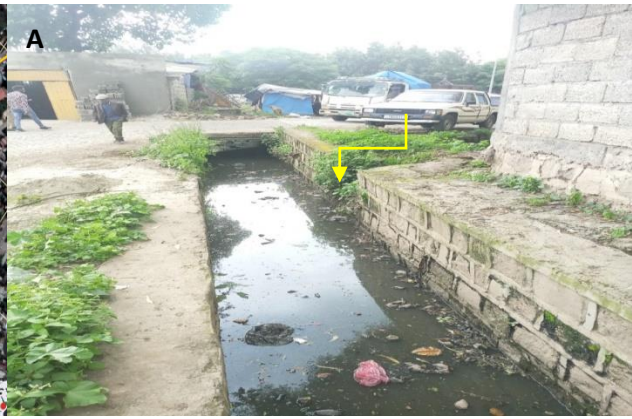
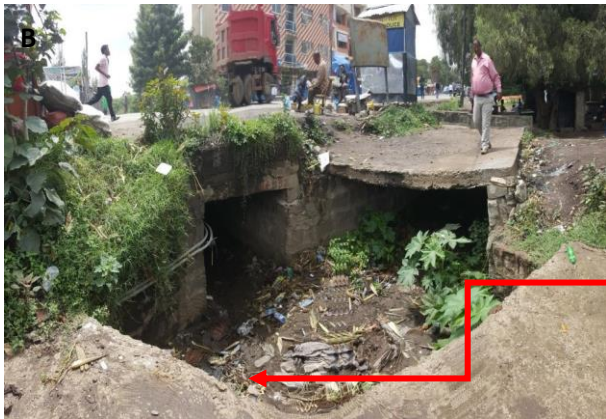
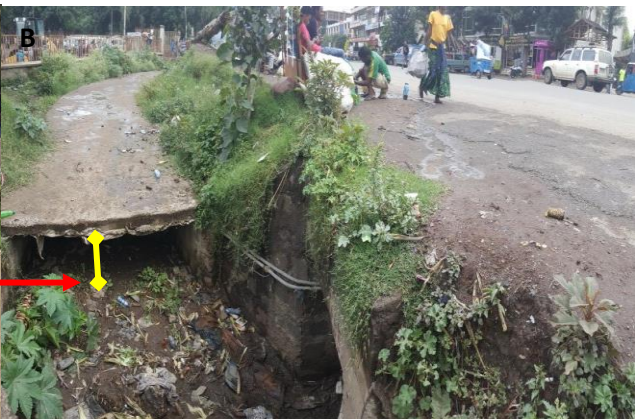
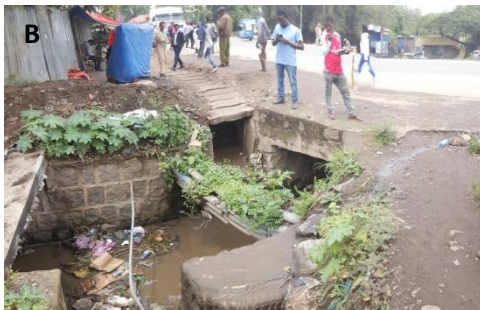
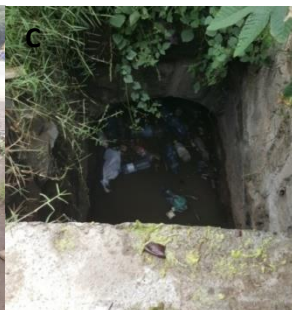
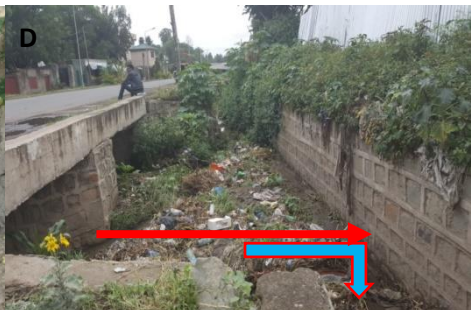
Blocked to prevent backflow

Drainage line in front of bus station seriously blocked with silt-up of mud and waste

Outlet point of highway culvert

Inlet point to culvert

Wall in front of outlet

The 1 in 10-year peak discharge passing the section was estimated by SCS method as 22.6 m<sup>3</sup>/s. A minimum of about 8.4 m<sup>2</sup> opening area is required to safely pass this discharge, whereas the existing culvert with a dimension of 1.5 m by 1.3 m is inadequate. Therefore, this culvert is recommended to upgrade to width of 4m and height of 2.5 m including freeboard and allowance for debris passage or equivalent ERA standard double (2 cell) box culvert of 3 m width by 2 m height.

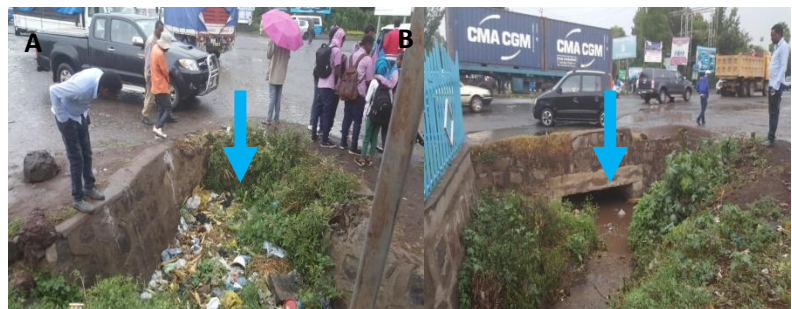
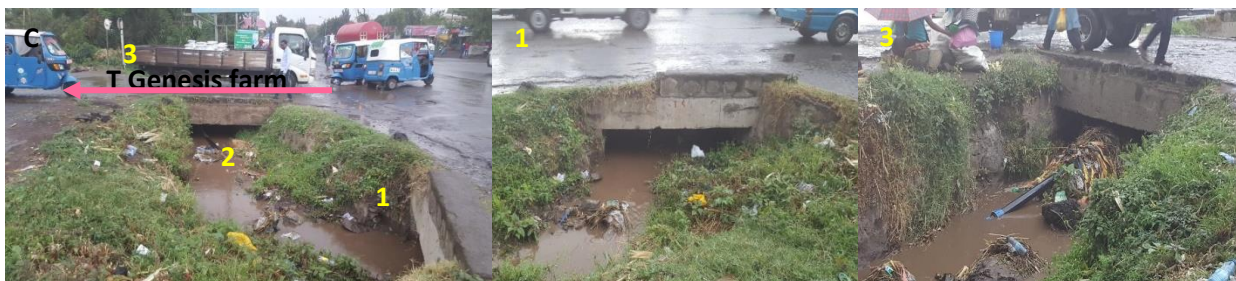
Inlet of pipe culvert blocked with solid waste.

Culvert filled with solid waste and grasses

The 1 in 10-year peak discharge passing the section was estimated by SCS method as 13 m<sup>3</sup>/s. The clear span opening of the existing culvert width and depth (depth reduced by sedimentation) are 1.6 and 0.6 m respectively; where as to safely pass a discharge of 13 m<sup>3</sup>/s need a minimum opening area of about 5 m<sup>2</sup>. Therefore, this culvert needs shall be replaced by ERA standard of width and height 3 and 2 m respectively.

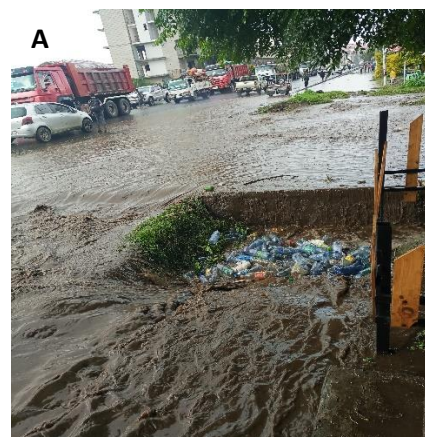
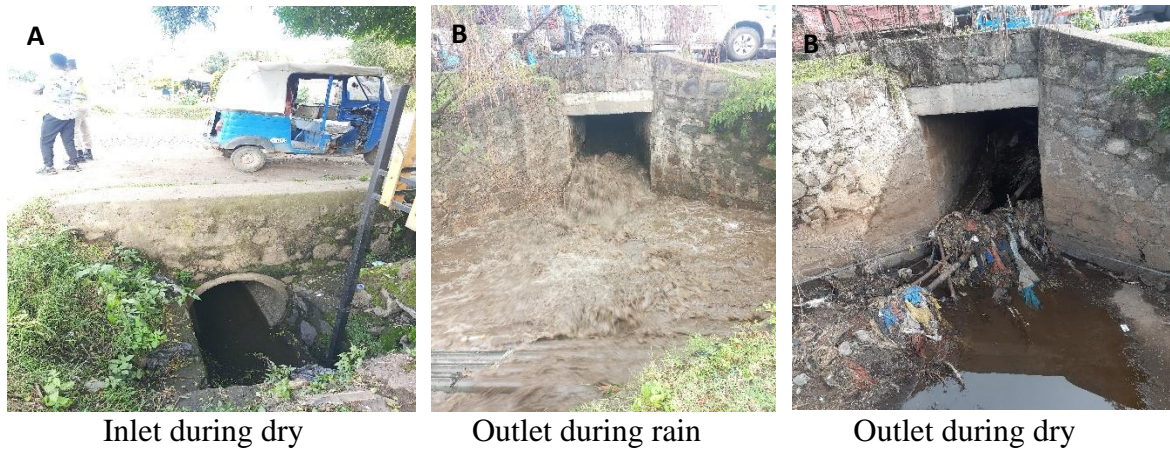
Figure 4. 19: Ziquala culvert inlet and outlet configuration, BC<sub>2</sub>.

Inlet during rain

The culvert at in front of Adea Floor Factory which has a much better capacity of 1.5 m width and 2 m depth can be retained, but needs clearing of the debris in the culvert. This culvert additionally needs modification of inlets as the inlet has less capacity to accommodate the upstream catchment runoff. This area is usually affected by flood rushing from the upper catchment area. Due to the sloping nature of the catchment and insufficient drainage approach inlet structure constructed along the road as a result the asphalt roadway is usually flooded. Proper priority approach inlet structure channel will be recommended to safely manage and transfer the flood to appropriate culvert.

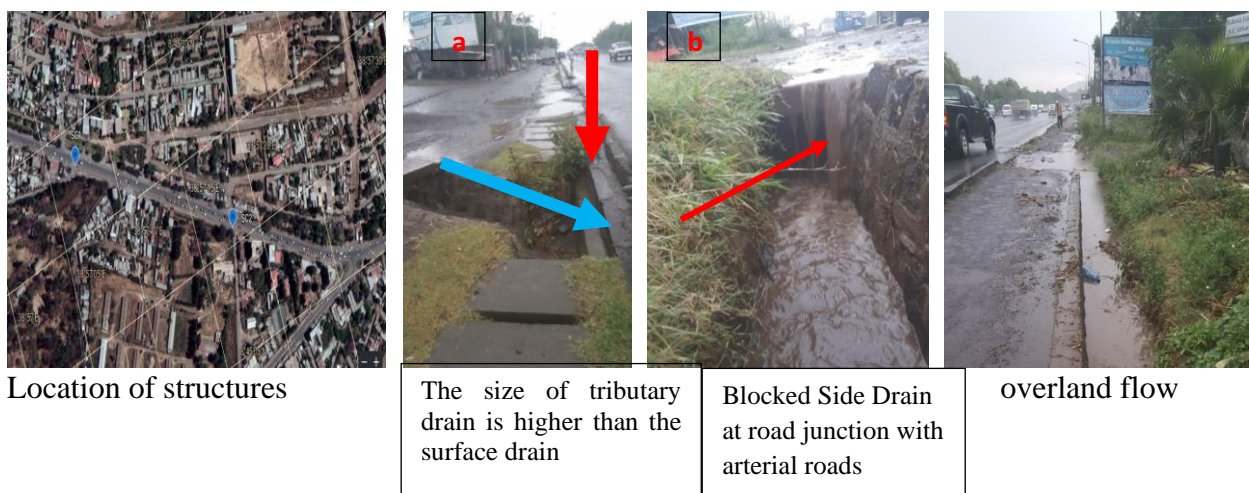
SC<sub>1</sub>: is located in area north of Elfora around Military Camp, Section a: The side drain along the asphalt road is blocked with debris and the surface drain flows and stagnation is visible on the pre-cast slabs at junction to arterial road. Section b: The side drain along the asphalt road is blocked with debris, vegetation & grass. And the storm water flow overland. Section c: The overland flow on the pedestrian re-joins the road surface drain downstream again, but further blocked and the overland flow continues downstream next junction pictures which is around 500 m far.

Figure 4. 21: Main Road slab culvert condition at Military camp.

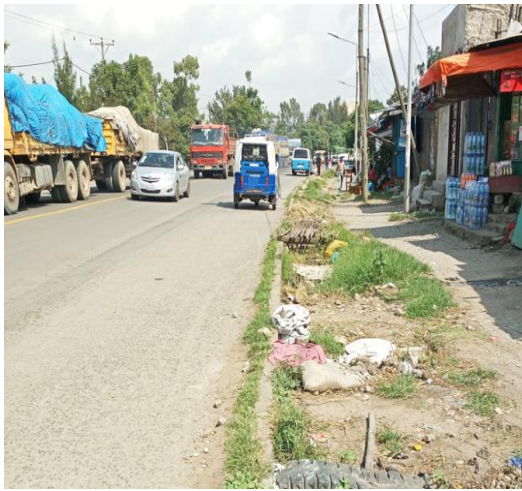
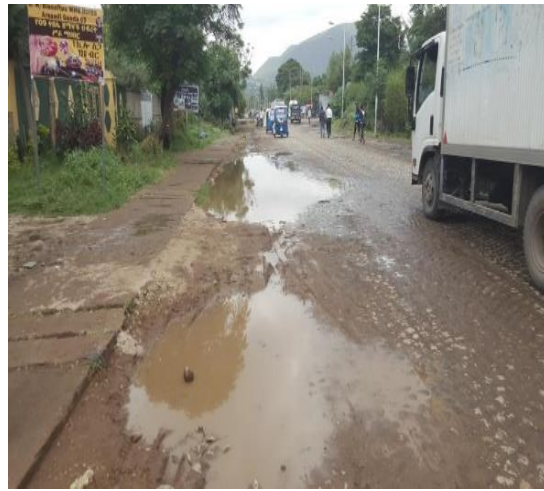
In some parts of the road the curb stones are totally damaged and is not giving proper service it was constructed for, except the newly built Ziquala Joint Road of 1.3 km.

Poor condition of curb stone

Slab cover not receiving surface runoff

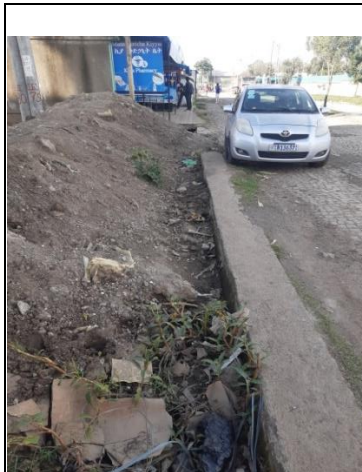
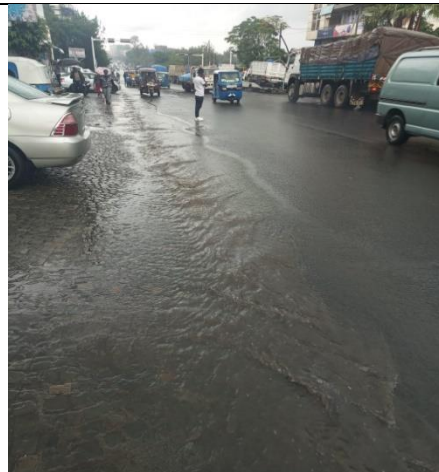
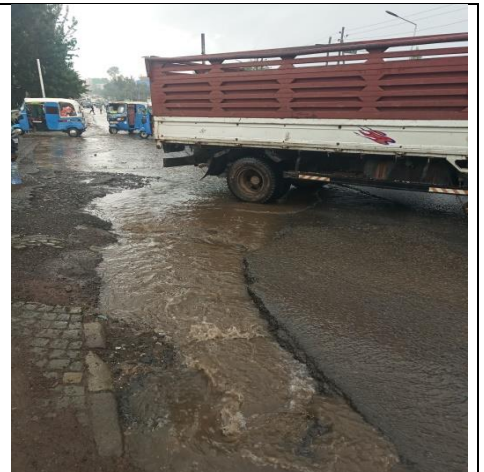
Figure 4.23 (b) also clearly indicates the covered drainage channel is already full of solid waste and even if there were no blockage of surface flow, there is no place for the runoff to flow in the drainages, here it will let the flow to flooding of the surface as well as the surrounding area.

Drainage Chamfer not receiving Surface drains and ditch filled with sediment

Flood flowing on the main road (no side drains)

Road started eroding by surface runoff

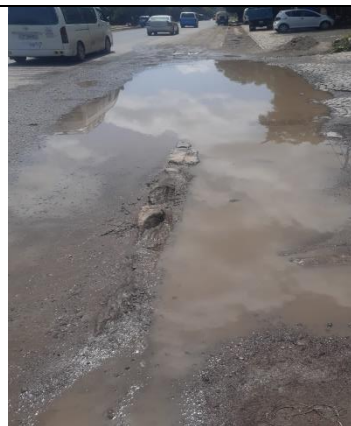
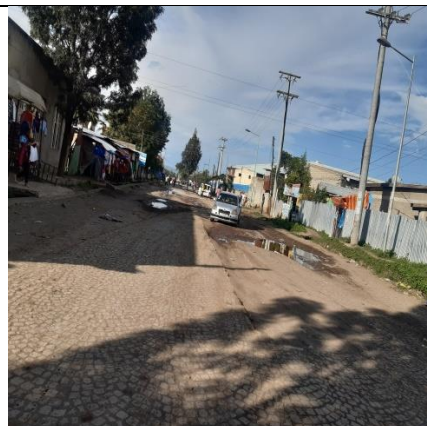
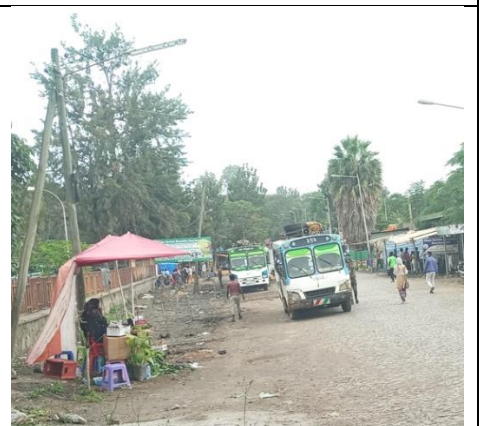
Improper connection of both drainage and road

Defomed Cobblestone road by Flood detention of the surface

Flood prone area with no side drainage
