AN EXPERIMENTAL INVESTIGATION ON THE CAUSES OF FLEXIBLE PAVEMENT
FAILURES: A CASE STUDY ON TARCHA – YALO ROAD SECTION.

A Thesis is submitted to School of Graduate Studies of Jimma University in Partial Fulfillment
of the Requirements for the Degree of Masters of Science in Highway engineering.

Hailemichael Debalke Damota

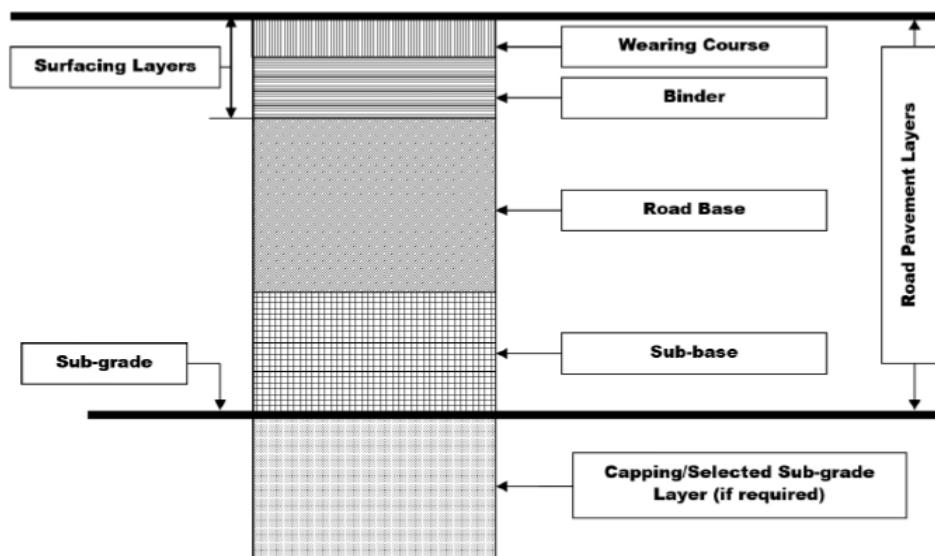
A true flexible pavement yields "elastically" to traffic loads. It is constructed with a bituminous surface treatment or a relatively thin surface of hot mix asphalt (HMA) over one or more unbound base layers on a subgrade. Its strength results from the load-distributing properties of a layer system designed to protect any underlying layer, including the subgrade, from compressive shear failure(17).

Figure 2-1. Flexible pavement profile (18)

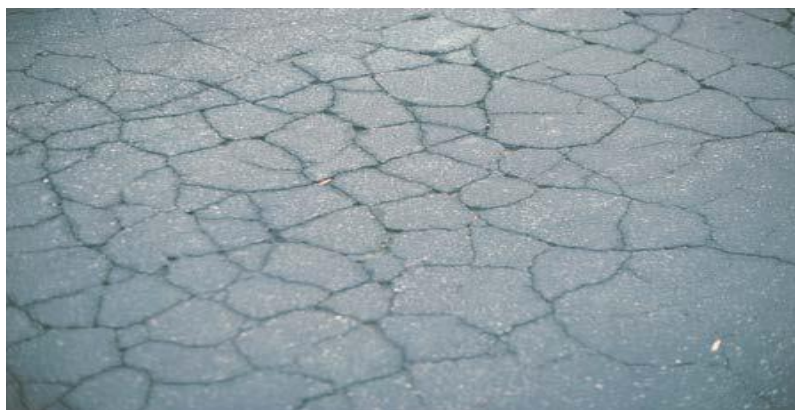
- **Low level of severity (L):**-Fine, longitudinal hairline cracks running parallel to each other with no, or only a few interconnecting cracks. The cracks are not spalled(22).
- **Moderate level of severity (M):**-Further development of light alligator cracks into a pattern or network of cracks that may be lightly spalled(22).
- **Higher level of severity (H):**- Network or pattern cracking has progressed so that the pieces are well defined and spelled at the edges. Some of the pieces may rock under traffic(25).

Figure 2-2 Fatigue Cracking (22)(25)

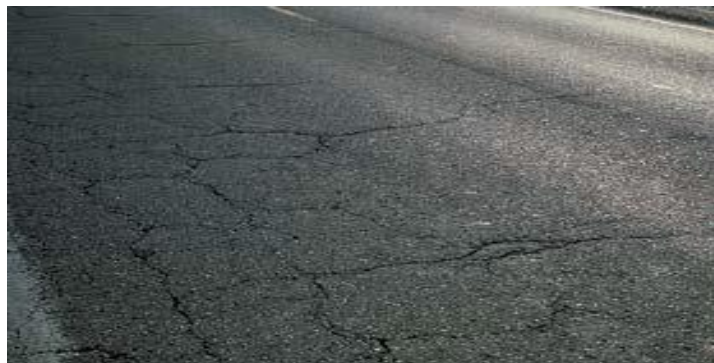
Block cracking is measured in m² given pavement section; however, if areas of different severity levels can be distinguished easily from one another, they should be measured and recorded separately (22)(25).

Figure 2-3 Block Cracking(22)(25)

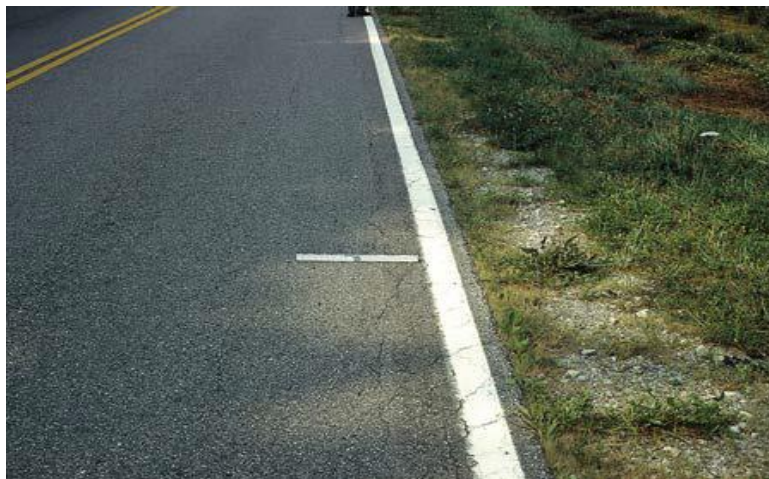
Edge cracking is measure in linear meters (feet) (22).

Figure 2-4 Edge Cracking(22)

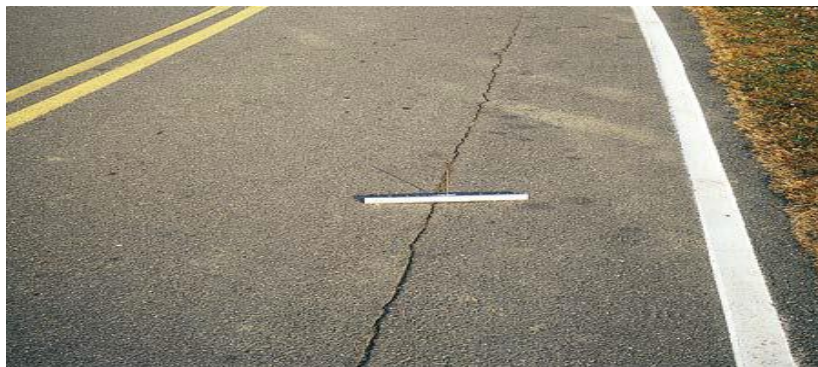
Longitudinal and transverse cracks are measured in linear meters (feet). The length and severity of each crack should be recorded. If the crack does not have the same severity level along its entire length, each portion of the crack having a different severity level should be recorded separately (22).

Figure 2-6 Longitudinal Cracking(22)(28)

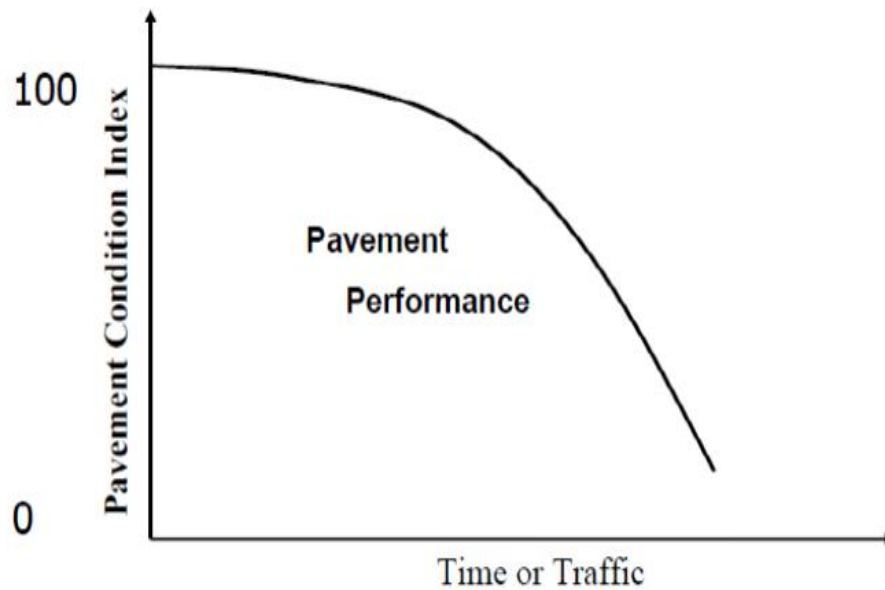
The PCI is a quick method of comparing the overall condition of pavement and magnitude of rehabilitation needs. The following figure shows how pavement condition typically deteriorates over time. The new pavement holds its good condition for a long period, but once it begins to fail; its condition drops rapidly (38).

Figure 2-10. Relationship between pavement condition and time(23)

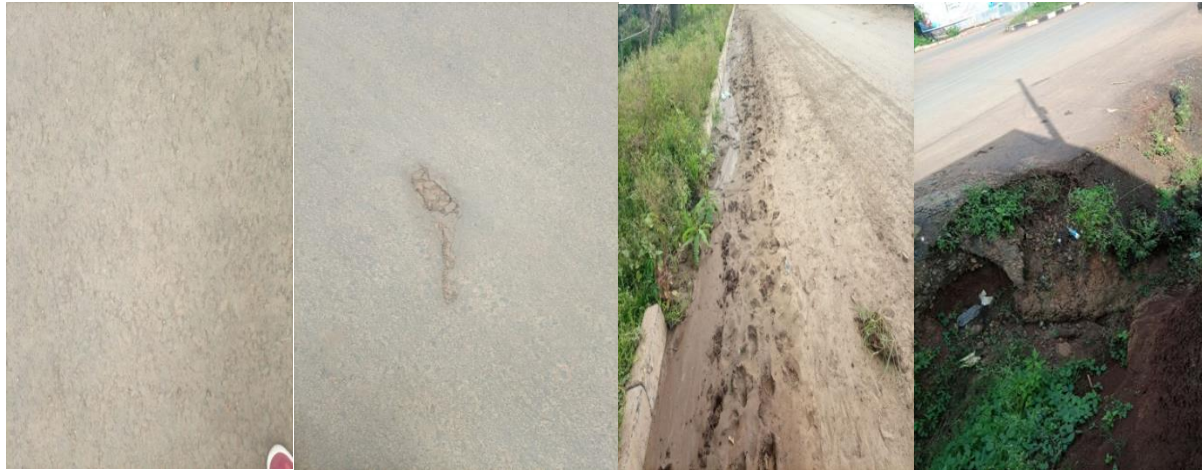
1. **Tarcha-Turi Road segment section (63+900-70+900):-**The road section is the section of study area with paved section. The paved section was seven kilometers. In this section the road has rutting, raveling, bleeding, polishing, edge cracking, potholes and drainage problems.

Figure 3-7 Distresses along Tarcha-Turi segment

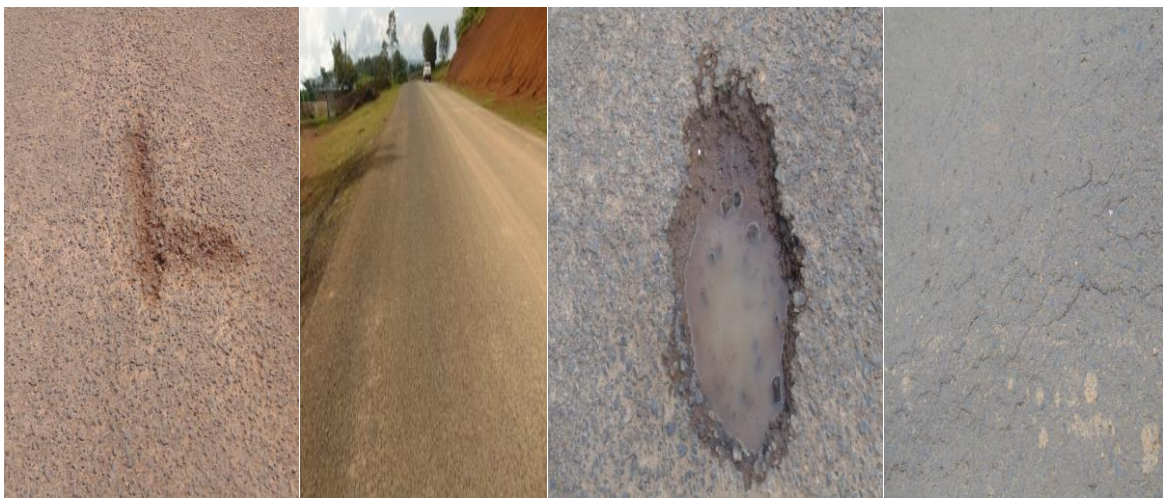
2. Waka-Tulema Segment Section (80+800-89+800): It is the paved section and it has more types of failures. The types of flexible pavement failures were observed in this section were potholes, bleeding, raveling, longitudinal and transverse cracking, rutting, corrugation, shoving, edge cracking, block cracking and depression.

Figure 3-8 Distresses in Waka-Tulema road segment

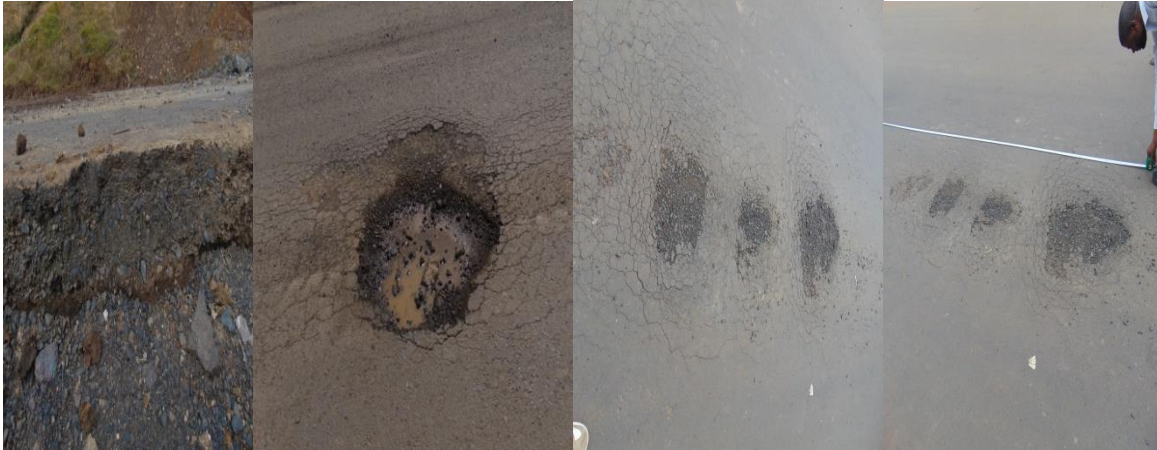
Figure 3-9 Distresses observed in Tulema-Gesa section

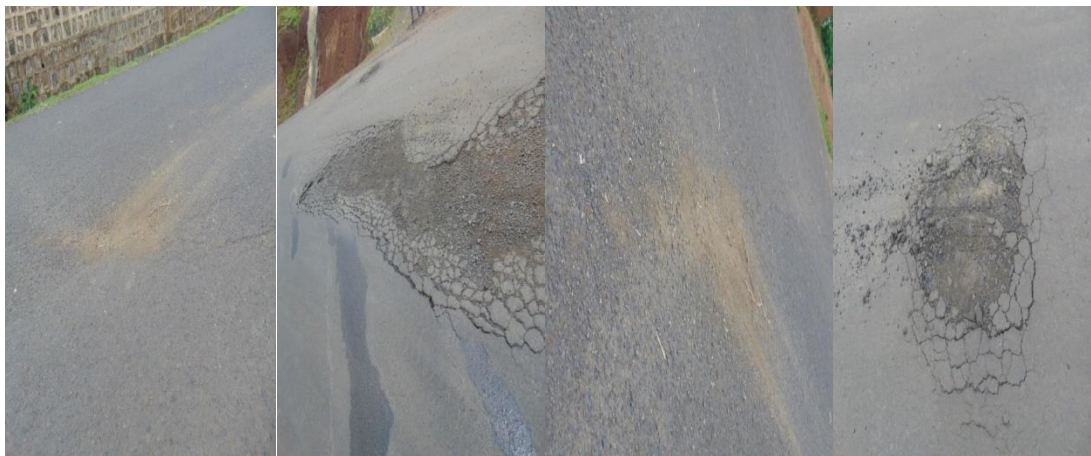
Figure 3-10 Distresses in Gesa-Elabqacho road segment

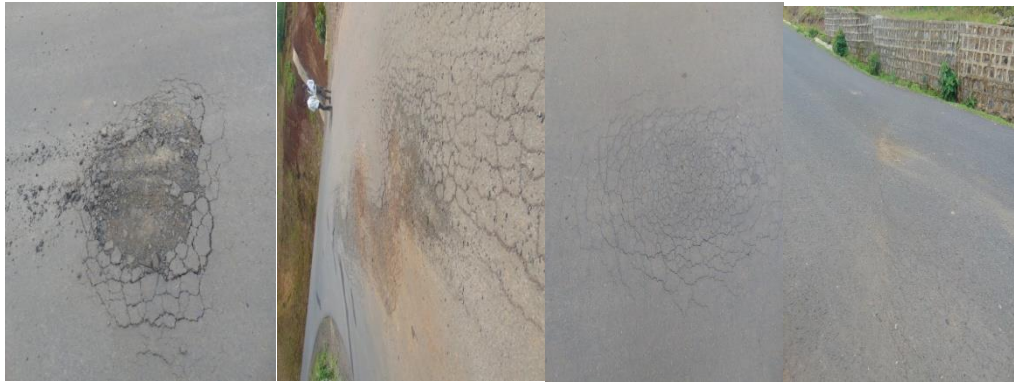
Figure 3-11 Distresses in Elabacho-Yalo road segment

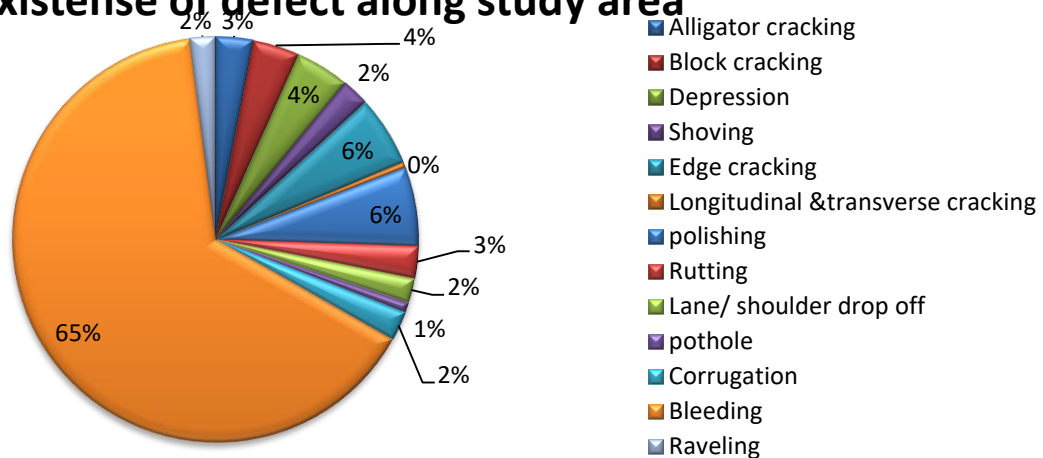
Figure 3-12 Pavement distresses distribution percentage

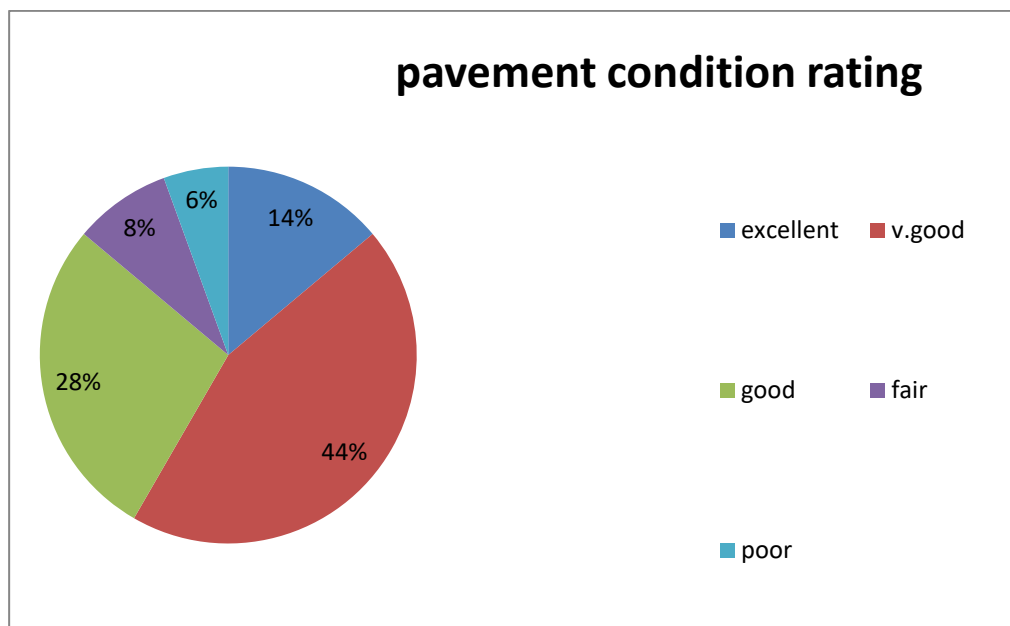
Figure 3-13 Percentage distribution of PCR

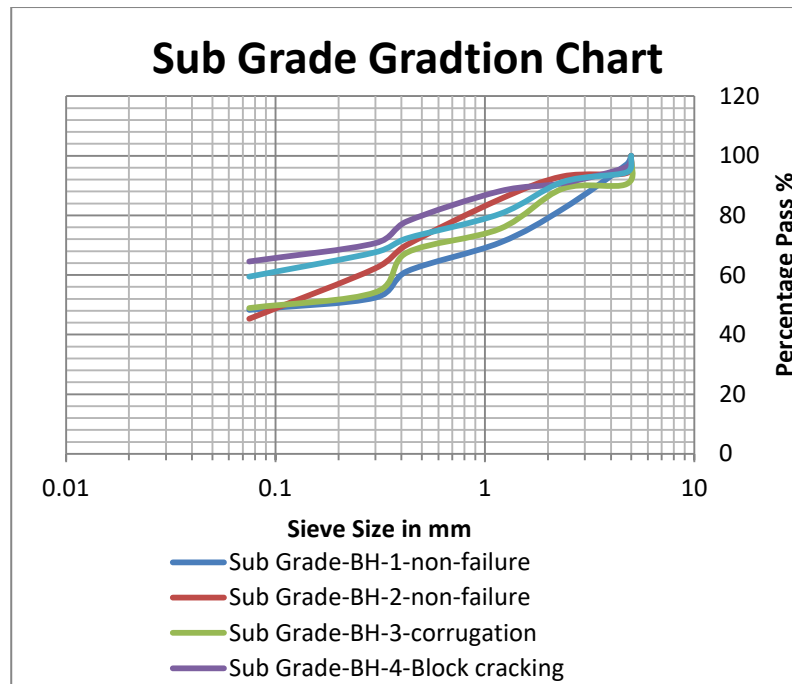
Figure 3-14 the distribution chart of percentage pass of subgrade soil

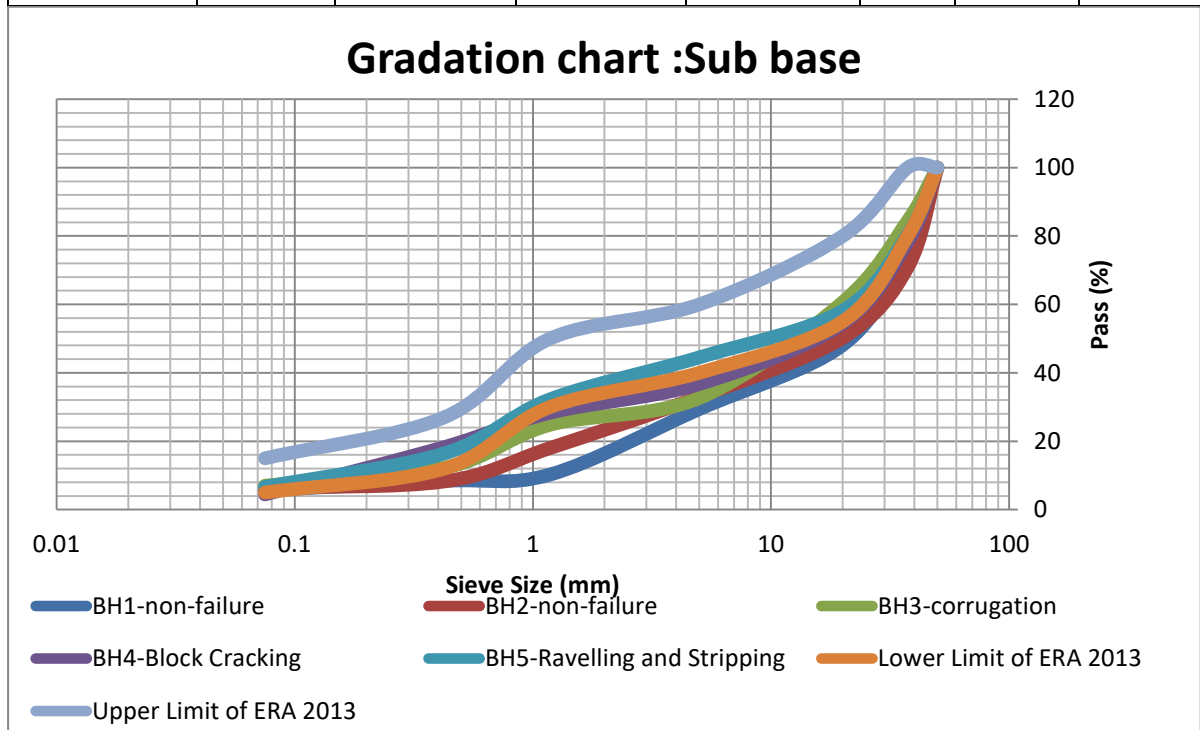
Figure 3-15 the gradation curve chart of sub base

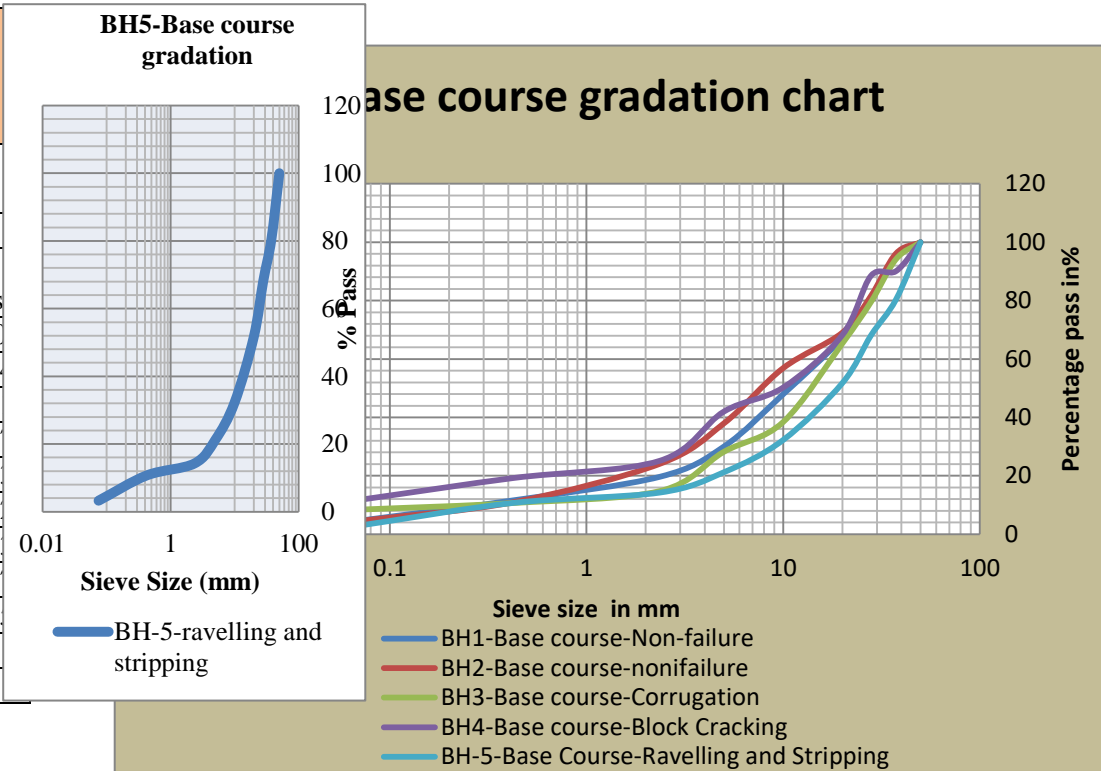
Base course materials Uniformity coefficient and coefficient of curvature

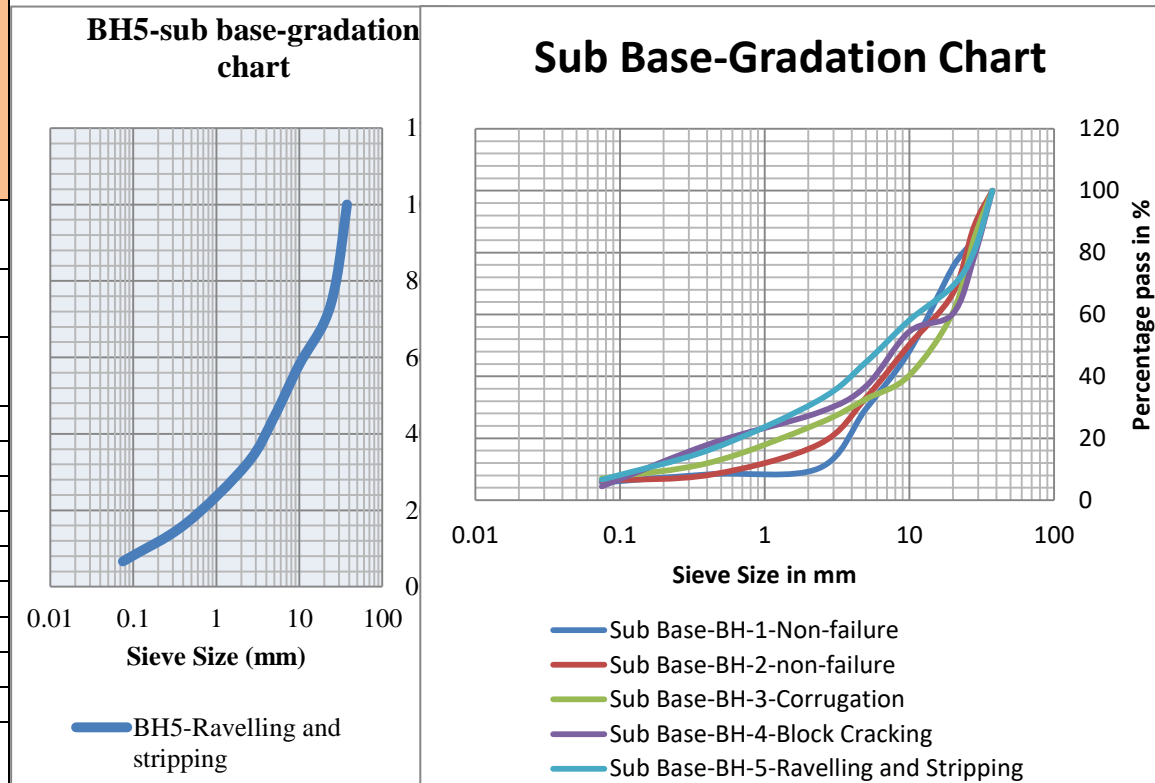
Sub Base materials Uniformity coefficient and coefficient of curvature
