Cause of Poor Drainage Condition and Its Effect on Pavement Performance, Jimma City Hermata Kebele

Independent project Submitted to School of Graduate Studies of Jimma University, in partial fulfillment of the requirements for the Degree of Master of Engineering in Highway Engineering

By:-Nigist Bezabih

July, 2020
Jimma, Ethiopia

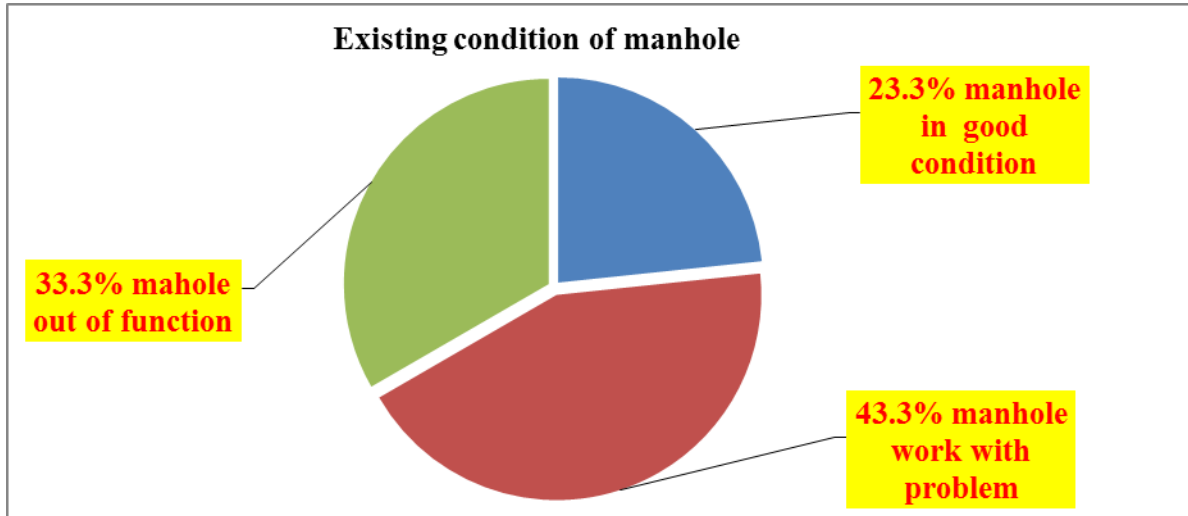
Figure 4.1a Existing condition of manhole and their Percentage Distribution

Existing condition of inlets				
Station	No. of inlets	Inlets in good condition	Inlets work with problem	inlets out of function
1+300_2+000	70	16	33	21

The study area drainage is characterized under curb inlets and pipe drainage. It is known that curb inlets are not easily blocked by debris and silt. But in this site it is observed that most inlets and are closed and manhole fill by debris are major problem shown in area. From field observation and data analysis it is observed that, the existing condition of manhole is insufficient. Due to this, 43.3% of manhole work with problem and 33.3% work out of function and 23.3% work without problem figure 4.1a

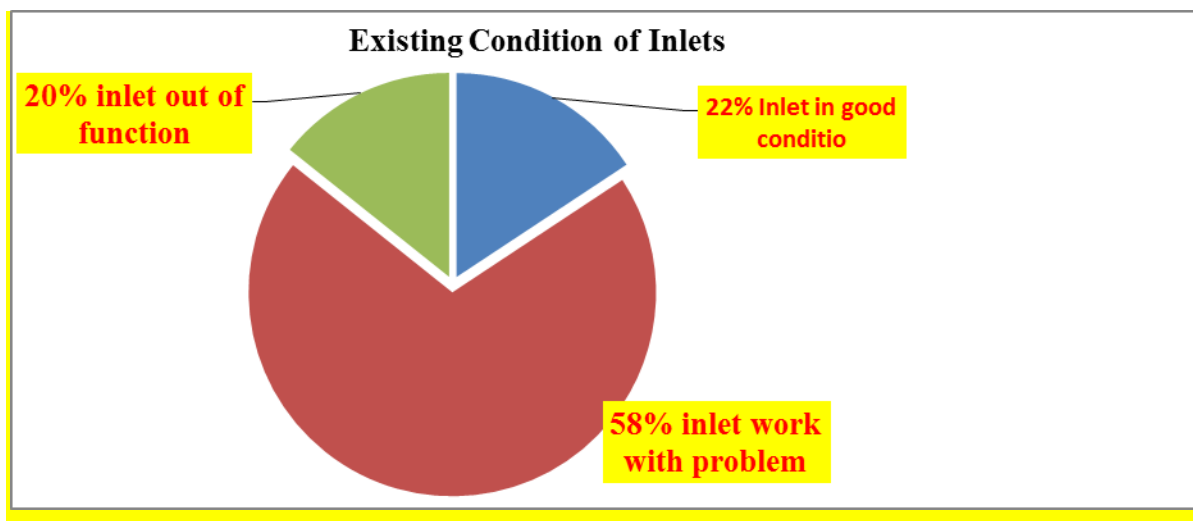
Figure 4.1b Existing Condition of Inlets and their Percentage Distribution

From field observation and data analysis it is observed that, the existing condition of inlet is insufficient. Due to this, 58% of drainage inlets work with problem and 20% work out of function and 23.3% work without problem figure 4.1b

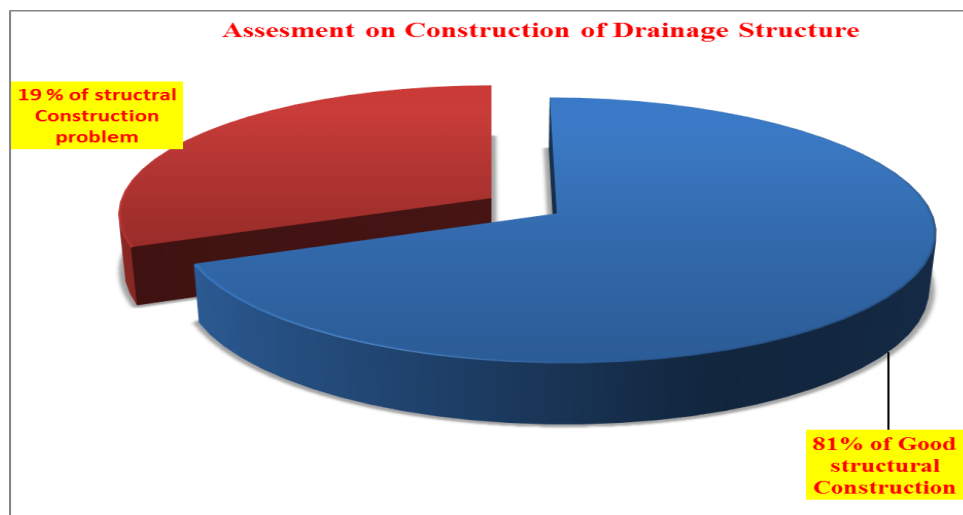
Figure *4.7 Condition of drainage construction and their percentage*

❖ Drainage structure Construction problem
➢   Over design inlet height and small inlet opening
➢   Surface water back to pavement due to poor construction.

From data collection in the field and analysis done it is observed that 21% of drainage structure construction problem and 79% of drainage construction is in good. The drain suffered from low capacity, over and under design inlet height, small inlet opening manhole covers overlap with pavement are lead to poor construction. The figure below shows that percentage of structural construction.
