Jimma University
School of Graduate Studies
Jimma Institute of Technology
School of Civil and Environmental Engineering
Department of Civil Engineering
Construction Engineering and Management Stream

**Assessment of Pavement Distress and Remedial Measures from Addis Ababa
to Gibe River Trunk Road**

By: - Michael Agonafir

October, 2016
Jimma, Ethiopia

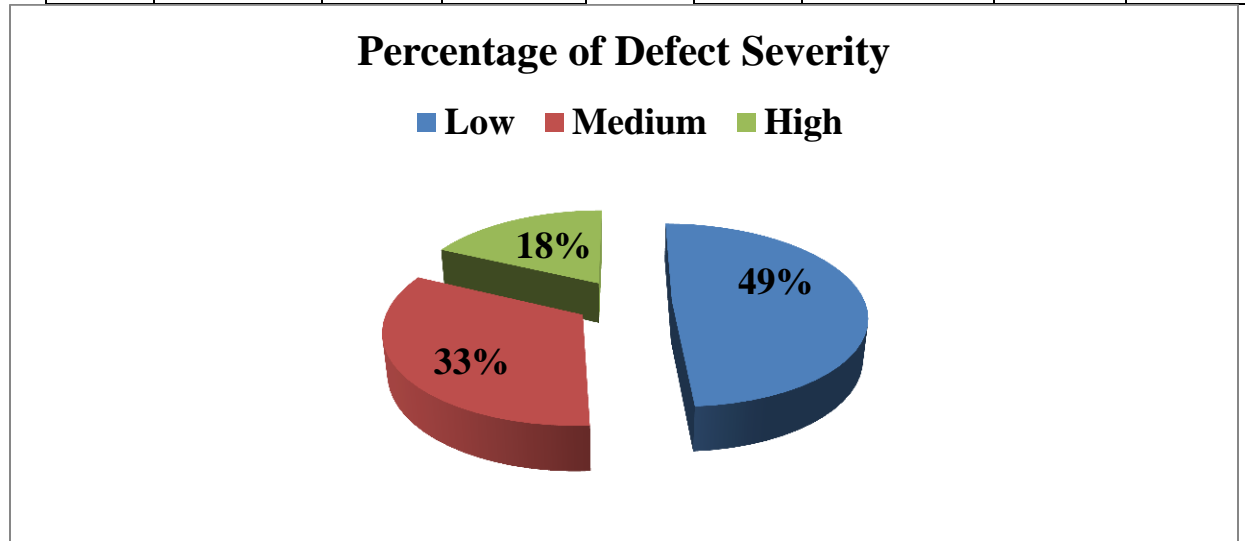
Figure 4.14: Percentage of Defect Severity

Result from Table 4.6 indicates that approximately half (49 %) of the defects have low severity and a round 67 % of the defects have high extent.
