INVESTIGATION OF THE CAUSES OF PREMATURE PAVEMENT FAILURES AND ITS ALTERNATIVE TREATMENTS

One of these roads failed before serving the design period is the Bedele - Metu road upgrading project, Lot - II (50.659 km) trunk road with 20 years design life. However, premature pavement failures have been manifested since the year 2017. The objective of this study is to assess the Causes of the premature pavement failures and also propose its alternative treatments. Hence, a desk study, field visual inspection and in-depth field and laboratory investigations have been undertaken.

The road condition survey indicates the existence of different types of distresses such as: potholes/patch failure, cracking, rutting, depression/failure, raveling/fretting and others. Field and laboratory investigation have been carried out and it shown that low air voids with void in mix result in a wearing course material <3%, such as 1%, that indicates the possible factor for occurrence premature pavement deformation. Also, insufficient surfacing layer thickness, such as 11.34 mm thickness difference would be the possible causes for the formation of surface deformation and workmanship problem of the asphalt

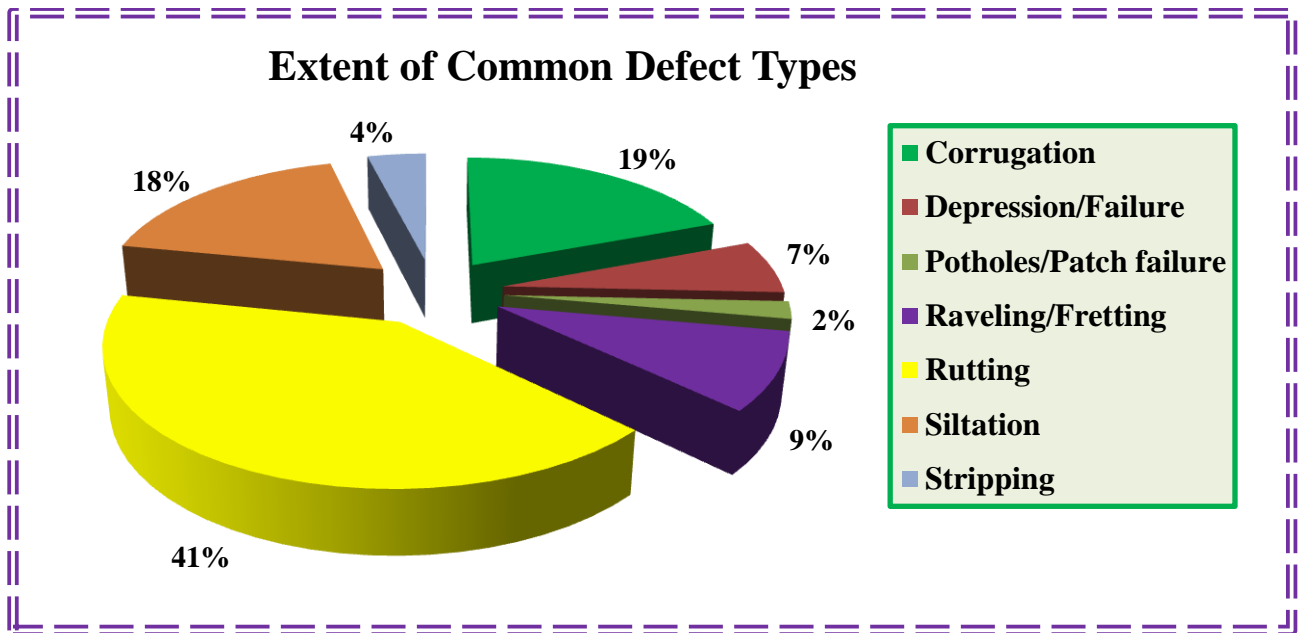
Figure 4.3: The percentage of common defects types with their extent along Bedele – Metu road upgrading project

Rutting (41%) and potholes/patch failure (2%) defect type are categorized under first and last based on their extent of which the defects are availing on the study area as indicated in figure 4.3. In addition, the severity level of those road defects have a ranking half percentage are grouped under severity level -2 (50%) with potholes/patch failure defect type (85%) as displayed above.

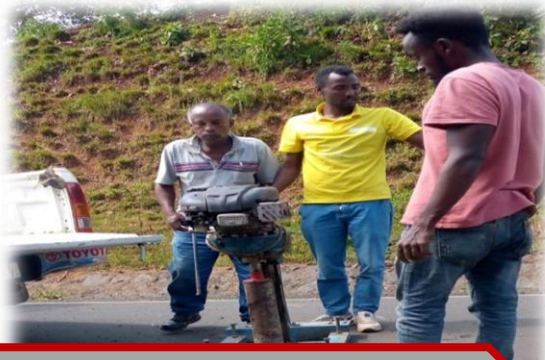
- Station: 64+015
- Longitude: 35.90112
- Latitude: 8.36501
- Defect Type: Normal Section
- Test No.: DCP02
- Pictured by: Eng. Asrat Getaye
