## Improving degradation resistance of ensete ventricosum fibre in cement-based composites through fibre surface modification

In recent years, natural fibre cementitious composites (NFCC) have gained popularity worldwide because of their potential application as low-cost construction materials. Despite the wide range of applications for NFCC, their long-term performance, i.e., durability under various exposure conditions, remains an open question. Natural fibres in a cementitious matrix may degrade over time as a result of the alkalinity of the cement matrix. In this study, Ensete ventricosum (Ev) fibre was treated with alkaline (NaOH) and hot-water to increase its resistance to alkaline attack. Fourier-transform infrared spectroscopy, X-ray diffraction, scanning electron microscopy (SEM), physical, and mechanical tests were performed on fibre bundles to evaluate the effect of surface treatment on fibre performance. After undergoing 0 and 25 wet-dry cycles, the composites reinforced with raw and treated Ev fibres were tested in a four-point bending configuration. In order to investigate cracking and failure behaviour, Digital Image Correlation and Acoustic Emission techniques were

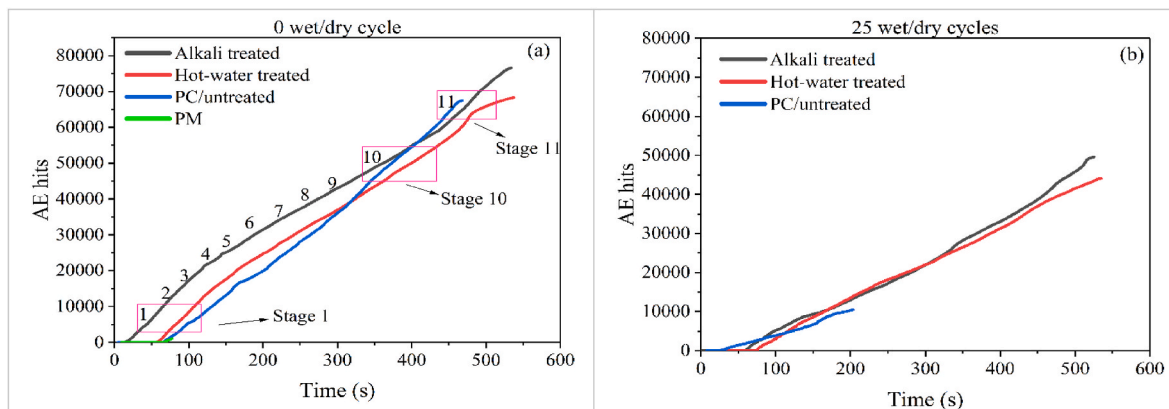
Fig. 11. AE activity vs. time (a) before wet/dry cycles, (b) after 25 wet/dry cycles.

**3.2.6.1. Total AE activity.** Fig. 11 shows cumulative AE activity vs. time for the whole duration of the mechanical test, before and after 25 wet/dry cycles for typical specimens. The AE activity of typical raw, hot-water, and alkali treated Ev fibre specimens before wet/dry cycling accumulated over 67,000, 68,000, and 76,000 hits respectively (Fig. 11 (a)), while the cumulative AE activity of the plain mortar was negligible since it failed by one single crack, without the numerous events of multiple cracking and fibre pull-out mechanisms. After 25 wet/dry cycles, the AE hits of the raw Ev fibre specimens decreased to less than 11,000 (Fig. 11 (b)). The AE hits for hot-water and alkali treated specimens, on the other hand, still showed lower activity after the wet/dry cycles, reaching 44,000 and 49,000, respectively.

This study used the total number of events, and AE parameters such as RT and AF, to analyse damage mechanisms. In order to check the possible shift of the AE parameters relatively to the load, AE parameters were considered in eleven cluster steps in this study: from Stage 1 (initial) which corresponds to low-load activities, to Stage 10 (peak stage) which corresponds to peak-load activities, and finally to Stage 11 which corresponds to activities after load drop (beam failure) (Fig. 11 (a)). Fig. 12 shows the averages of the AE parameters for the 11 loading stages.

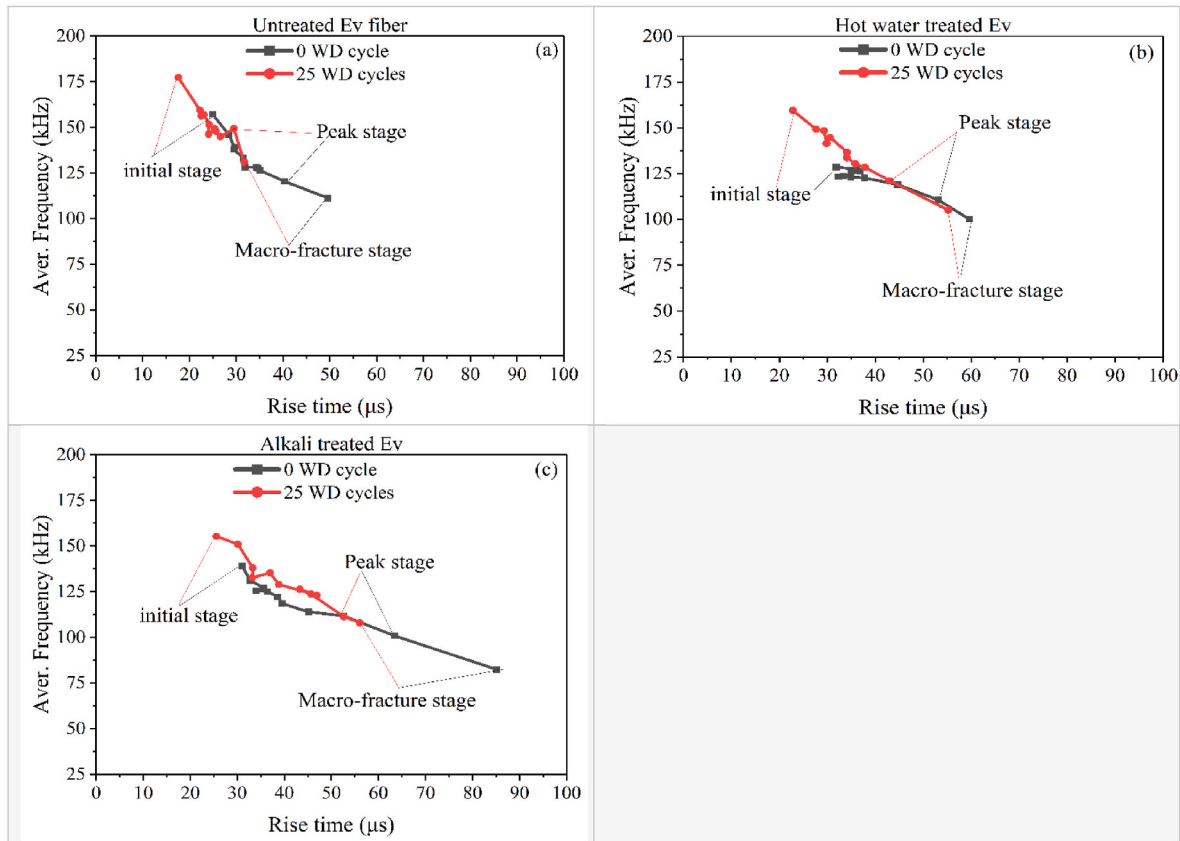
Fig. 12. Average frequency vs. rise time (a) raw Ev, (b) hot-water treated Ev, (c) alkali treated Ev.

The AE analysis of the PC specimens (raw fibre) began with a high AF (>150 kHz) and short RT (25  $\mu$ s) before wet/dry cycling, see "initial stage" in Fig. 12 (a). The ACK theory suggests that at low loads cracking of the brittle cement matrix is dominant, implying that the early AE signals originate from this mechanism [60]. There is a gradual shift to lower frequencies and higher RT values from stage to stage, implying also a smooth transition on the actual fracture mechanism until stage 9 (pre-peak). During the peak stage (10) and post-peak (macro-fracture) stage of loading, there is a stronger shift of AE parameters which indicates a transition from matrix cracking to fibre pull-out activities. This shift is compatible with the relevant RILEM recommendation [59], signifying the gradual transition from tensile to shear mechanisms.

It is interesting to notice the behaviour after 25 wet/dry cycles. The initial loading stage of the AE parameters shows higher AF (175 kHz) and shorter RT (approximately 15  $\mu$ s) than the reference specimen (Fig. 12 (a)). This indicates that fibres are not contributing to the reinforcement and the material tends to fail in pure cracking due to tension. In principle, fibres help to increase the load bearing capacity of cementitious materials, but if the interphase between the fibres and matrix is weakened by wet/dry cycles, then the fibres do not contribute to the load bearing capacity and the material fails in pure cracking typically, with fewer cracks. This has been supported by previous studies on corrosion-affected steel reinforced concrete and other cementitious composites [61]. It is shown that even at low load (1st stage <10 % of maximum load) the partial deterioration of the reinforcement effect is obvious through the AE parameters before any new load-induced damage is inflicted and no transient load drop or other cracking sign is visible in any other way. Later on, the AE parameters again tend to gradually shift towards the "shear" side of the graph as the pull-out events tend to dominate.

The situation is similar for the different treatments like hot water (Fig. 12 (b)) and alkali (Fig. 12 (c)). In all cases, there is a gradual transition from tensile to shear AE signals during loading, while after the durability deterioration, a strong shift to higher frequencies and shorter signals was noticed even from the initial loading stage. This shift can be regarded as a prediction for the final lower mechanical properties of the

deteriorated samples, as indeed all samples after the exposure to wet/dry conditions exhibited clearly lower mechanical capacity. Furthermore, for the durability exposed specimens, the untreated fibre type (Fig. 12 (a)) showed the highest frequency (above 175 kHz, as aforementioned) implying the most deteriorated reinforcement effectiveness and indeed it also exhibited the highest drop of load bearing capacity (ultimate load just 0.3 kN, Table 3) after the durability cycles. Even before the deterioration (control values, Table 3) and despite the small load capacity differences at that stage, it can also be noted that the raw ones (untreated) exhibited higher frequency (above 150 kHz vs. 125–130 kHz) and shorter RT (25  $\mu\text{s}$  vs. 30–35  $\mu\text{s}$ ) than both treated types resulting also in slightly lower mechanical capacity for the raw fibre specimens. The above observations shed light to the loading and deteriorating mechanisms of the different types of materials with or without wet/dry cycles while they also demonstrate for the first time the relevance of the AE classification in these NFRC composites.
